historic Drane, James, House

Continuation sheet Drane, James, House Item number 7 Page 1  
Garrett County, Maryland

JAMES DRANE HOUSE  
 ACCIDENT, MARYLAND  
 GARRETT COUNTY

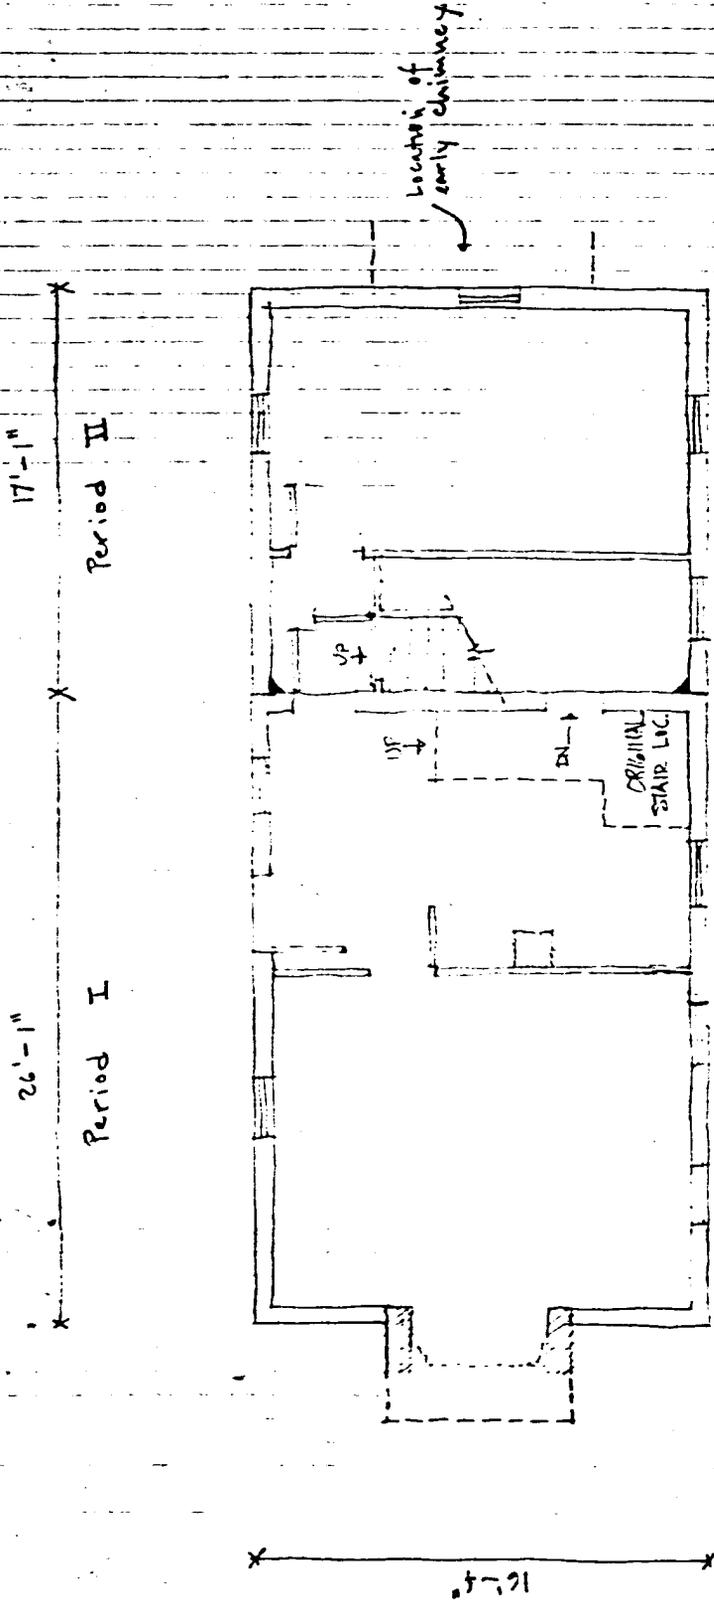
Measured Sketch Plan

6 10 Called North

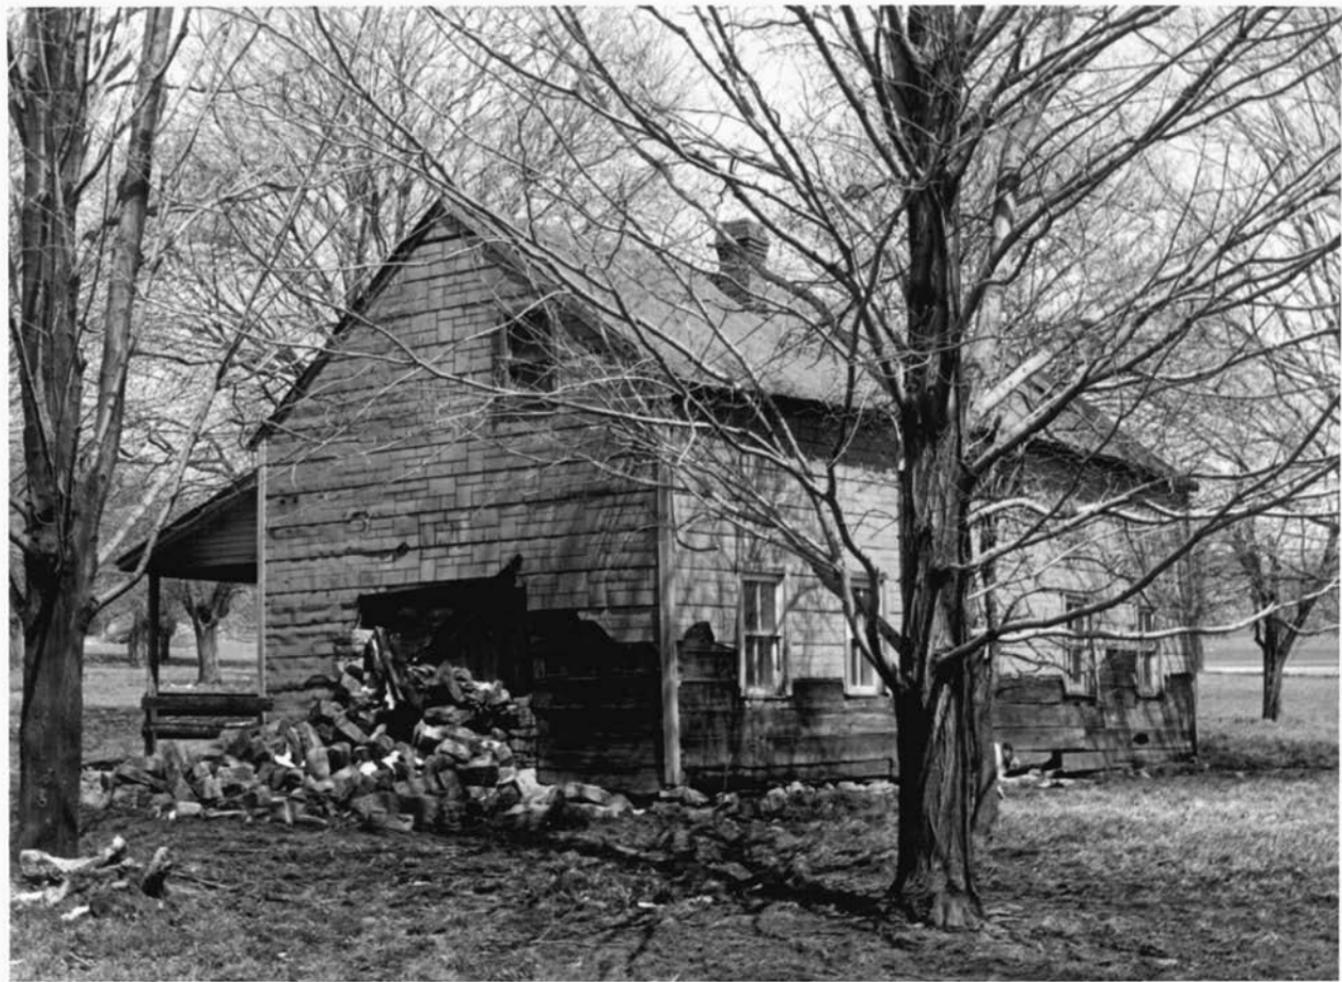
7  
James Drive Log Home  
Bridgewater  
Asa Hunt  
Garrett Co., Md  
SW View  
Apr. 1, 1974

pre 1800 log house  
listed 11 January 85

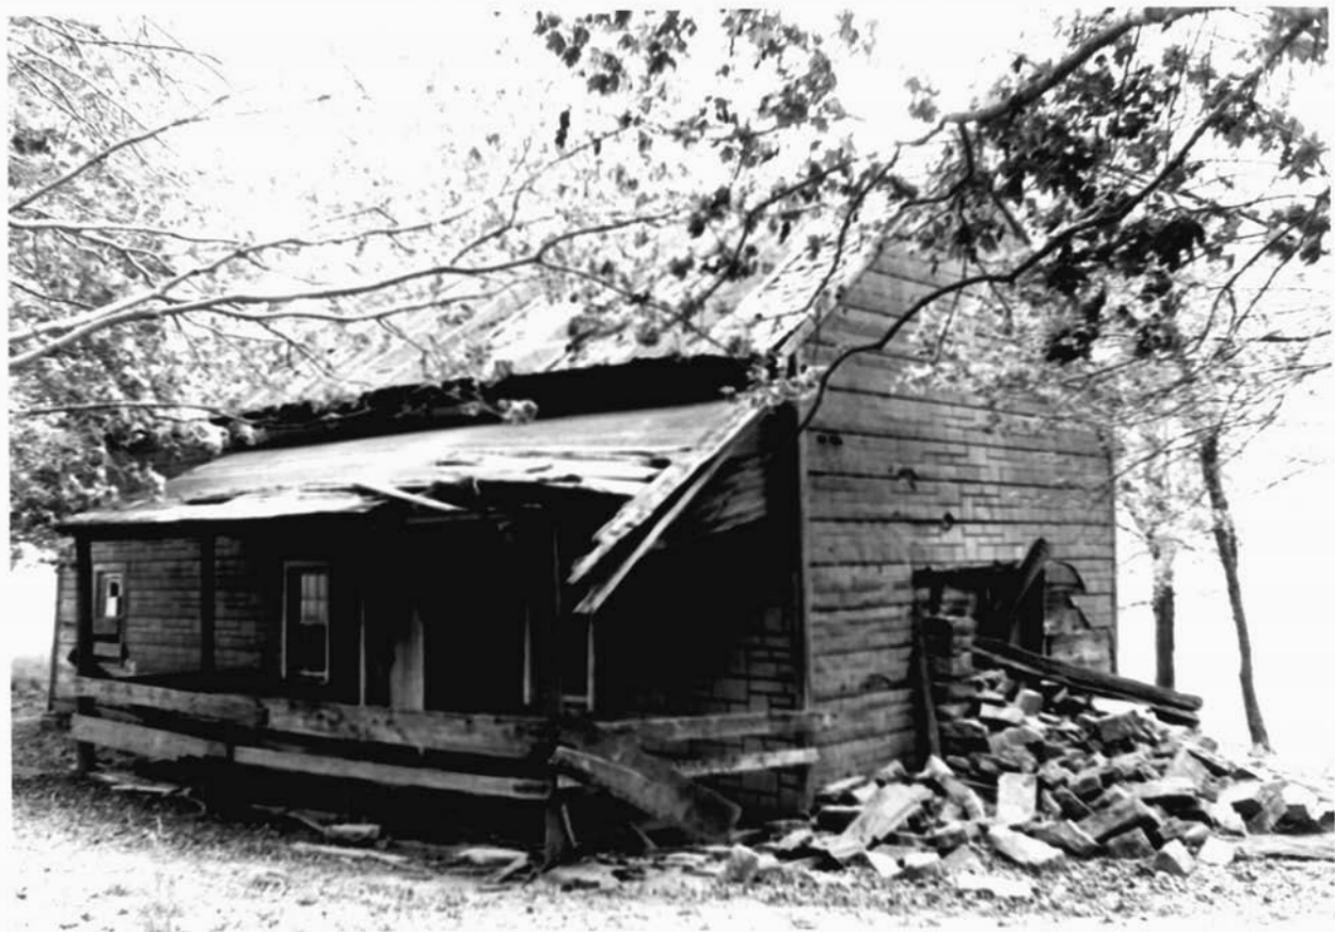
DRAWN HOUSE

New Marker, from W

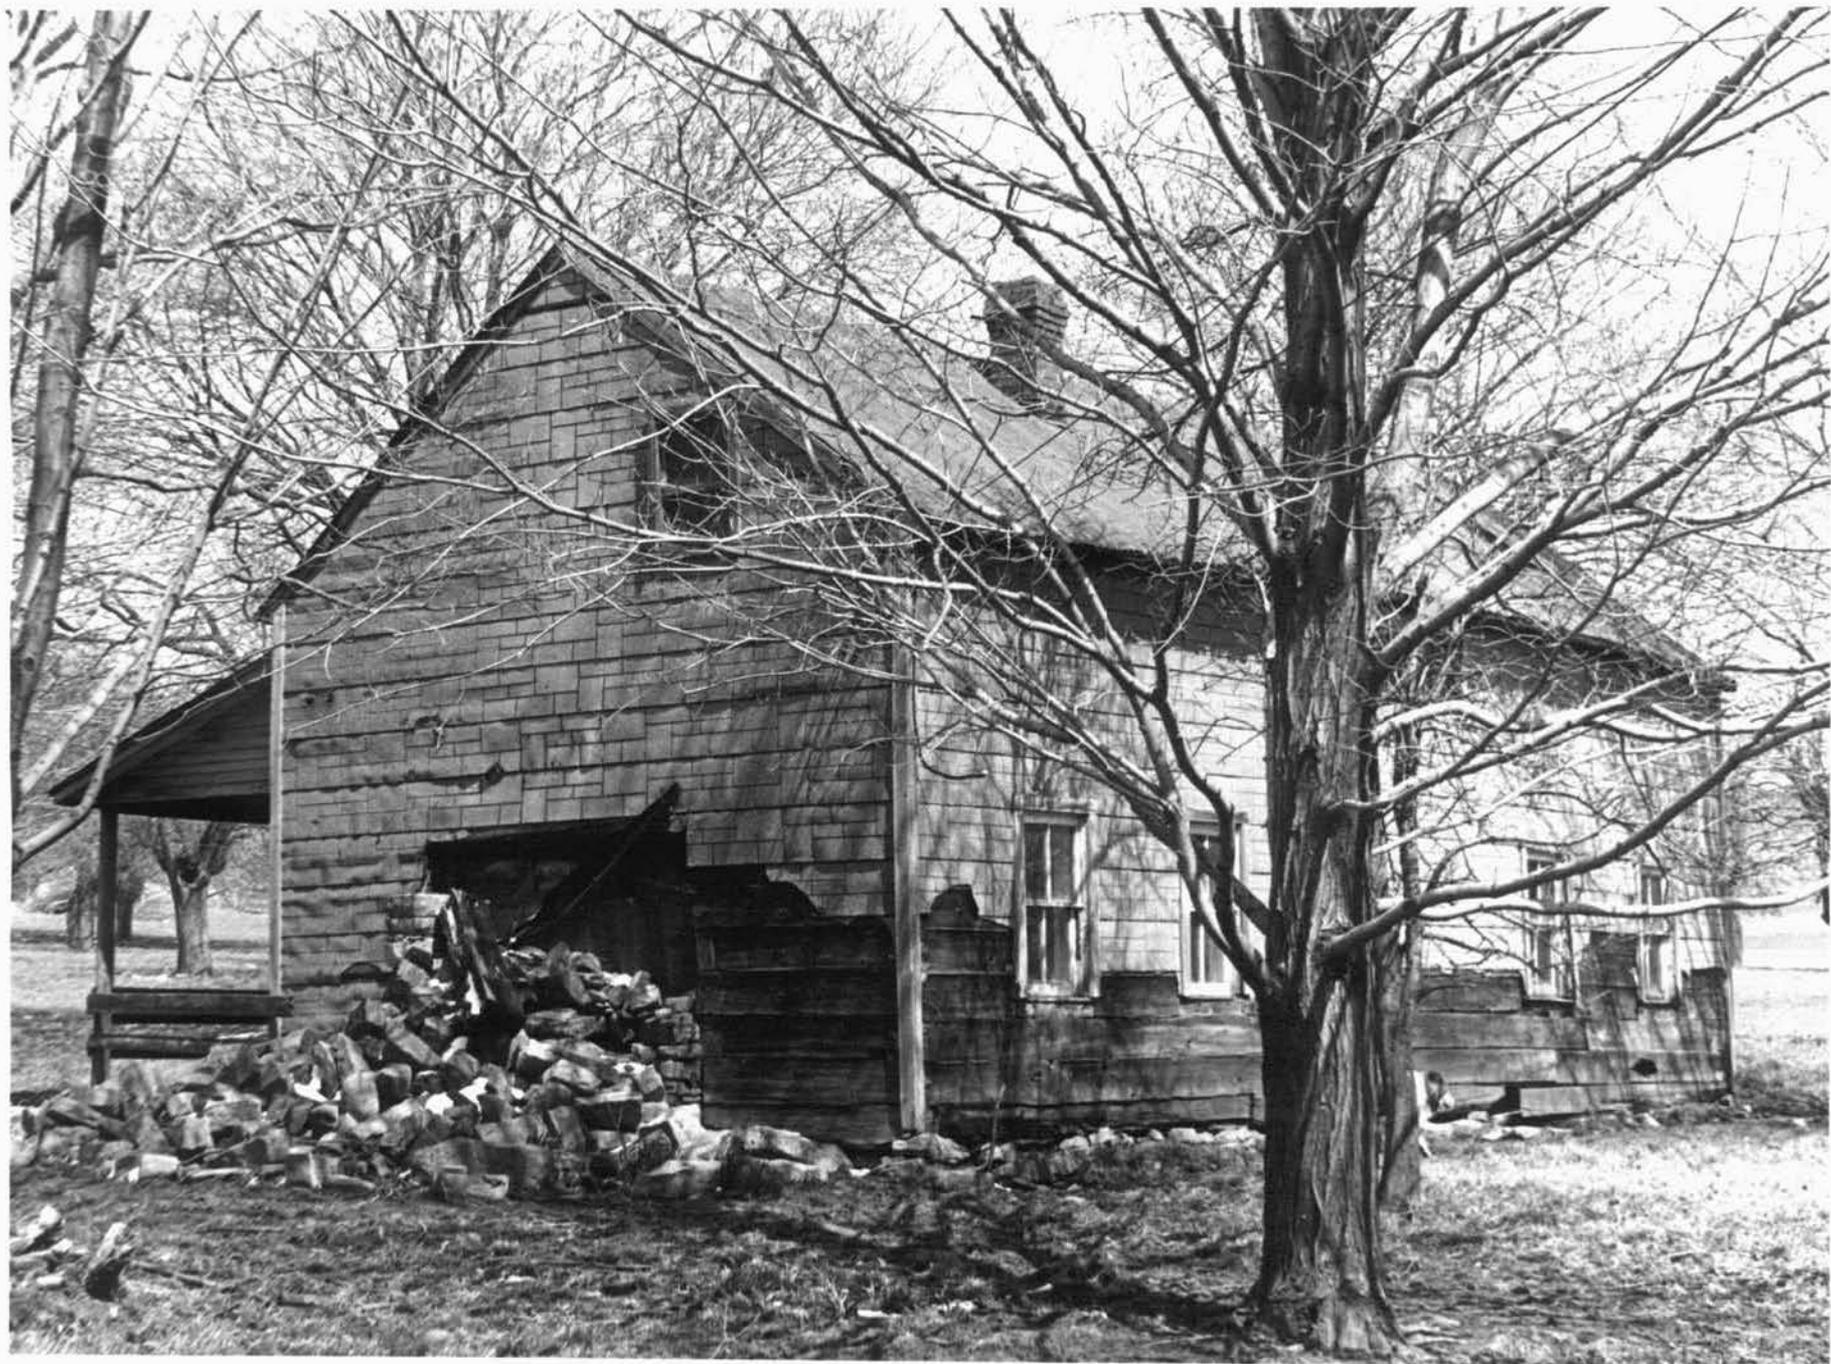
G - II-B-010

Drone House  
east of Accident  
Garrett Co. Md  
1924

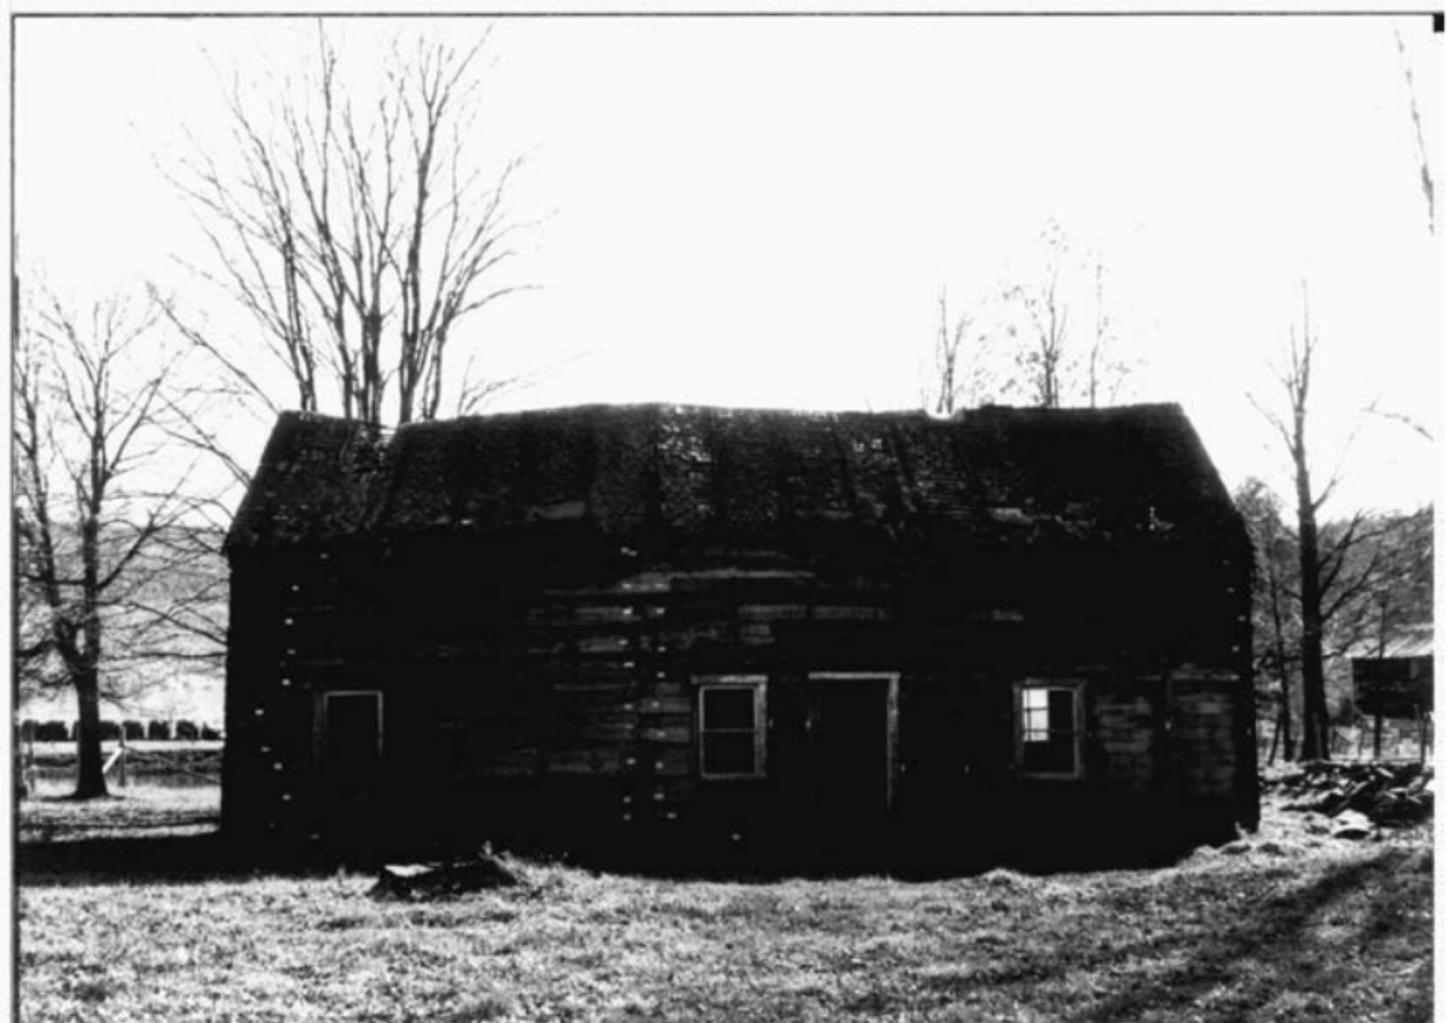
G-11-B-010

The principal facade of the original section of the house faces north toward the cemetery. The door is offset to east of the center and is flanked by a single window on either side. The east window is fitted with 6/6 sash while the west window has replaced 2/2 sash dating to the late 19th or 20th century. There are no windows in the low second story on this facade. Plain, wide weatherboard siding extends the full length of this facade. These boards are secured with machine nails and continue uninterrupted across the seam between the original house and the addition. The outline of an early gable roofed entrance porch is visible above the north door; a more recent lean-to porch in a state of collapse extends across all three bays of the original building.

north side  
front

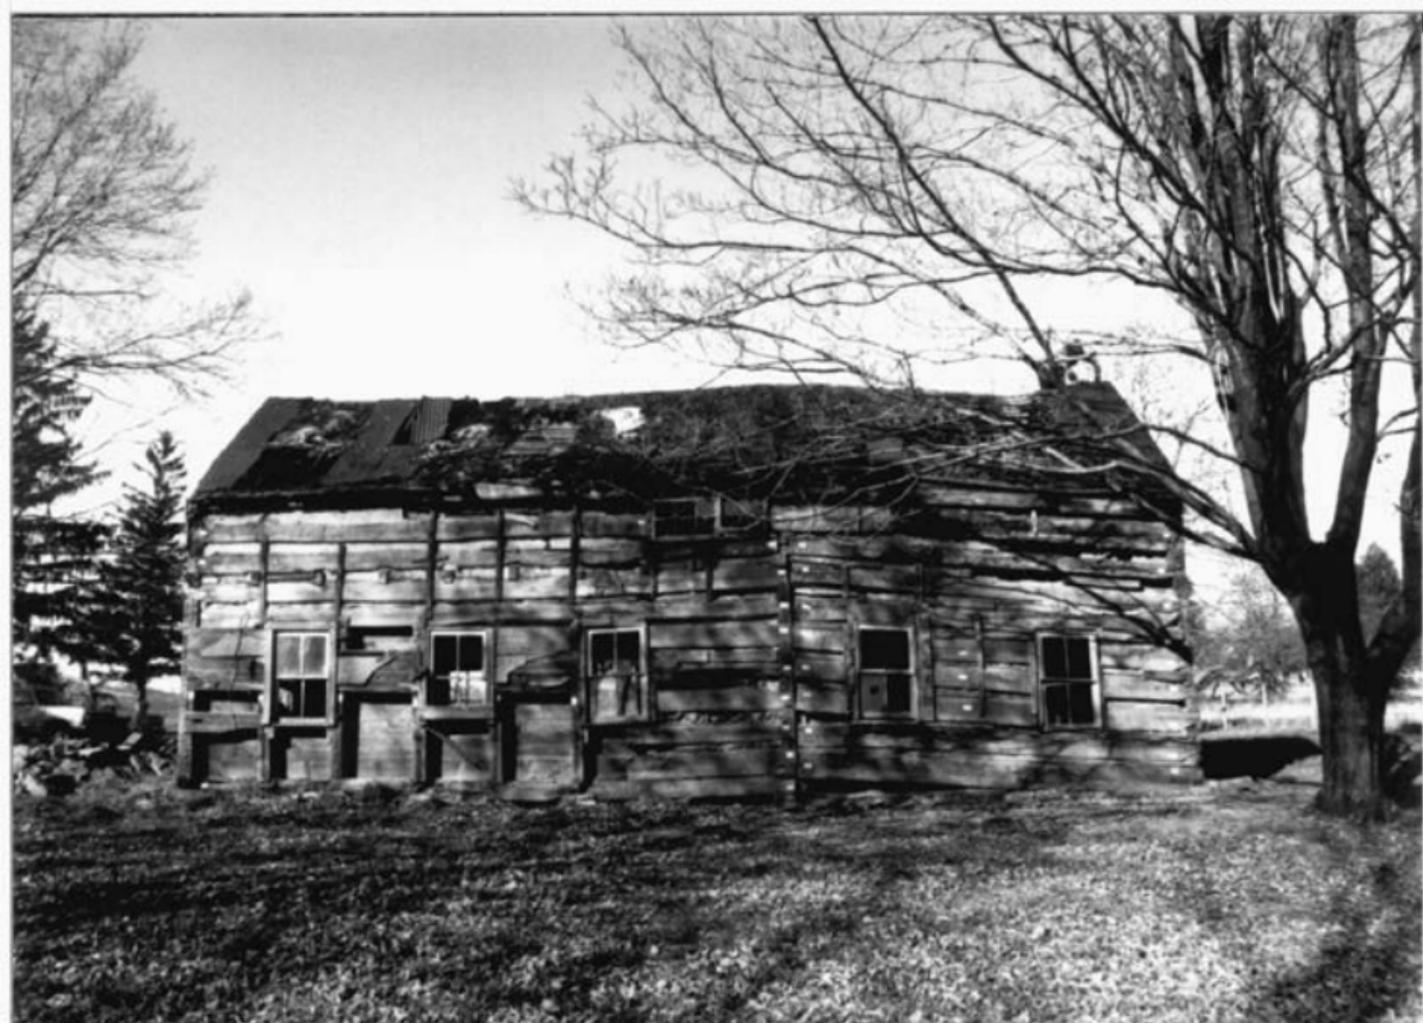
G-11-B-010

On the south or rear facade of the original house, there are three windows with replaced 2/2 sash on the first story; a long rectangular window opening to east of center pierces the low second story. This opening is fitted with a narrow double sash window mounted on its side. Small gaps and knotholes in the siding on this facade make it possible to determine that the lower portion of this wall is constructed of both heavy timber frame and of horizontal log. The log construction extends from the original southeast corner of the building approximately seven feet to the west and then is abruptly terminated below the sill of the east window. The upper portion of the wall is entirely of log construction.

Southside

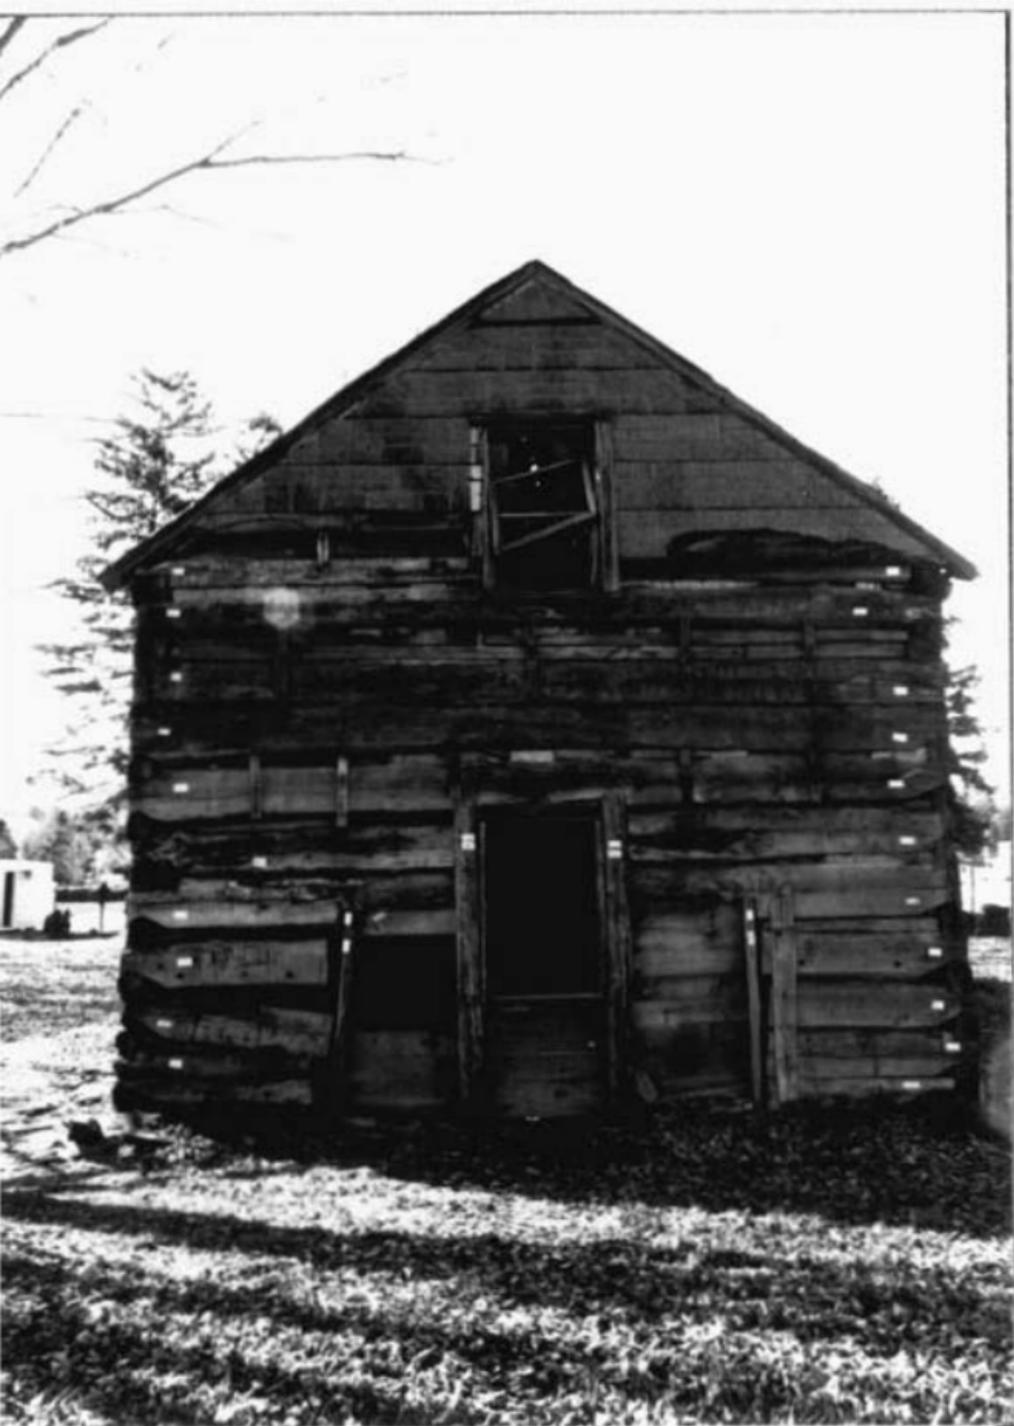
G-11-B-010

West side  
(East)

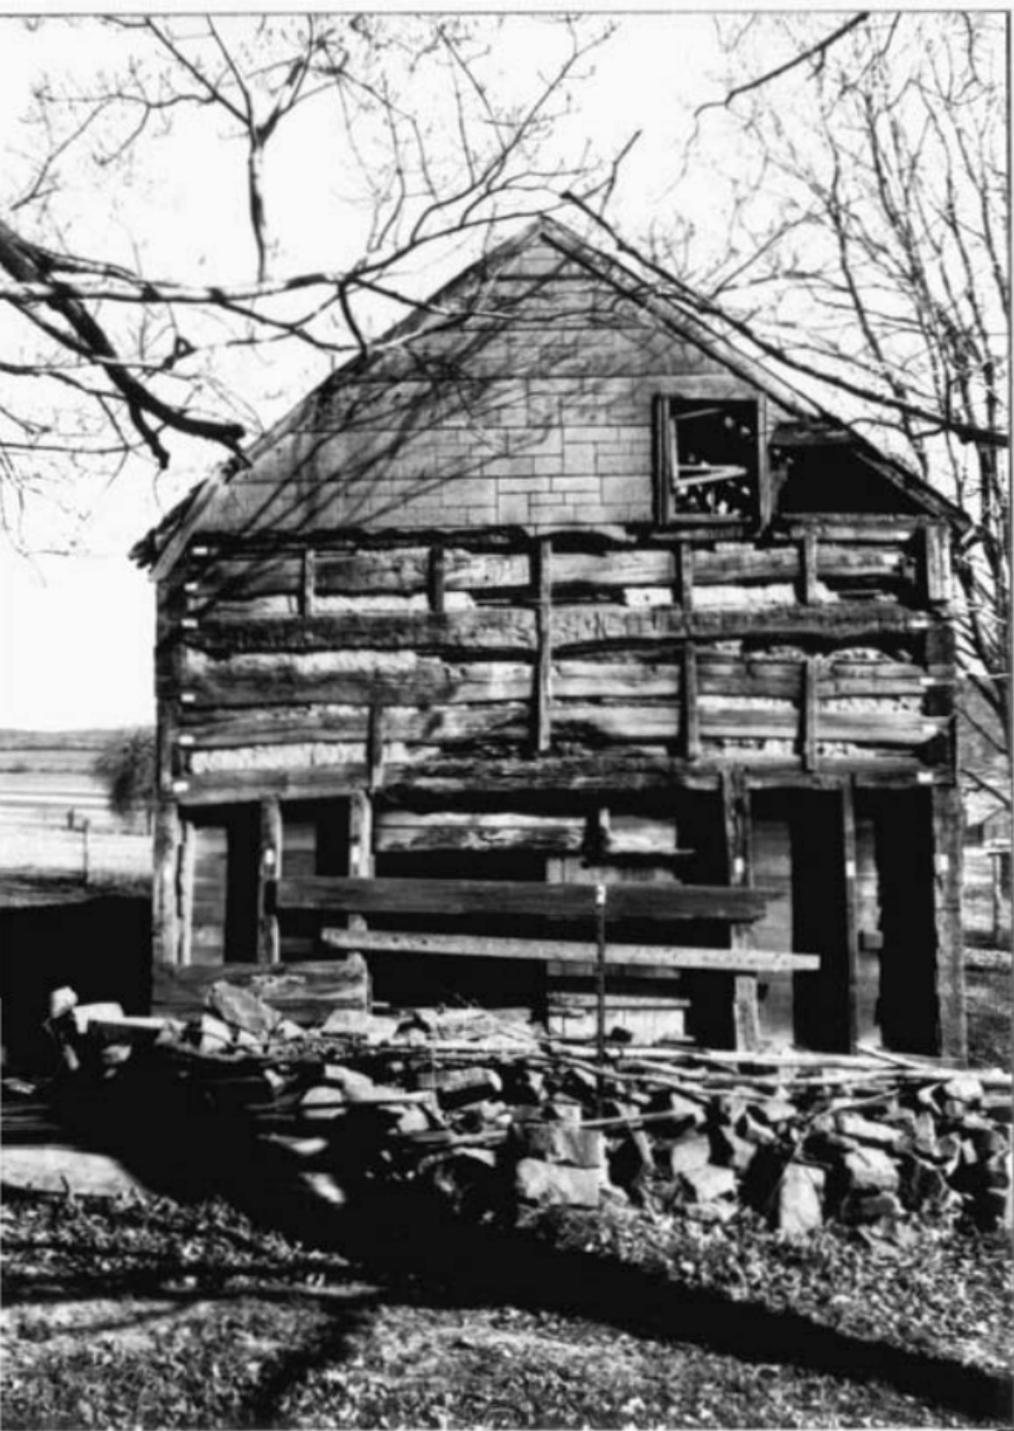
G-11-B-000

A large exterior stone chimney on the west gable wall collapsed in 1970, but remains partially intact. The approximate form of the large firebox remains discernible and the heavy wood fireplace lintel is lying among the fallen stones. Portions of the lower wall are exposed where several weatherboards have fallen off to the south of the chimney, revealing heavy timber framing.

west side
