National Register of Historic Places Inventory—Nomination Form

historic Stanton's Mill

National Road Stone Arch Bridge at Stanton's Mill
Grantsville
Public

HISTORIC NATIONAL ROAD STONE ARCH BRIDGE AT STANTON'S MILL

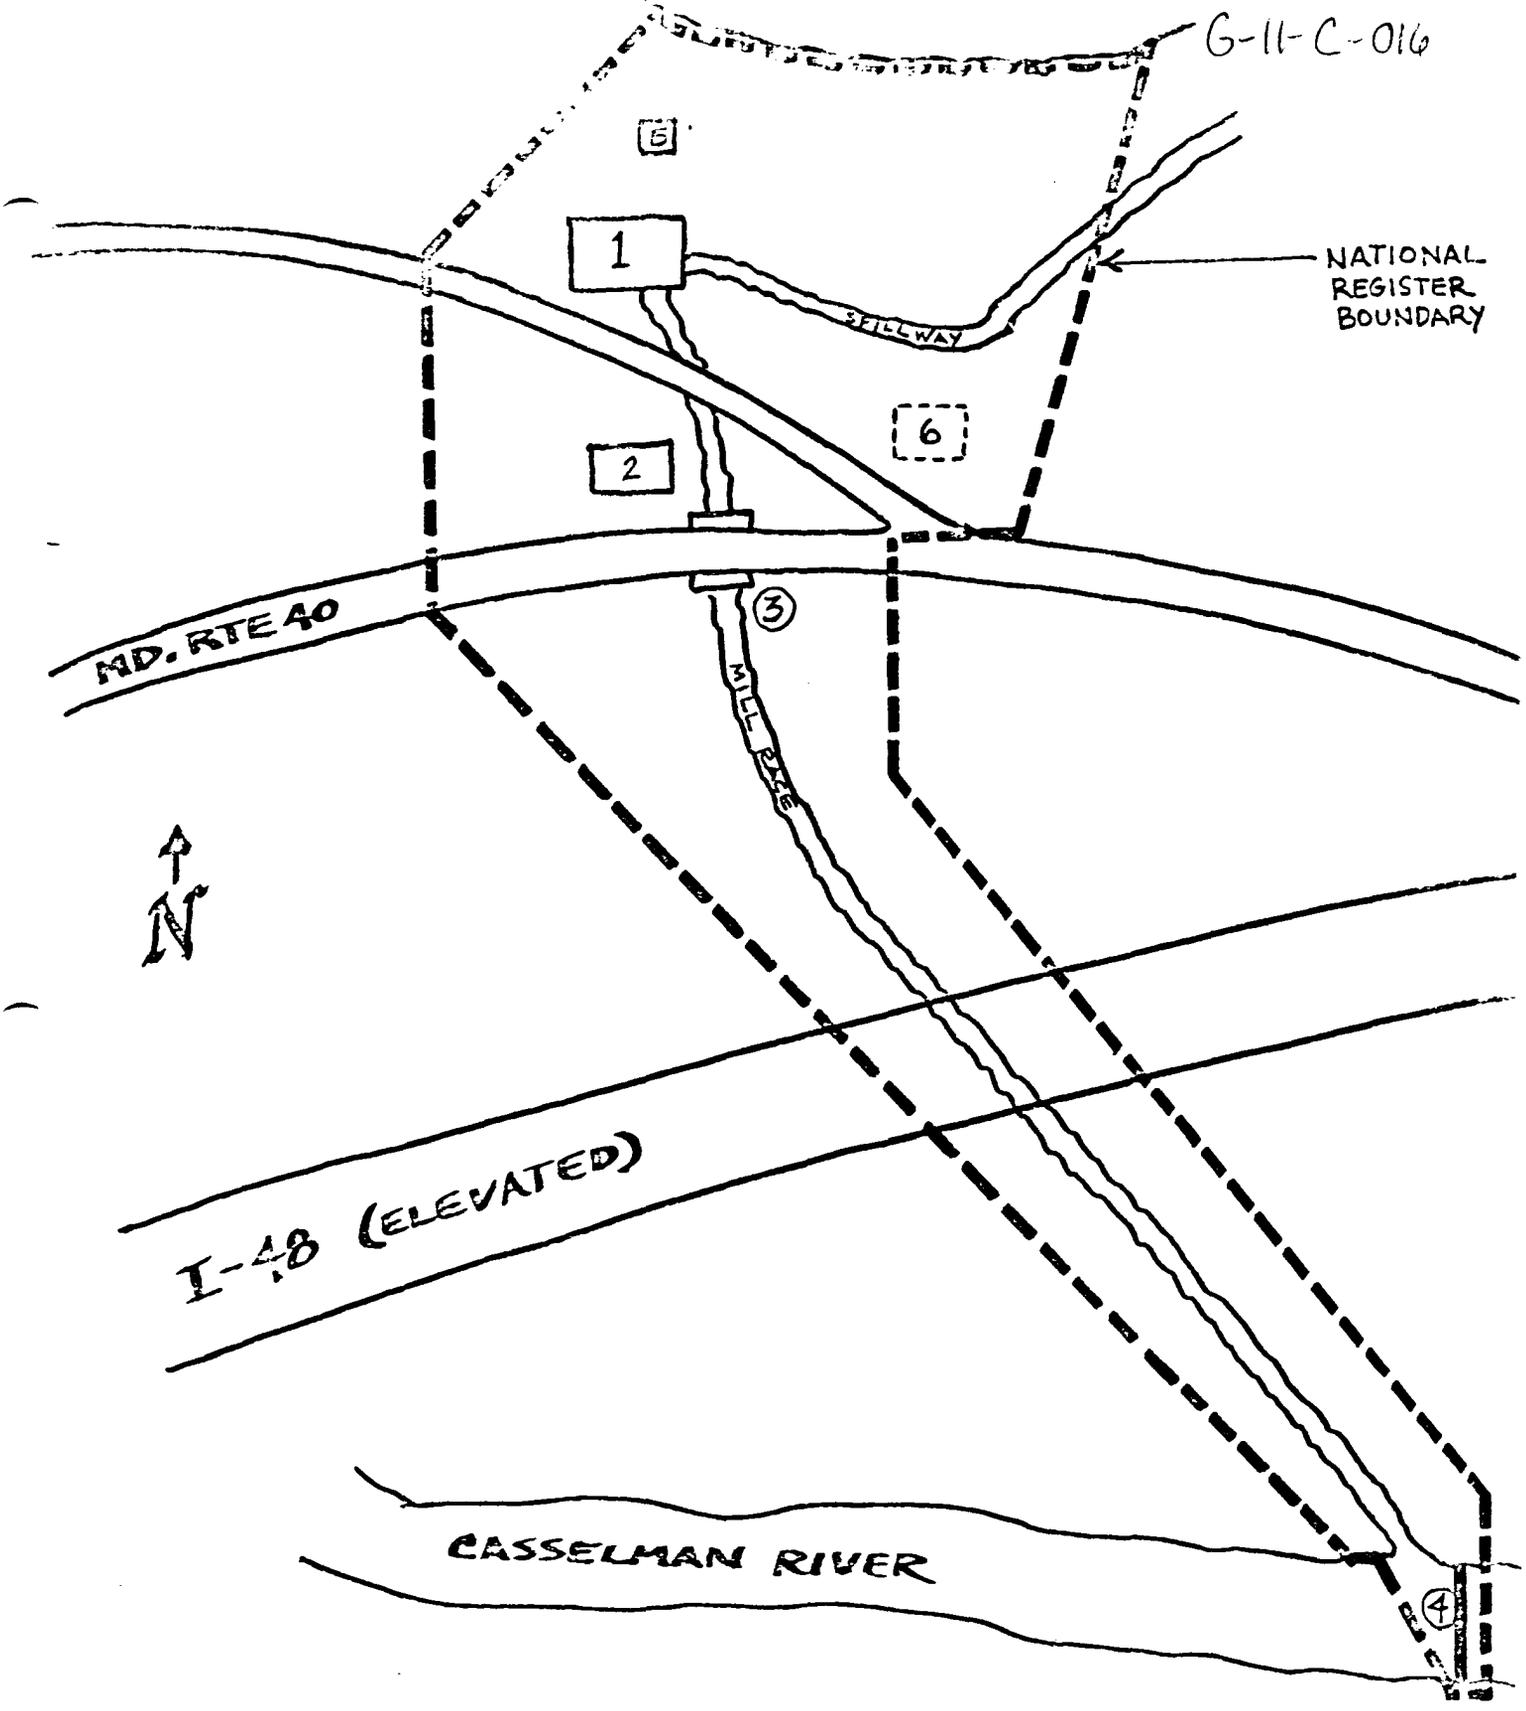
**STANTON'S MILL
SITE PLAN
NOT TO SCALE**

- 1. MILL
- 2. ca. 1900 STORAGE BLDG.
- 3. 1817 BRIDGE
- 4. TIMBER CRIB DAM
- 5. HOG PEN
- 6. RUIN OF ORIGINAL STOREHOUSE

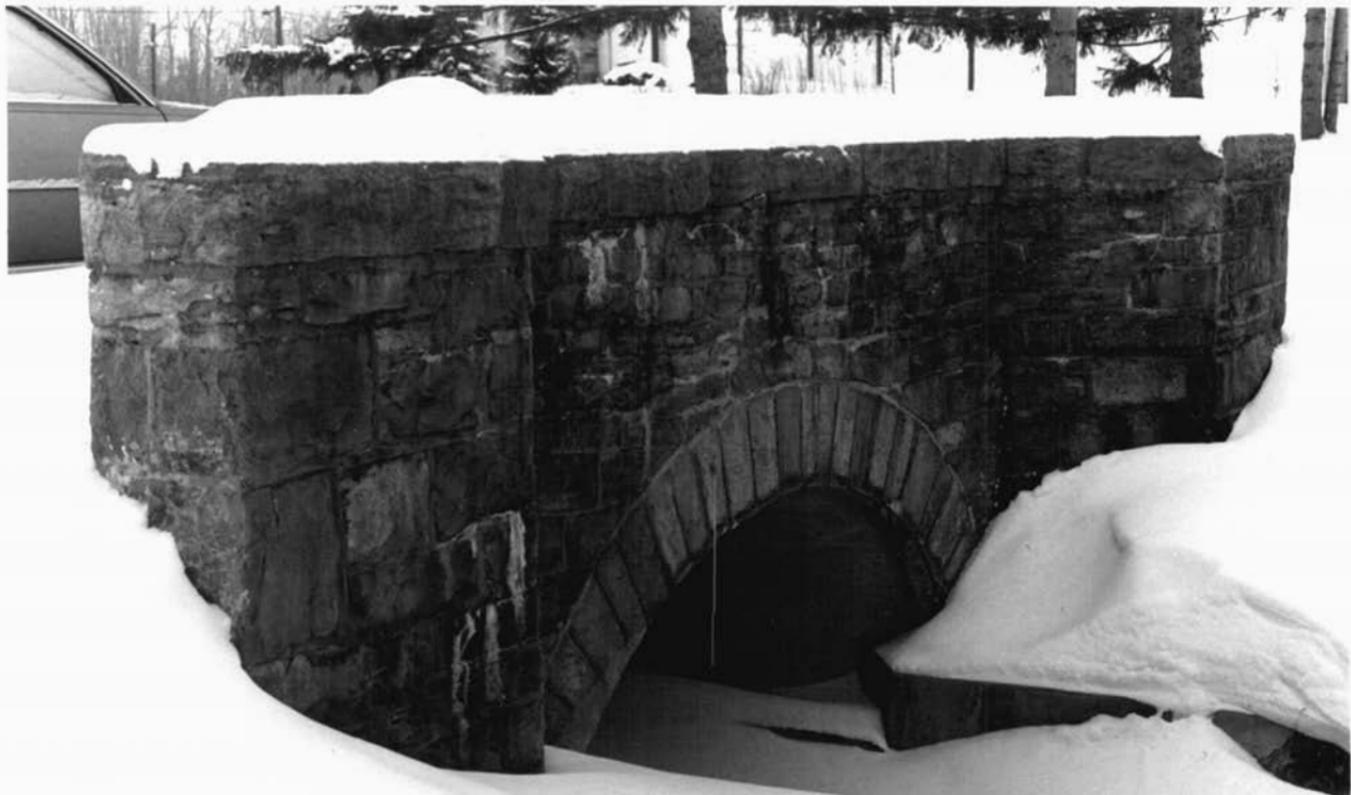
National Road Bridge, Stanton's Mill

The bridge is a single span stone arch culvert bridge. The bridge measures approximately 30 feet in length and 36'7" in width, wing wall edge to wing wall edge, while only 30'9" wide from central section wall edge to wall edge. Average wall thickness is 1'8". The bridge is constructed of cut sandstone blocks. A central panel, containing a voussoired arch, is flanked by slightly tapering wing walls.

The bridge appears to be in excellent condition, and appears to be virtually unchanged except for the provision of a concrete coping on the top of the bridge and covering the underside of the culvert arch in the 1960's.
