G-III-C-196

Windmill Farm  
Private  
Bittinger vic.

INVENTORY FORM FOR STATE HISTORIC SITES SURVEY

Windmill Farm

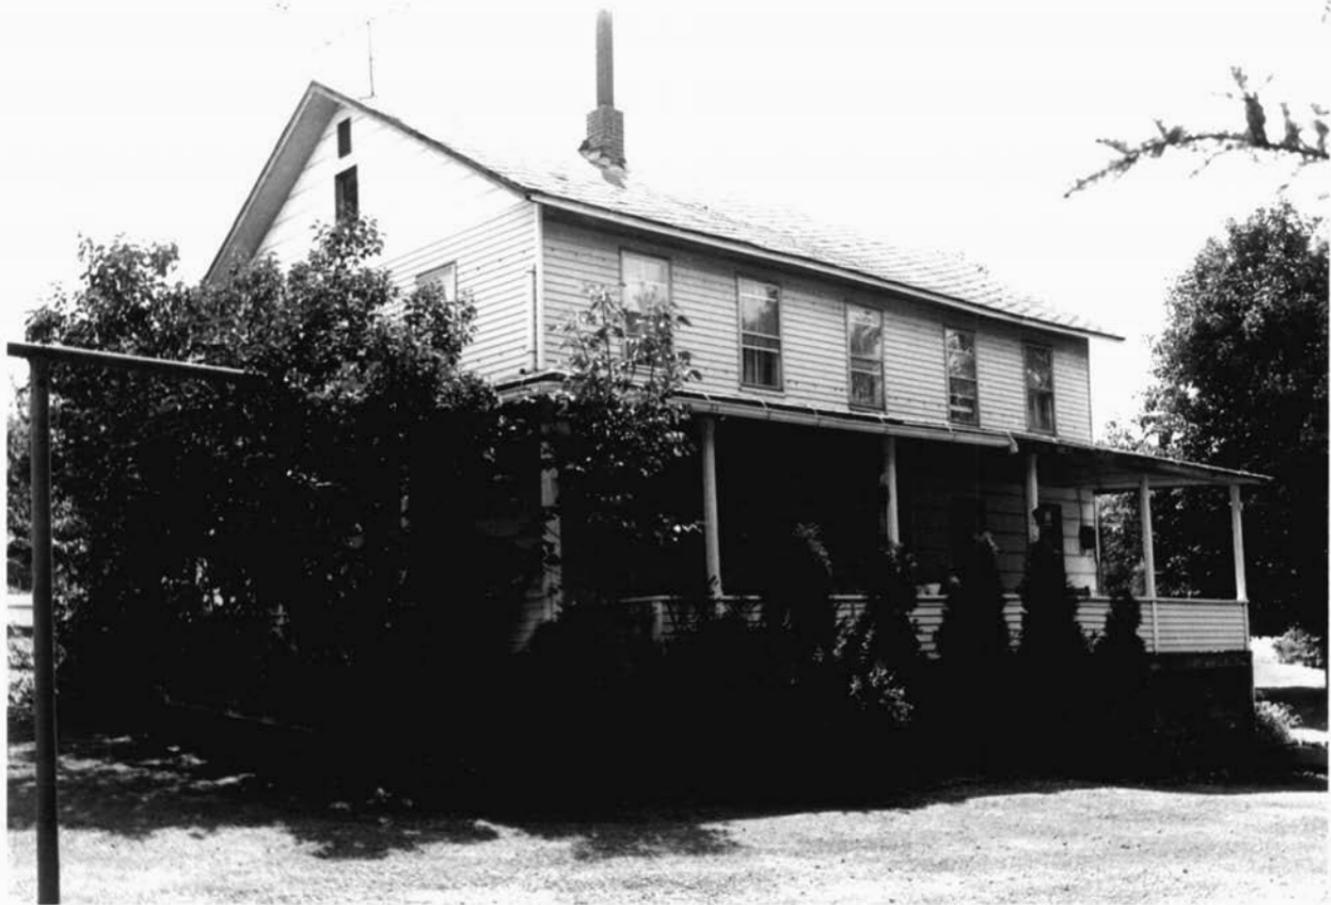
G-III-C-196  
Windmill Farm  
Garrett Co., MD  
M. Stinson 1981  
E & N elevation

The house is a two-story, five-bay by two-bay structure with a gable roof. A porch, supported by chamfered wooden posts, runs the length of the facade. A similar porch is located at the rear, north, elevation. Central entrances are located at both porches.

The house has a central brick stove flue. 2/2 sash windows light the house. Single pane windows are located in the gable ends.

The house rests on a stone foundation. The first story is covered with aluminum siding. Corrugated metal covers the roof.

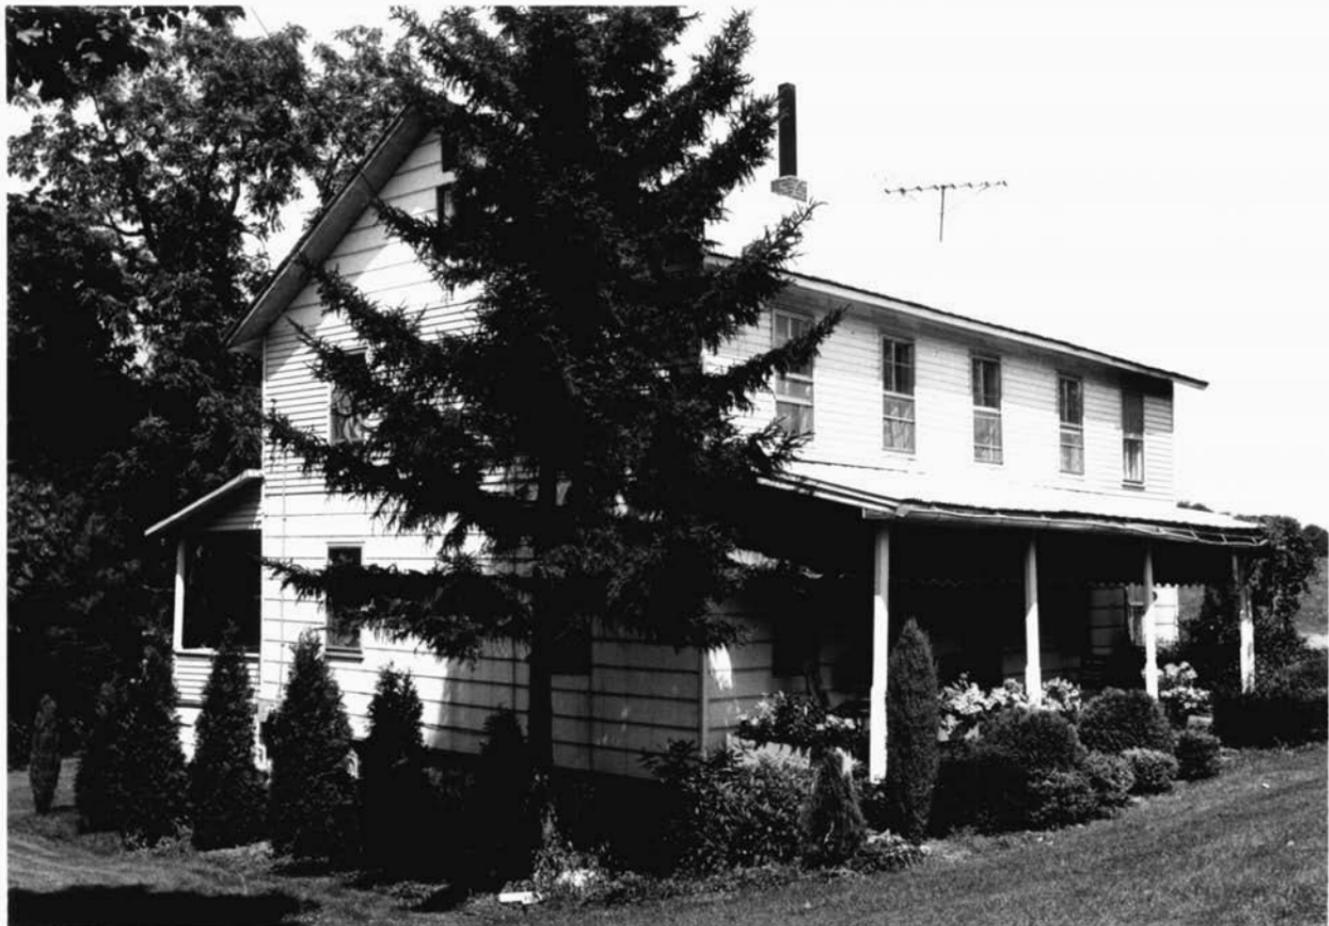
G-III-C-196  
Windmill Farm  
Garrett Co., MD  
M. Stinson 1981  
W & S elevation

This frame house is situated in a hilly area on Rt. 495 approximately 1¼ miles north of Bittering. The house faces south.
