Maryland Inventory of Historic Properties number: CS-III-C-197

Name: Big Run Rd over Big Run

MARYLAND INVENTORY OF HISTORIC BRIDGES
HISTORIC BRIDGE INVENTORY
MARYLAND STATE HIGHWAY ADMINISTRATION/
MARYLAND HISTORICAL TRUST

SHA Bridge No. G042 Bridge name Big Run Road over Big Run

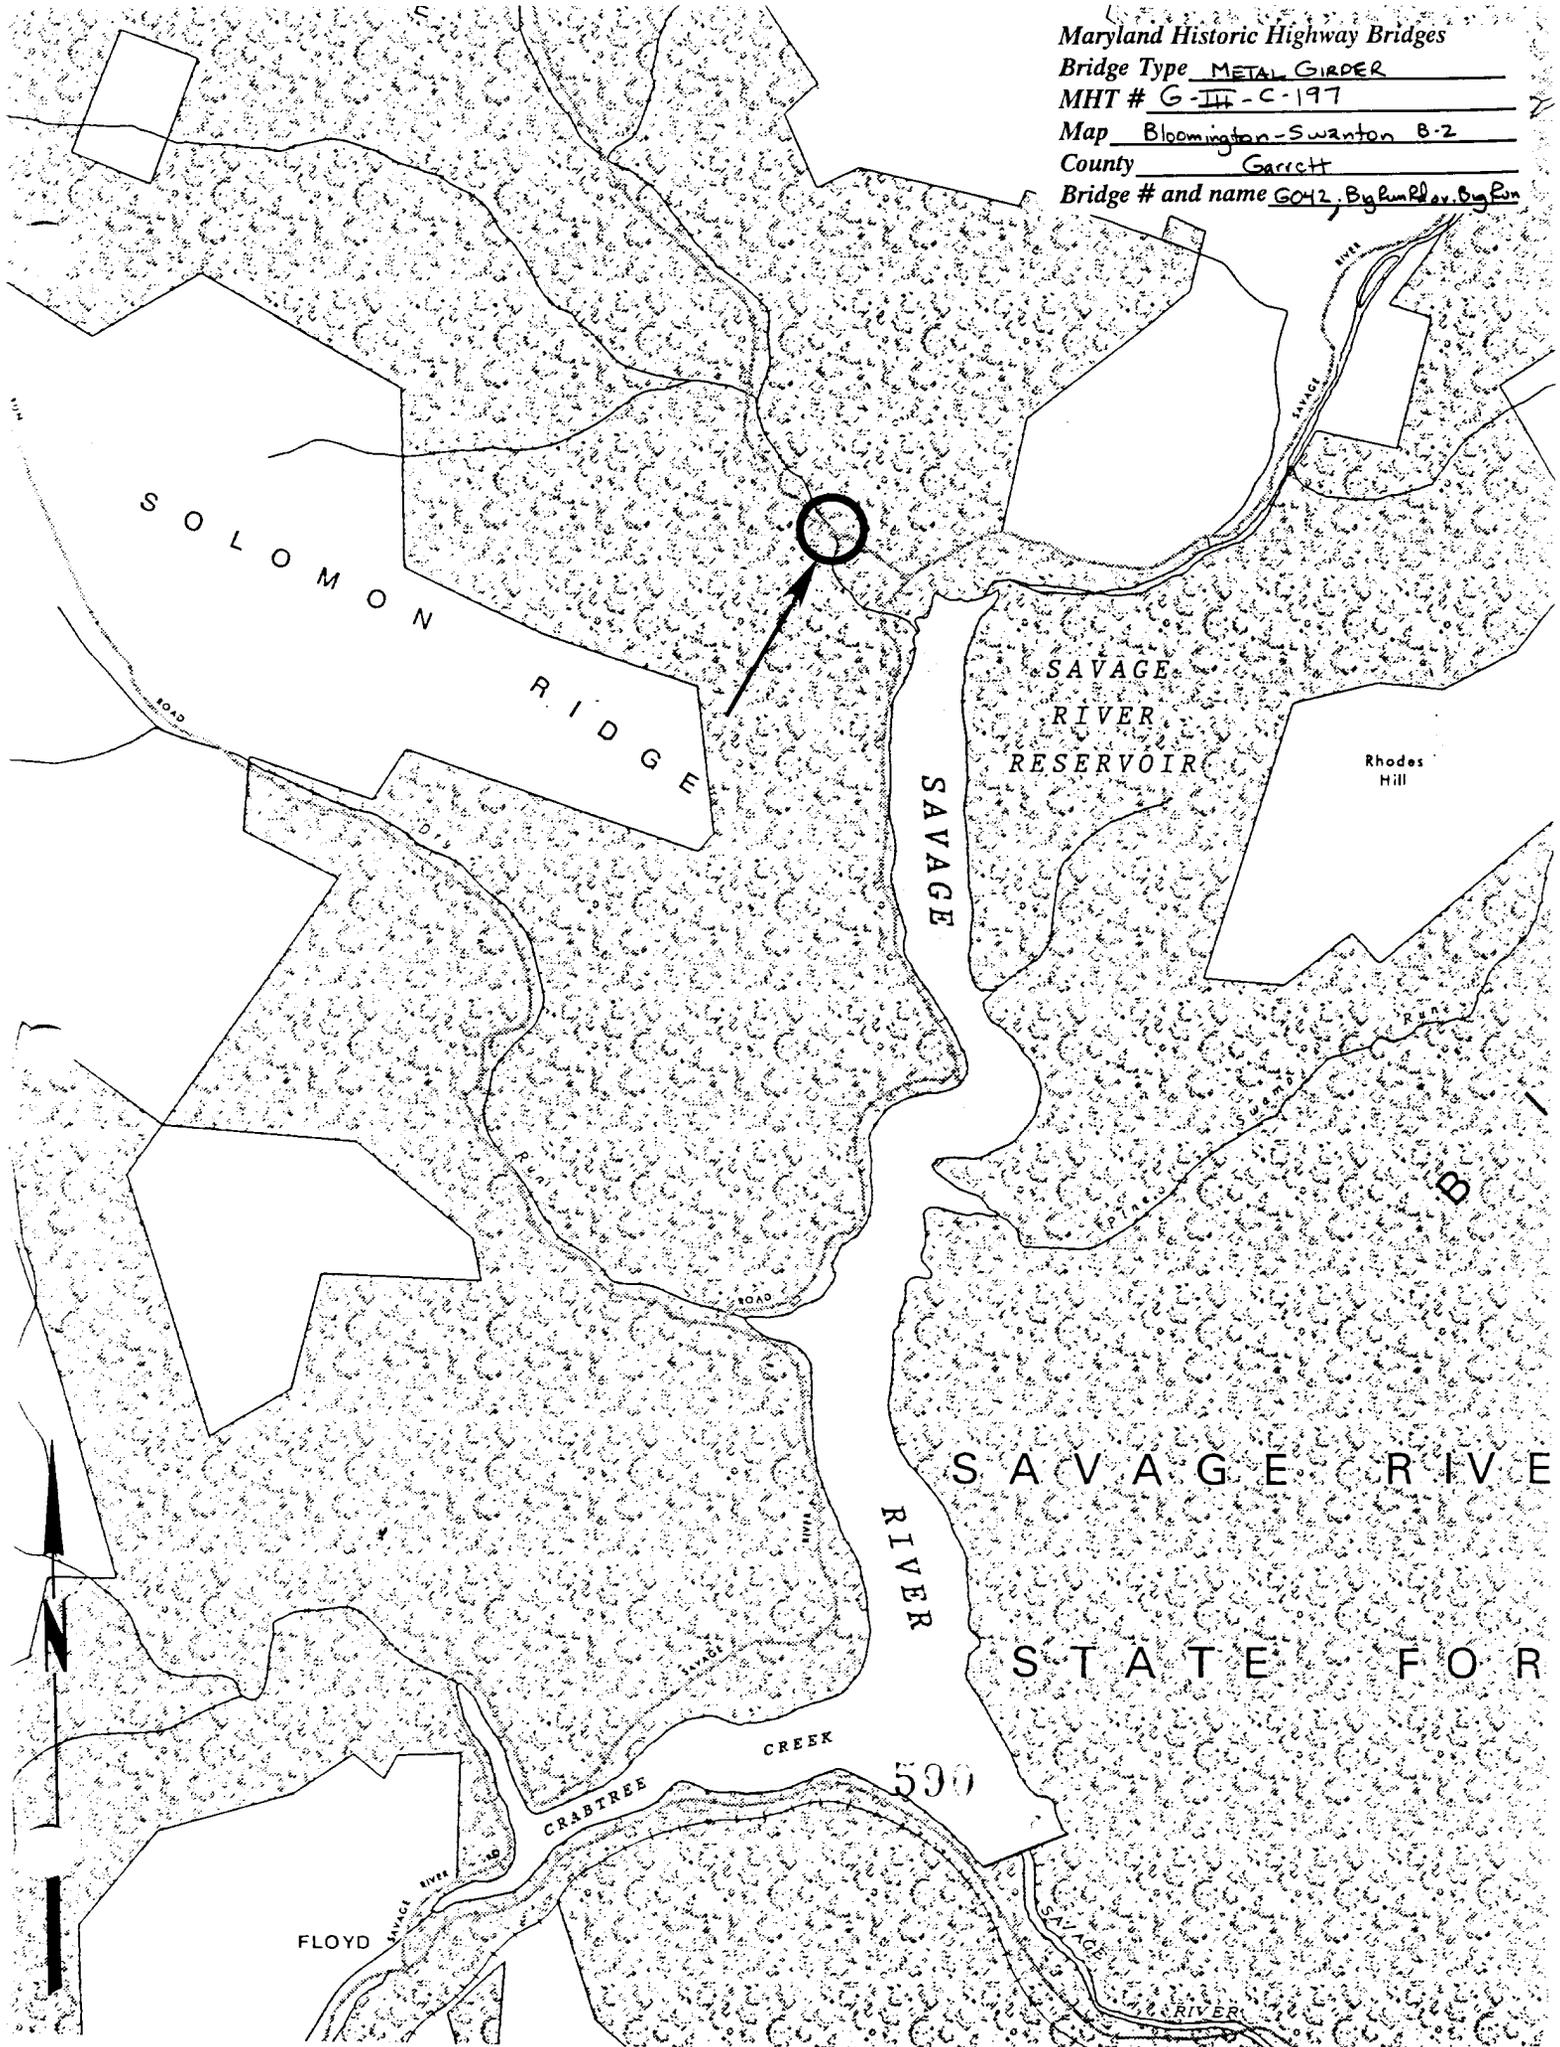
- 1 Gr III C-1997
- 2 Big Run Rd over Big Run
- 3 Garrett Co, MO
- 4 Ryan McKay
- 5 3/97
- 6 MD SHPO
- 7 East approach
- 8 1 of 5

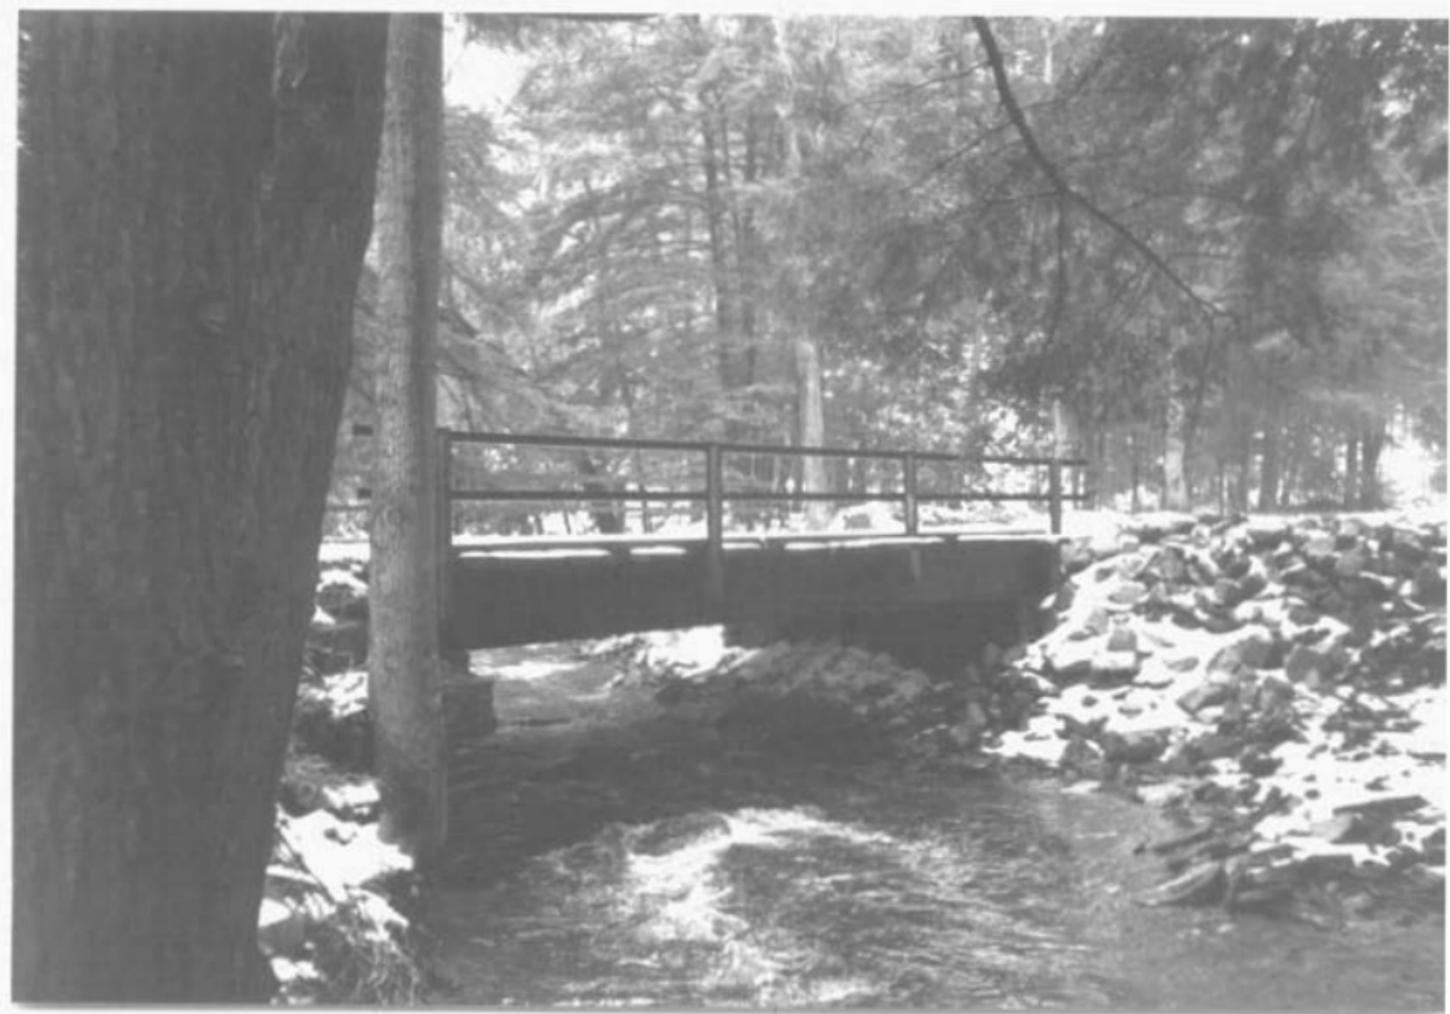
1. G-III C-197
2. Big Run Rd over Big Run
3. Garrett Co, MD
4. Ryan McKay
5. 3/97
6. MD SHPD
7. Downstream elevation
8. 2 of 5

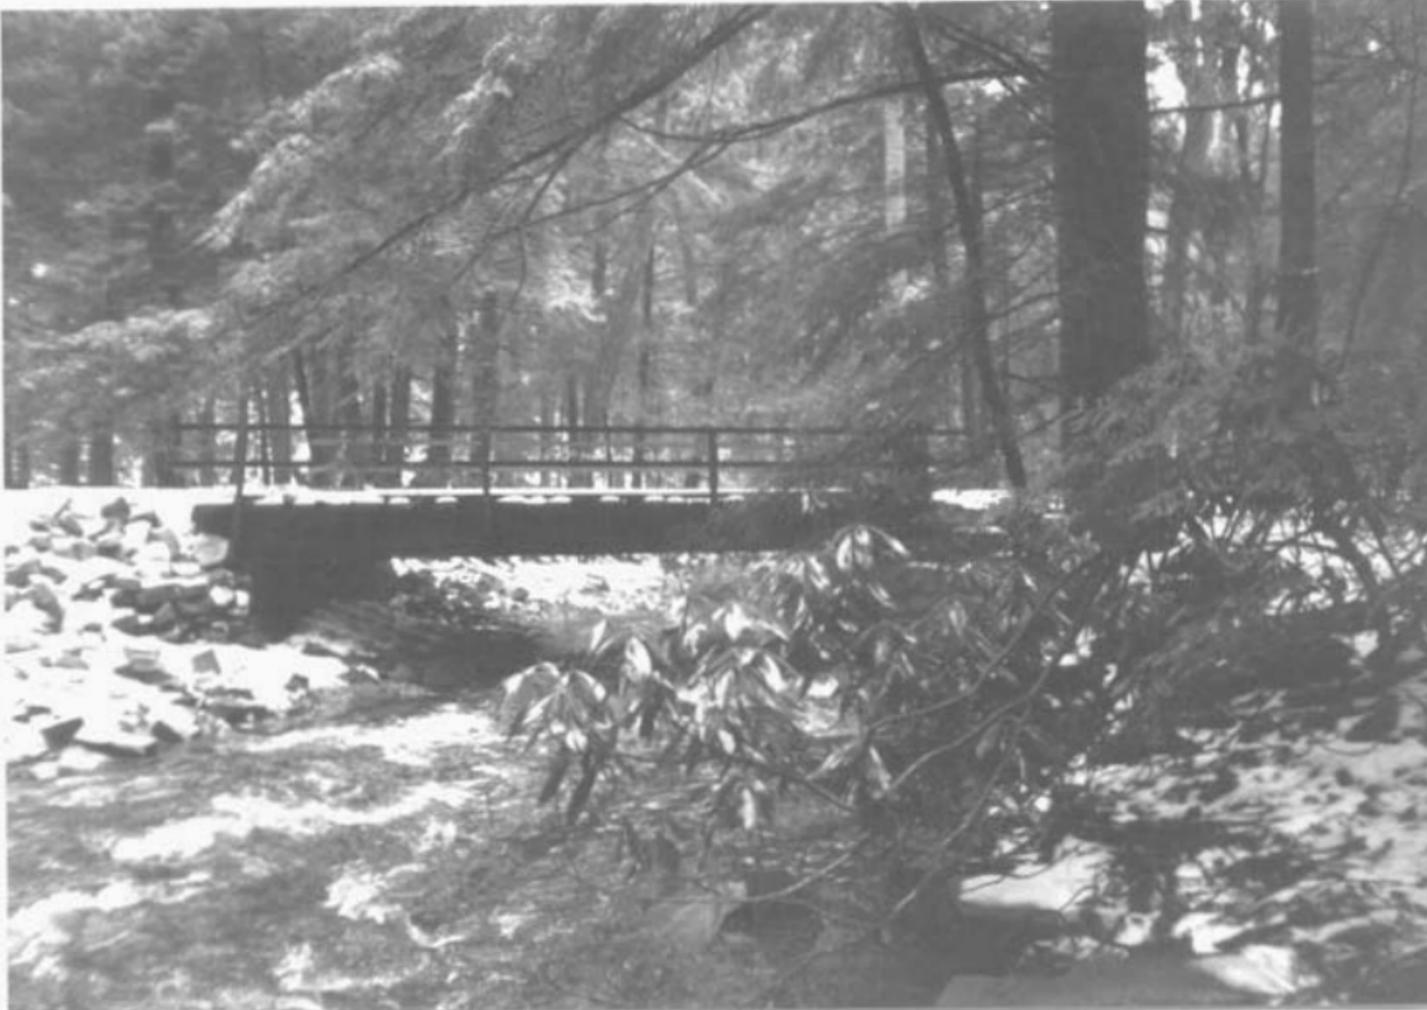
1. G-III C-197
2. Big Run Rd over Big Run
3. Garrett Co, MD
4. Ryan McKay
5. 3/97
6. MD SHPD
7. Upstream elevation
8. 2.75

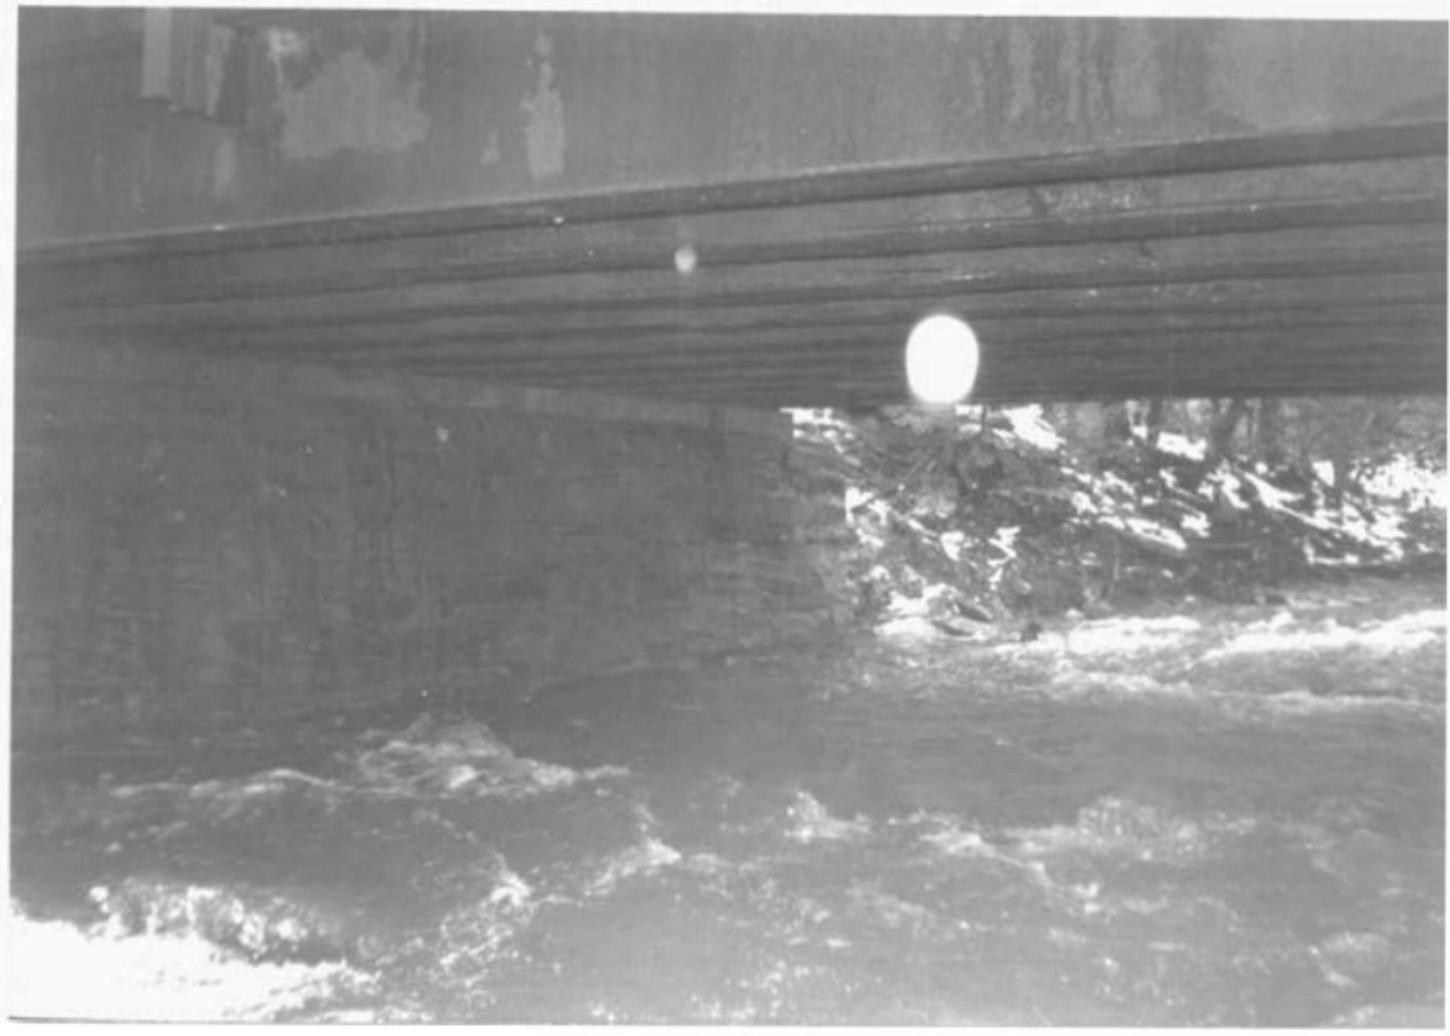
1. Er. 31-5-1997
2. Big Run Rd over Big Run
3. Gurrett Co, MD
4. Ryan McKay
5. 3/97
6. MC SHAD
7. Detail of printer
8. 4 of 5

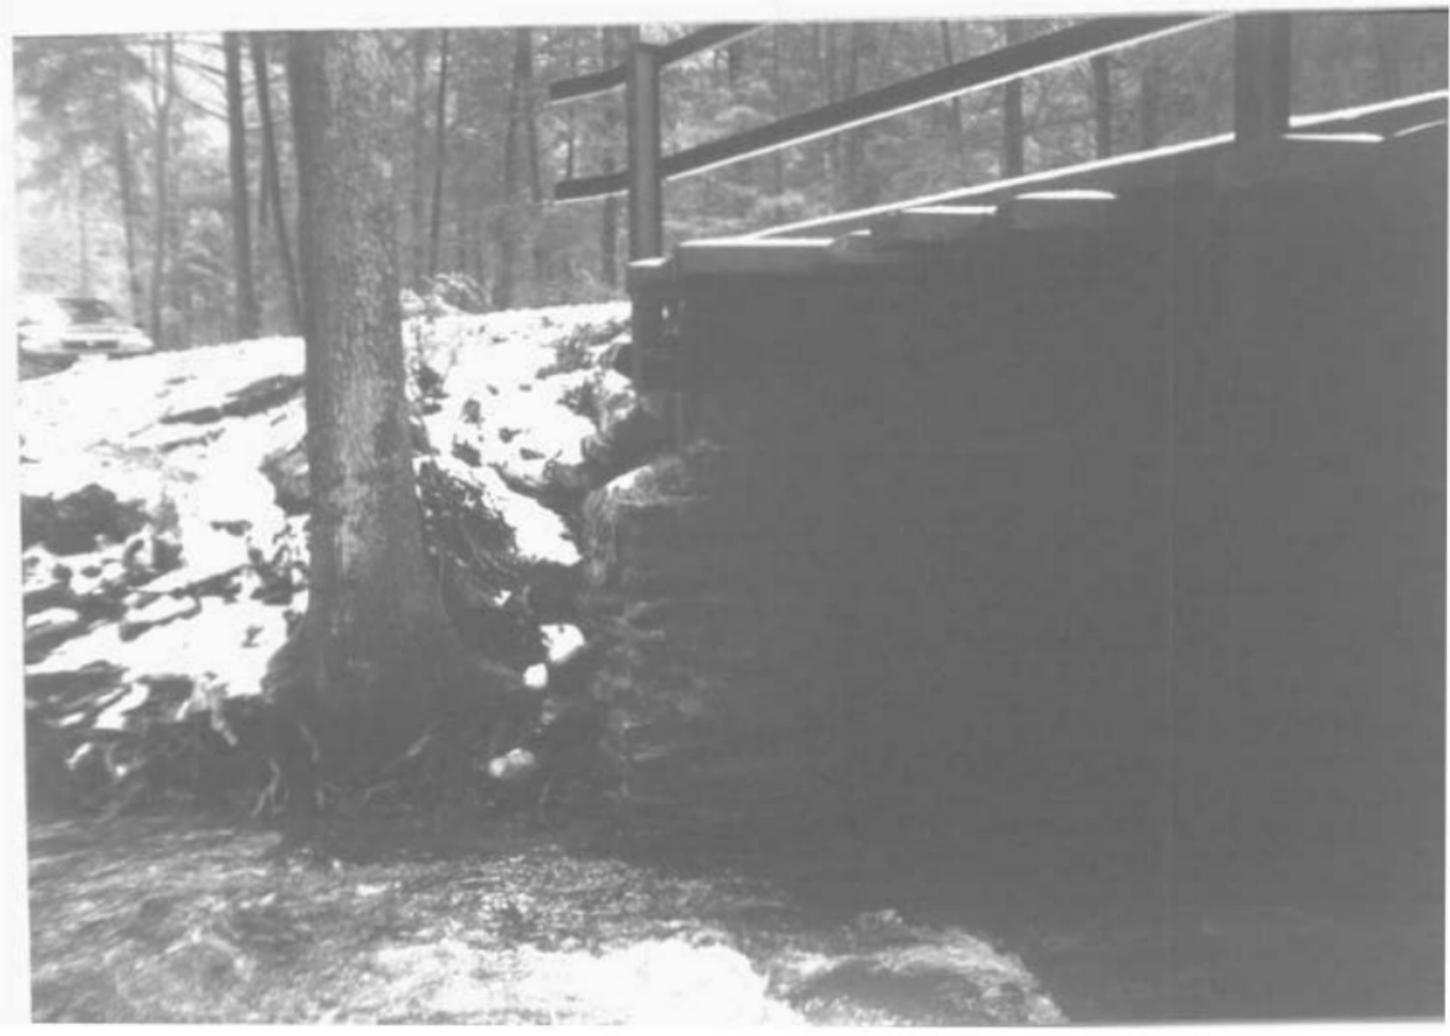
8. 5 of 5

7. Detail of West abutment
