**INDIVIDUAL PROPERTY/DISTRICT  
MARYLAND HISTORICAL TRUST  
INTERNAL NR-ELIGIBILITY REVIEW FORM**

Property/District Name: Harold G. Bittinger Farm Survey Number: G-IV-A-204

Project: US 219/Oakland Vicinity Improvement Project Agency: MSHA

## Maryland Inventory of Historic Properties Form

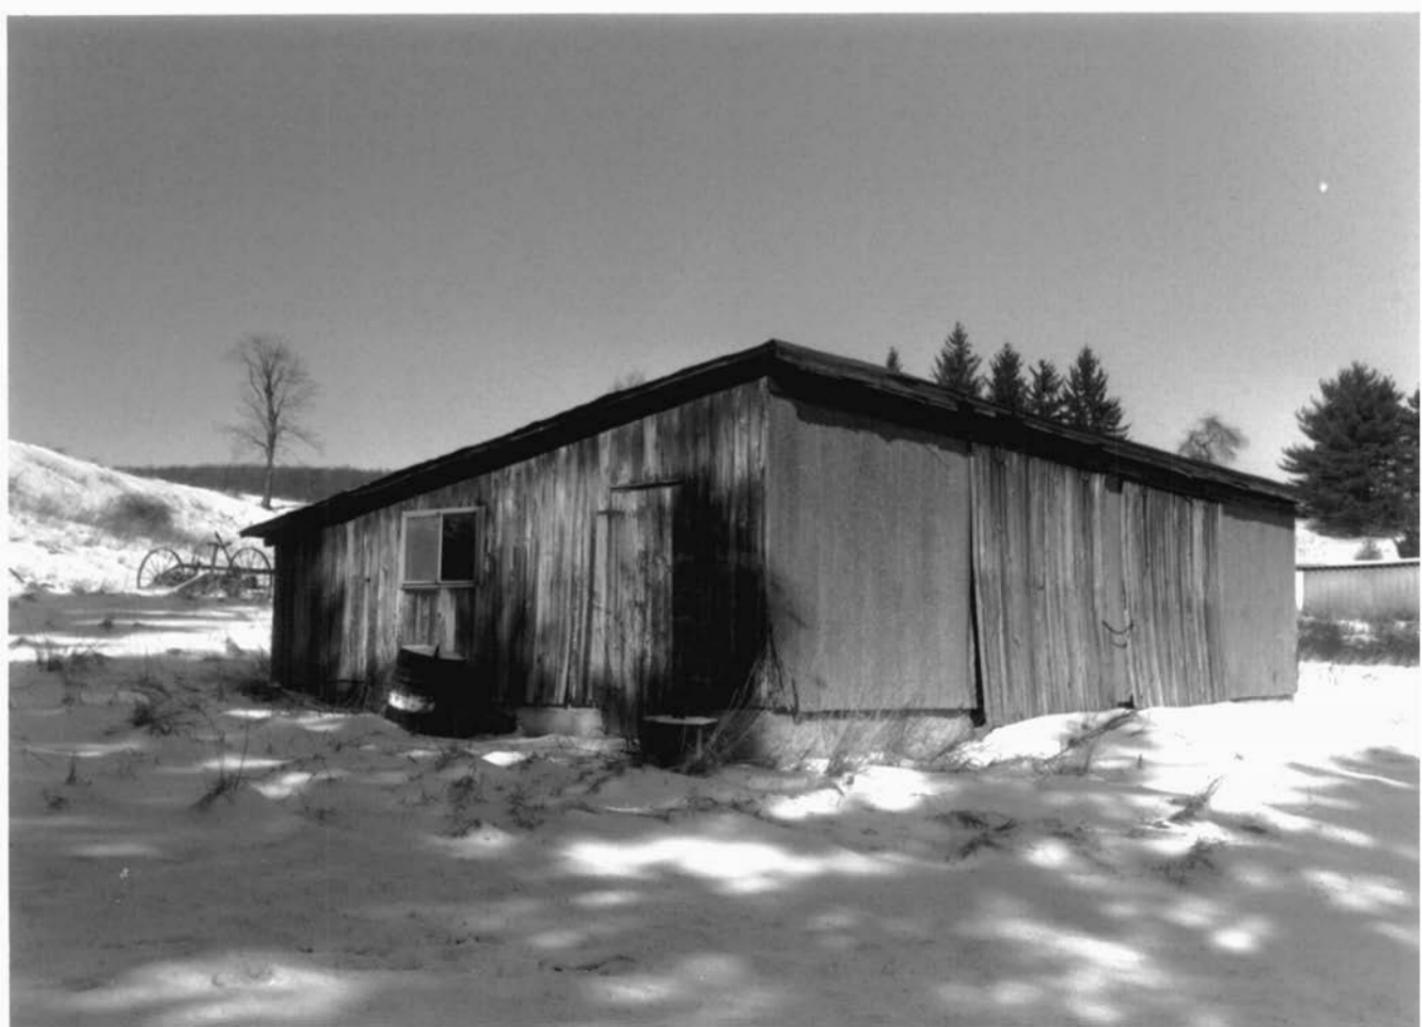
1067

Several outbuildings stand on the property. A one-story gable-roofed cinderblock shed topped with an asphalt-shingled roof stands just to the south of the main house. This building is accessed by a five-panel wooden door and lit by six-light fixed sash windows; all door and window openings are finished with wooden surrounds. A one-story gable-roofed frame dwelling stands just behind and to the west of the main house. This building is constructed on a concrete block foundation, sheathed in asbestos shingles, and topped with an asphalt-shingled roof. An exterior metal stovepipe exits from the building through the foundation. A paneled wooden door provides access to the interior. Windows are mostly two-over-two, double-hung sash. A shed-roofed frame shed stands to the south. This shed stands on a concrete block foundation; it is clad in a mixture of vertical wooden boards and corrugated metal on one long wall. The building is pierced by sliding wood and metal garage doors and several two-light sash windows. A two-story gable-roofed concrete block garage is located south of the house. This building is topped with a corrugated metal roof finished with exposed rafter feet; the tops of the gables are clad in board-and-batten siding. Two sliding wooden garage doors open into the northeast gable of this building, and several two-light fixed sash windows light the interior. A vertical board door at second-floor level opens into the southeast elevation; a metal stovepipe exits from the center of the building near the ridge line. A long and narrow one-story frame wooden-floored corncrib topped with a corrugated metal roof stands just south of the garage. This building rests on concrete block piers and is sheathed in open wooden slats for ventilation. A one-story frame shed stands behind the corn crib to the southwest. Constructed on brick piers, this building is clad in wooden shingles and topped with a rolled asphalt shed roof. Several six-over-six, double-hung wooden sash windows light the interior. A ruinous bow-roofed, gable-fronted frame shed or chicken coop stands behind the corn crib and the first shed. This building rests on stone piers; it is clad and roofed in rolled asphalt. A wooden door pierces one gable. The building is finished on the interior with a wooden floor. A long gable-roofed frame barn with a full-length concrete-block shed roofed addition on its southern elevation stands south of this cluster of smaller buildings. This barn is sheathed with vertical wooden boards and topped with a rolled asphalt roof. A large set of swinging wooden doors opens into the long northern elevation, and a one-story gable-roofed concrete block addition projects from the southwest corner. The principal framing members consist of mixture of hewn and sawn timbers.

SW + SE ELEVATIONS FACING N SHED

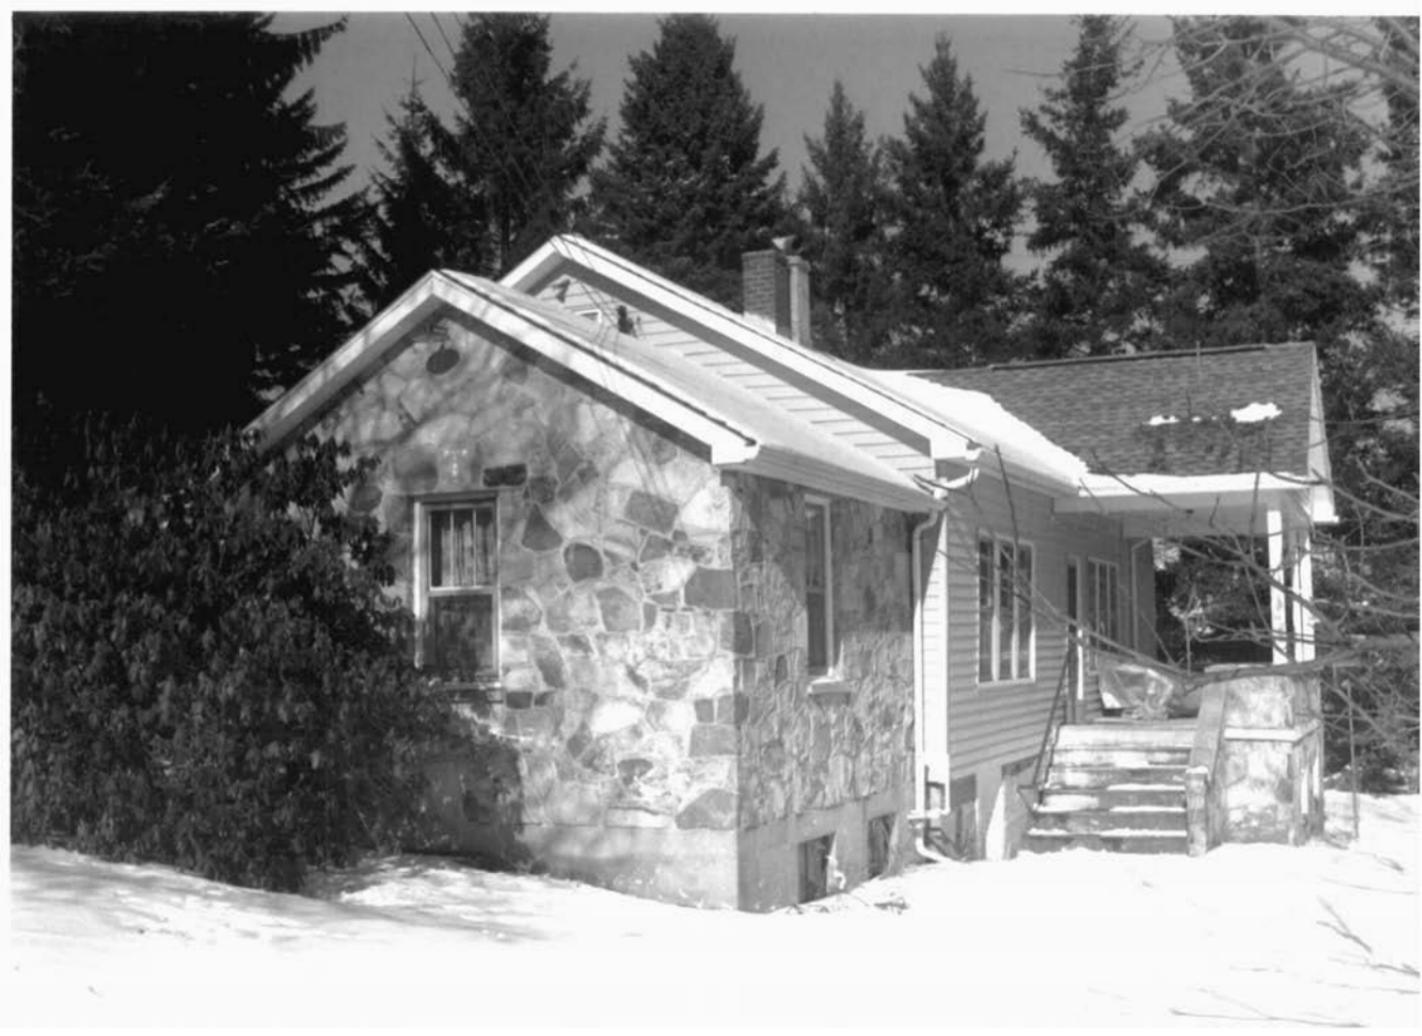
2067

The house is built on a foundation that is a mixture of poured concrete and concrete block. The foundation appears to enclose a full cellar. The walls are clad in gray aluminum siding with white trim, and the building is topped with an asphalt-shingled gable roof finished with an aluminum eave. The addition that extends from the southwest gable is faced with stone, as is the base of the front porch. Two side-by-side interior corbeled brick chimneys rise from the roof at the ridge line.

SW + SE ELEVATIONS FACING N

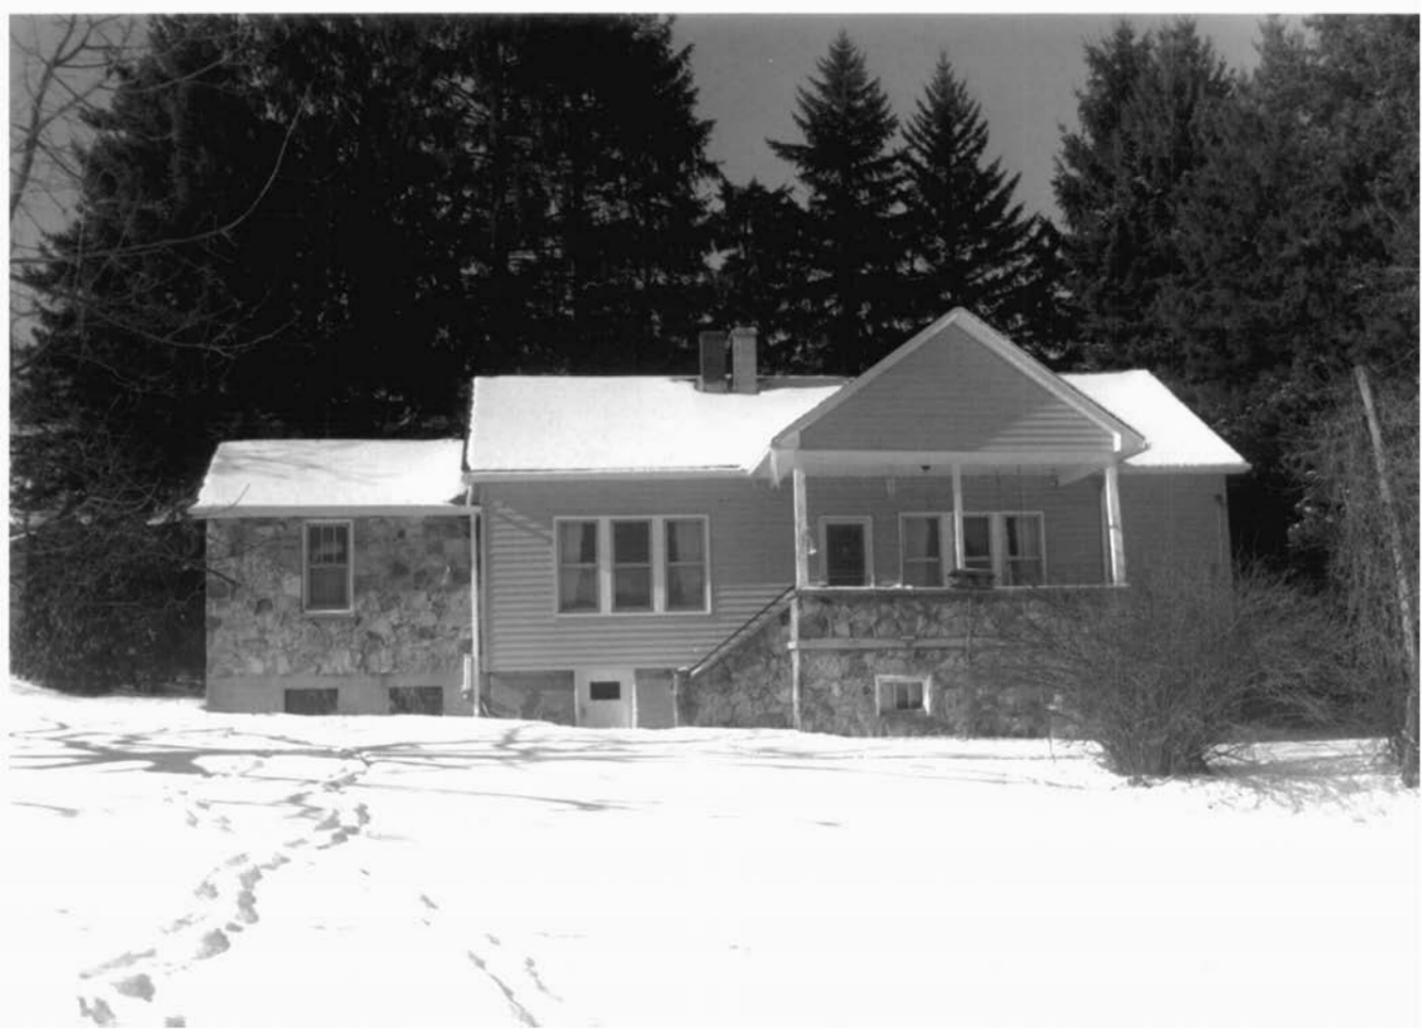
3067

Several three-light fixed sash windows pierce the front porch at cellar level. All window openings are finished with aluminum surrounds. The front entrance is more or less centered on the southeast elevation. It contains a paneled wooden half-glass door. The cellar door is located on the same elevation and consists of a solid wooden door pierced by a single glass pane on top. Two other entrances lead into the northeast and southwest sides of the rear addition. All door openings are finished with aluminum surrounds.

The open-sided front porch consists of a stone-faced foundation, four-by-four wooden posts, a concrete deck, an aluminum ceiling, and an asphalt-shingled gable roof. The porch gable is clad in aluminum siding to match the rest of the house. Concrete steps bordered by a stone-faced railing lead from the yard up to the level of the porch deck.

SE ELEVATION FACING W

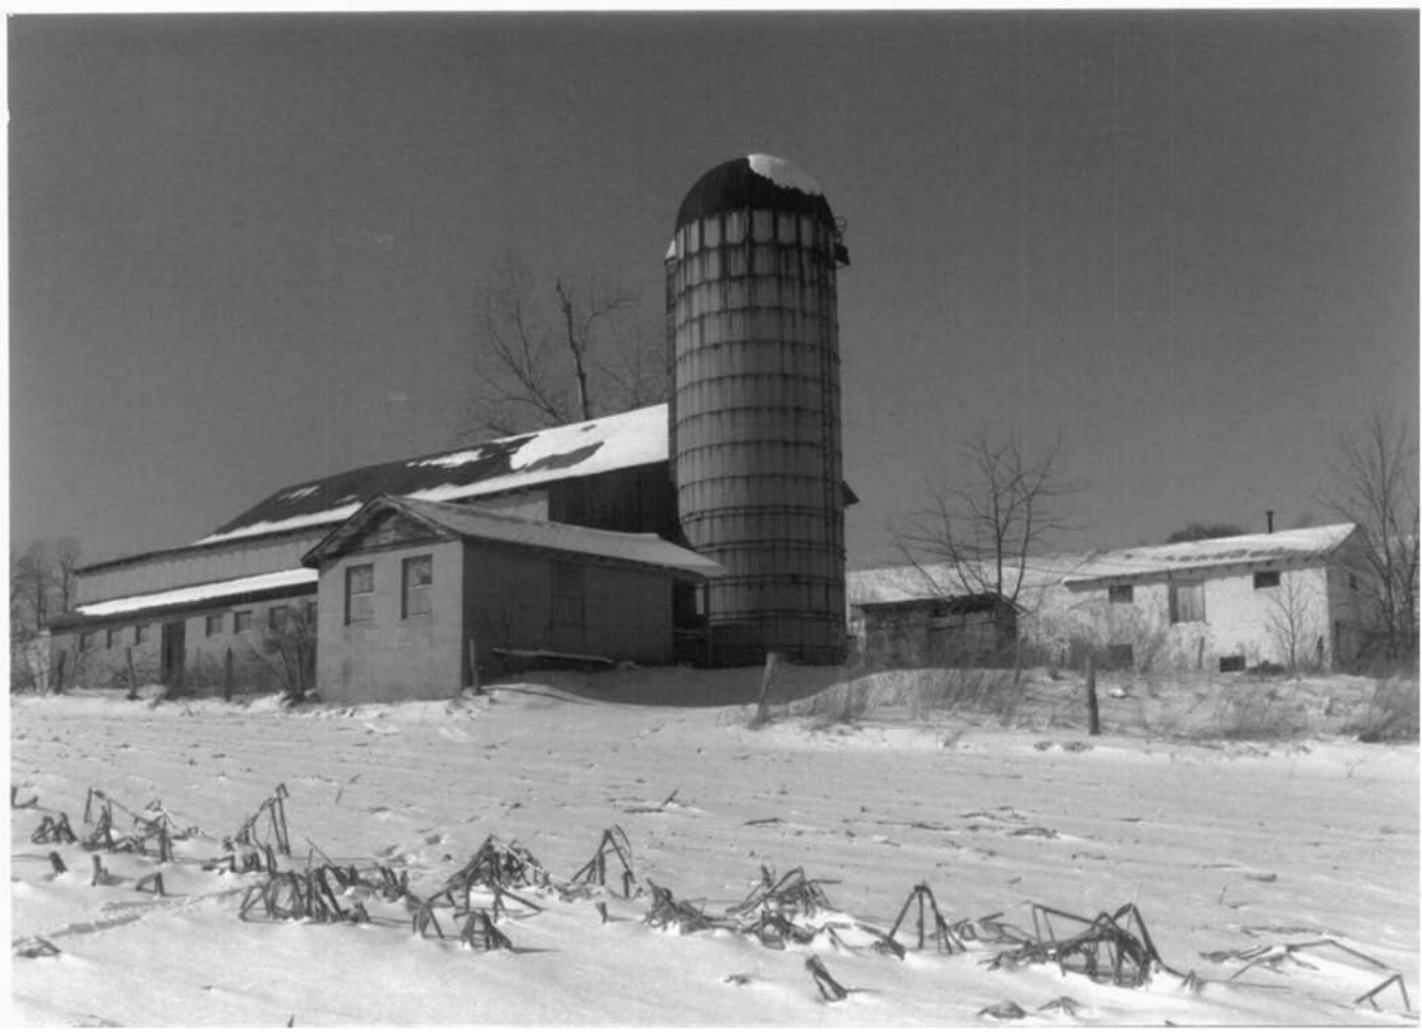
6067

A concrete silo with a domed metal roof and metal turnbuckles stands to the northeast; a concrete walkway links the silo to the barn. Adjacent to the silo and the southeast corner of the barn stands a concrete block gable-fronted dairy. This building is topped with a gable roof and lit by two-over-two, double-hung sash windows. Horizontal wooden boards sheath the upper parts of the gable walls. An open covered porch supported on four-by-four wooden posts extends from one gable.

SE+NE ELEVATIONS FACING W

DAIRY/BARN/CORN CRIB/SHED

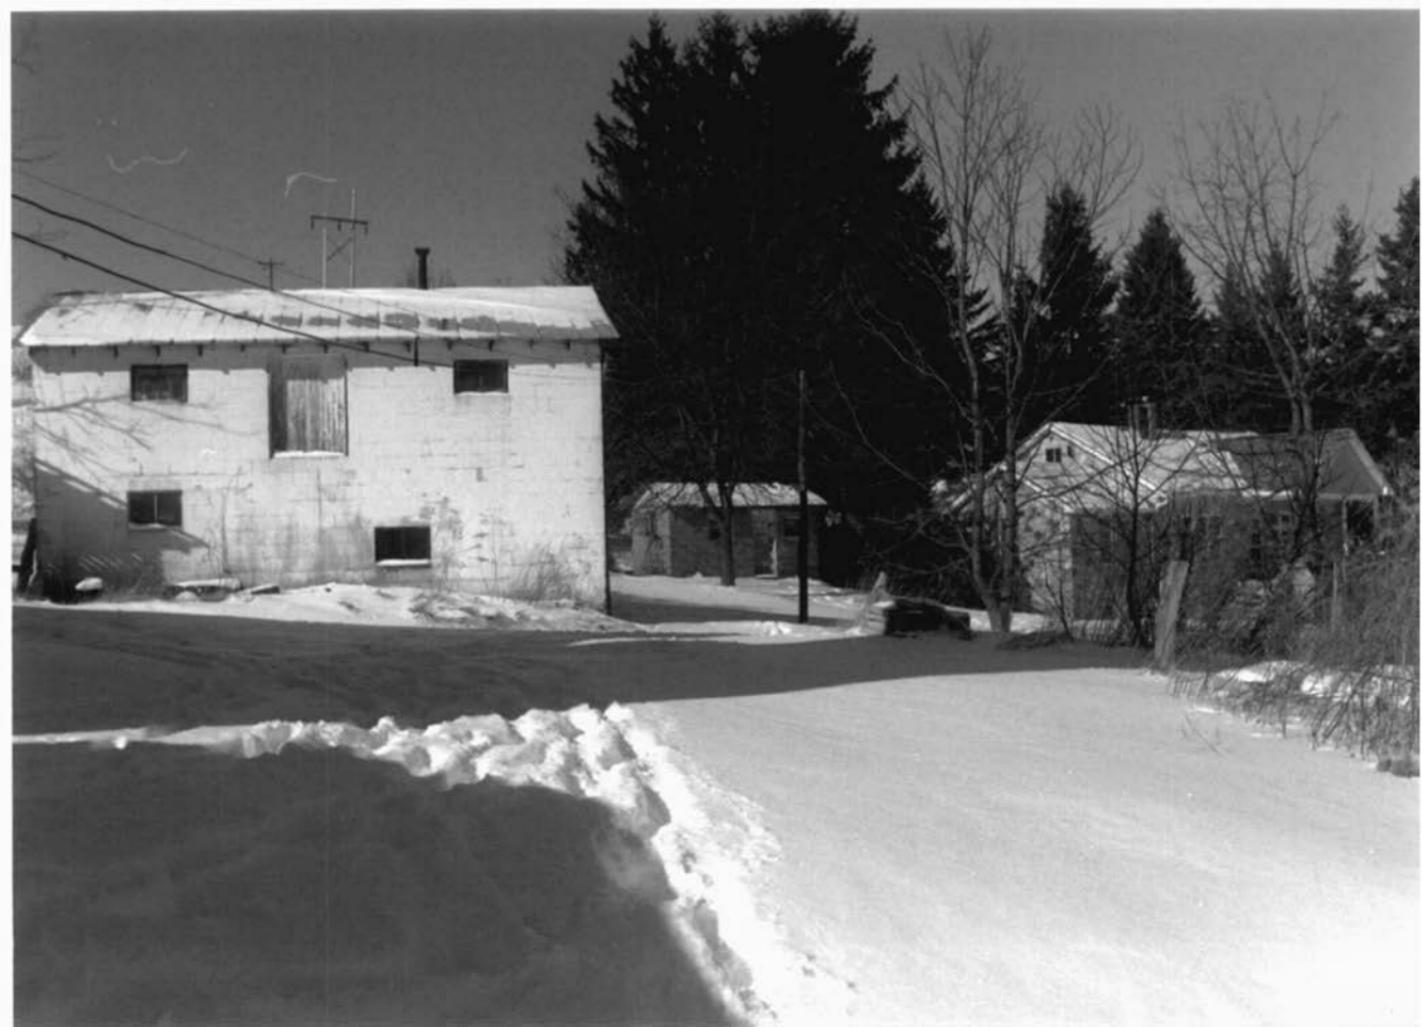
7 of 7

SE ELEVATIONS FACING N 2 SHEDS + HOUSE
