G-V-A-122
Chris Martin Farm
Red House
Private

INVENTORY FORM FOR STATE HISTORIC SITES SURVEY

G.V.A. 122
CHRIS MARTIN FARM
 GARRETT COUNTY, MARYLAND
 VICINITY OF RED HOUSE

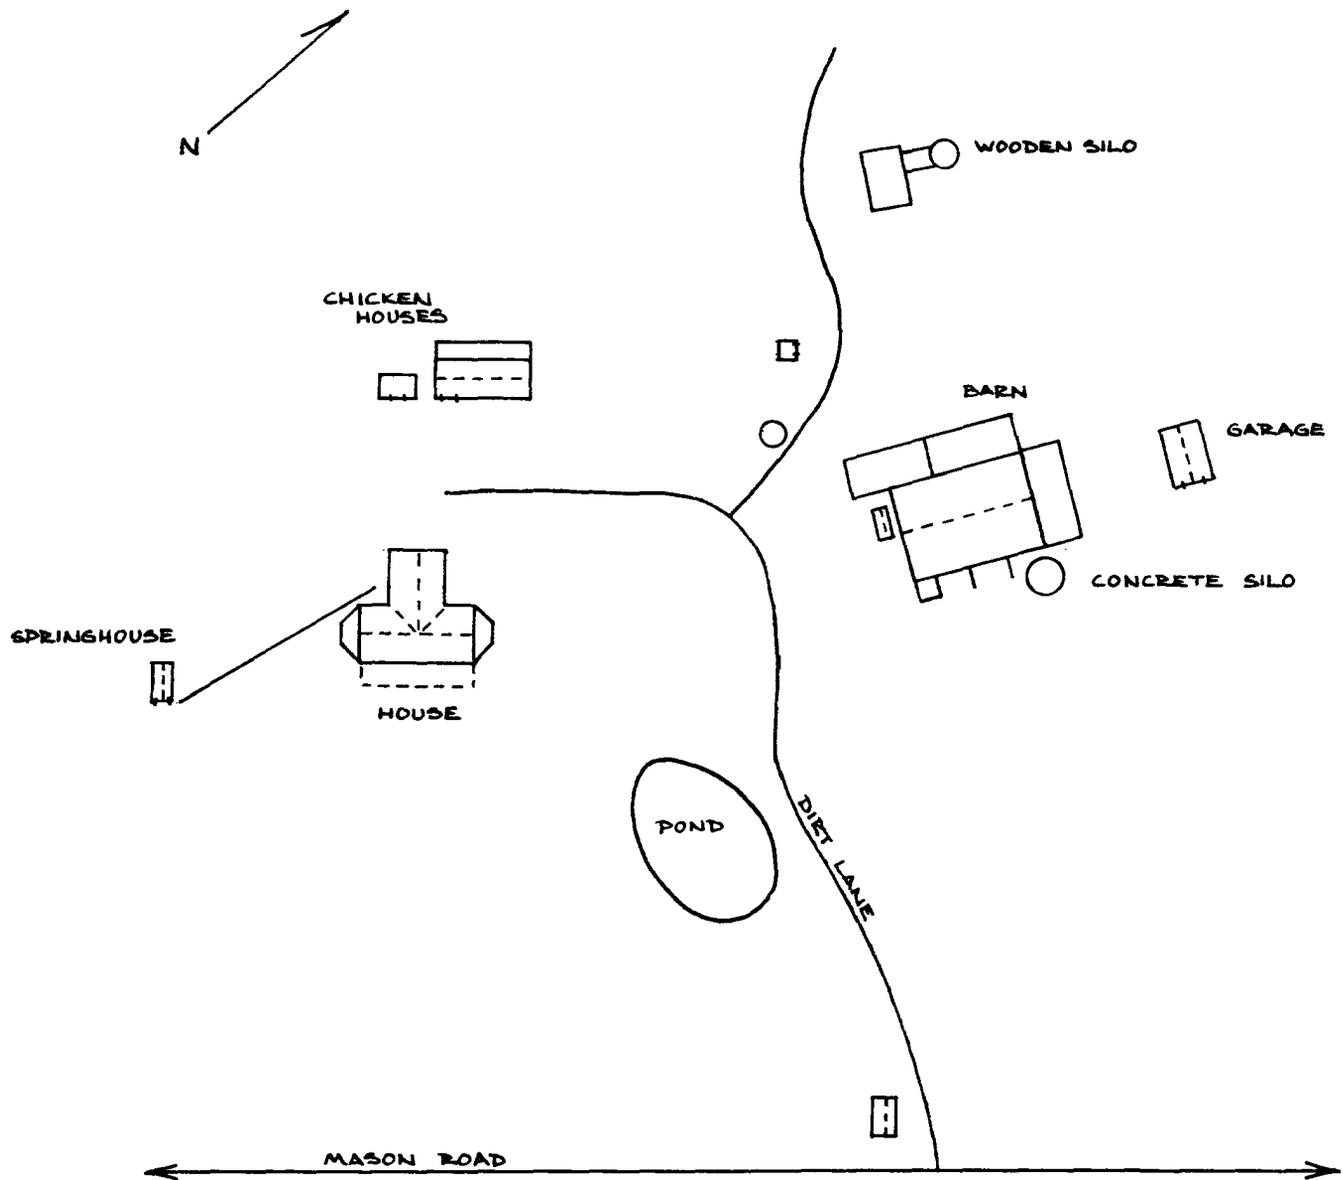
SITE PLAN -- NOT TO SCALE

The Chris Martin Farm is located on the northwest side of Mason Road approximately .5 mile northeast of U.S. Route 50. The farm consists of a house, a barn, a springhouse, two chicken houses, and several other outbuildings clustered together near the road.

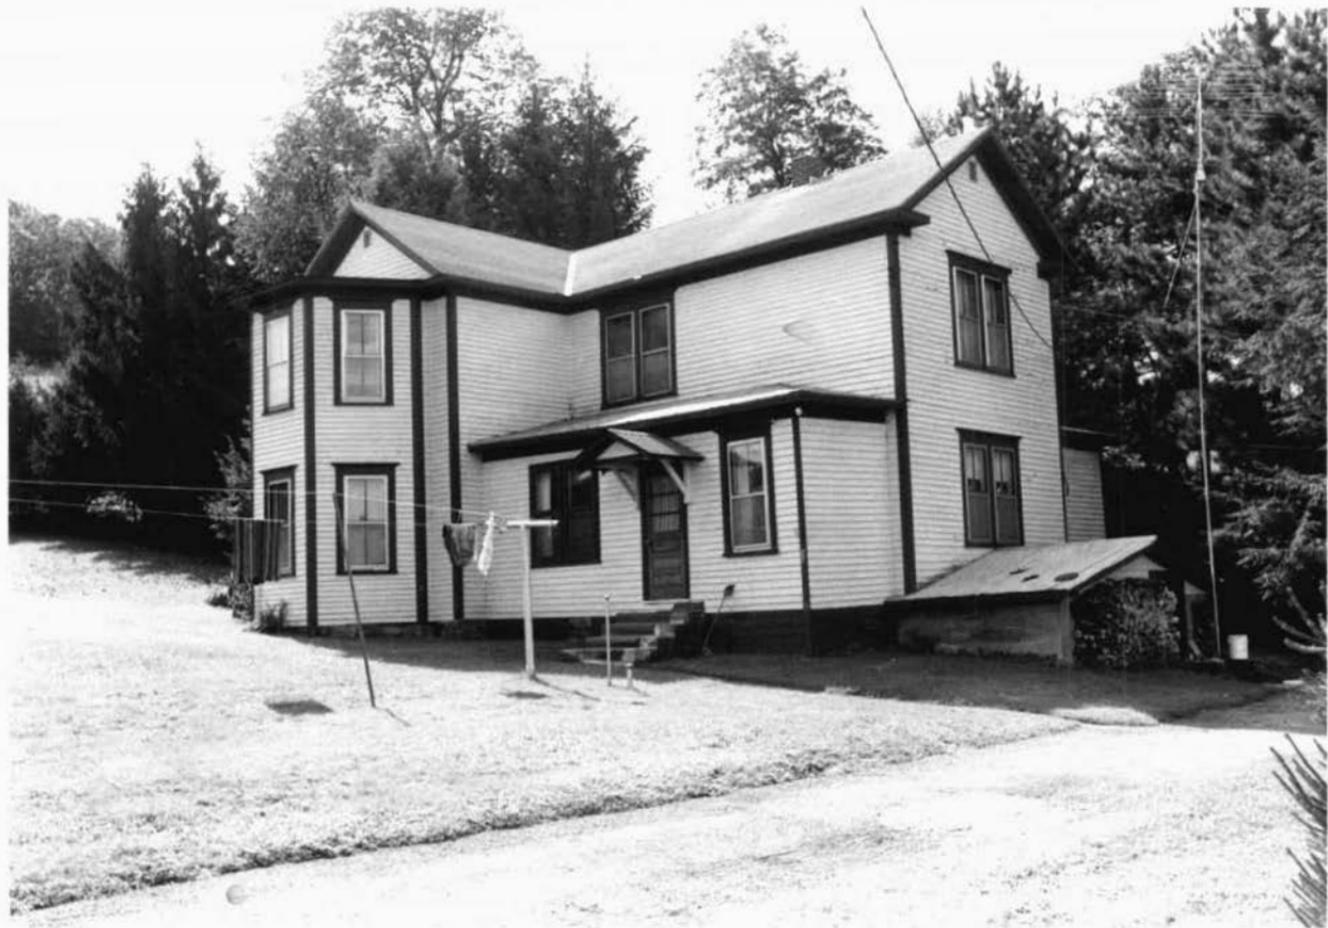
G-V-A-122
Chris Martin Farm
Garrett County, MD
Donna Ware 10-7-80
NE elevation

The house is a frame, two story, gable-roofed building with its facade oriented to the southeast. Its basic configuration is a T-plan with a three bay by one bay main block and a two bay rear extension. The facade has a symmetrical, three bay, center door arrangement. A two story bay window with a flat roof is located at each endwall of the main block. Both the facade and rear porches have been enclosed.

Two over two sash windows with plain board surrounds and drip moldings light the building on all elevations. Weatherboard siding with cornerboards and quarter-round molding at the angles of the cornerboards cover the exterior walls. The roof has a box cornice with partial gable end returns and a plain board frieze with a narrow molding between the frieze and the cornice. The house rests on a foundation of coursed, roughly squared stone.
