G-V-A-141
Harvey C. Yoder Farm
Gortner
Private

ca. 1900

INVENTORY FORM FOR STATE HISTORIC SITES SURVEY

Harvey C. Yoder Farm

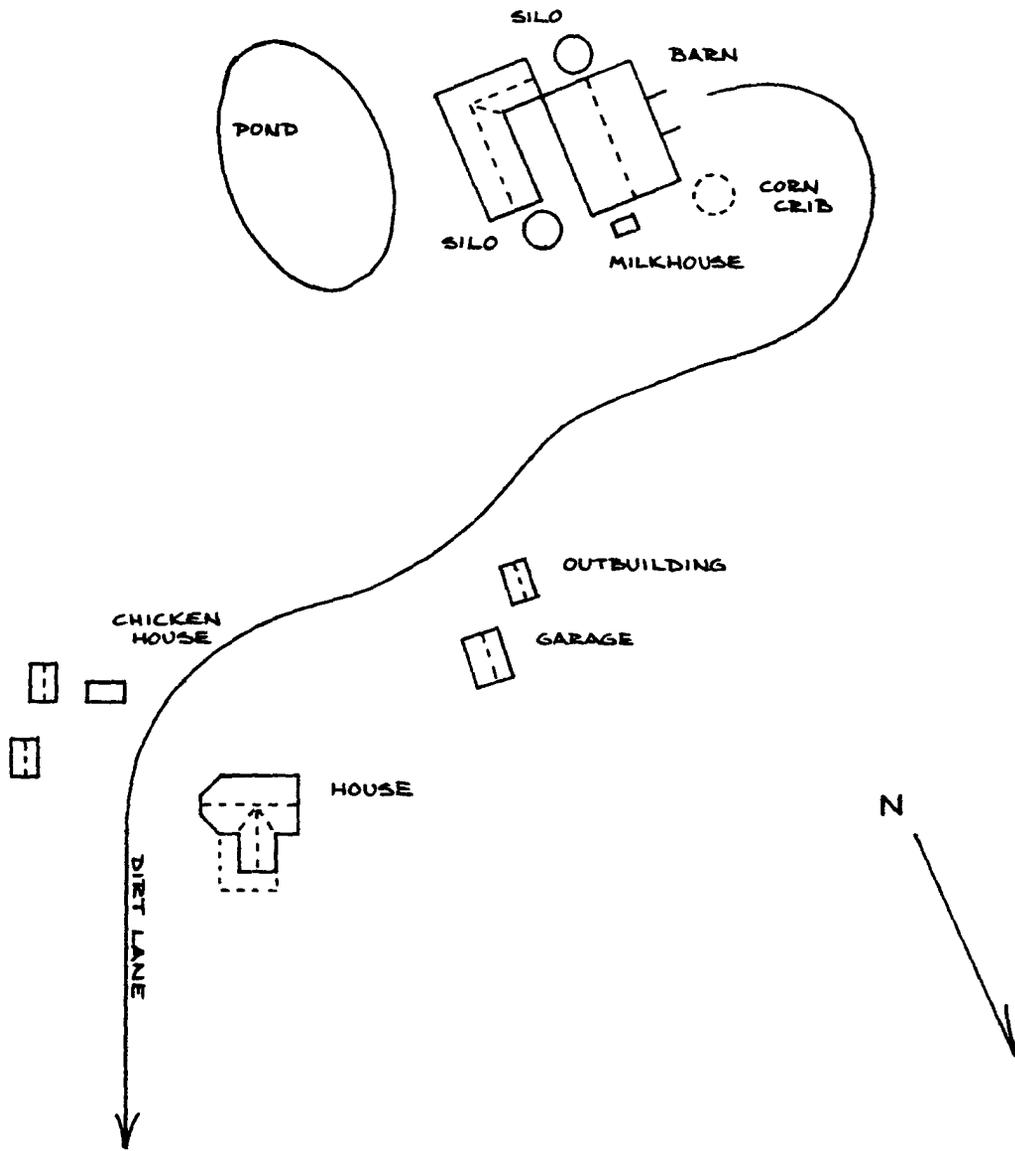
G·V·A·141
HARVEY C. YODER FARM
 GARRETT COUNTY, MARYLAND
 VICINITY OF GORTNER
 SITE PLAN -- NOT TO SCALE

The Harvey C. Yoder Farm is located on the south side of Paul Friend Road approximately .7 mile east of U.S. Route 219. The farm is situated at the end of a dirt lane .1 mile from the road.

A frame, gable-roofed bank barn on a poured concrete foundation is situated southwest of the house. Louvered ventilation panels pierce the walls on all elevations. The barn is sheathed in weatherboard and has an earthen bank entrance on its west side. A cylindrical metal ventilator with a pointed cap is located on the middle of the ridgeline.

Several small, frame outbuildings are also included on the property.

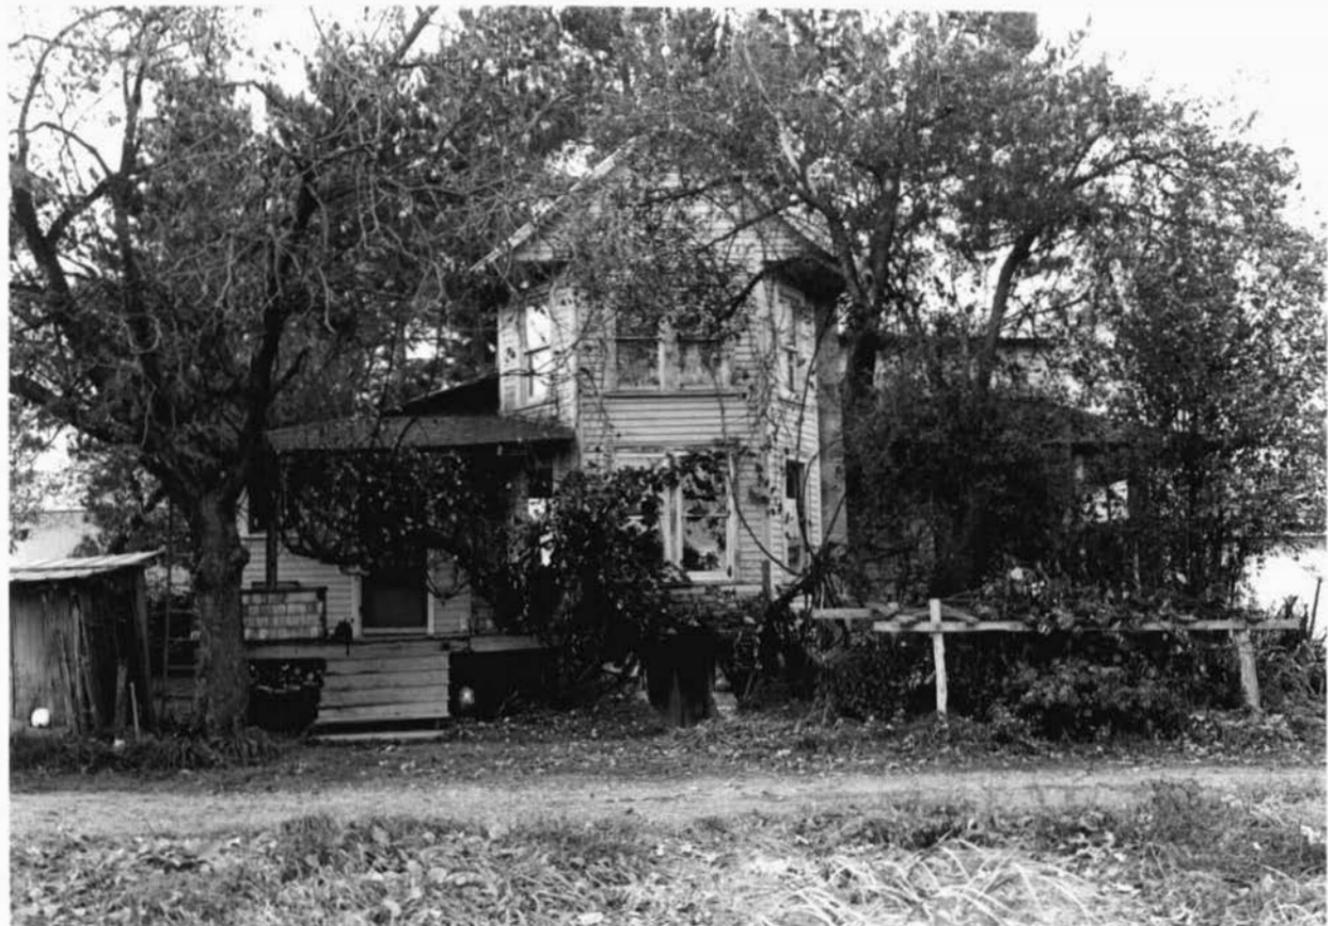
G-V-A-141
Harvey C. Yoder Farm
Garrett County, MD
Donna Ware 10-14-80
SE elevation

The house is a two story, frame building on a whitewashed rubble stone foundation. Its basic configuration is a T-plan. The facade occupies the southeast side of the leg of the "T" and the southeast endwall. This endwall takes the form of a gable-roofed bay window. A porch extends around the southeast and northeast elevations of the leg of the T. A one story, shed-roofed addition on a concrete block foundation covers the southwest elevation.

Two over two sash windows with plain board surrounds and drip moldings light the building. The bay window is lit by a pair of two over two sash on its main face and by single one over one sash on its two side faces. The facade door is composed of a frosted glass window in a floral design set over six square sunburst panels. A transom light tops the doorframe.

The exterior walls of the house are covered with weatherboard siding. The gable roof has a covering of corrugated metal and its rafter ends are exposed and decoratively trimmed. The porch has five turned posts supporting its shed roof.
