G-V-A-157

Sam Slabach Farm
Gortner
Private

INVENTORY FORM FOR STATE HISTORIC SITES SURVEY

Sam Slabach Farm

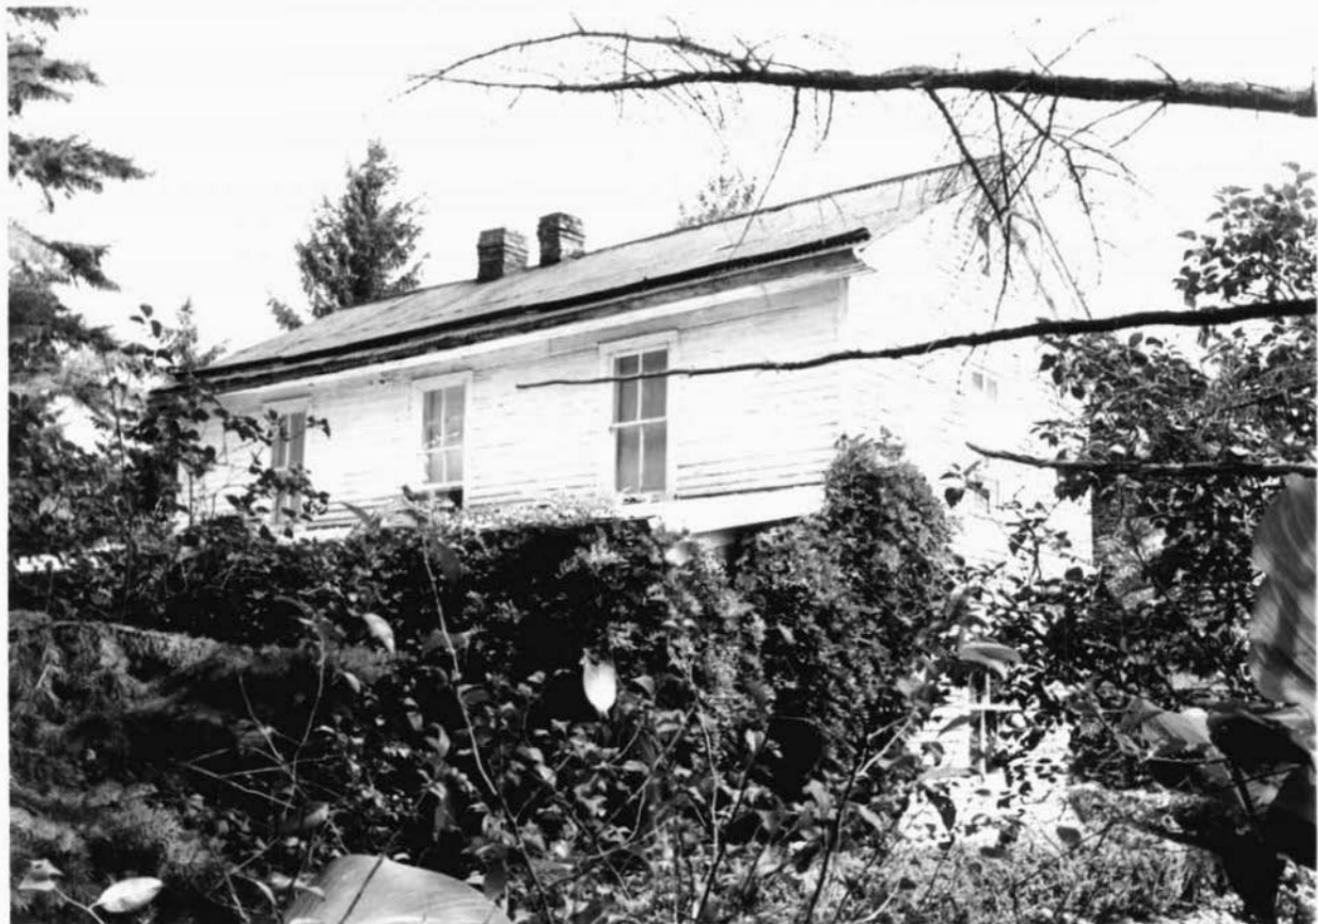
Facade: SW elevation

This frame farmhouse is situated in a hilly wooded area on Gortner Road, approximately one mile southeast of the town of Gortner at Rt. 219. The house faces southwest. It is a two story, three bay by one bay gable roof structure with a single bay deep ell. A single story, one bay by one bay shed addition is located at the northwest elevation. A wooden porch extends the length of the facade, supported by turned posts.

The house has two central brick chimneys. Two over two sash windows, framed with plain flat boards, light the house. Single pane windows are located in the gable ends. The house is covered with weatherboard siding. Corrugated metal covers the roof.
