HA-1129
CARVER-MASLIN HOUSE
Havre de Grace, Md.

c. 1890

INVENTORY FORM FOR STATE HISTORIC SITES SURVEY

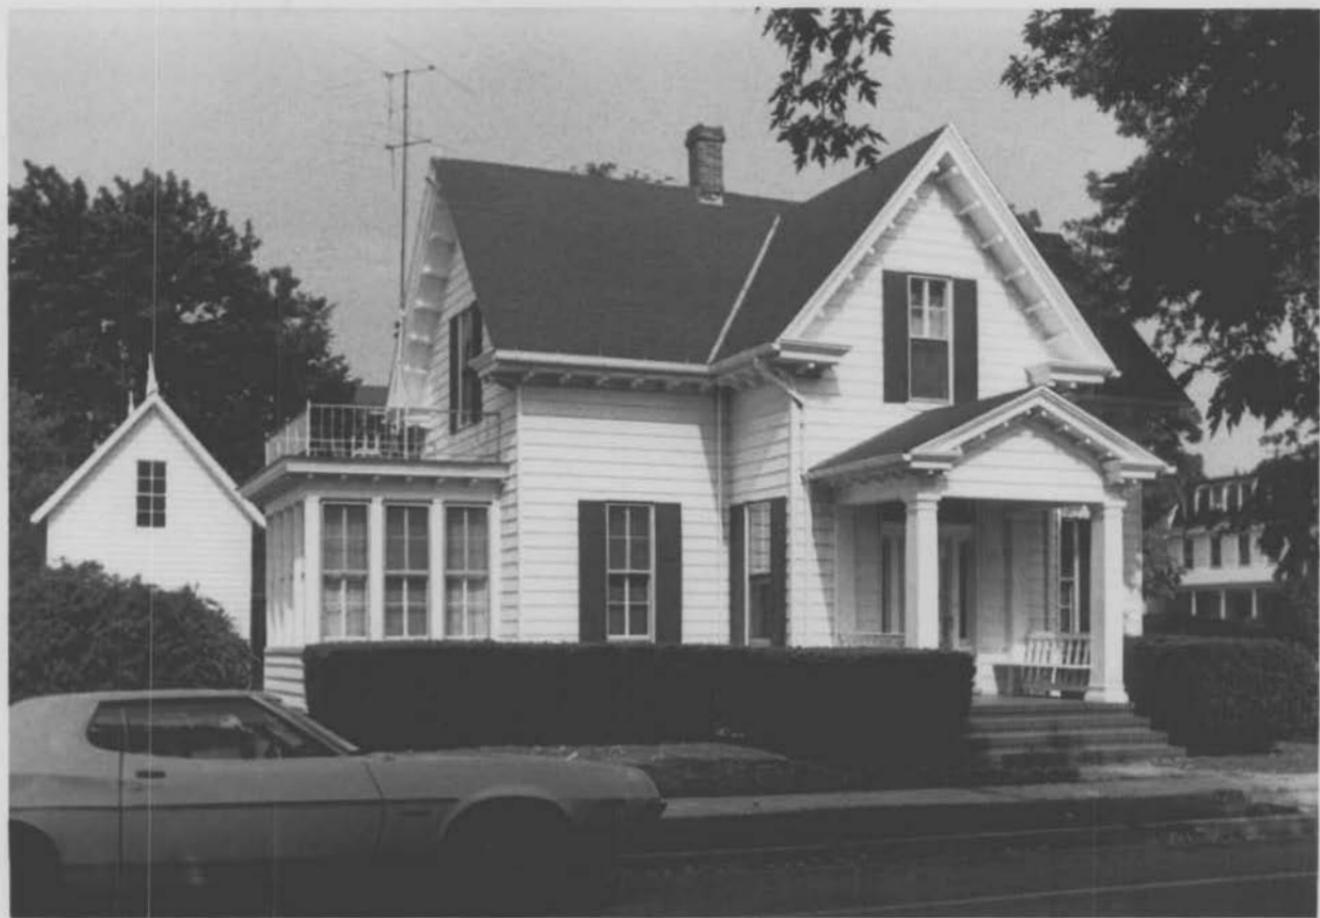
MA-1129 Carver - Madin Hsc.
100 S. Washington St.
East Elev. *Harve de Grace*
Marion Norton 6/13/77

The principle facade, three bays across, has an advanced center bay with an above grade porch across it. Repeating the treatment of the main gables, the triangular pediment of the front gable of the porch is outlined with plain brackets. The porch is supported by piers with molded bases and capitals. In place of side railings, the porch has benches, their backs made of vertical slats formed to resemble arrows. Another porch with benches and lattice work top and sides is on the north elevation of the kitchen wing, and on the kitchen wing at the south elevation is a small one bay porch with a hipped roof and lattice across the front. Across the south elevation is a porch with a deck on top of it. The porch is enclosed with glass to create a sun room.

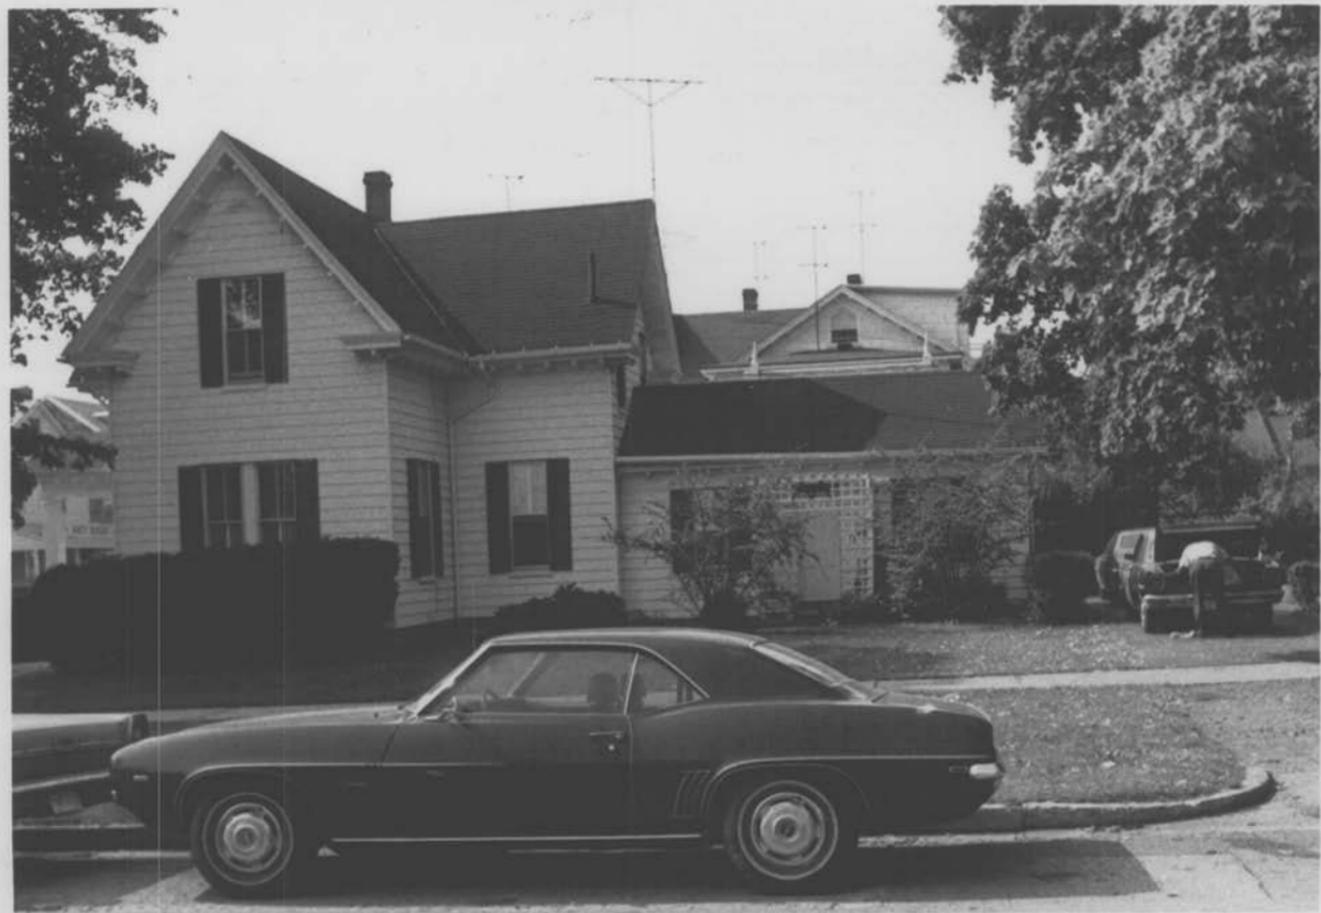
North Elevation

A pair of windows are in the advanced center bay on the north and south elevations.
