National Register of Historic Places  
Inventory—Nomination Form

historic Rockdale (preferred)  
and/or common The Robinson/Stirling Place

Rockdale  
Harford County  
Maryland

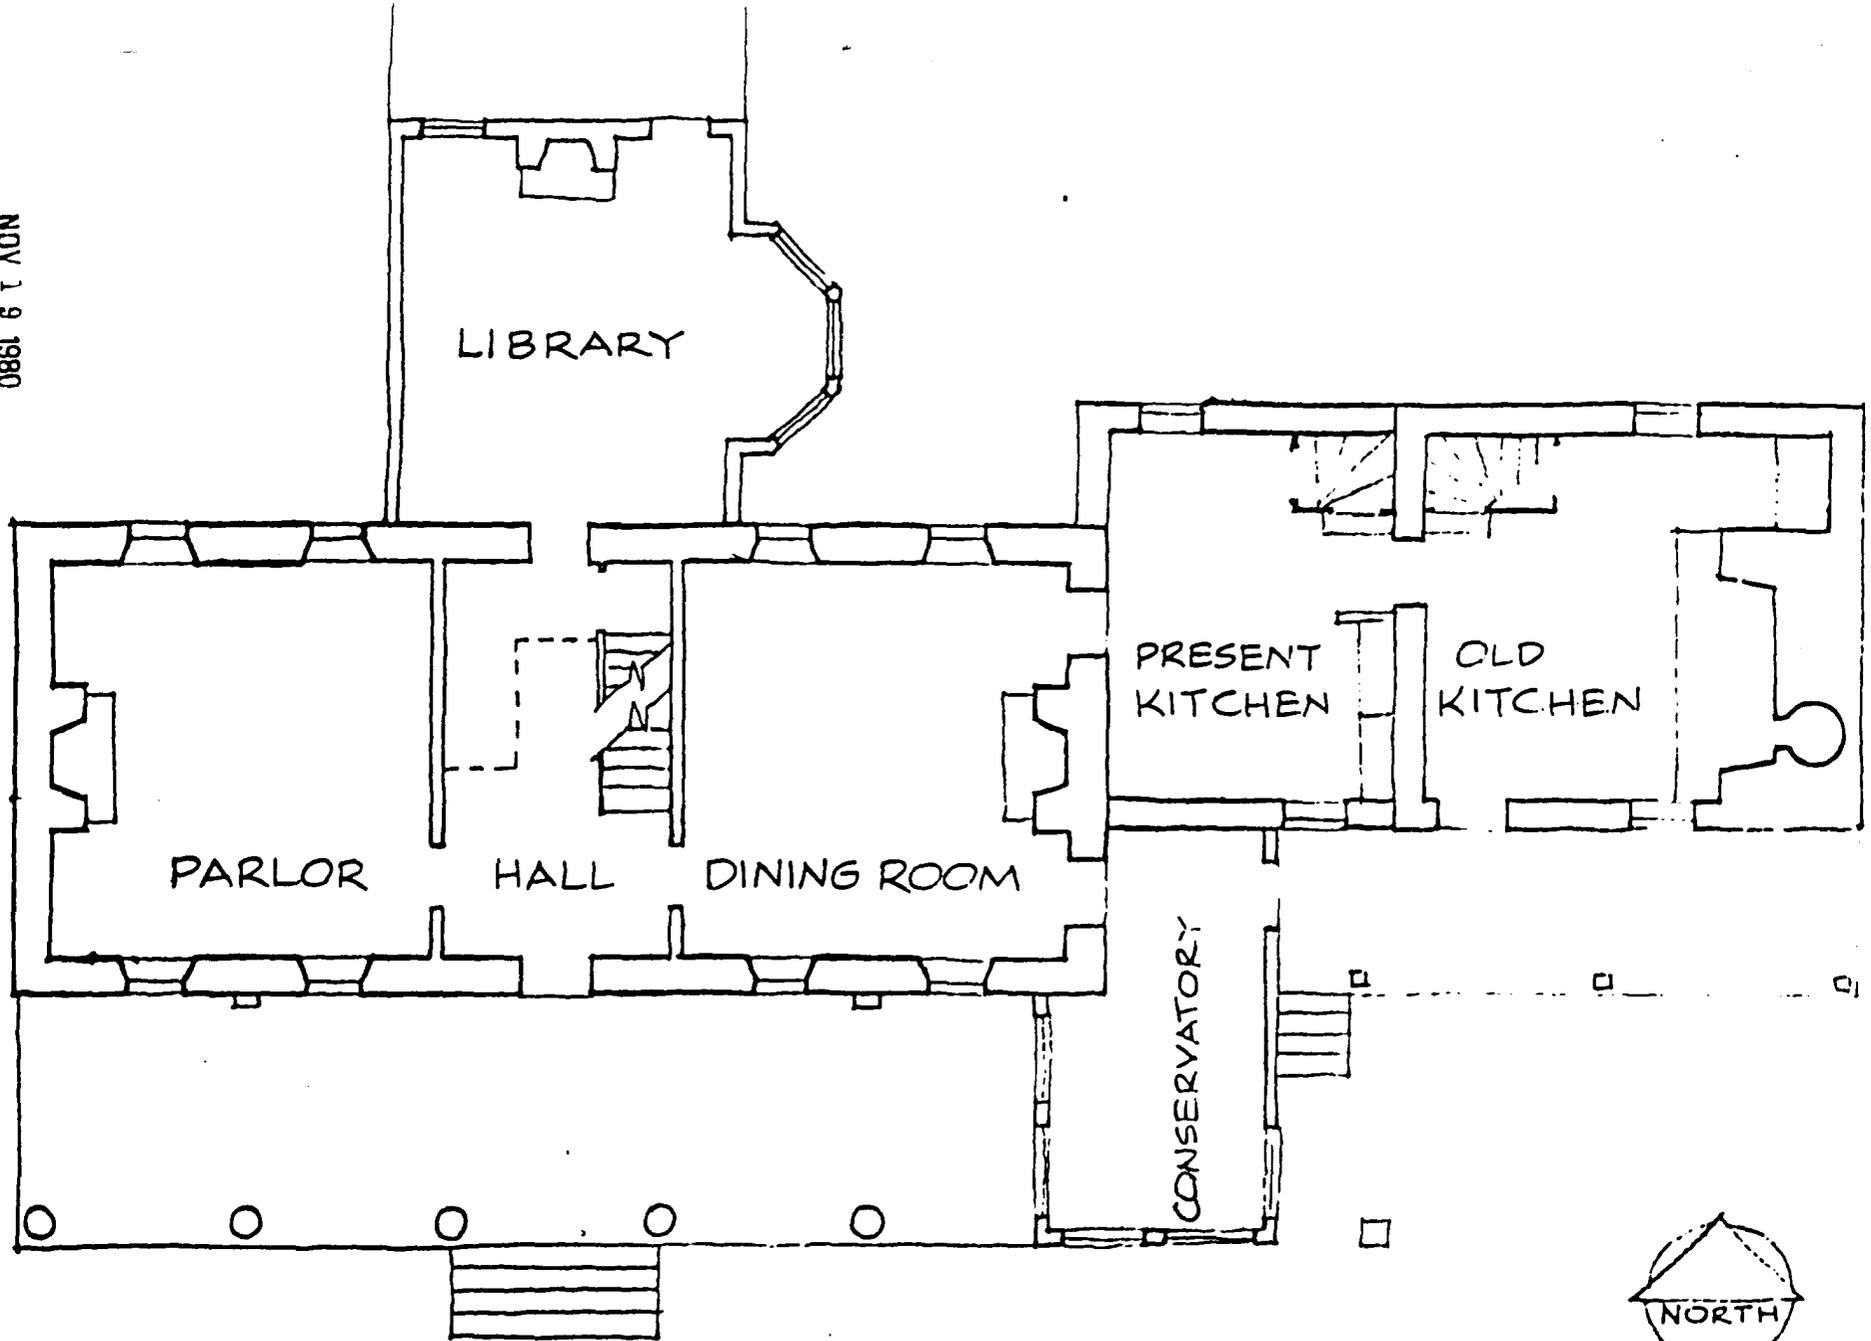
FIRST FLOOR PLAN NOT TO SCALE  
SKETCH BY JAMES T. WOLLON, JR., ARCHITECT  
29 JANUARY 1980

In plan the main house contains a wide center hall with a single large room on either side. At the north end of the center hall the staircase rises open, with an intermediate landing in each story, to the third story. Virtually all original detailing remains including the staircase with its round rail, rectangular balusters and colonette newels, six-paneled doors, paneled window jambs; corner-block trim, chair railing, baseboard and mantels of the Greek Doric order. An early 20th century alteration in the second story associated with the addition of the south bay window slightly reduced the size of the two principal chambers to create a large central south chamber.

In plan the main house contains a wide center hall with a single large room on either side. At the north end of the center hall the staircase rises open, with an intermediate landing in each story, to the third story. Virtually all original

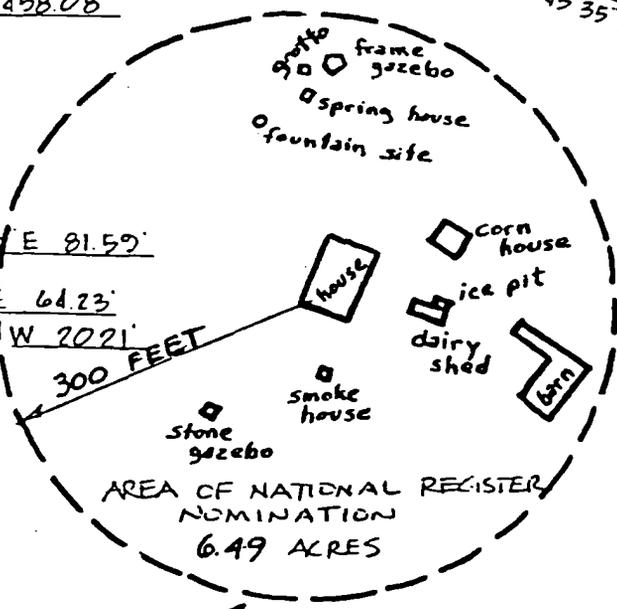
boundary map 1980

The boundary of the nominated area is delineated by a broken line on the attached drawn to a scale of 1"=200' and consists of a circle with a radius of 300 feet drawn from the extreme southeast corner of the house.

The boundary for the Rockdale nomination is a circle with a radius of 300 feet drawn from the extreme southeast corner of the house. The boundary was drawn to include the minimum area necessary to provide a setting for the house and outbuildings to incorporate the landscaped areas

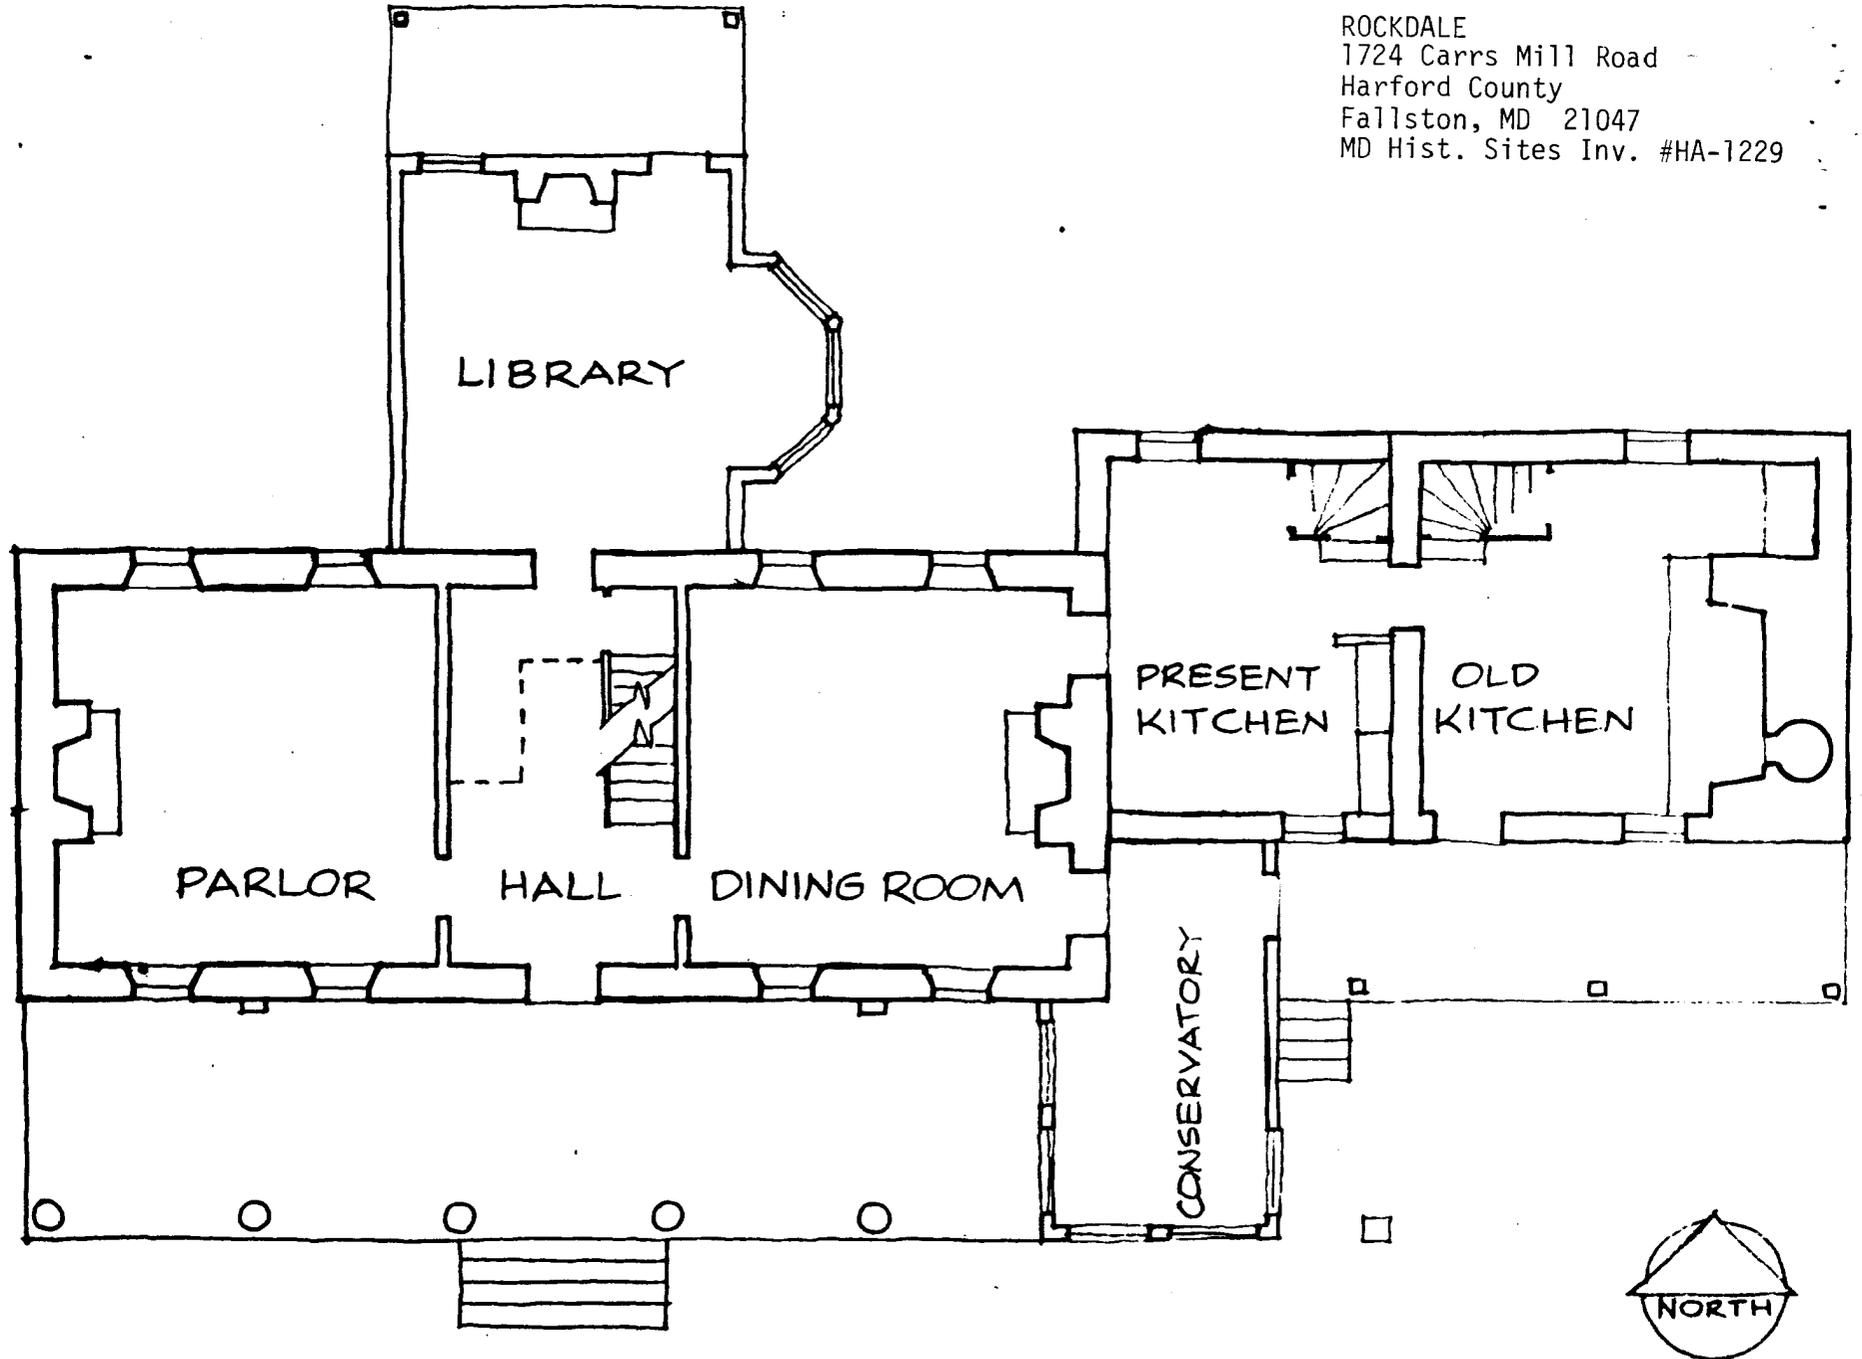
**FIRST FLOOR PLAN** NOT TO SCALE  
SKETCH BY JAMES T. WOLLON, JR., ARCHITECT  
29 JANUARY 1980

detailing remains unaltered including the staircase with its round rail, rectangular balusters and colonette newels, six-paneled doors, paneled window jambs, corner-block trim, chair railing, baseboard and mantels of the Greek Doric order. An early twentieth century alteration in the second story associated with the addition of the south bay window slightly reduced the size of the two principal chambers to create a large central south chamber.

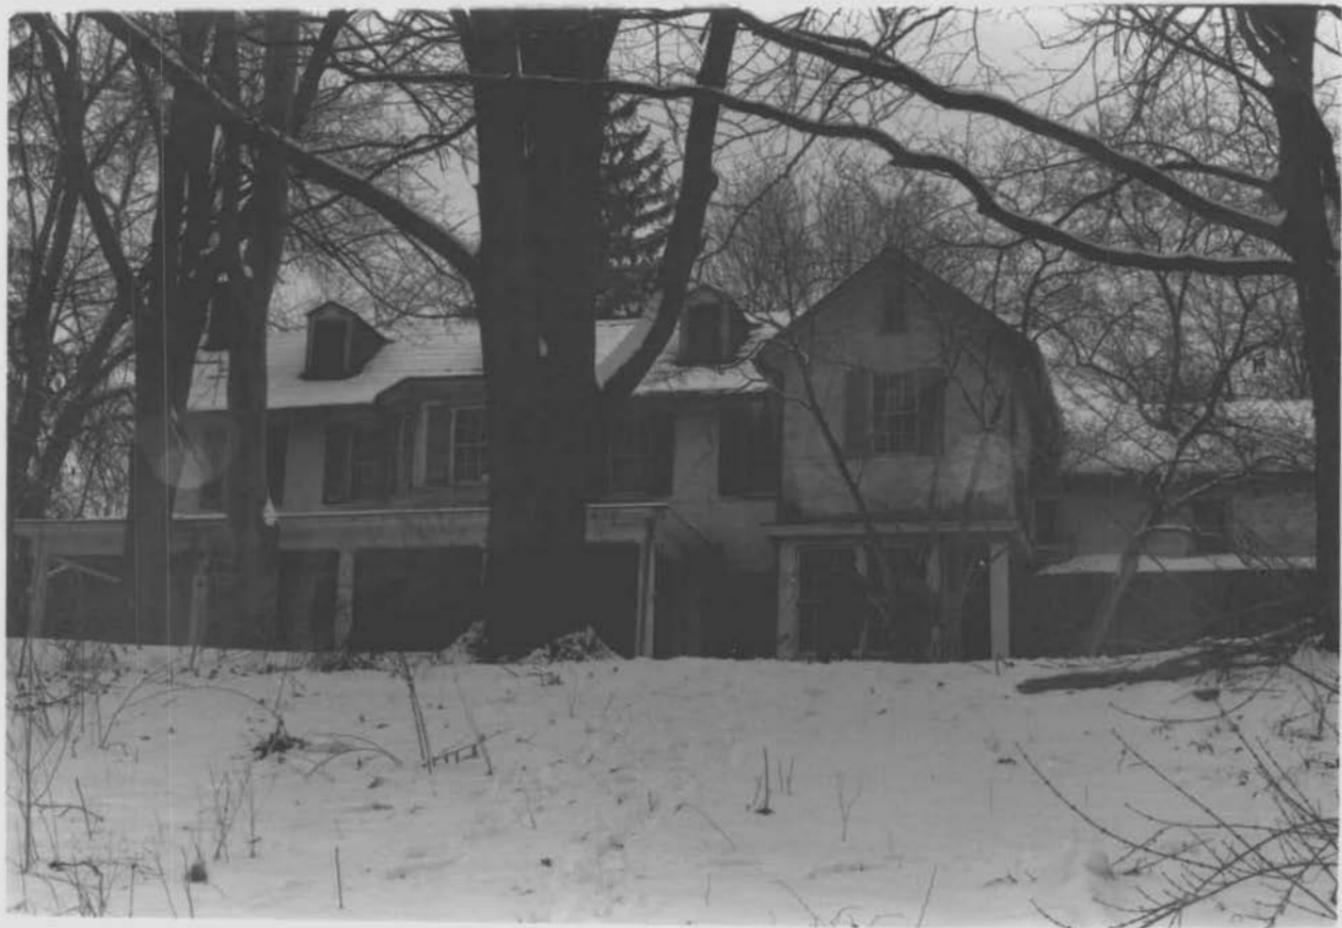
Rockdale HA-1229  
Fallston, MD 21047  
Susan M. Deeney  
February, 1978  
Southeast

The main house is five bays in length, two and one-half stories in height, of stone construction, stuccoed and scored. A brick chimney rises flush with each end gable. The principal entrance centered in the south front is a six paneled door with glazed transom. Typical windows are 6/6 with narrow beaded frames and louvred blinds. Three dormers are in the southerly slope of the roof, each with 6/6 windows. A one-story porch extends across the south front, its fluted wooden columns of the Greek Doric order. Originally three bays in width, it was extended the full length of the house early in the 20th century. The bay window, added early in the 20th century to the central bay of the second story, has a 6/6 window in its south side with 4/4 windows in the flanking sides.

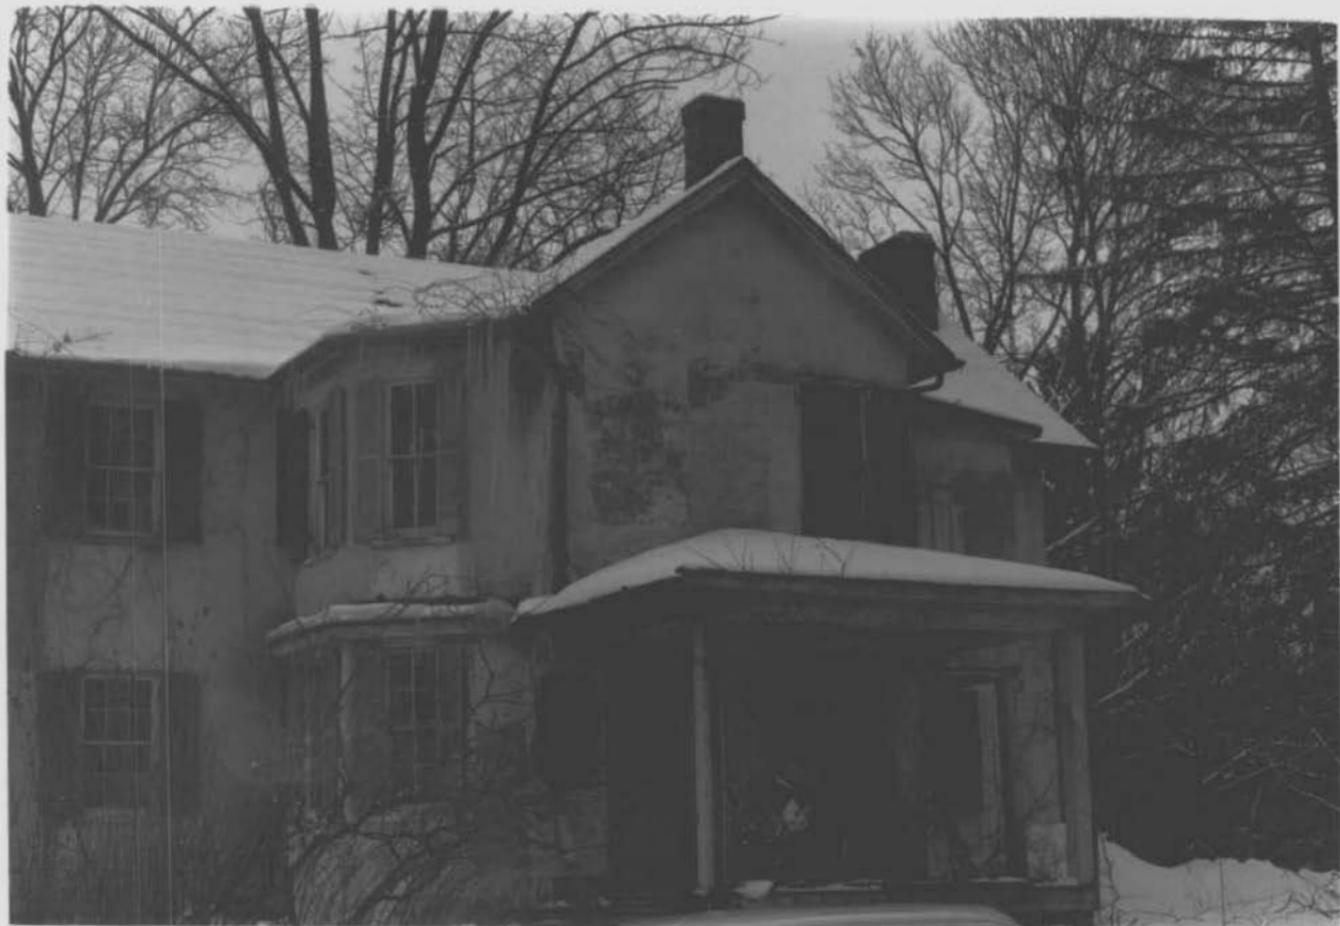
Rockdale HA-1229  
Fallston, MD 21047  
Susan M. Deeney  
February, 1978  
North

The north facade is similar to the south but its central bay is covered by the north wing, an early 20th century addition of frame construction stuccoed over wood lath over weatherboarding. Two stories in height with a gabled roof, it has a two-story bay window projecting from its east side and a small porch sheltering the entrance in the north end.

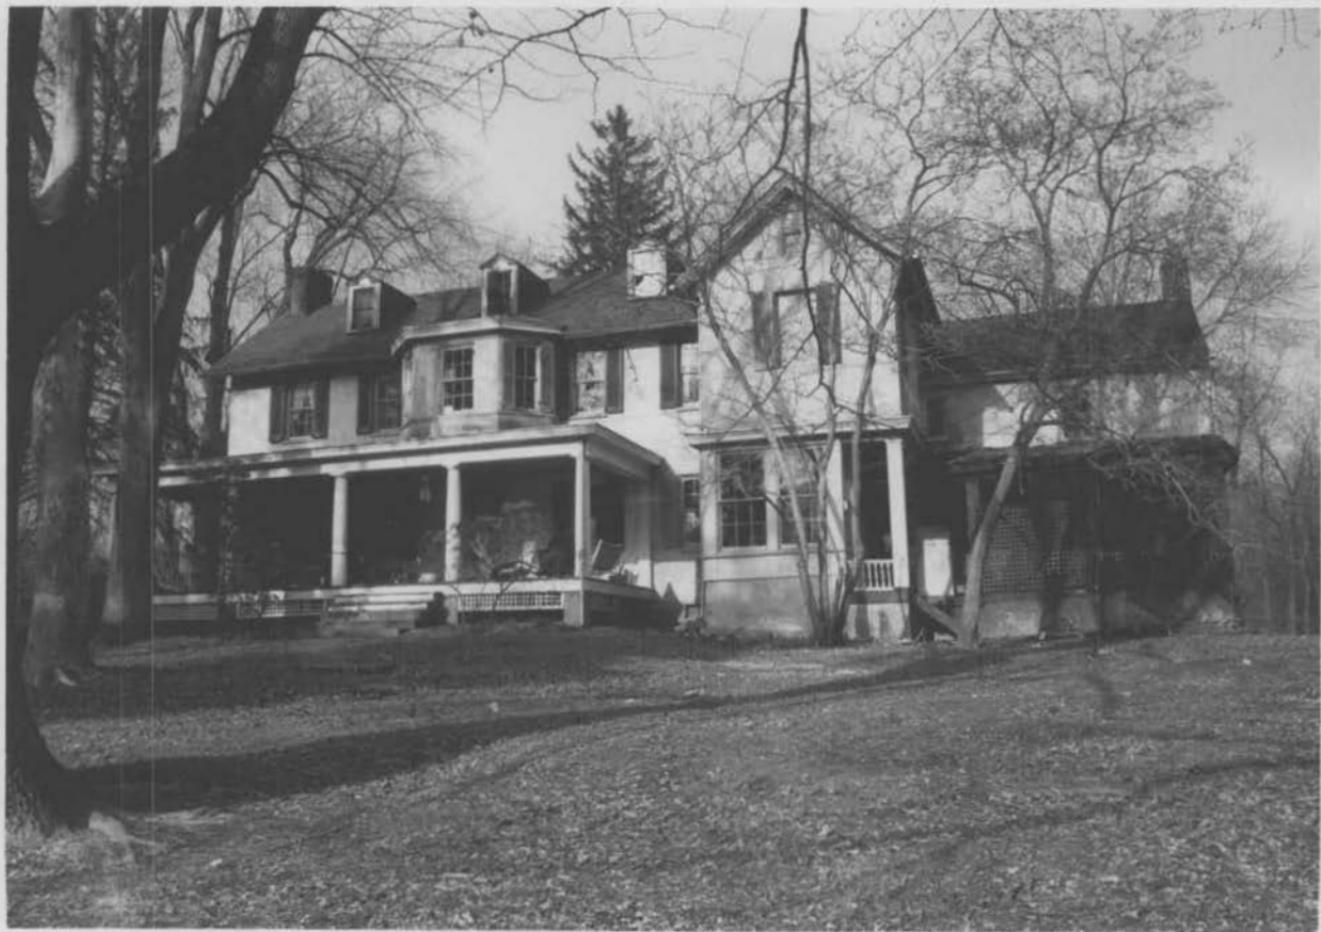
Rockdale  
Fallston, MD 21047  
Natalie Shivers  
South

The main house is five bays in length, two and one-half stories in height, of stone construction, stuccoed and scored in imitation of ashlar. A brick chimney rises flush with each end gable. The principal entrance centered in the south front is a six paneled door with glazed transom. Typical windows are 6/6 with narrow beaded frames and louvred blinds. Three dormers are in the southerly slope of the roof, each with 6/6 windows. A one-story porch extends across the south front, its fluted wooden columns of the Greek Doric order. Originally three bays in width, it was extended the full length of the house early in the twentieth century. The bay window, added early in the twentieth century to the central bay of the second story, has a 6/6 window on its south side with 4/4 windows in the flanking sides.

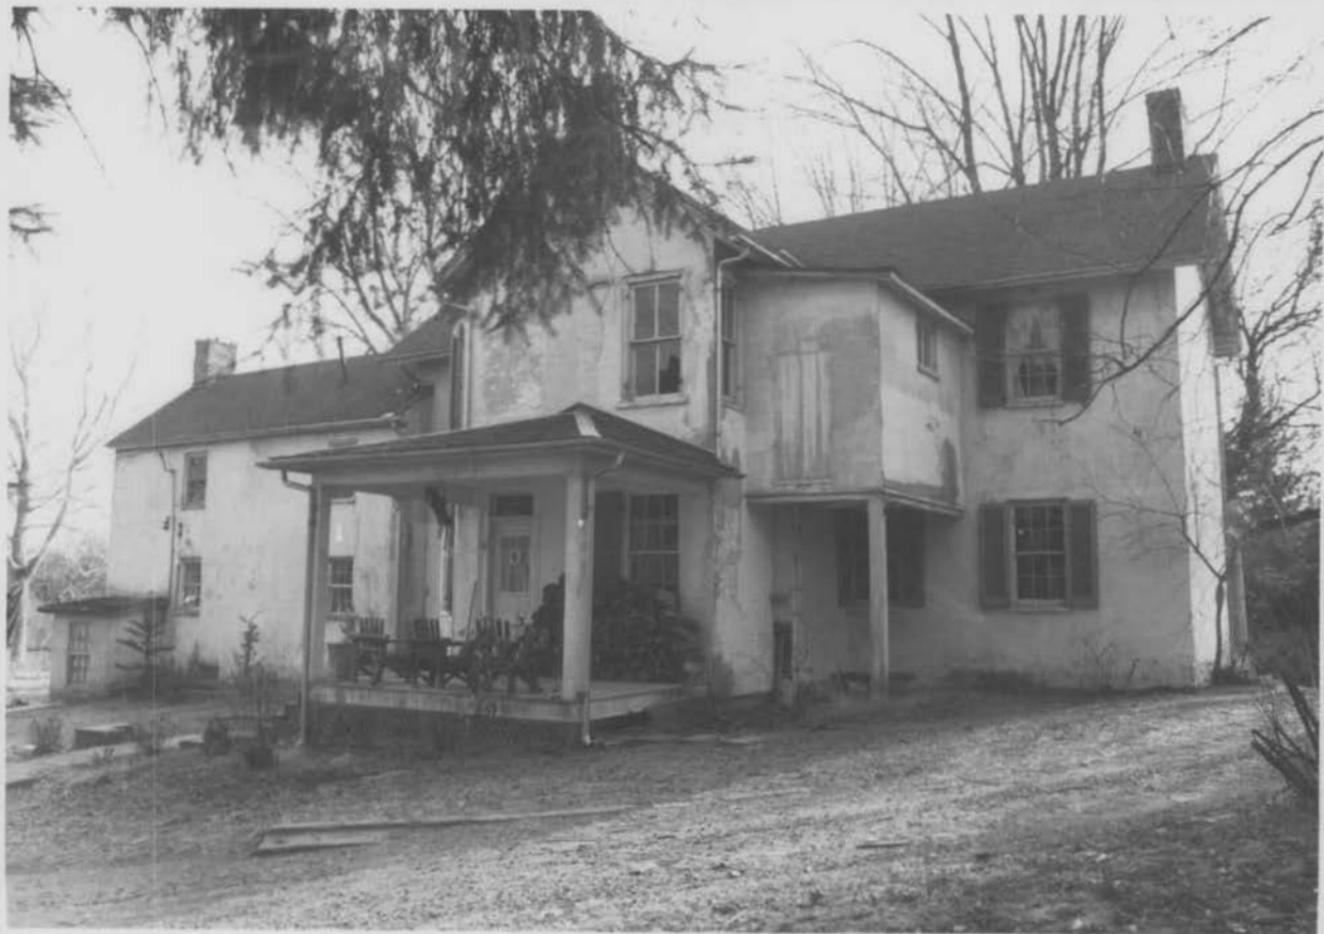
Rockdale  
Fallston, MD 21047  
Natalie Shivers  
North

The north facade is similar to the south but its central bay is covered by the north wing, an early twentieth century addition of frame construction, stuccoed over wood lath over weatherboarding. Two stories in height with a gabled roof, it has a two-story bay window projecting from its east side and a small porch sheltering the entrance in the north end.
