HA-1395

INVENTORY FORM FOR STATE HISTORIC SITES SURVEY

Mrs. Dunnigan's Hotel and Restaurant

County Extension Office

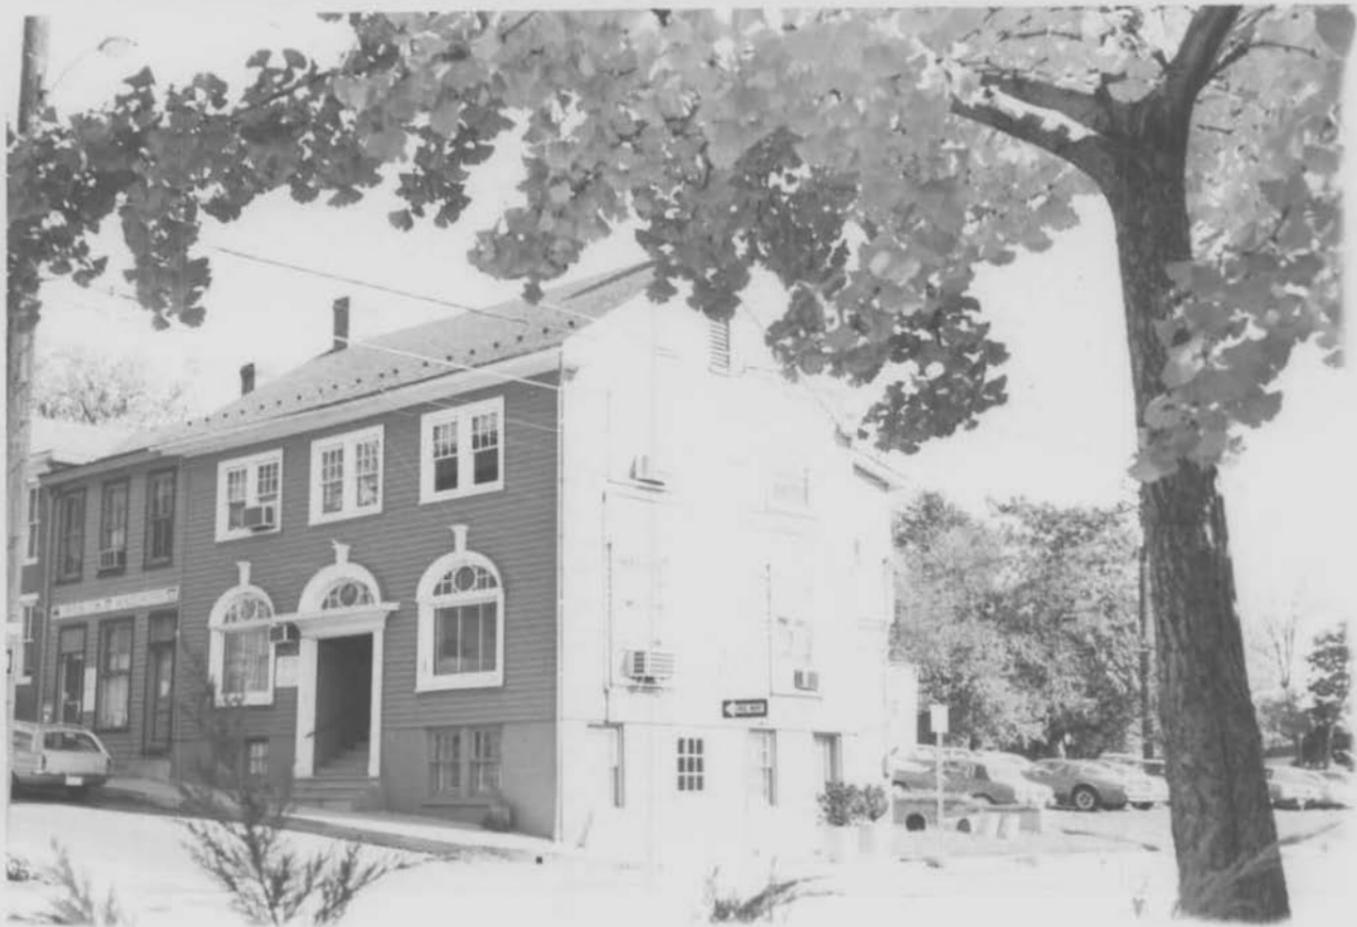
L. to R : RANNEBERGER BLDG, 31 COURTLAND +
COUNTY EXTENSION BLDG, 33 (COURTLAND)
BEL AIR.

FACING NORTH
M. LAREW, 1978

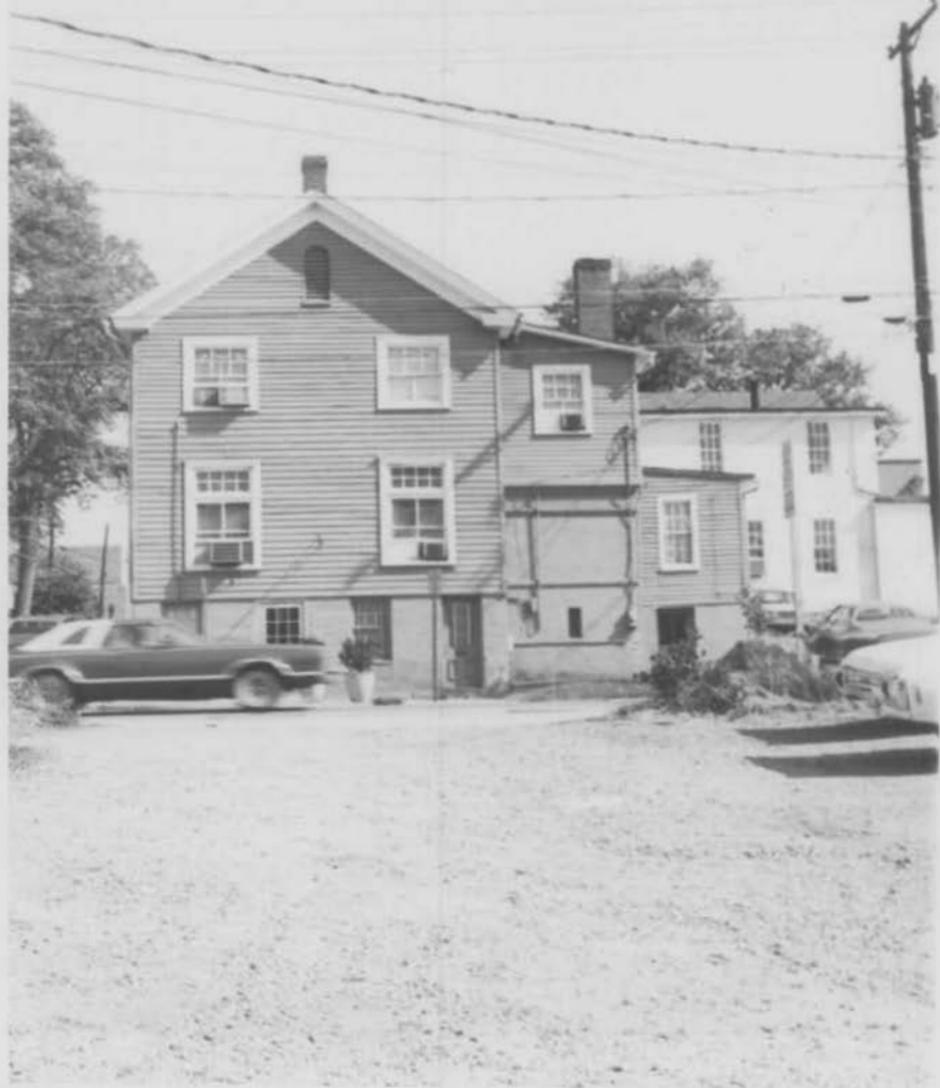
WEST ELEVATION, SHOWING ADDITIONS

The County Extension Building is on the southwest corner of Courtland and Bond Streets in the Town of Bel Air, Maryland. It is a three story frame building on a stuccoed stone basement with a slate gable roof and two corbel capped inside end chimneys, one on the east elevation, and one in the west elevation of the 1879 addition. The present fenestration and the applied decoration on the facade are the result of a 1906 remodeling which gives the building, probably built around 1868, a Classical Revival look. The original building was a three bay by two bay structure in ship-lap siding. Two two story additions to the rear have been made, the first, a one room addition to the southeast by Barbara Ferry Dunnigan in 1879, and the second, a vault in the basement and first story topped by a room and bath in the second story by the Harford Mutual Fire Insurance Company in 1906.

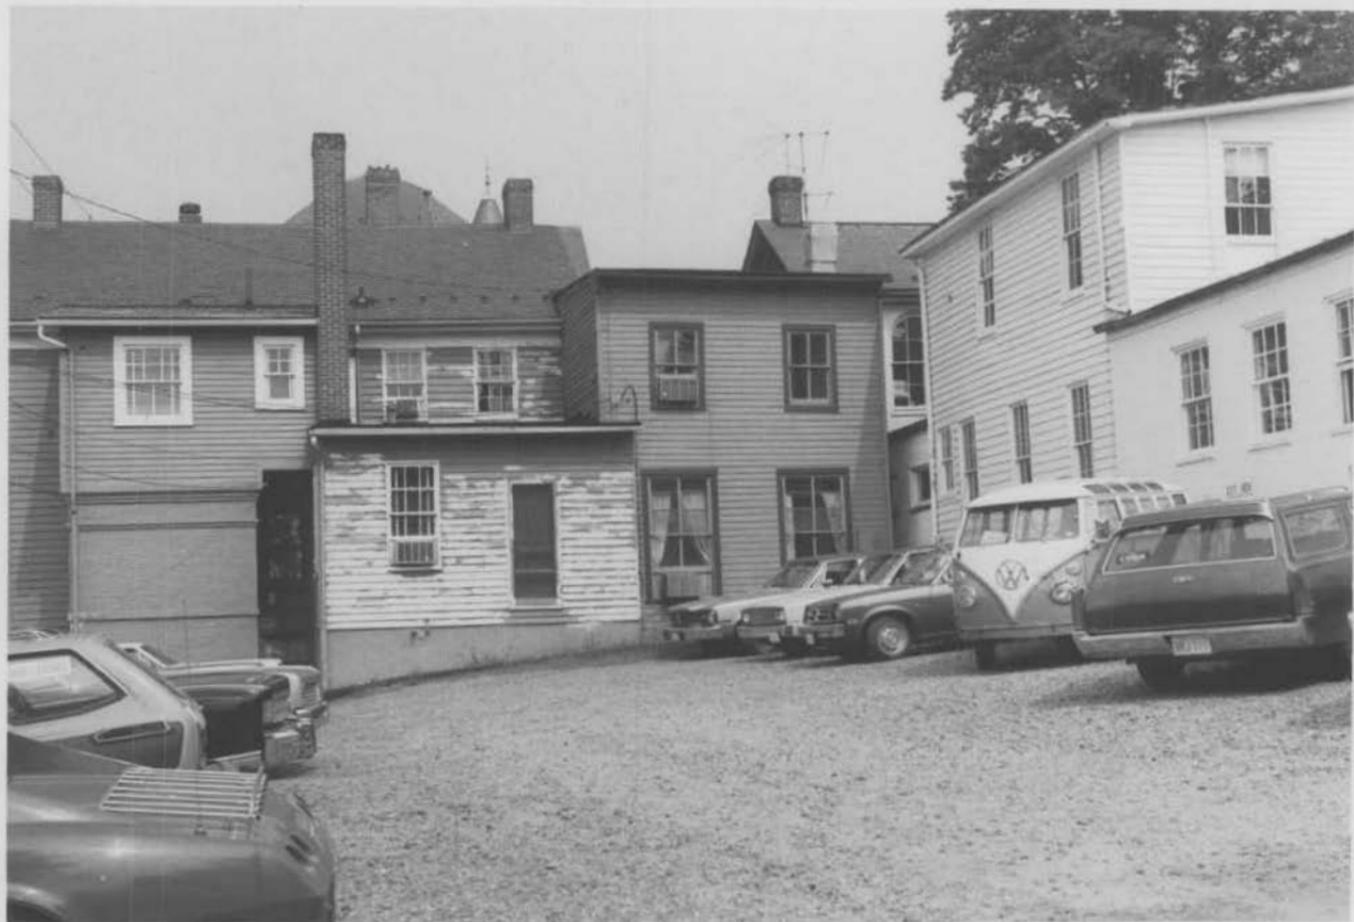
L 40 R 33, 31, 29 COURTLAND, BEL AIR
REAR (SOUTH) ELEVATIONS

~~STATEMENT OF SIGNIFICANCE~~ Partition in center of it - Kitchen fireplace? See photo of rear elevation for vault Insurance Co. put in chimneys seem to match. The Insurance Co. must have put that 2nd floor bathroom in - no tub so doesn't date from Hotel days, but woodwork matches - also the room next to it on the W. - three steps down to that room from next forward west room.

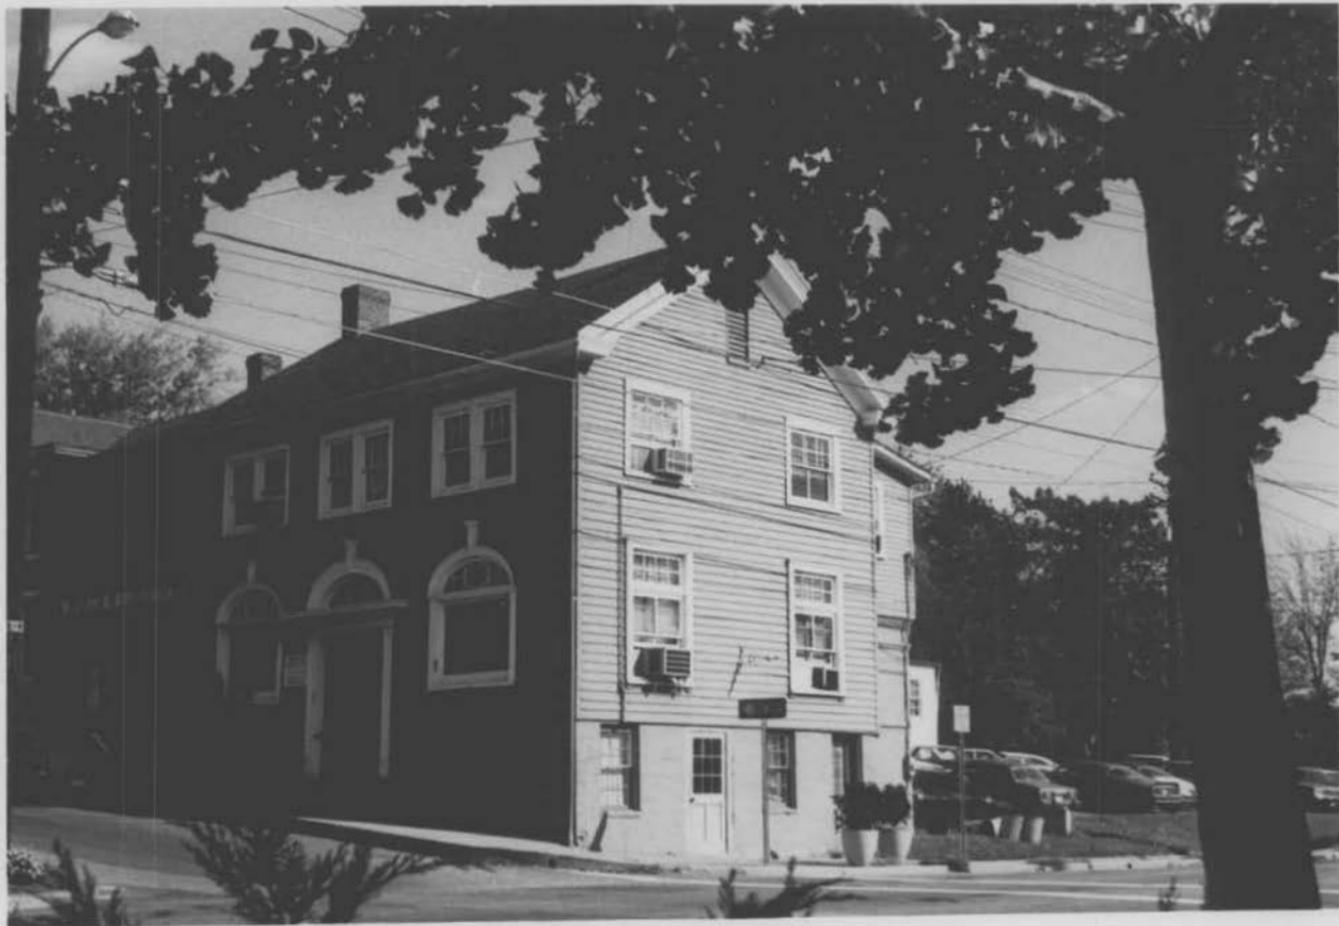
Mrs. Dunnigan's Hotel + Restaurant
33 Courtland, Bel Air
n + w elev
M. Larew, 1979

The three stories of the facade each have a different window treatment. In the basement each end bay has a pair of double-hung 6/6 windows set in wooden surrounds. The entry which begins in the middle bay of the basement and continues into the first story is set in a wooden frame which supports an entablature topped by a round arched transom with a carved console in the place of a keystone. The transom has a round pane in the center, flanked by 2/4 square panes which accommodate themselves to the curve of the arch. A large, single pane window with a transom matching that over the entry flanks the entry on each side. The second floor windows in the front elevation are double, double hung 6/1, set in wooden surrounds. A flight of three concrete and 6 wooden steps rise to the recessed doorway. Double doors with a single glass pane above and two wooden panels below are topped by two horizontal panes in the transom. The Bond Street elevation also has three different window treatments. The basement, or first, level has a four bay arrangement, window, door, window, door. The windows are double-hung 6/6 like those in the facade. The two doors have nine window panes in the top over wooden panels. When Mrs. Dunnigan owned the building there was a liquor store in the basement, which probably accounts for the double access to the first level. The windows in the top two stories are similar in design, the differences being attributable to size. The two first floor windows are double-hung, 2/2, with a 4/4 transom topped by a thin entablature, all in wooden surrounds. The second story windows are double hung, 6/2, without entablature. The second story window in the vault (1906) addition in this elevation matches the other two second story windows, but the windows in the rear, or south, elevation are simple 6/6. Apparently only the two elevations visible from the streets were modified in the 1906 remodeling.
