**MARYLAND HISTORICAL TRUST
DETERMINATION OF ELIGIBILITY FORM**

Property Name: Reckord Mill Complex Inventory Number: HA-1470 / HA-1471
 Address: 424 N. Main St. (432 Rock Spring Ave.) City: Bel Air Zip Code: 21014
 County: Harford USGS Topographic Map: Bel Air
 Owner: BNH LLC Is the property being evaluated as a district? X yes
 Tax Parcel Number: 245 Tax Map Number: 301 Tax Account ID Number: 025934
 Project: MD-924 Bel Air Streetscape Project Agency: SHA
 Site visit by MHT Staff: X no ___ yes Name: _____ Date: _____
 Is the property located within a historic district? ___ yes X no

MARYLAND HISTORICAL TRUST
NR-ELIBILITY REVIEW FORM

INVENTORY FORM FOR STATE HISTORIC SITES SURVEY

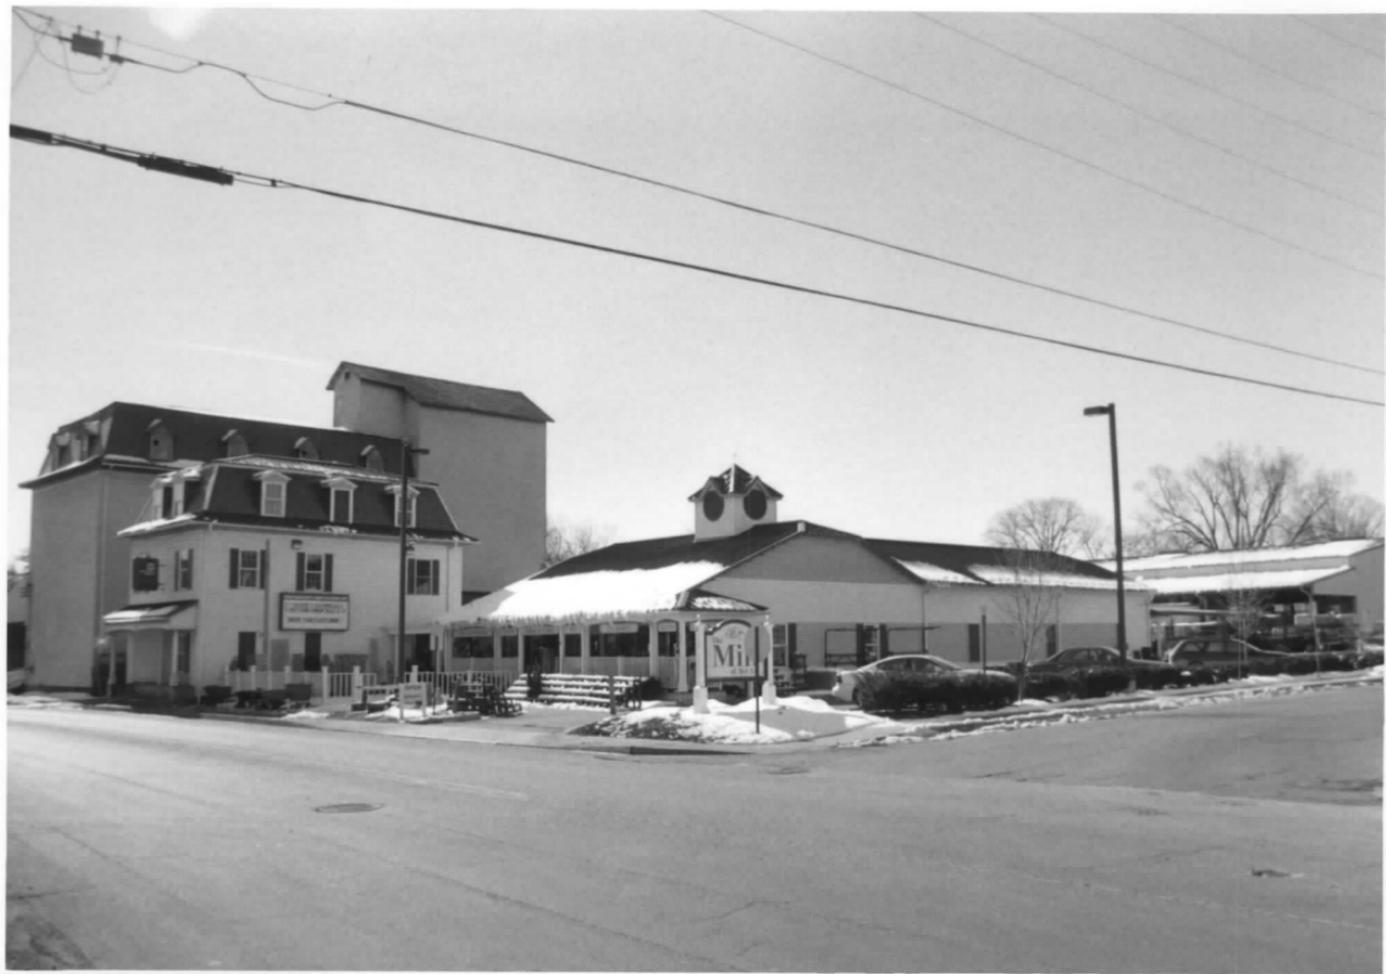
Overview

The Reckord Mill complex includes a four-story mill building with an attached five-story grain elevator, a three-story office building, a modern one-story retail store, and a modern one-story warehouse. Mansard roofs with patterned slate characterize the mill and office buildings. Fenestration and exterior materials on both of these historic buildings have been altered substantially. All of the buildings on the property are clad in modern siding, and modern standing-seam metal roofs predominate.

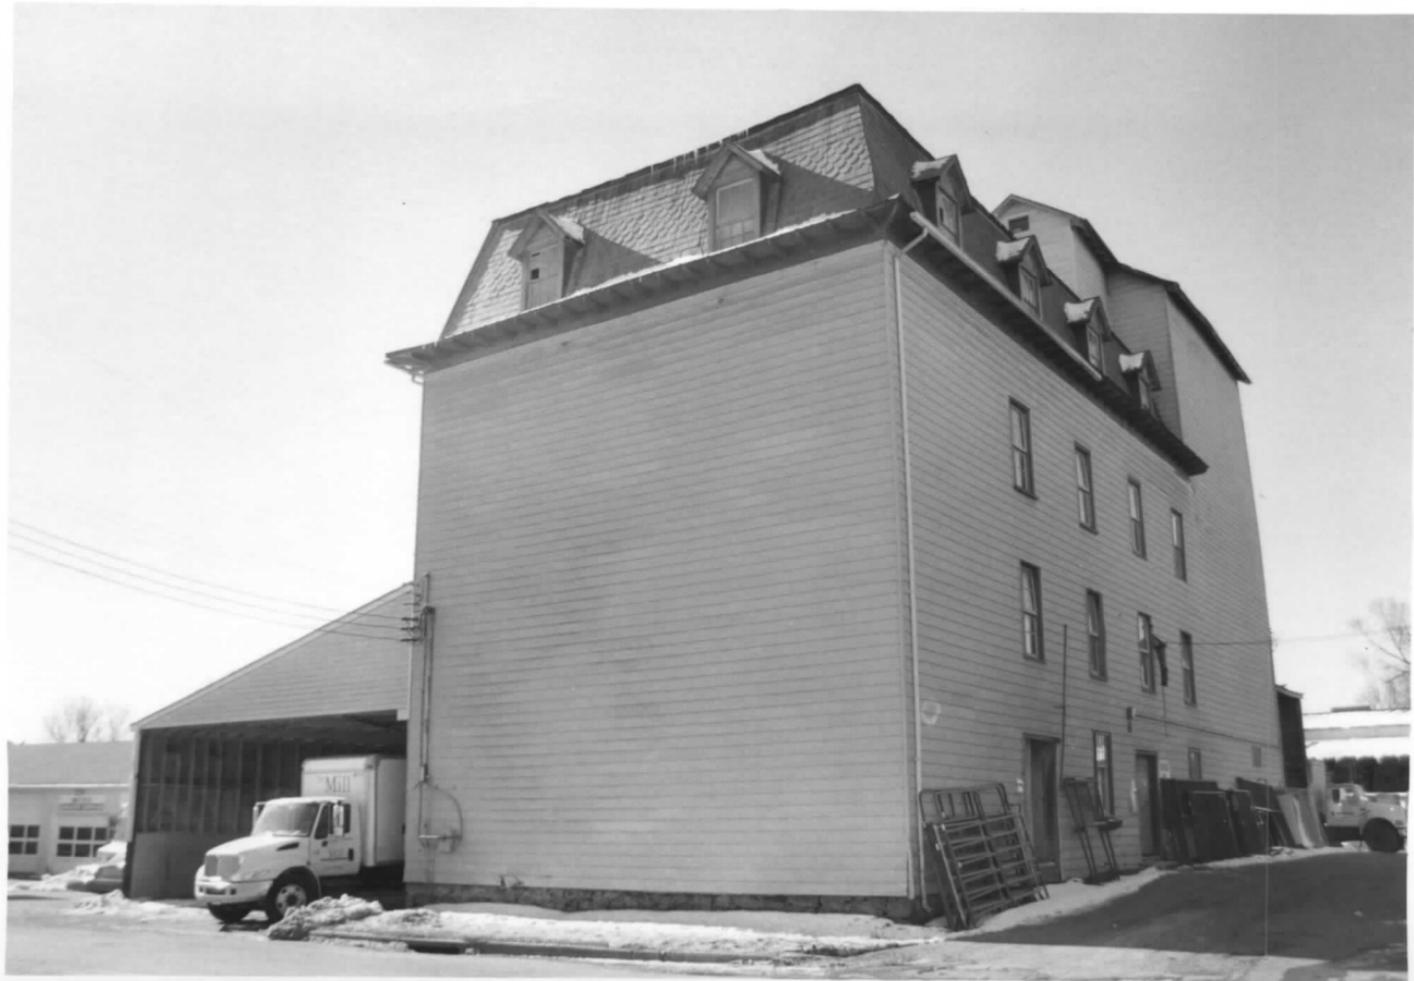
Mill - eastern facade & north elevation

The northern elevation of the building is the most intact, having windows or doors in four bays on each of the building's three stories, and four gabled dormers penetrating the slate-covered Mansard roof above. No openings are present in the first bay.

The main block of the mill building measures approximately 40 feet wide by 60 feet deep, and is 4 stories in height. The building's foundation is stone, the walls are clad in modern synthetic siding, and the fourth story is contained under a Mansard roof that has exposed rafter tails. A tall five-story grain elevator with a gabled roof is attached to the western (rear) elevation, and a large one-story shed-roofed garage wing is attached to the southern elevation of the building. Several small appendages

are present on the rear of the building. Siding on the mill used to have vertical seams. The building is currently clad in modern synthetic siding with horizontal seams mimicking the appearance of clapboards. The steep slope of the building's Mansard roof is covered in patterned slate on three sides, with metal on the fourth. At one time the mill had three bays in each of the three stories, for a total of nine windows on the eastern façade, plus two gabled dormers. The dormers survive today, but vinyl siding covers all of the window openings on the body of the building.

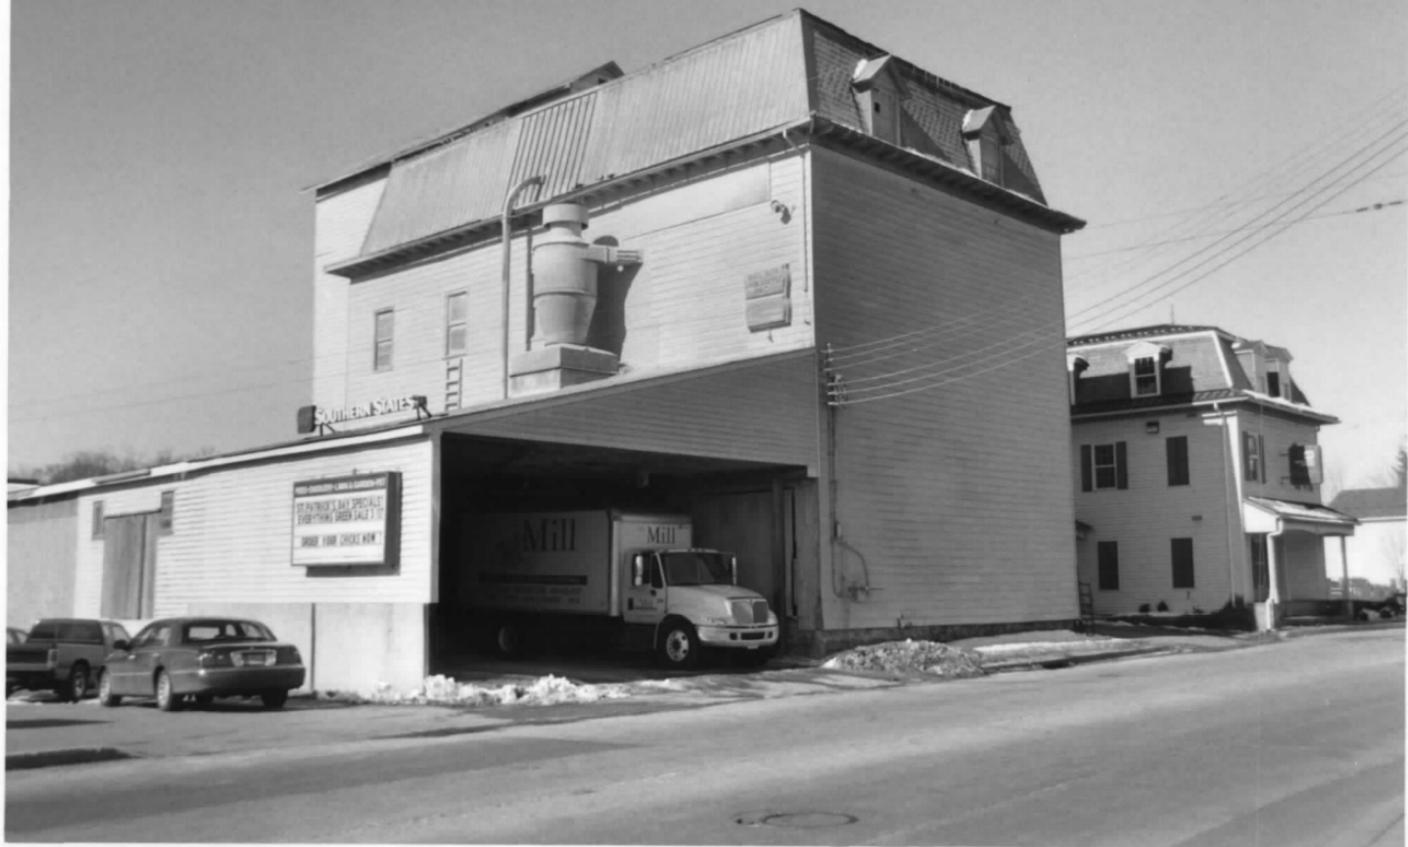
Mill -- eastern facade & south elevation

The southern elevation of the building historically contained five openings on each level, plus four gabled dormers on the steeply pitched Mansard roof. Currently, large a shed roof wing that allows two trucks to pull in and load under cover occupies the first and second levels of this elevation. Windows are present in the first, second, and third bays on the third level. Air handling equipment occupies the fourth bay, and vinyl siding covers the window that formerly existed in the fifth bay. All of the dormers on the southern elevation have been removed, and the roof slate has been replaced by metal.

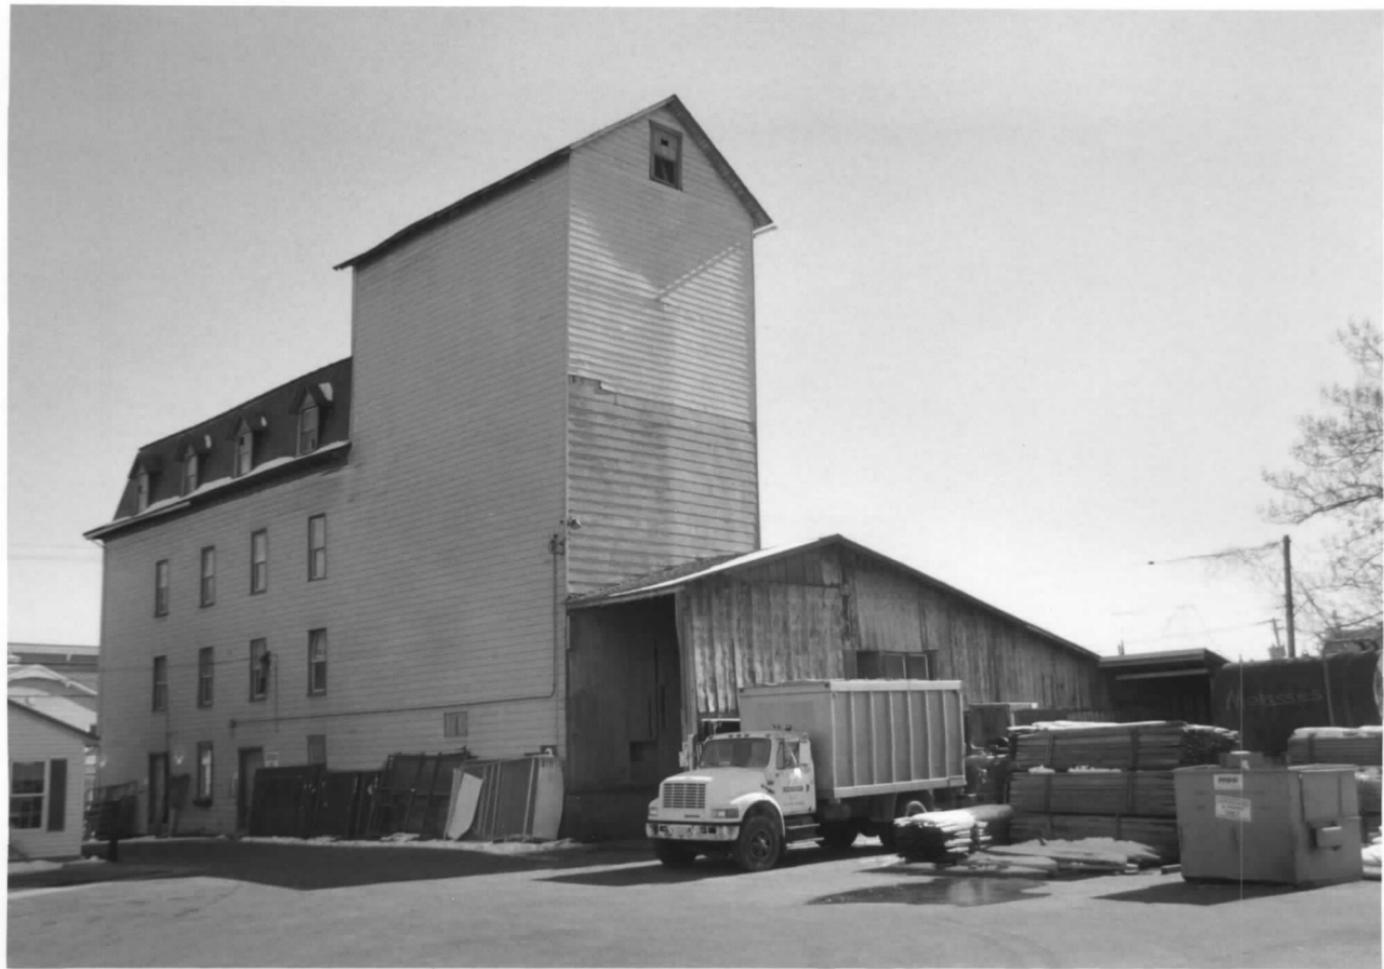
Mill-- north and west elevations

The building's entire west side is occupied by a large five-story grain elevator with a gabled roof. The frame building is clad in synthetic siding, and its only opening is a six-over-six window in the gable end. A metal-sided one-story addition with an asymmetrical gabled roof is attached to the western elevation of the grain elevator and connects with the concrete block and synthetic sided garage/loading dock wing on the south side. A tank for molasses is present outside of the building, along with a couple of small modern shed additions.

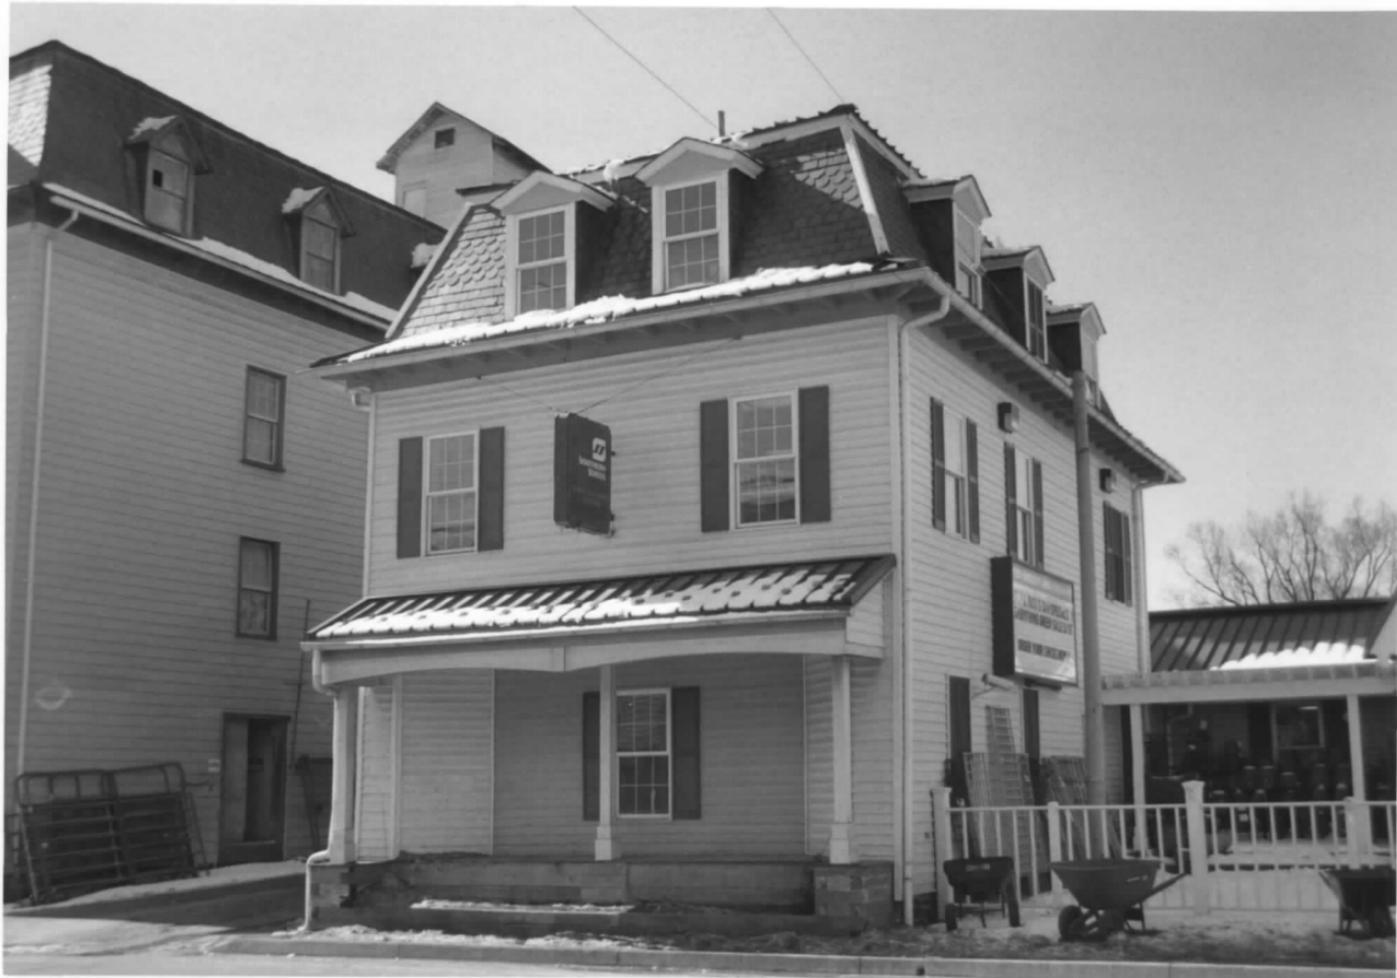
office -- eastern facade & north elevation

A narrow one-story porch with a shed roof is present on the façade of the office building. This structure has a concrete deck and is supported by three irregularly spaced wooden posts. The fascia is slightly arched, and the roof is clad in standing-seam metal with snowbirds. This porch is modern, but one-story porches have been present on this building in the past.

Beneath the porch, the façade of the office contains a recessed central bay that reflects the building's use as a store during the second half of the twentieth century. While this recessed area would have contained a commercial storefront entry and windows, a single central six-over-six window is currently present. Historically the building had a central entrance flanked with one window on each side. Above the porch, one window is present in each of the outer bays, and a sign projects from the center.

The office's northern elevation contains window openings in the first, second, and fourth bays on both stories. Modern shutters are fixed closed on the ground-level windows.

The main block of the office building is a three-story frame building with a mansard roof and a stone foundation. It is generally three bays wide and four bays deep, although the fenestration is irregular. The office building has a residential appearance, and is clad in vinyl siding and contains modern six-over-six vinyl windows throughout. A modern one-story wing with a gabled roof has been added to the rear of the main block. This addition is connected to the modern retail store by a modern one-story gable-roofed hyphen.

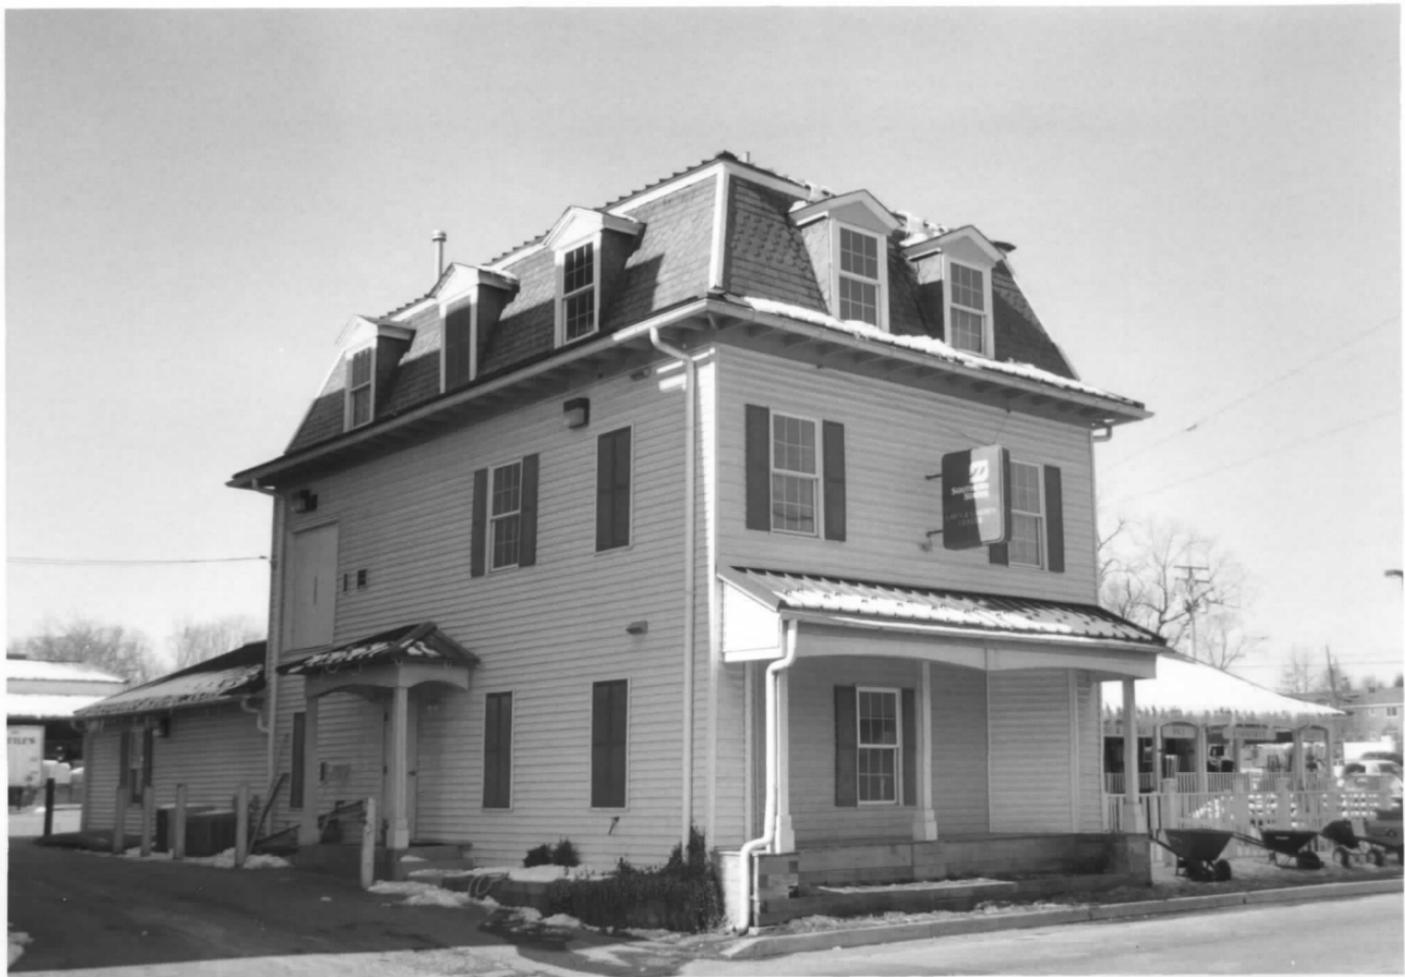
Office -- eastern facade & south elevation

The southern elevation of the main block of the office building contains openings in each of the four bays at ground level. The first, third, and fourth bays contain window openings, while the second bay contains a hollow steel door topped by a small hipped porch. On the second level a double door is present in the first bay, no opening is present in the second bay, and window openings exist in the third and fourth bays. Shutters are fixed in the closed position in all but one of the window openings on this elevation. The presence of the large doorway reflects the use of the upper story of the building for grain storage through most of the twentieth century.

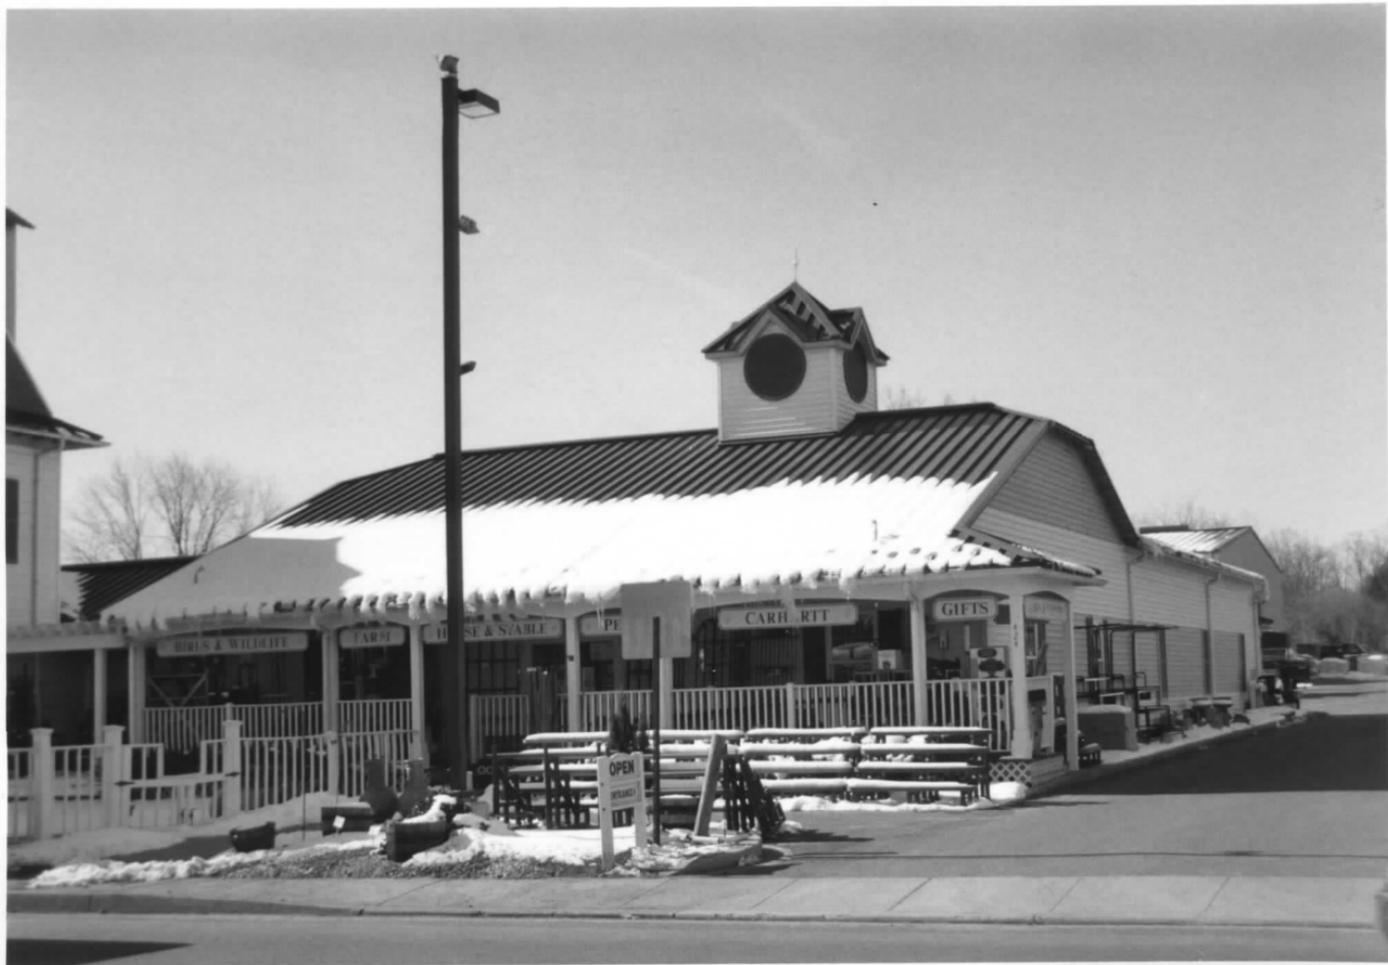
Modern retail store, eastern facade & north elevation

A large modern retail store was constructed on the northeast corner of the mill property in 1996-1997. The one-story frame building is clad in two-tone vinyl siding and has a standing-seam metal roof. The main portion of the building has a clipped gable roof with an off-center cupola having a pyramidal roof. A large rear wing with an asymmetrical clipped gable roof extends from the rear of the main portion of the building, the ridges meeting at the cupola. A round vent topped by a small gable is present on each side of the cupola. A one-story porch extends the full length of the eastern façade. Detailing on this porch is similar to that on the office; it has a concrete deck and an arched fascia supported by simple wood posts. Signs are hung between each pair of posts, and vinyl railings also span these distances. This building occupies land most recently occupied by a filling station, and historically a storehouse or warehouse.

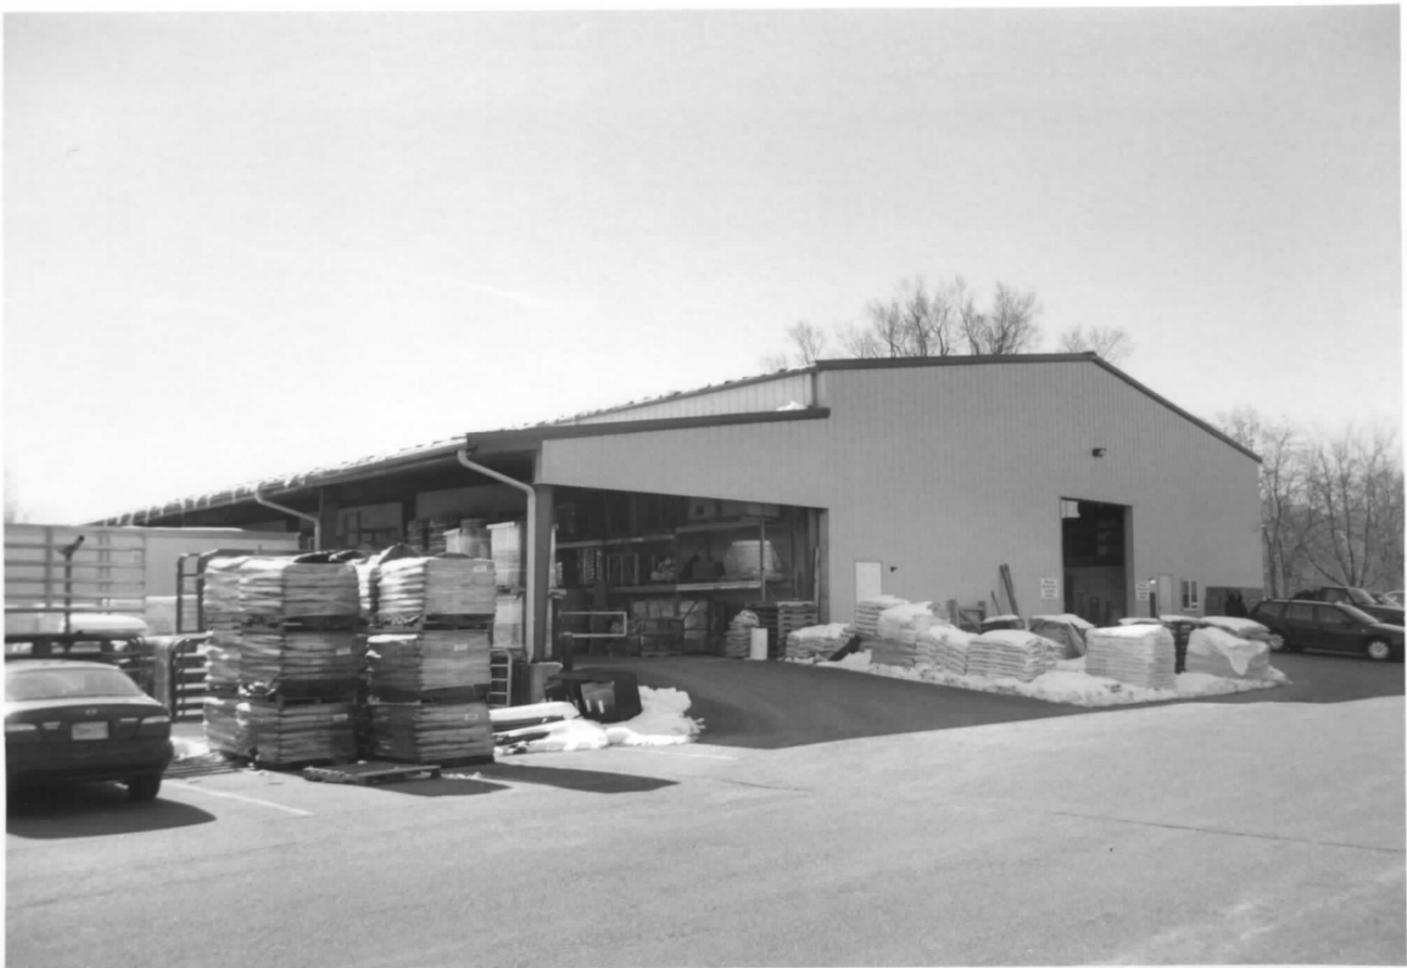
modern warehouse, north & east elevations

Also in the late 1990s, the mill property was expanded to the west through the acquisition of land owned by Columbia Gas. This expansion allowed for the construction of a large one-story warehouse with a metal-covered gable roof. The warehouse is clad in metal siding, and has a garage door in the northern elevation. A large shed wing is present along the length of the east side of the building, providing a sheltered exterior storage area for lumber, feed, and other items.

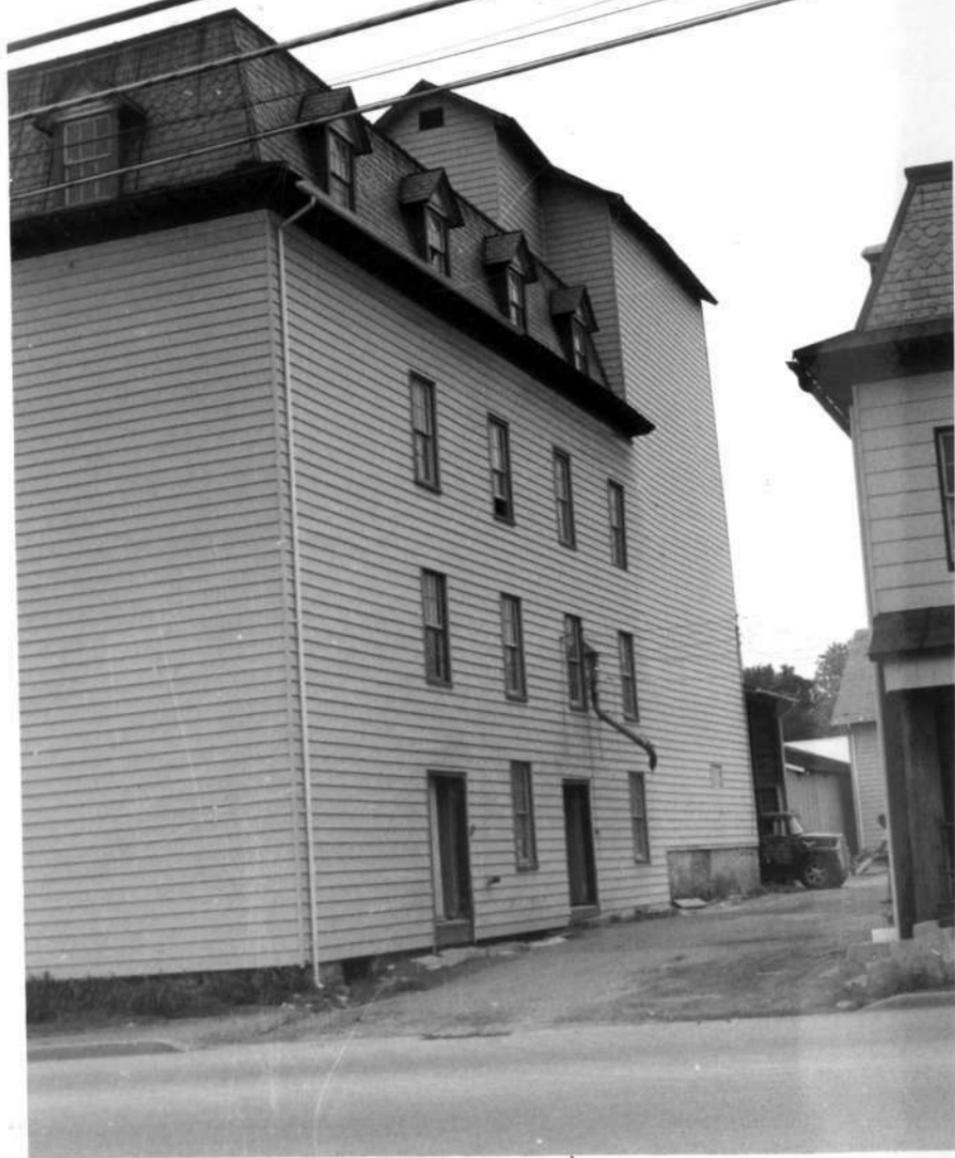
HA-1470 (mill) Rickord Mill - Bel Air Farm Supply
NA-1471 (office) 432 Rockspring Ave, Bel Air
NA-1472 (shed)
NA-1473 (warehouse) n. elev. of the mill
M. Larow, 1979

The windows, roof, and gables of the mill are similar to those of the office, but the street (east) elevation has no windows, and the dormers on the south side have been removed. The grain elevator has no windows save for one in each gable (east and west). The loading dock behind the elevator is open on the north side, has three windows on the west and sliding doors on the south. The south shed (which is attached to the south side of the loading dock so that the sheds form an L around the west and south sides) is open to the east and has five 6 pane windows, a loading door, and another 6 pane window (from east to west).

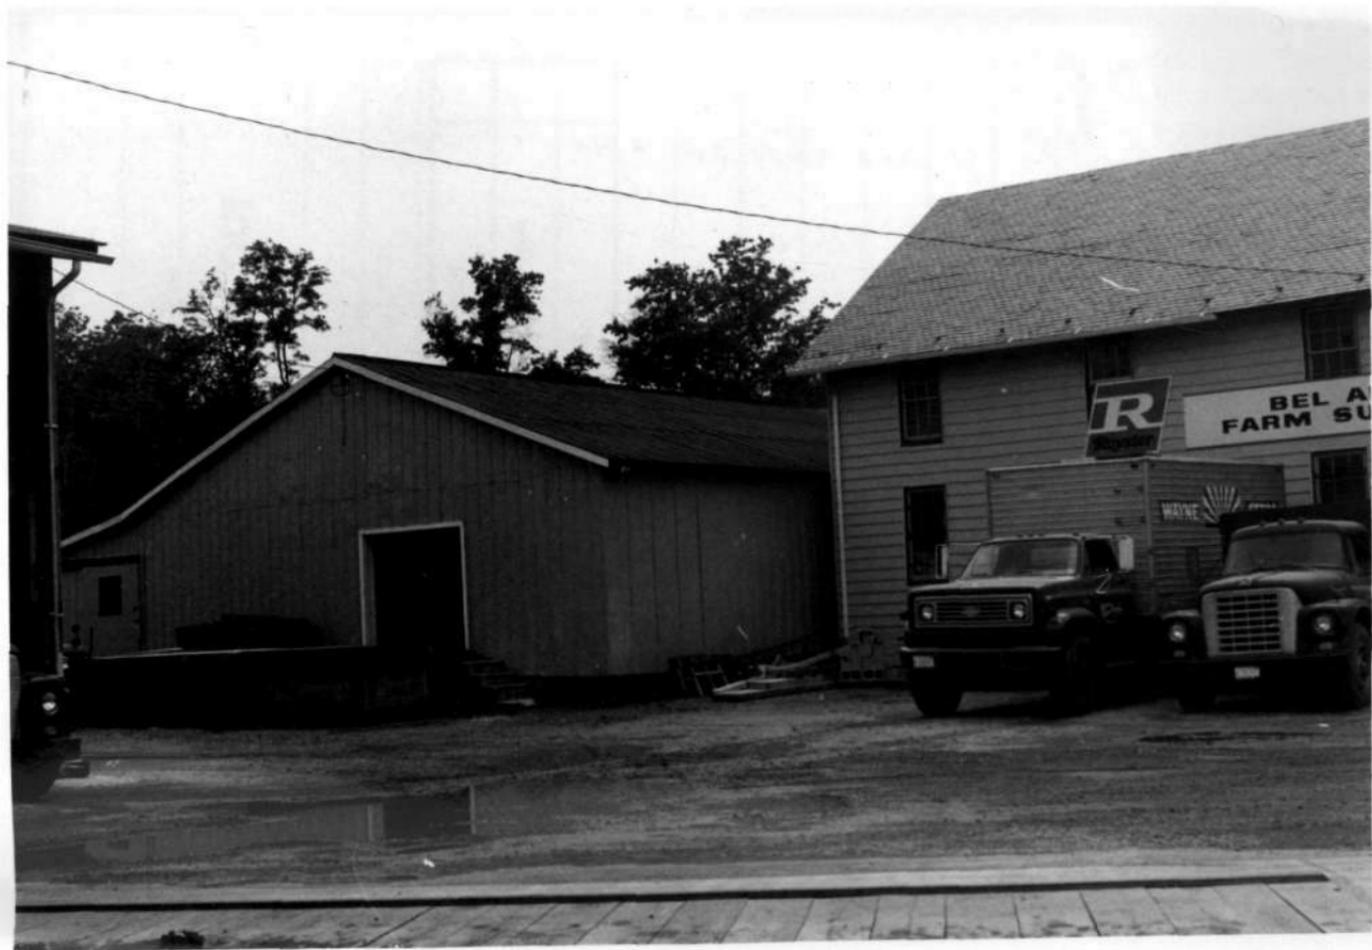
HA-1470 (mill) Reckord Mill - Bel Air Farm Supply
HA-1471 (office) 432 Rockspring Lane, Bel Air
HA-1472 (shed) L to R - S. warehouse & portion of N. warehouse
HA-1473 (warehouse)

Two warehouses occupy the southeast portion of the lot. The southernmost is a simple $1\frac{1}{2}$ story vertical-sided structure with a gable roof (east-west ridge) and a further shed on the south side. A concrete loading dock with steps down the north side is across the east elevation. The large open door is just north of center. The second warehouse, which is aluminum-sided and two stories, with a slate gable roof (north-south ridge) was moved to its present location in 1953 from the north-east corner of the lot where its ridge ran east and west. The filling station is now on that location. The windows of the 5 bay structure are 6/6 double hung sash. A concrete loading dock crosses the front (east) of this building, too. The loading door is in the second bay from the north. This building is used for feed sack storage. Around back are large storage bins for grain.

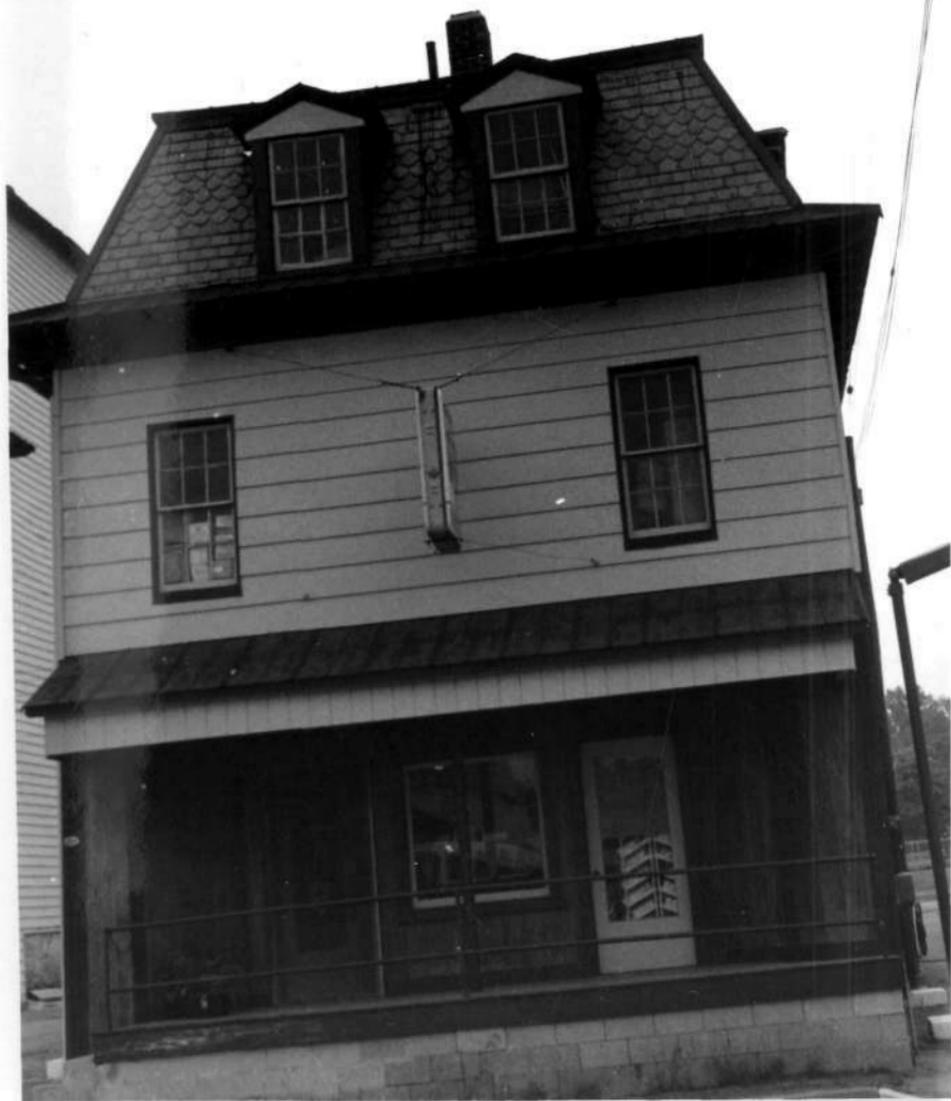
HA-1470 (mill) Reckord Mill - Bel Air Farm Supply
NA-1471 (office) 432 Rockspring Ave, Bel Air
NA-1472 (shed)
NA-1473 (warehouse) front (east) elev. of office
M. Larew, 1979

The office building, the north structure, is two stories plus mansard, two bays by four, covered with aluminum siding, with a shed porch supported by square posts on the first story front (east) elevation. The slate mansard roof is broken by dormers with triangular pediments. The dormer windows (and the others) are 6/6 double hung sash with plain surrounds painted plum. There is a wide bracketed overhang between the top floor and the mansard. The first story facade has been paneled in vertical siding. Its three bays are door, window, door. A new (1979) single story two bay by two bay section has been added to the west elevation of this building. It has a gable roof with ridge running east and west and sliding aluminum framed windows. The entrance to the office is in the east bay of this addition. The other three doors, two in the east elevation and one just east of the new door. The addition houses office and counter space. The ground floor of the old section is given over to display counters. The enclosed staircase to the second story is in the southeast corner of the south wall. The other two stories are used for storage; apparently they always were.

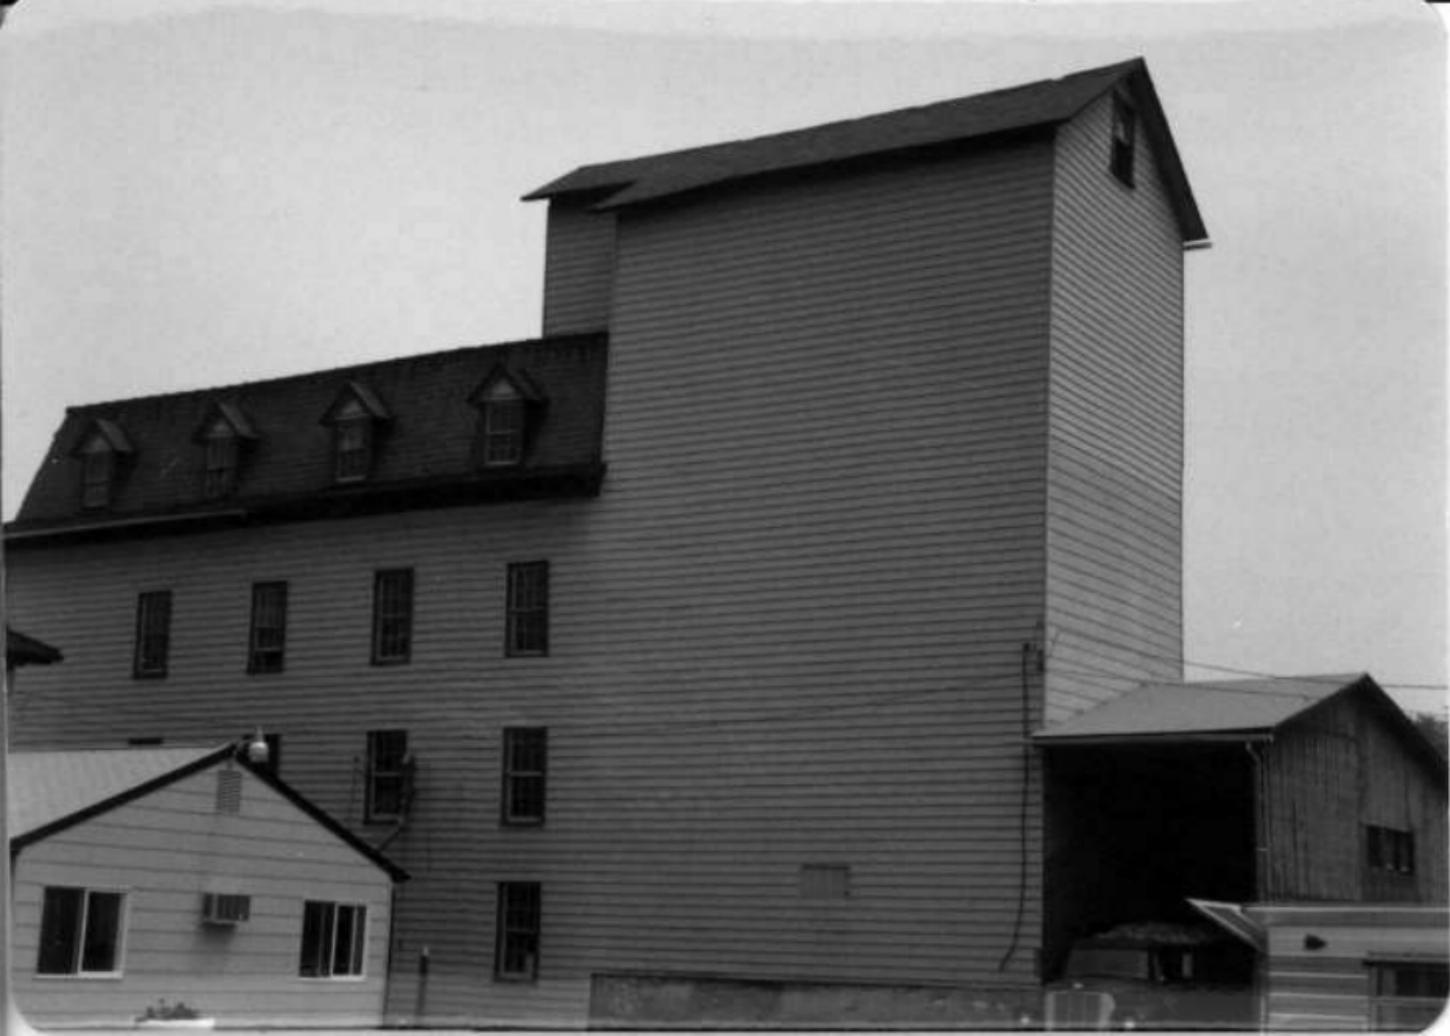
44-1470 (mill) Redford Mill - Bel Air Farm Supply
44-1471 (office) 432 Rockspring Ave, Bel Air
44-1472 (shed) front (east) elev. of mill
44-1473 (warehouse) Mr. Larew, 1979

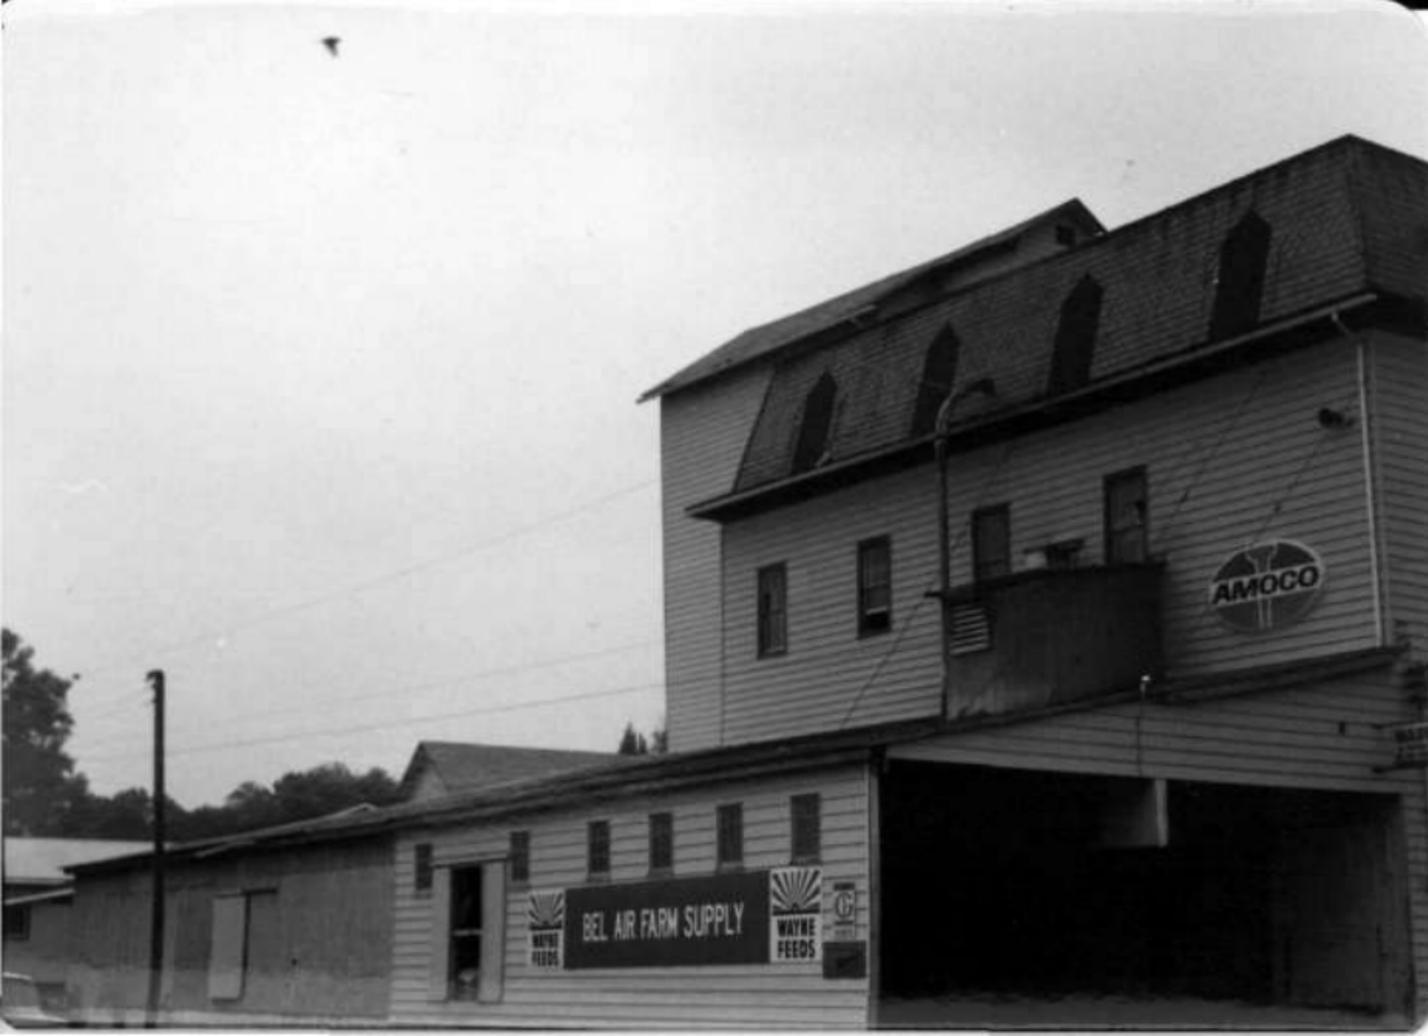
HA-1470 (mill) Reckord Mill - Bel Air Farm Supply
HA-1471 (office) 432 Rockspring Ave, Bel Air
HA-1472 (shed)
HA-1473 (warehouse) N. warehouse looking west
M. Larew, 1979
