HA-1493

Chandler House
133 Thomas
Bel Air
Private

INVENTORY FORM FOR STATE HISTORIC SITES SURVEY

Chandler House

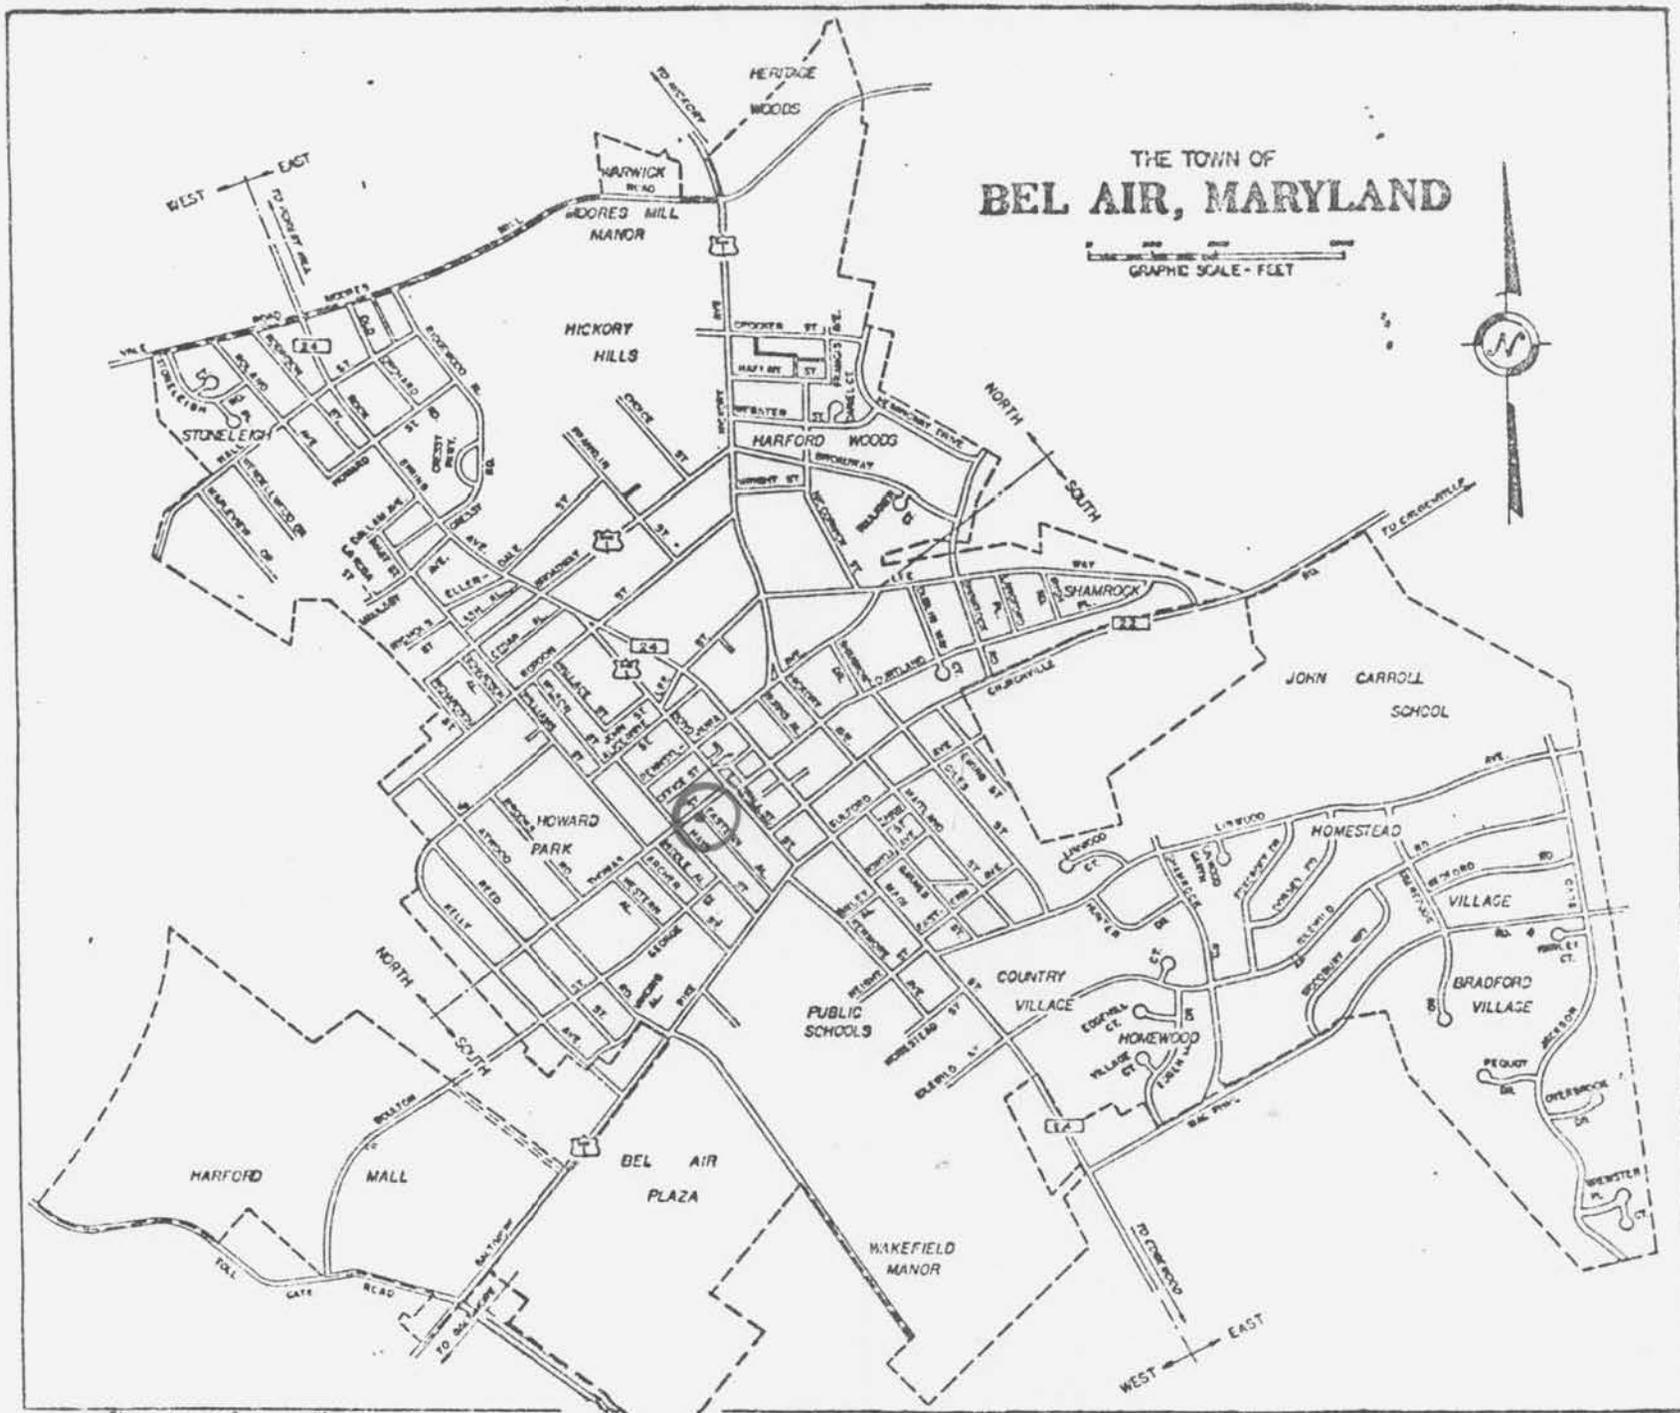
NA-1493 Chandler House, 133 Thomas St.
Bel Air

This is the best kept house in a row of two bay shotgun houses. It shows how attractive these modest homes can be, especially with roses climbing up a porch trellis.

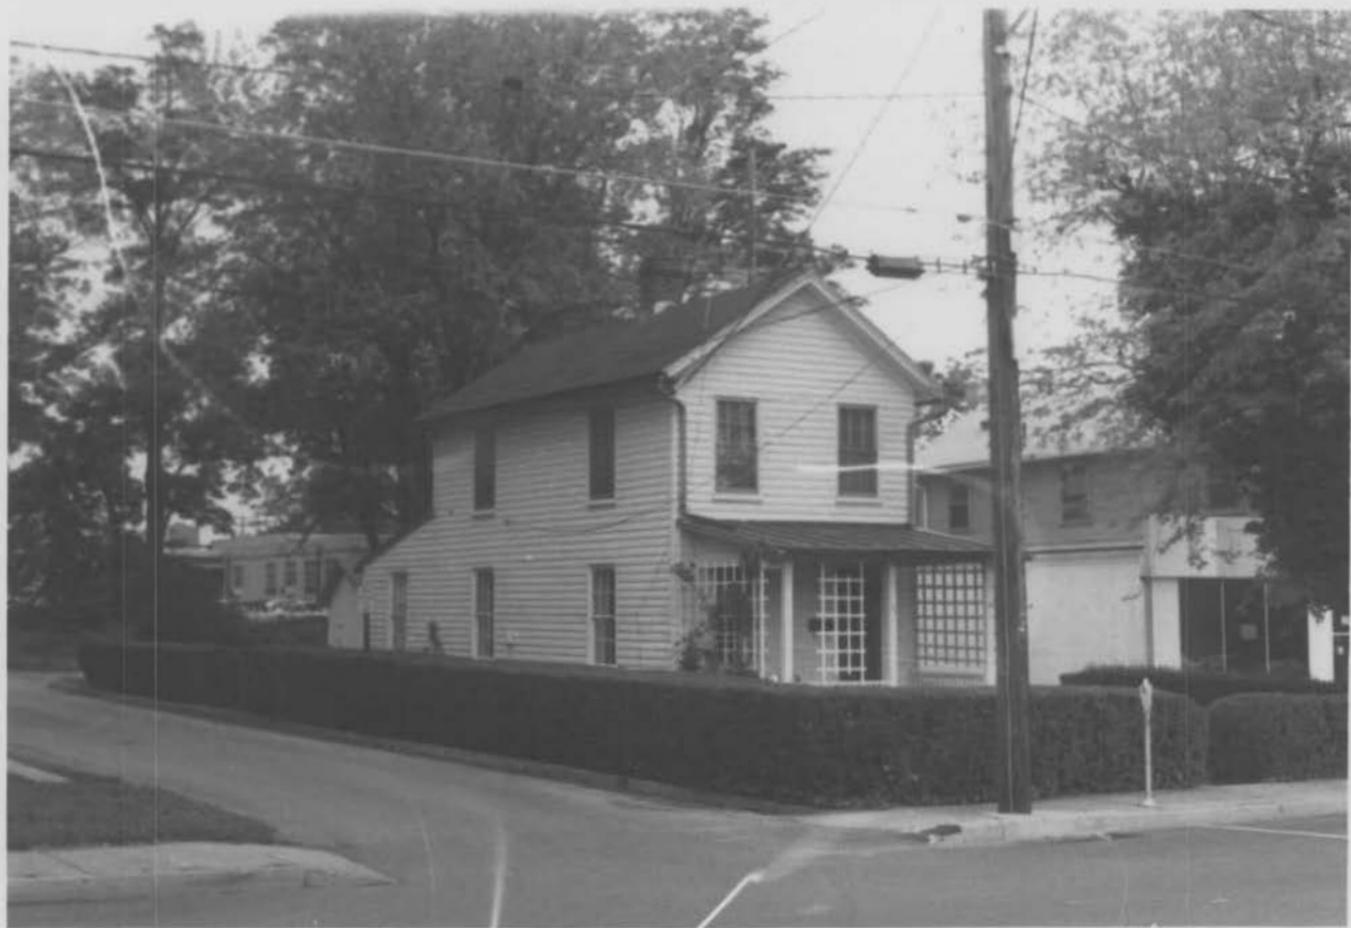
HA. -1493

This small, two-bay, two-story shot-gun house is at 133 Thomas Street in the Town of Bel Air, Harford County, Maryland. Its shiplap siding shines a sparkling white showing that this is an owner-occupied house. The windows are 6/6 double-hung sash set in plain, thin surrounds. The original half-glass door is topped by a two pane transom. The shed porch with a plain balustrade is carried on chamfered posts. The center chimney has a corbelled cap. The shed addition in back has been extended one bay to the west. This extension is covered in asphalt siding and has a single 4 pane casement in the front (north) elevation.

Red roses climb a trellis on the east side of the front porch, reminding us how attractive these humble homes can be when well kept.

Chandler House, 133 Thomas St., Belton
e. + n. elev.
M. Lacroix, 1979
