HA-1584

Frame Bank House
3119 Ady Road

INVENTORY FORM FOR STATE HISTORIC SITES SURVEY

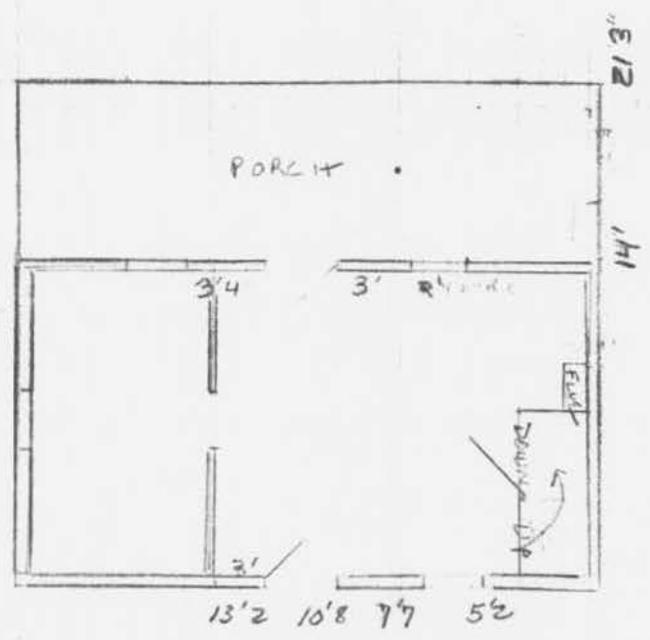
2nd level

The plan provided for a kitchen in the first lever (stone portion) a parlour and unheated sleeping room on the first level with a bilateral transversely divided 1/2 story above.

An interior stove flue occupies the west gable-end and winder stairs for all three levels are in the north west corner of the building.

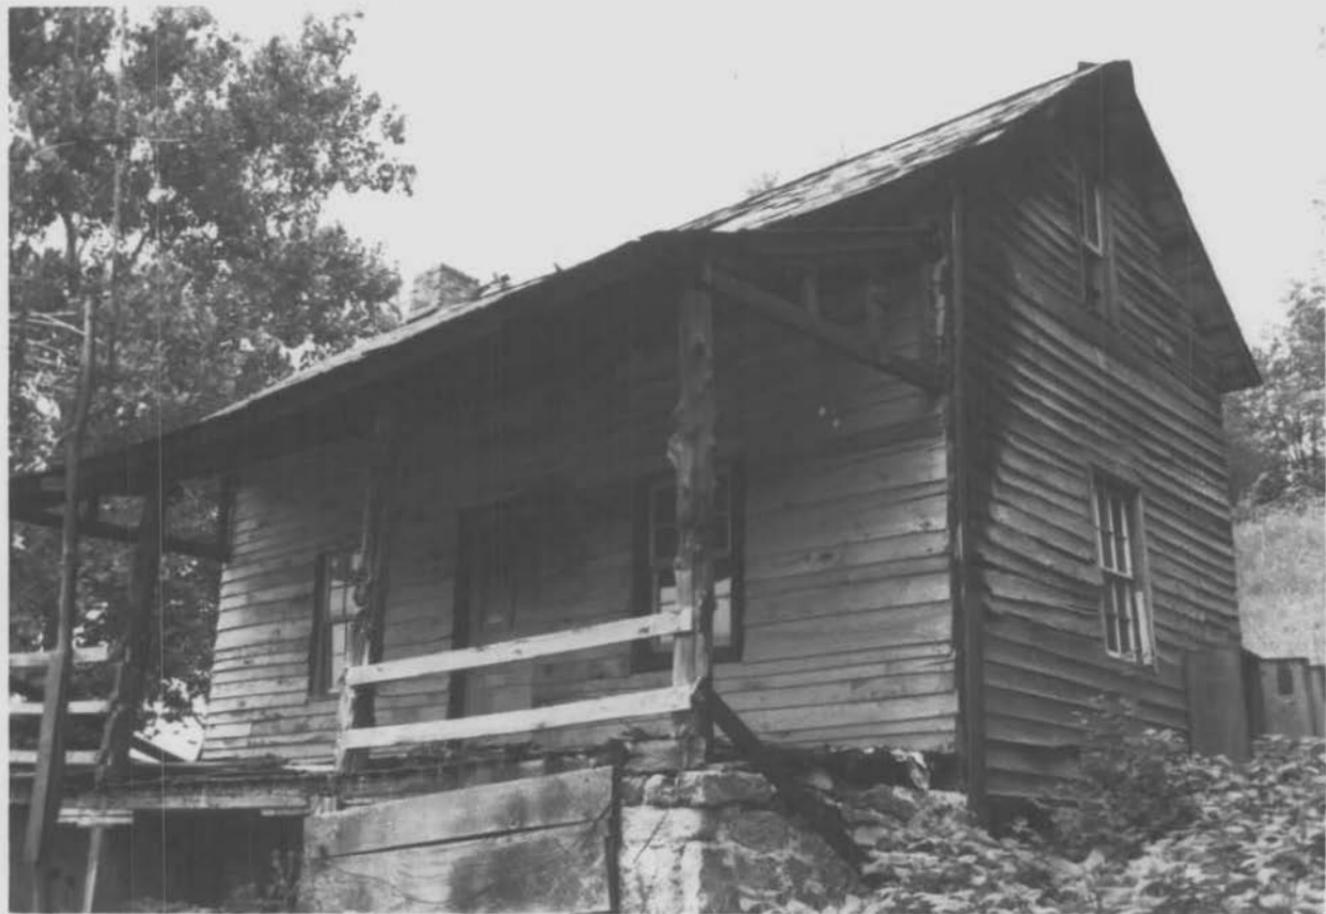
southeast elevation

The south facade is perhaps the most interesting. The house is 14' deep, however, the stone end walls are a total length of 21'3" providing strong stone supports for the two-story gallery on this side. Transverse puncheons support the second story floor and unfinished treeposts support the shed roof. The south wall of the kitchen is not stone but frame, with whitewashed clapboards attached with cut nails.

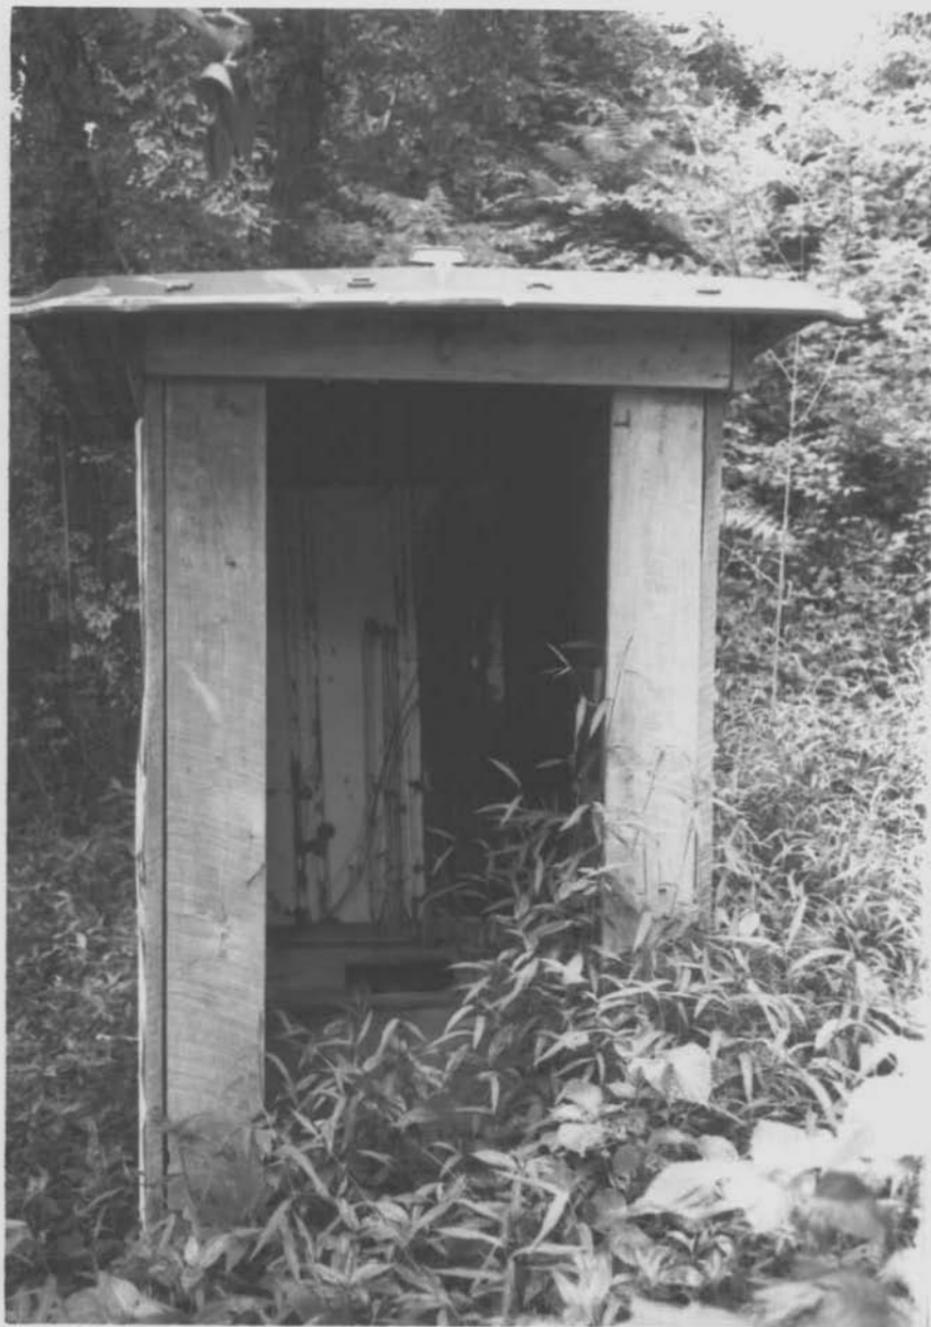
Privy- south elevation

Also on the site is a springhouse-dairy and a great number of sheds. The current privy is a most interesting construction consisting of corrugated sheet metal in the normal proportions for a one-holer. Its grand feature is a roof that is accomplished with the hood of a 1957 Ford. The down turn of the hood just above the radiator forms a streamlined cornice for the privy and the appropriately placed chrome letters of FORD announce the age of the materials and the paradox of their use.
