Robert Smith House

HA-2050

603 North Hickory Avenue

Maryland Historical Trust Maryland Inventory of Historic Properties Form

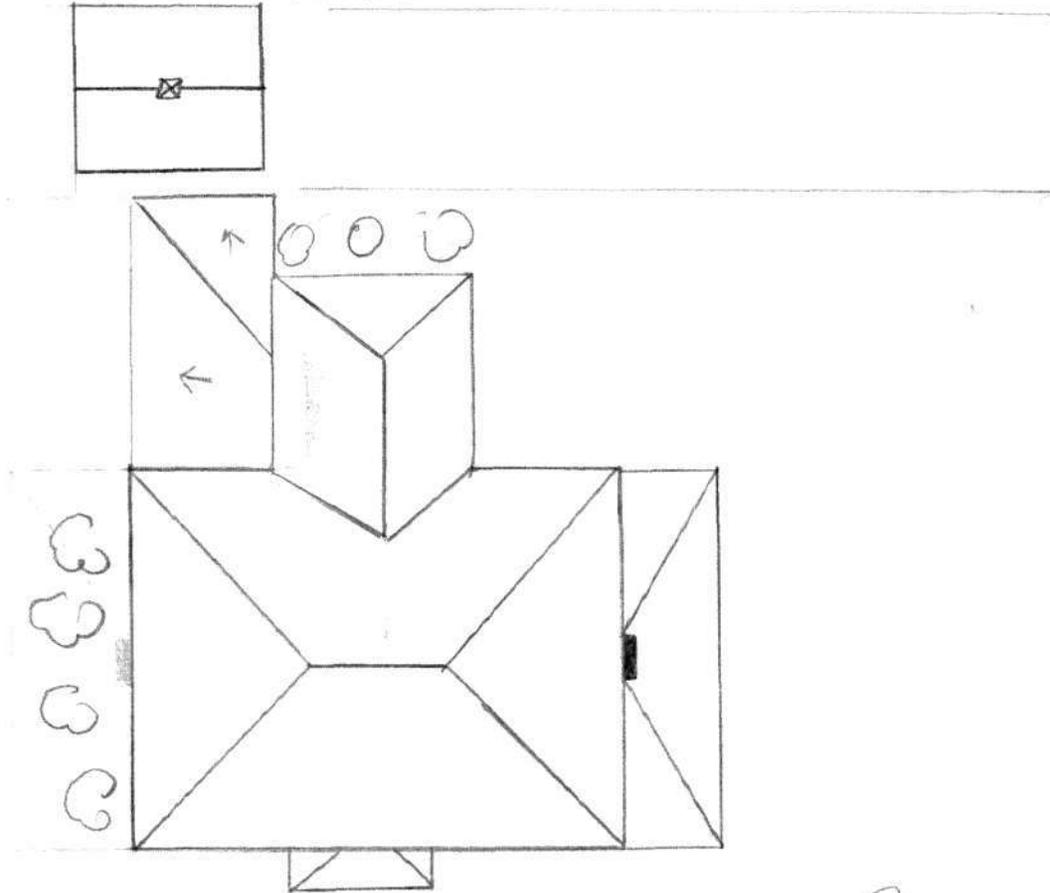
Robert Smith House
603 N. Hickory Avenue
Harford County
Bel Air
Site Plan

This Colonial Revival-style dwelling is located on a level grassy lot at the northeast corner of North Hickory Avenue and Crocker Street in Bel Air, Maryland. A few foundation plantings front the dwelling and several large trees surround the house. No longer extant, a hedgerow originally lined front of the property along the streets. A paved driveway leads to the house and detached garage from Crocker Street, whereas the house faces west towards North Hickory Avenue.

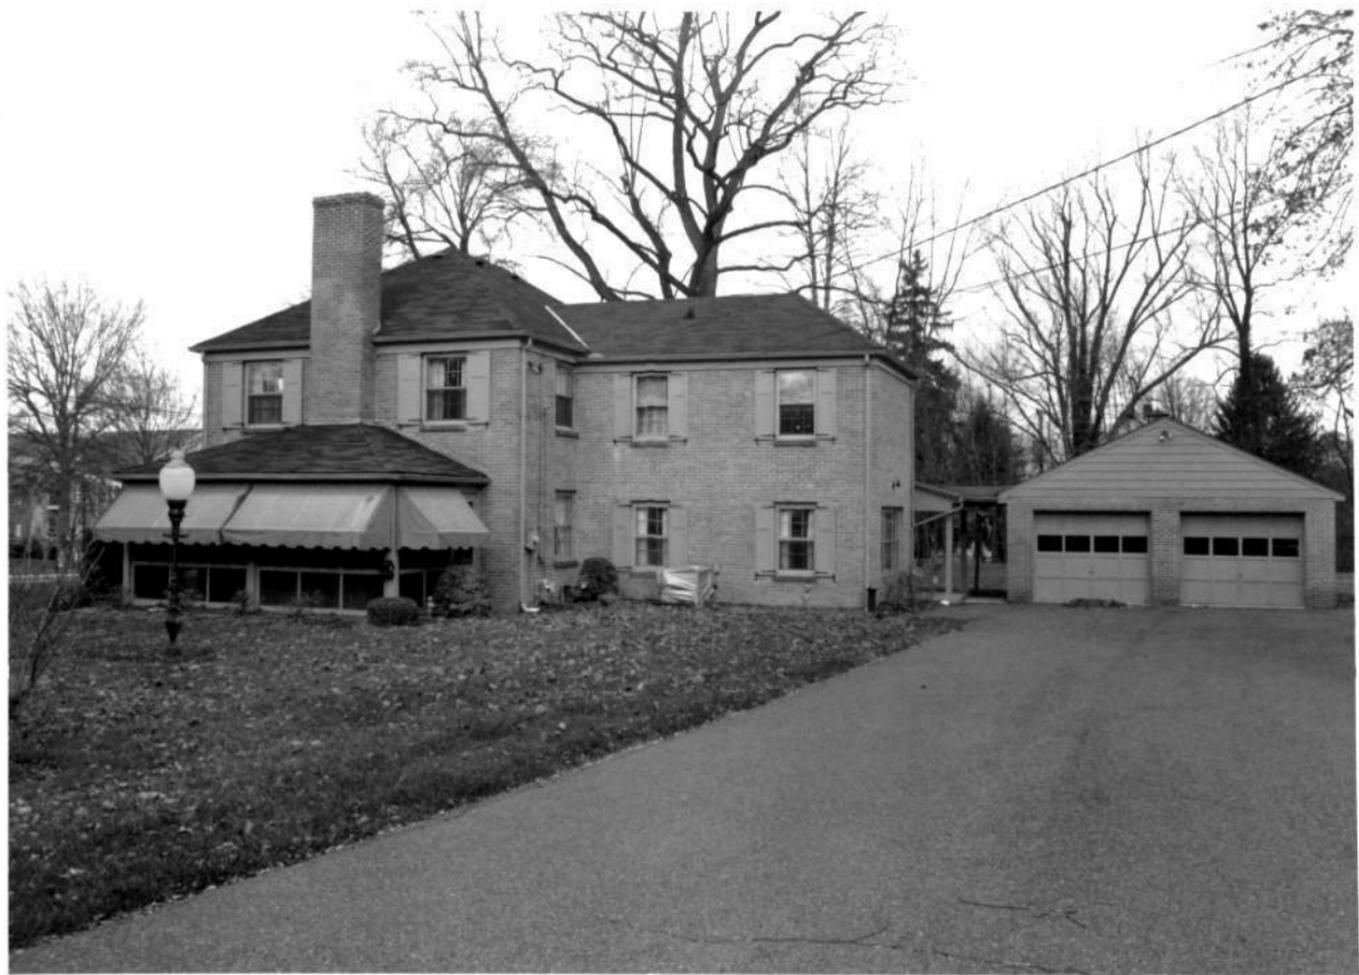
1 of 8

The three-bay-wide façade of the dwelling is pierced with two 8/8 double-hung, wood-sash windows flanking a central entry vestibule. All windows have rowlock sills and all double-hung windows have wood-paneled shutters. The vestibule contains one single-leaf, 2-light/4-panel wood door and is capped with a flat roof and a rooftop, metal balcony. The door features a Colonial Revival-style wood door surround with triglyphs and metopes in the frieze, and fluted pilasters, with a set of three large ovolo moldings inside of the pilasters. The second story is pierced with two 8/8 windows and one round, 9-light wood casement window. The basement level is illuminated with two 2-light metal, awning windows with metal wells.

West elevation, view looking NE

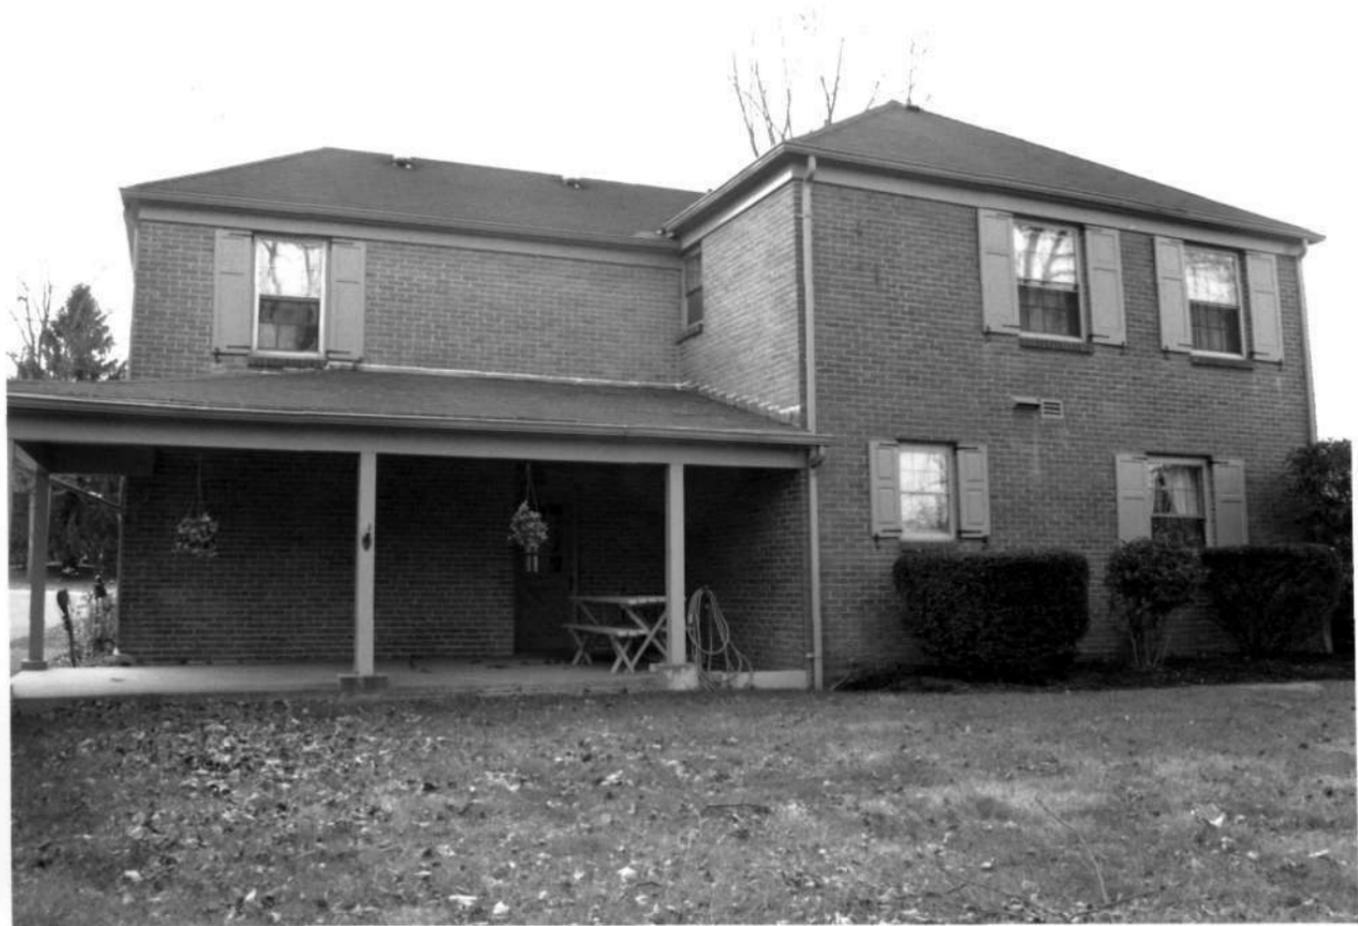
HA-2050
Robert Smith House
603 N. Hickory Ave.
Harford County, Bel Air, MD
Arcadia Preservation
12/2004
MD SHPO
SOUTH ELEVATION
2 of 8

The south elevation of the main block has two single-leaf, 9-light/cross-panel wood doors flanking the chimney. The second story is illuminated with two 8/8 windows. The screened porch has a slate tile floor and is supported with square posts. The first and second stories of the rear addition on the south elevation each contain two 6/6 double-hung, wood-sash windows.
