INVENTORY FORM FOR STATE HISTORIC SITES SURVEY

Belle Vue Farm

Susan M. Deeney, Field Historian

HR-242

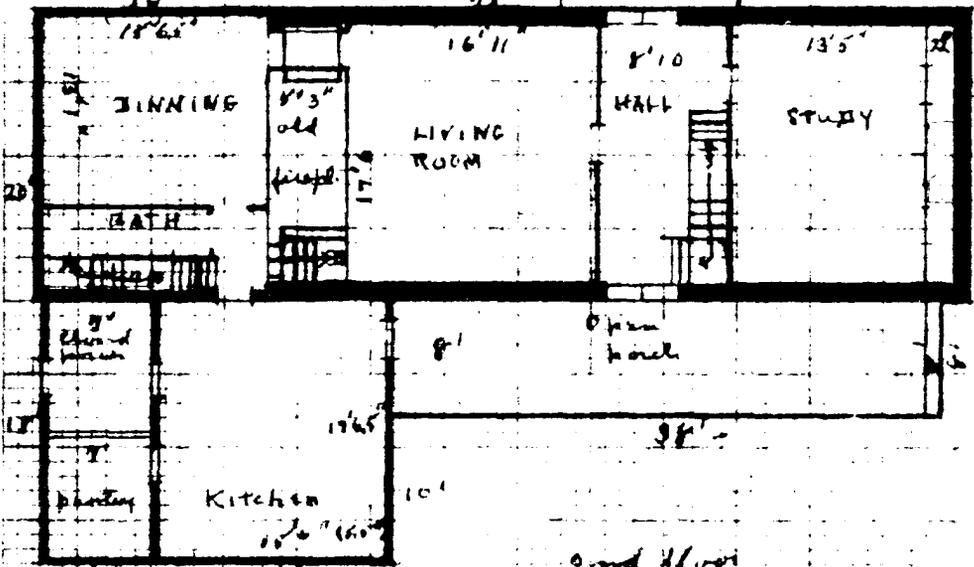
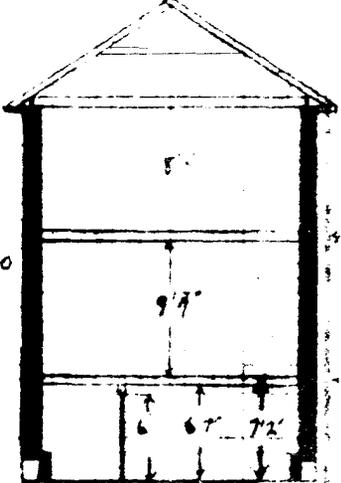
1st floor

Inside, this section is arranged in the classic center through hall floor plan. The closed string stairway is located in the west corner. It has pine treads and turned balusters. The stair is paneled with mould paneling. Vertical beaded boards line the stair on the second elevation. The hallway has two tiers of moulded paneling with chair-rails and a box cornice.

Brick walls 1 1/2" thick
 Wooden walls 5/8" thick
 Wall partitions 3" thick

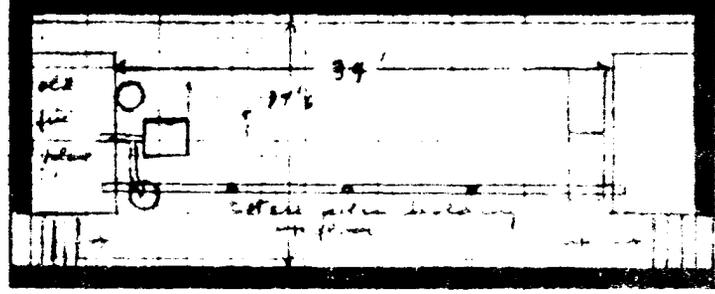
sub-basement

There are no chair rails in the east room. A plain fireplace is in the center of this room's east wall. In the cellar of the brick section it was necessary to reinforce old beams. Brick fireplace supports are visible here.

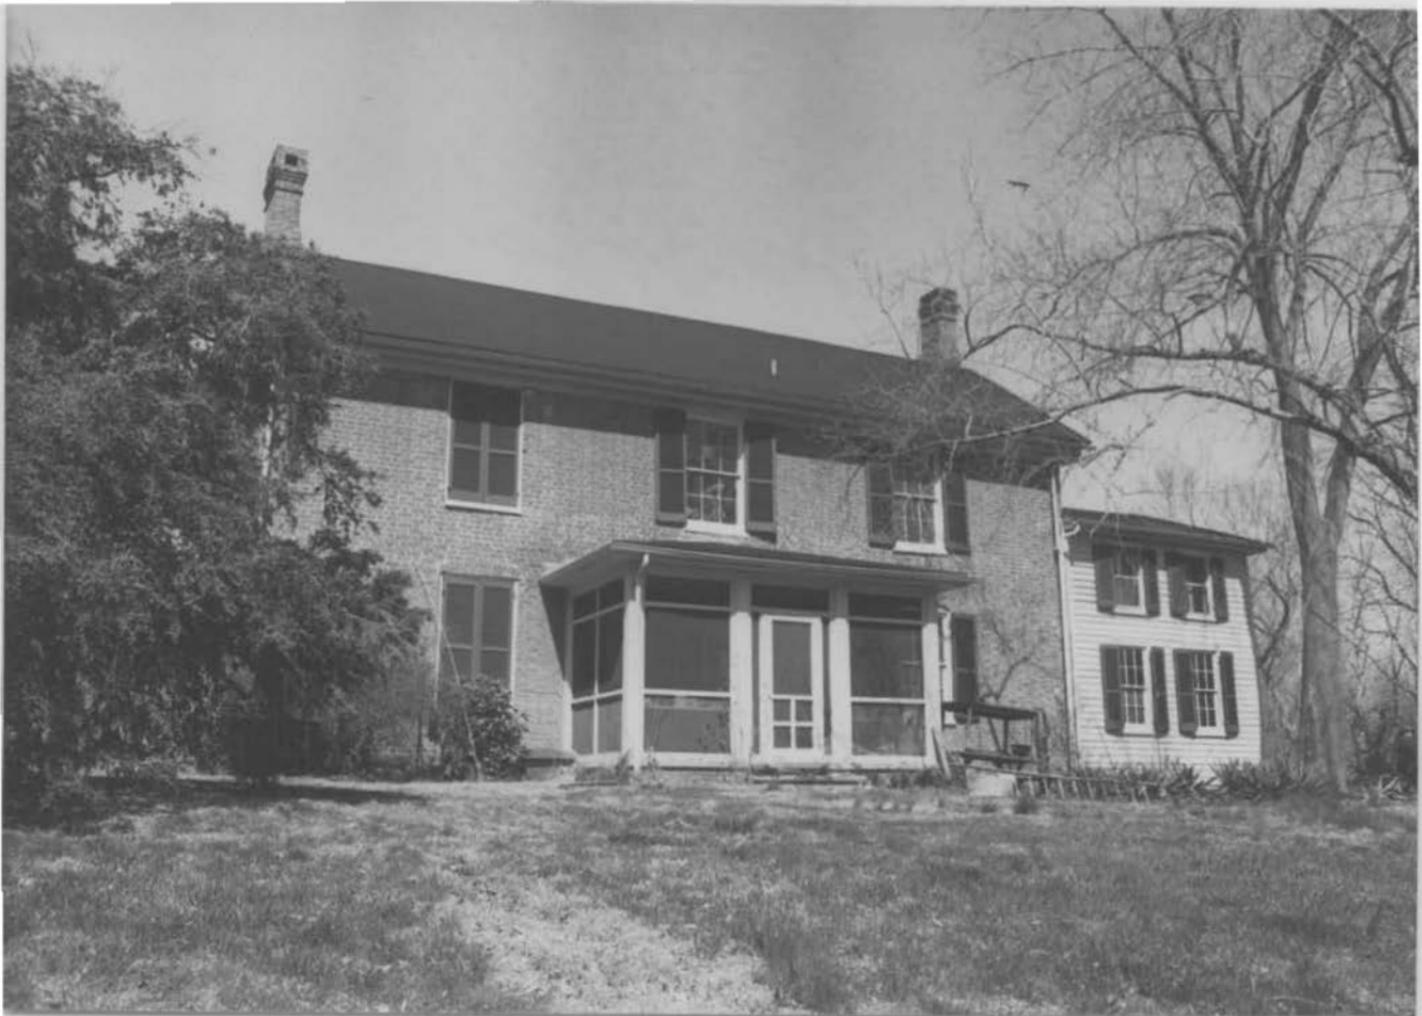
HA-242

The main part of this house is two stories high, and three bays by two. The brick walls are Flemish bond. A moulded brick water table can be seen on the south east facade. The principal entrance is in the center bay of the south east facade. This has double hung, moulded panel doors. A four light transom is overhead. A one bay, screened in entrance porch shields this doorway. Windows louvered shutters. Windows on the front facade have semi-elliptical brick header arches that appear to be an added feature.

Belle Vue Farm
Havre de Grace, MD
Susan M. Deeney
Southeast
April, 1977

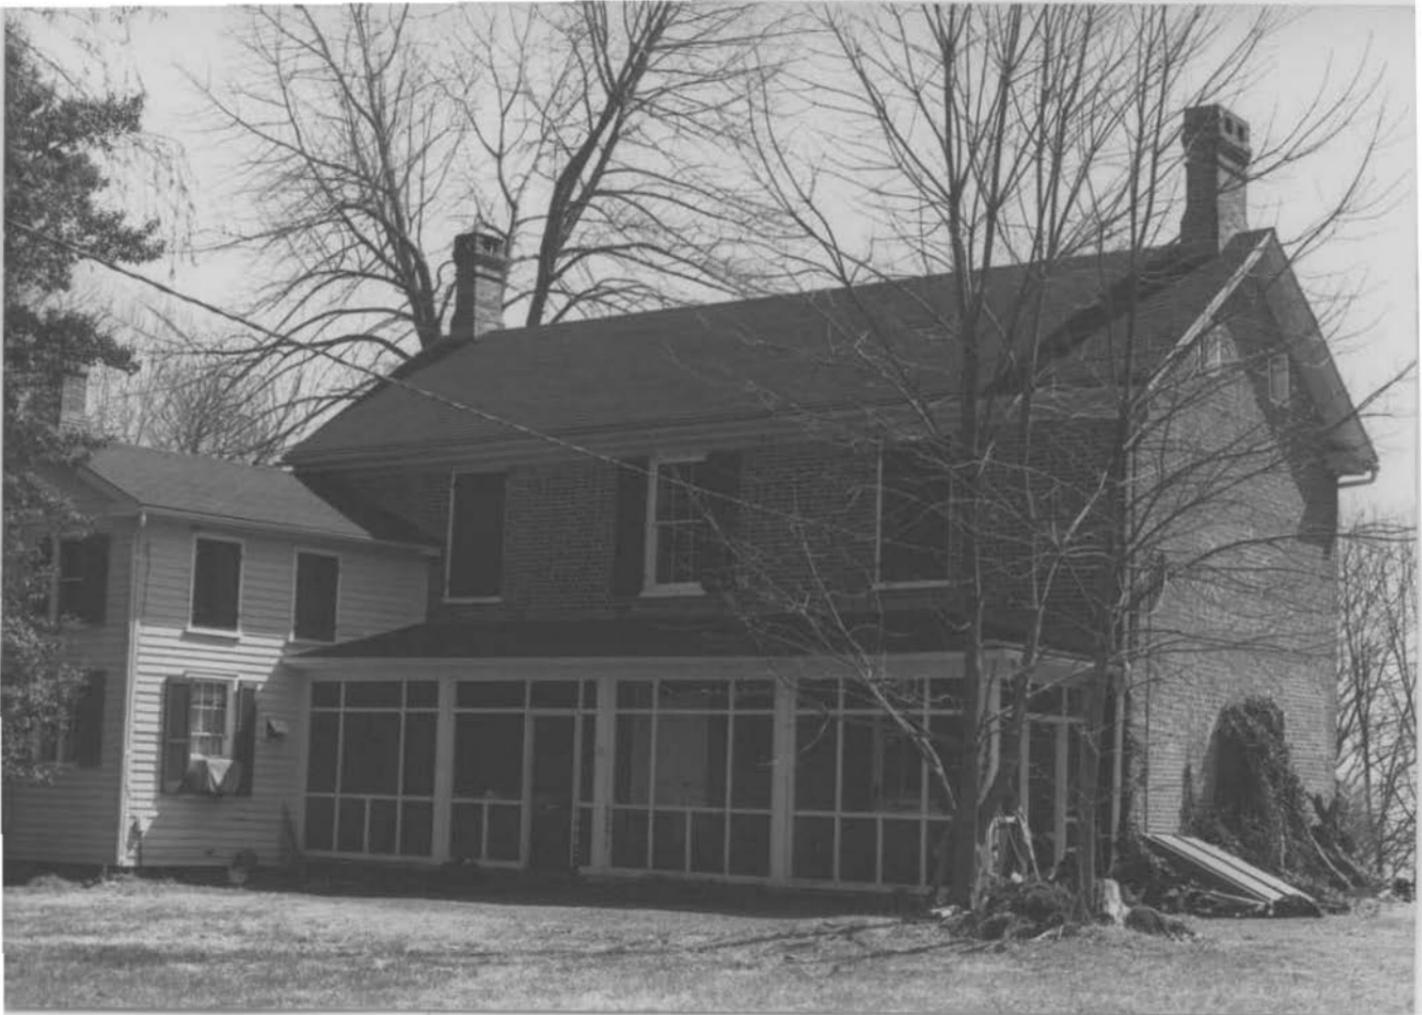
HA-242

The north west facade has many glazed headers. A three bay, one tier, screened in porch is on this side.

Belle Vue Farm
Havre de Grace, MD
Susan M. Deeney
North
April, 1977
