HA-257

1885-1886

Bauer House
53 E. Broadway
Bel Air
Private

INVENTORY FORM FOR STATE HISTORIC SITES SURVEY

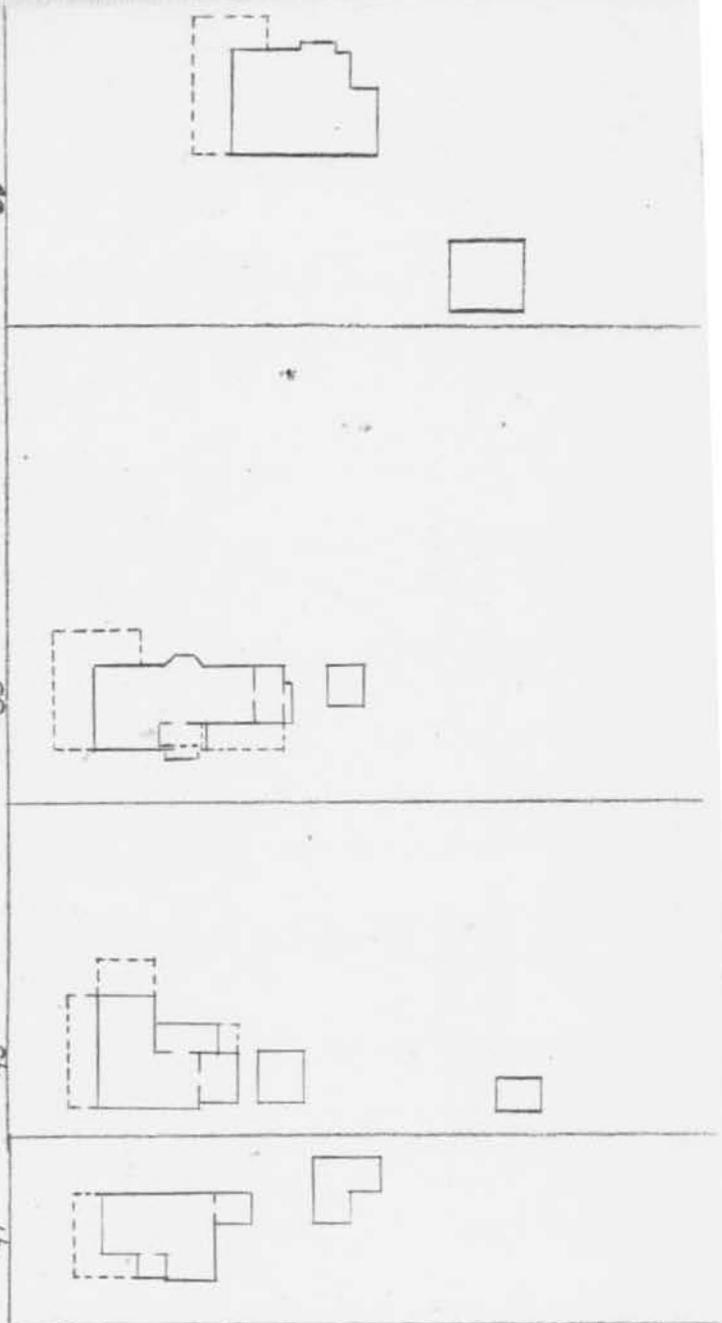
1930 Sanborn Map

Bauer House
53 E. Broadway
Bel Air

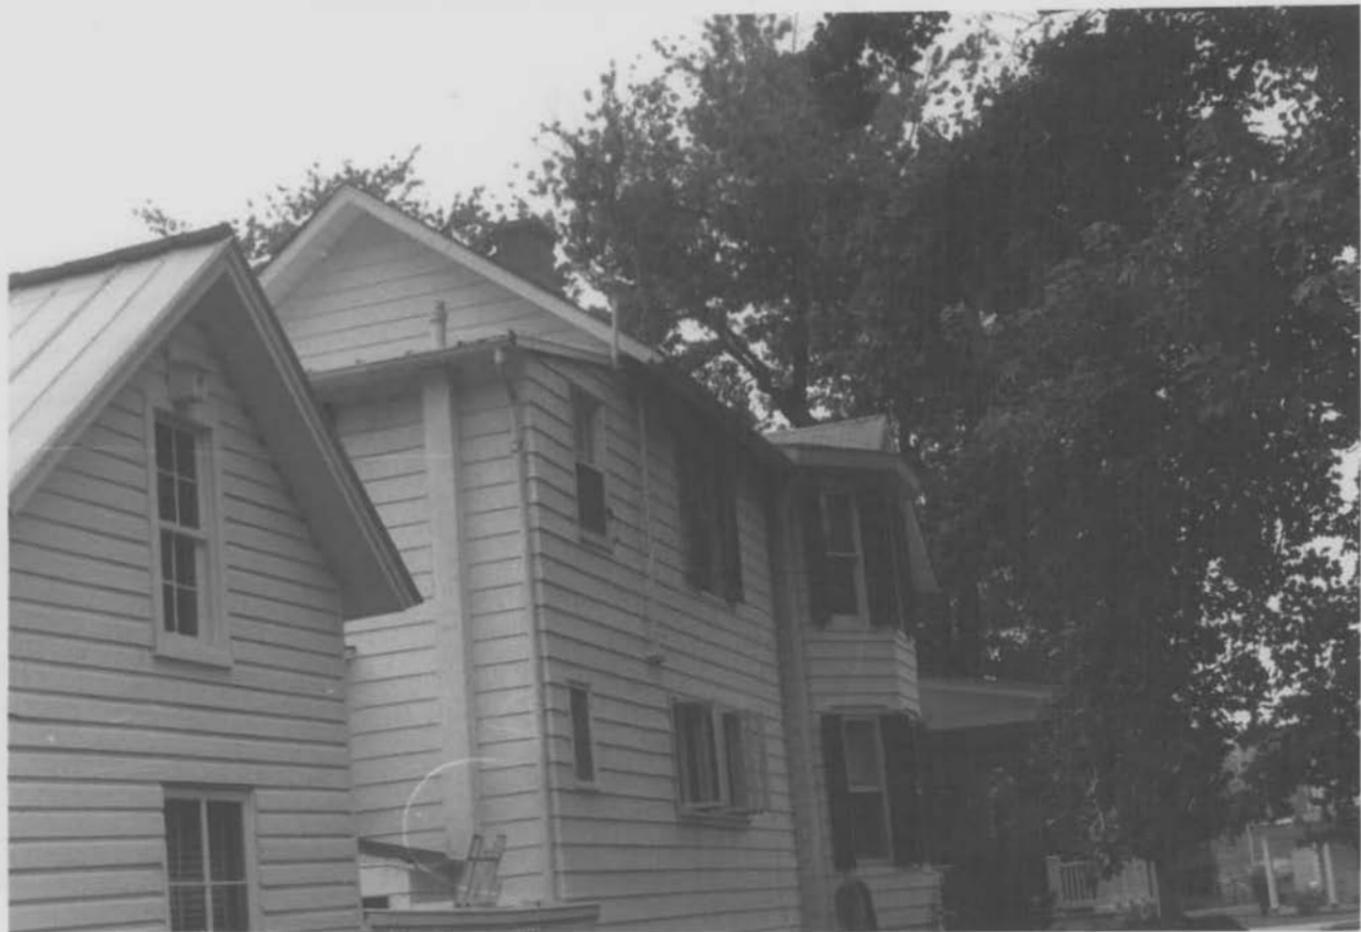
HA-257

The two story hexagonal bay in the east elevation was added by the Harris family after 1907 to give more light and room in the dining room. Miss Hall added the casements next to it very recently to give the kitchen more light. Continuing south along the east elevation one finds an enclosed back porch with a shed roofed second story added room. The rear (south) elevation shows the enclosures more clearly. The west side was porch below and sleeping screened porch above. All of the rear porch spaces have been enclosed except the second story sleeping porch.

Bauer-Hall House, 53 E. Broadway, Bel Air
E. elev., looking n
M. Larew, 1979

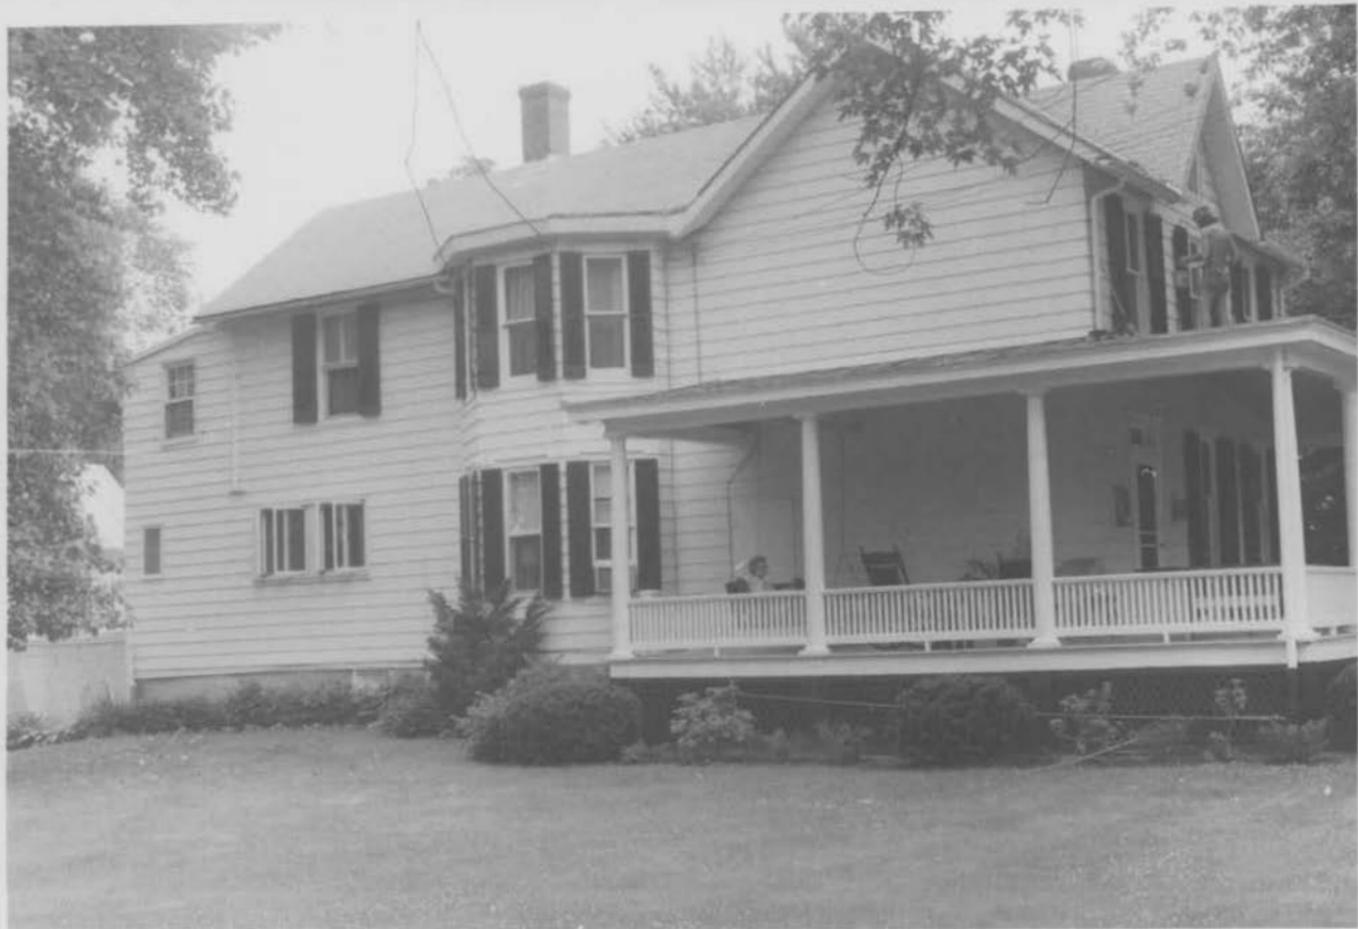
HA-257

This two story, three bay aluminum sided house with a gable in the middle of the front (north) elevation is at 53 East Broadway in the Town of Bel Air, Harford County, Maryland. Most of the windows in the house are 2/2 double hung sash. Exceptions are the two west windows in the front (north) elevation which are 2/4 reaching to the floor, a 2/2 round-arched window (the rest are flat) in the front gable, the windows in the two story bay in the east elevation which are 1/1, and a pair of new aluminum casements in the kitchen (first floor east elevation). Most of the windows are flanked by louvered shutters. The gable ends, east and west, of this L-shaped house are blind with the exception of a pair of nine pane casements which flank the fireplace in the west elevation. The entrance in the east bay of the ground floor has a two pane transom over the door which is glass over two panels. A porch with Doric columns and a plain balustrade shades the front (north) and east elevations as far back as the two story bay in the first story. A porch swing and traditional chairs make this porch an old fashioned pleasant place on a hot day.

Bauer-Hall House, 53 E. Broadway, Bel Air
e + n elev

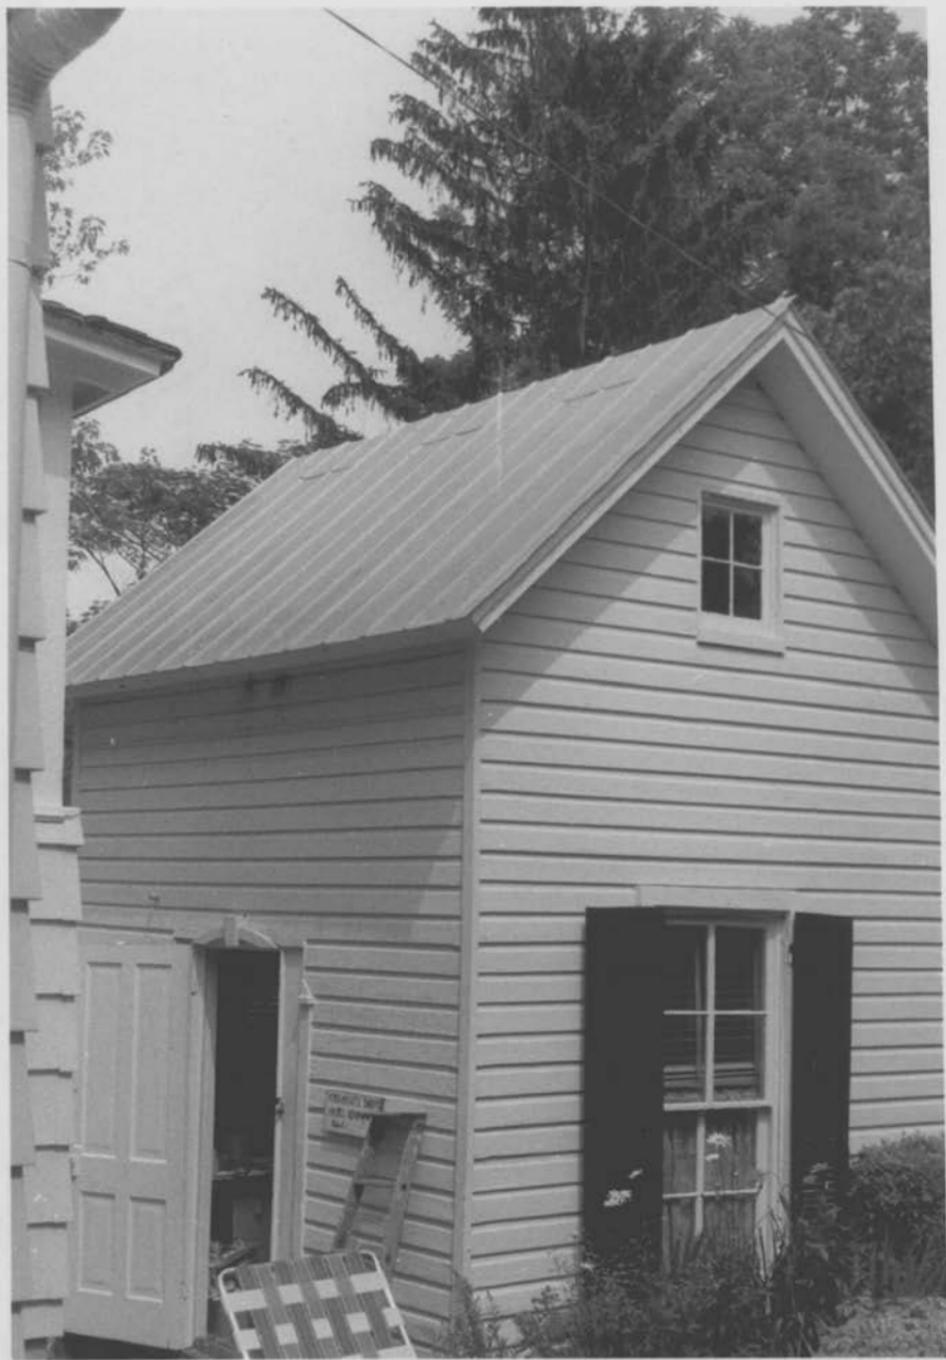
HA. - 257 Bauer-Hall House, 53 E. Broadway, Bel Air
woodshed; n. + w. elev.

Two other buildings are on the lot: a two car garage with a gable roof on the southwest corner of the lot and a one and a half story wood shed just behind the house. It has a tin-covered gable roof with ridge running east and west. Its windows are 4/4 double hung sash, two of them in the east elevation and one, flanked by louvered shutters in the west elevation. Also, on the west side is a 4 pane window in the gable. A four panel door is in the north elevation. Miss Mary Hall uses this small building as a workroom except in the winter. Here she paints (mostly landscape) and restores antiques.
