HA-50

Bull-Barrow House
Harford County
Kalmia vicinity

INVENTORY FORM FOR STATE HISTORIC SITES SURVEY

Bull- Barrow House

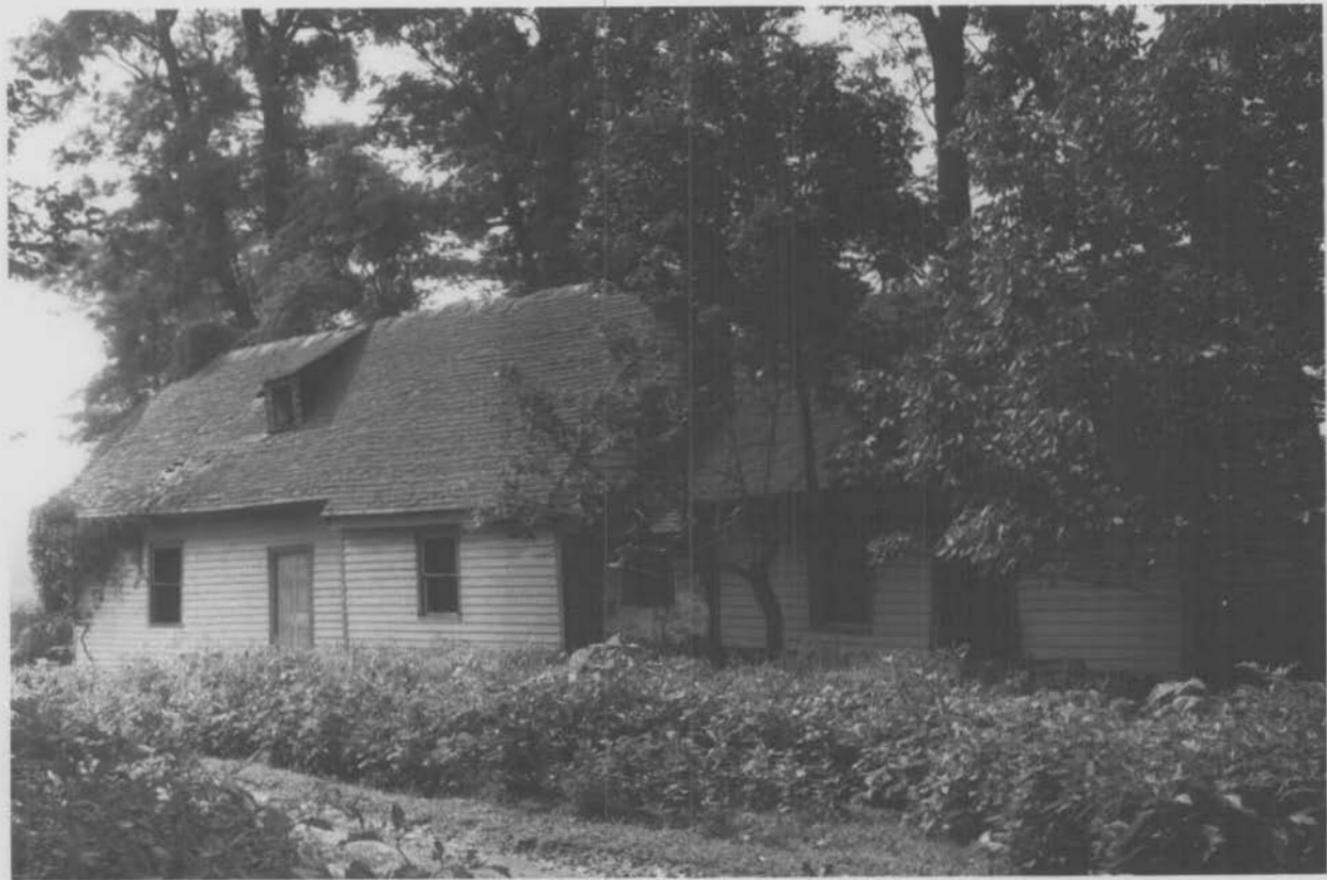
Barrow-Bull House HA-50
Churchville, MD
Paul Penrod 8/76
West

This property has neither been lived in nor maintained for at least forty years and has already begun to go through it's death throes. Gaping holes are in the roof, water damage is abundant and a general rot has long since set in.

The dwelling faces towards the west and is composed of three sections. The northernmost one is of original squared and chinked logs and is one bay by one. The logs are covered over on the exterior by bevelled frame. The southern unit is also of bevelled frame and measures three bays by two. These sections are connected by a short stone "breezeway", one bay across. The windows on the breezeway have wooden lintels, and a pair of 2 X 2 attic windows adorn the gable extremes of the house, whose parts are under the same contiguous roof. The two original free-standing sections have finished attics. A low stone foundation is found underneath the southern portion of the building. The windows are all 1 X 1 and are not indigenous to the original house. Opposite doors are stationed on the eastern and western sides of the southern half of the house, and a single entryway is sited on the eastern facade of the log unit. A three-light transom is above the western door of the southern section, and a small cellar bay is positioned on the same unit's southern wall. A single shed dormer faces east and is over the southern part of the house. The roof itself is gable-flank; wood shingles on the southern part and asphalt on the northern wing. A four-bay shed-roof enclosure covers the main entrance on the western side. Two older brick flues are located on the inside ends of the northern and southern extremes. A third, more recent, near the northern end of the principal section of the dwelling.
