HO-1100
Lewis and Blanche Burgess Farm
13100 Triadelphia Road
Private

Maryland Historical Trust Maryland Inventory of Historic Properties Form

Inventory No. HO-1100

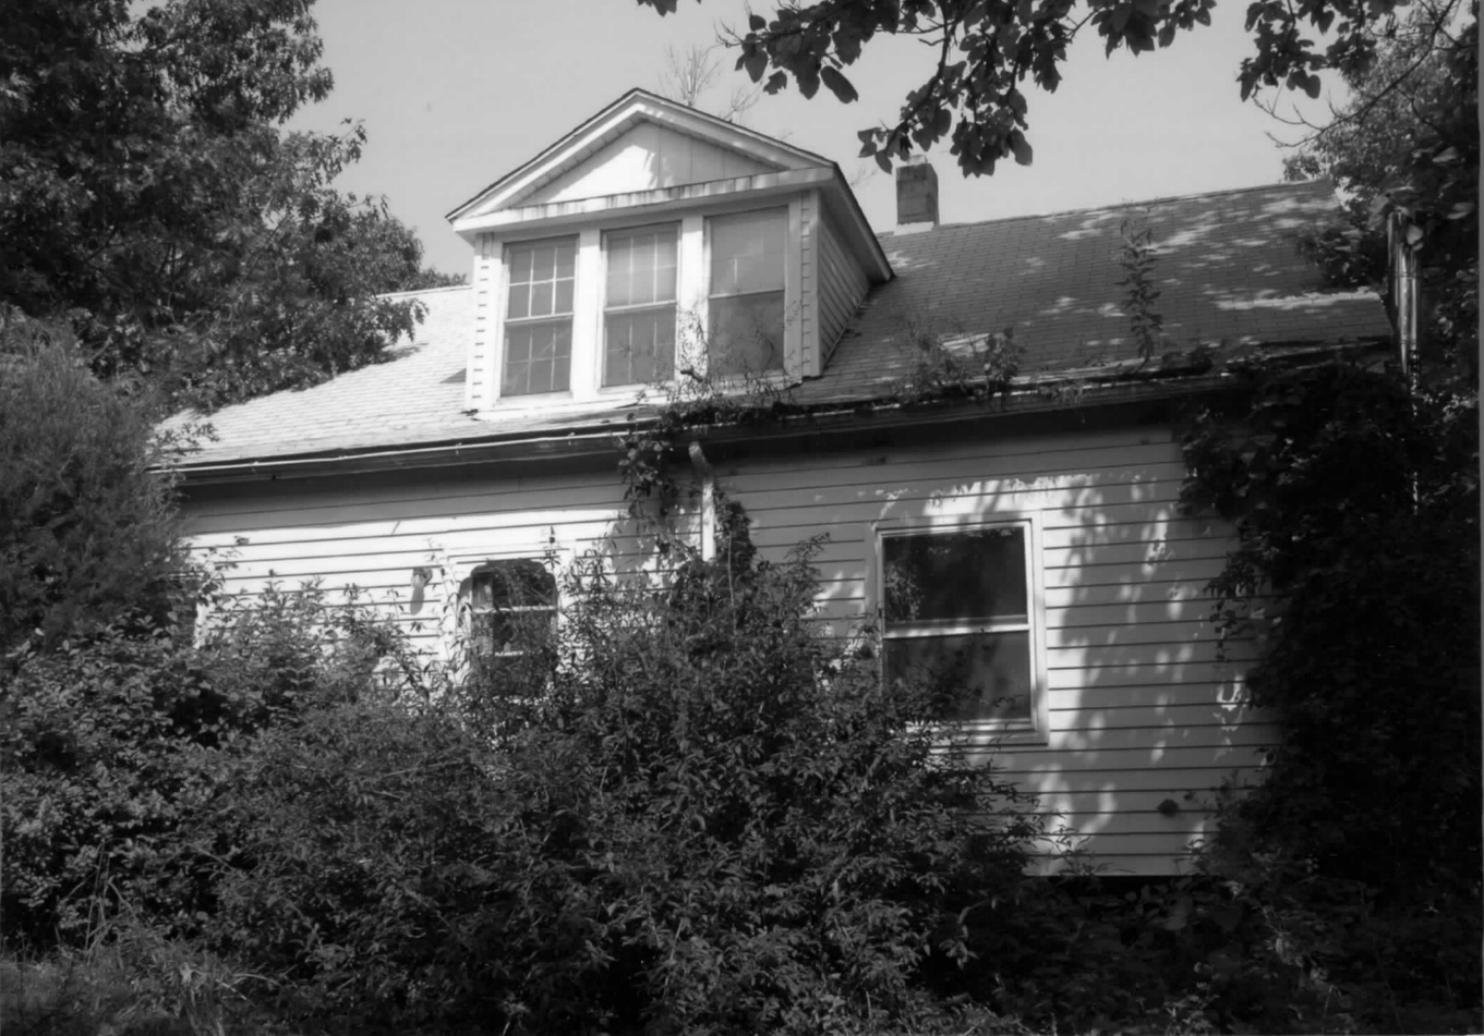
1 of 4

The south elevation has an enclosed porch across the front, under the extended slope of the roof. It is set on CMU piers and has a new door in the center bay and new sash in the end bays. There is a large gabled dormer in the center with triple six-over-six sash. The front wall of the house, now inside the porch, has diamond-pattern asphalt shingle siding, with a doorway in the center and a six-over-six sash to each side.

South elevation

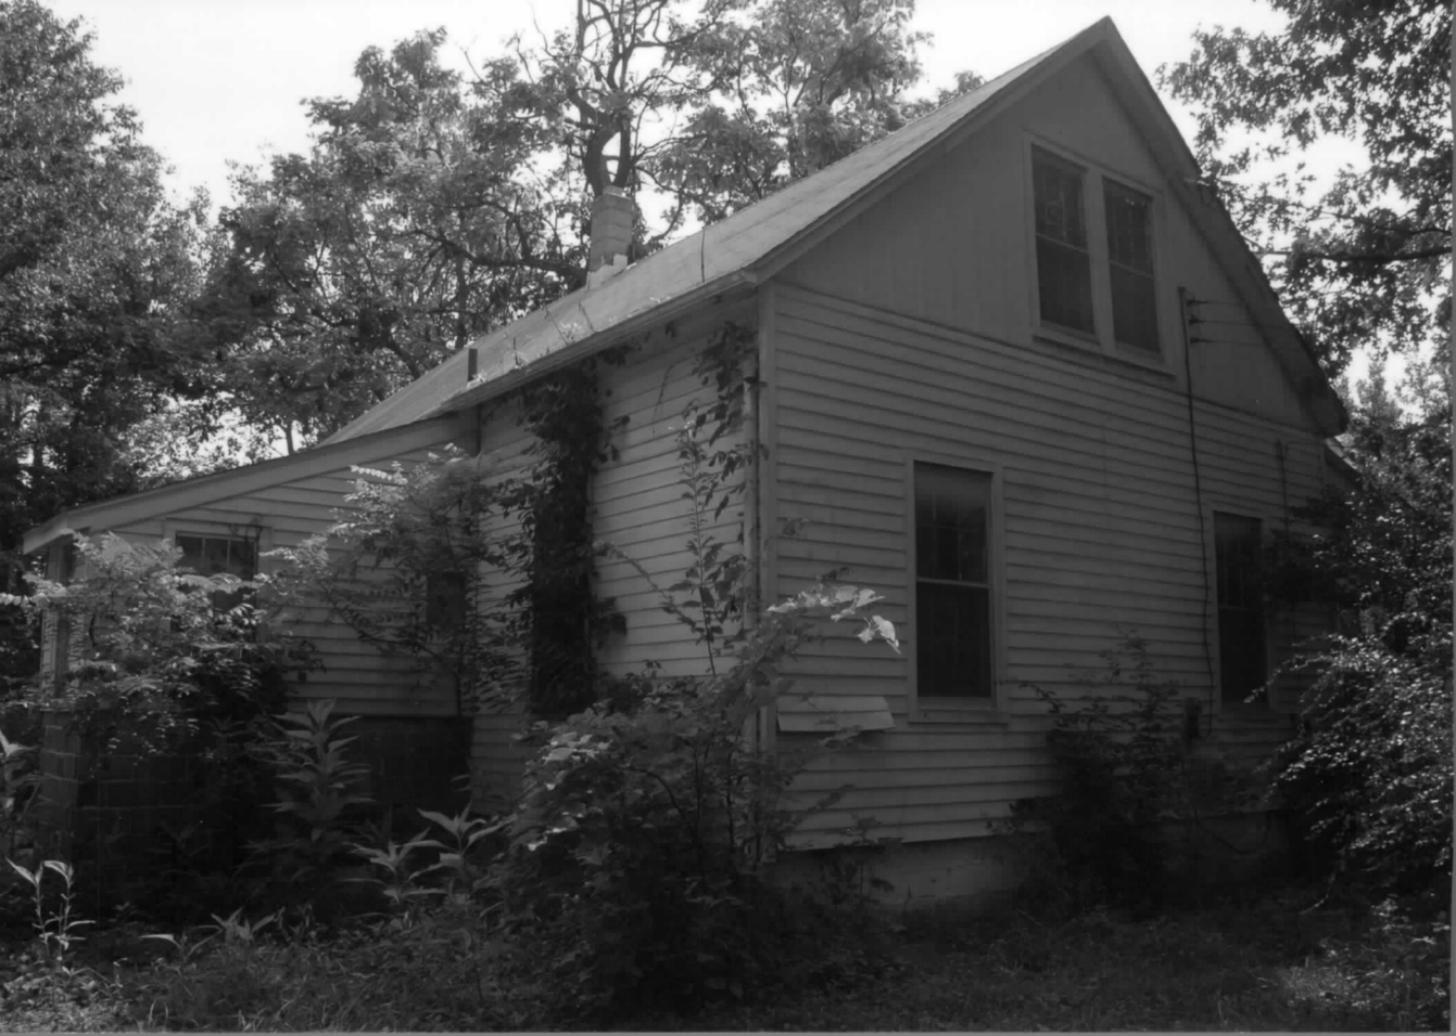
2 of 4

The north elevation has a narrow four-over-four sash in the east bay and no opening in the west bay. The center has a shed-roofed projecting enclosure of three bays, of the same materials as the rest of the house. The east bay has a six-over-six sash, the center bay has a door, and the west bay projects out even further, with a six-over-six sash on all three sides.

North + west elevations

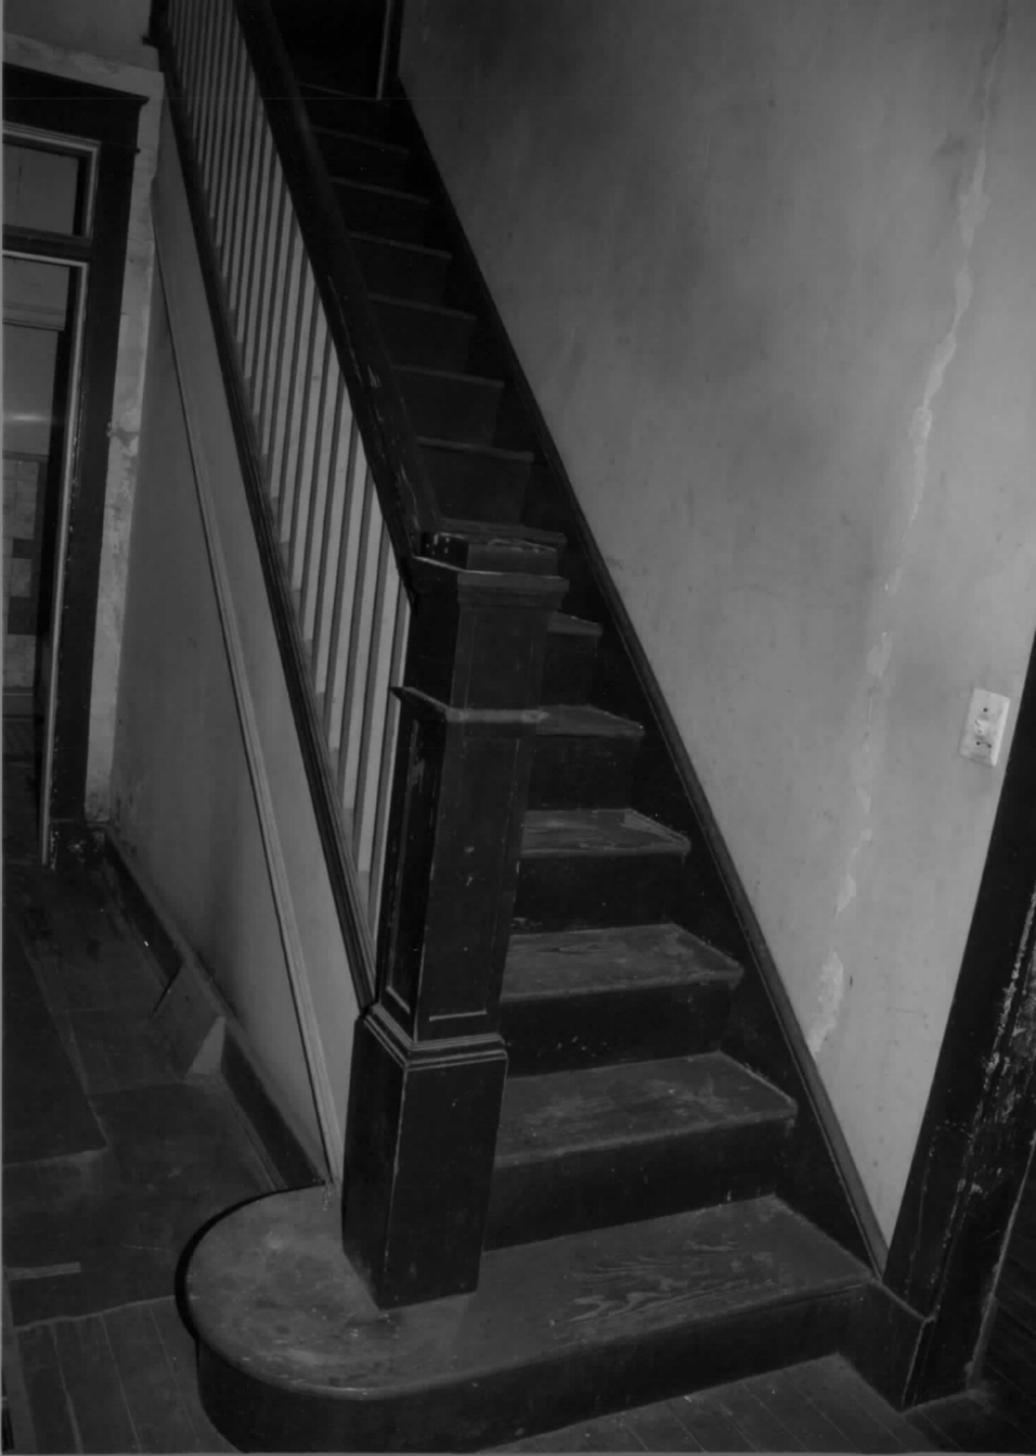
3 of 4

The interior is a center-passage, double-pile plan. The passage has a straight stair with a closed stringer on the east wall. It has a square, paneled newel post and square balusters. The bottom tread is wider and rounded on the end. The architrave throughout is plain on the sides, with a cornice across the top creating a rudimentary entablature. The west wall has a wide opening with later infill of three 15-light doors. The northwest wall has a doorway into a cross-passage that connects the two rear rooms and a bathroom that projects off the center of the back wall. The partition between the southwest and northwest rooms has a wide opening with typical trim, but there is ghosting on the floor of the wall and a narrow doorway, indicating that this is a later alteration. There are now wood shelves built into part of this opening. The northeast room was the kitchen and retains a cast iron sink with drain board on the east wall, with varnished wood cabinets on the wall above. There is a stove chimney in the southwest corner of this room, and a pantry projects off the north side. The bathroom has black and white tile on the floor and a white and blue marbled plastic tile on the walls. The floor is rotted here and in the cross passage. The attic is finished with paneling on the knee walls, rafters, and collars, and has a room at the east and west ends, with the stair landing between them at the north end.

Interior, center stair passage, vw.
northeast

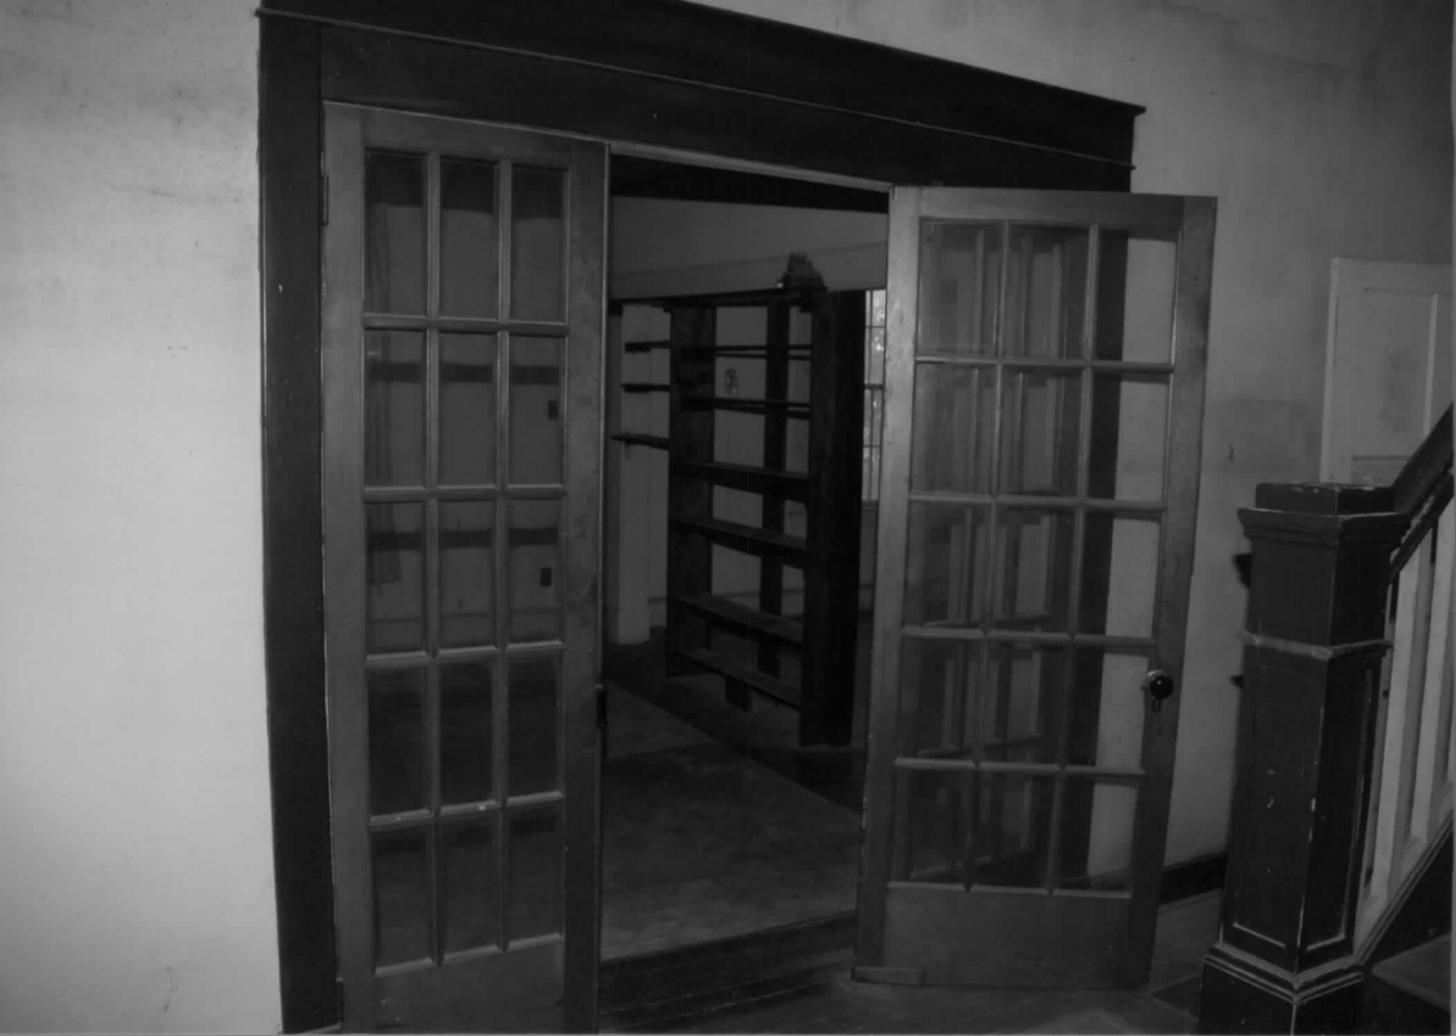
4 of 4

Interior, view from center stair passage
to southwest room
