HO-1119
Gaither-Harding Farm
13000 Wainwright Road
Private

Maryland Historical Trust Maryland Inventory of Historic Properties Form

Inventory No. HO-1119

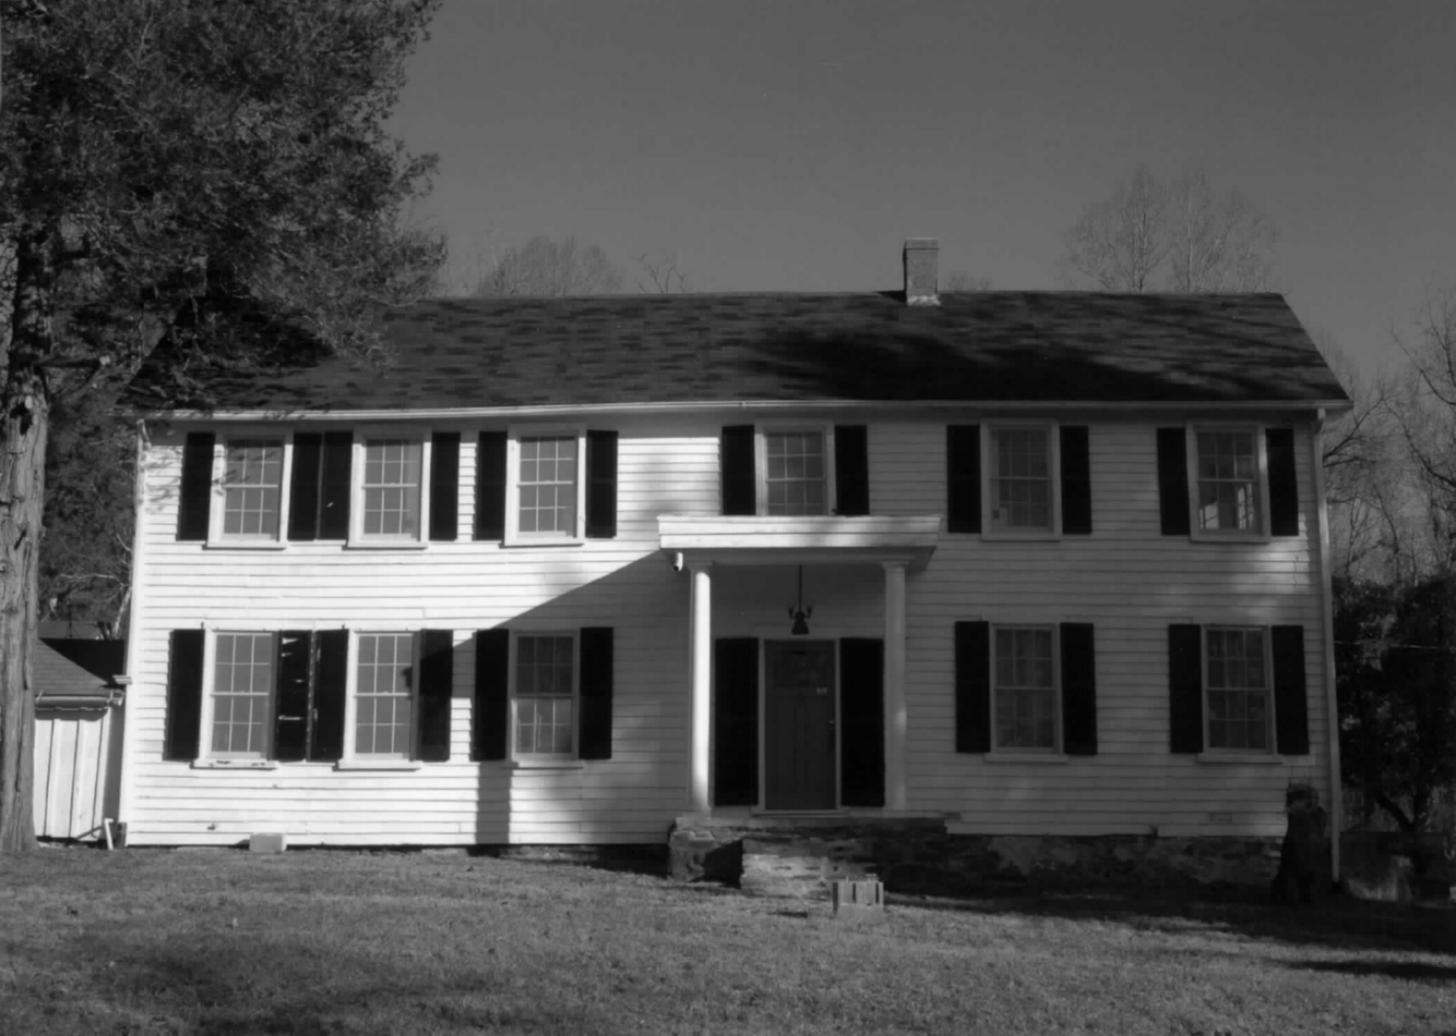
1 of 6

On the southwest elevation the first story south-center bay has a door with six lights over two tall panels, with head-cut trim. There are old shutters that are not original to this location that are screwed to the wall. There is a one-bay porch with a rubble stone foundation topped with a layer of rubble stone to raise it up, and with a concrete pad poured on top. There are rubble stone steps on the southwest and southeast sides, and they are as high as the line between the two layers of stone. The porch has two wood columns that appear to be new replacements, and has bead board soffit. There is a flat roof with inverted-v-seam metal and internal gutters. The remaining five bays have a six-over-six sash with head-cut trim that has a beaded interior edge. The trim has no hinge mortises, but the blinds are mostly old and screwed to the walls. Between the south-south-center and south bays are two seams in the siding that are 35 ½ inches apart, are not as high as the tops of the windows, and

extend down to the stone, as if for a doorway. The infill siding between these seams is fastened with wire nails, while the siding to either side has cut nails. The second story has six shorter six-over-six sash that match the first story. There is a wood box cornice with returns.

House, southwest elevation

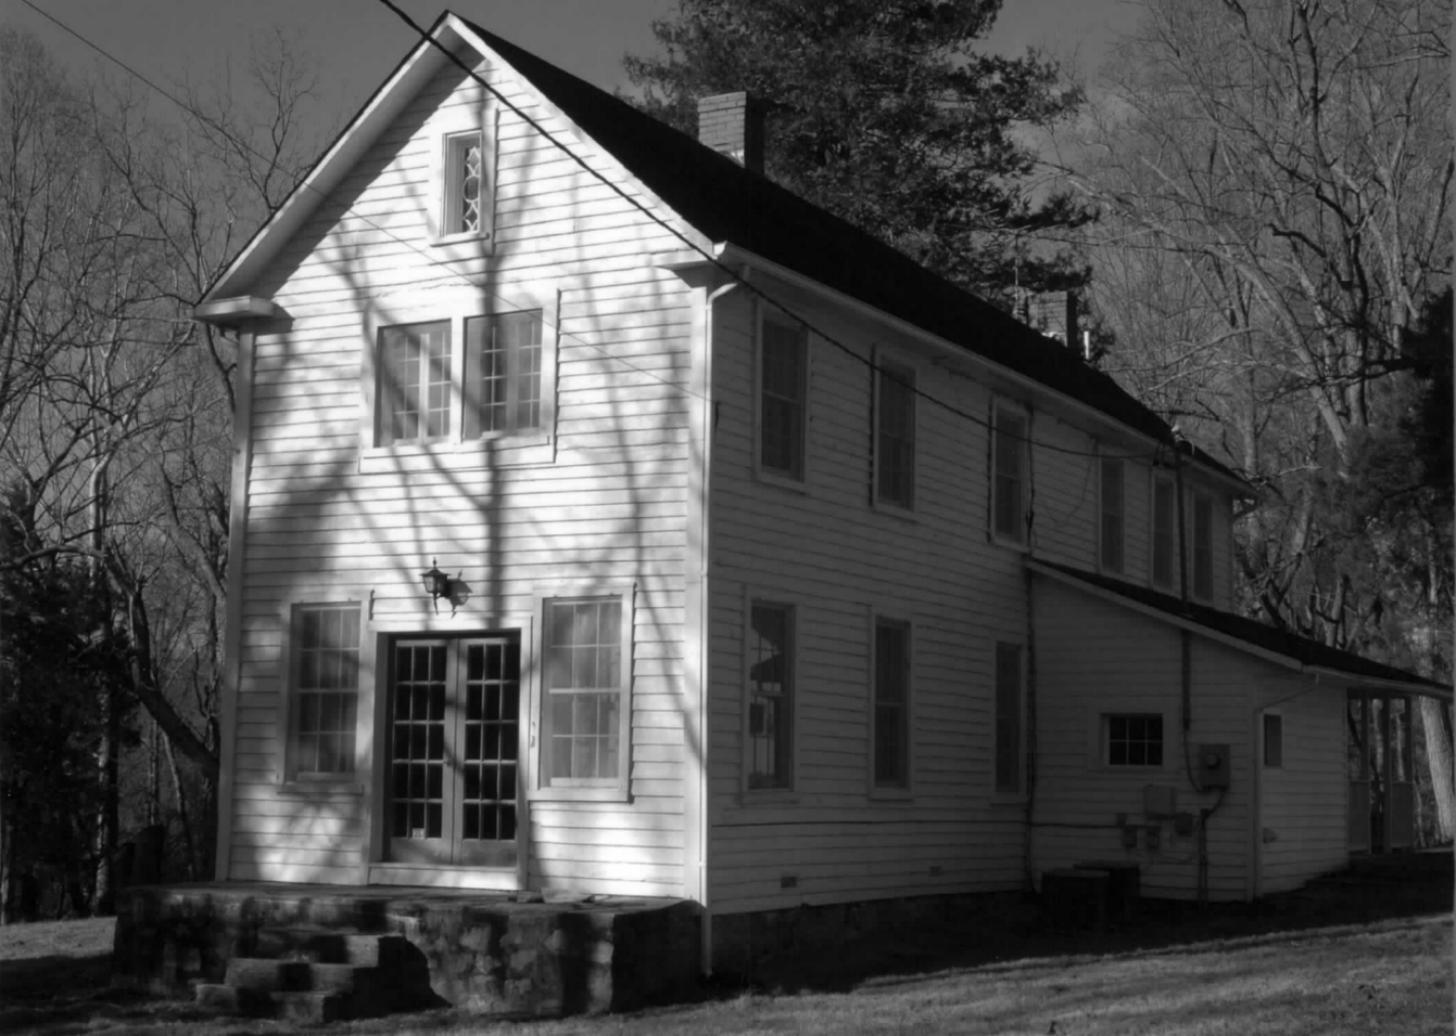
2 of 6

The southeast elevation has a rubble stone porch with a flagstone deck that runs the width of the building, with four rubble stone steps to the southeast. The first story has a pair of 15-light wood doors in the center, with head-cut trim that appears to be newer than the doors. To each side is a six-over-six sash with head-cut trim that does not have beads. The second story has two pair of eight-light casements with wide head-cut trim with no beads. The gable end has what appears to be part of a reused sidelight in the center, with wide head-cut trim. To each side is a vertical seam in the siding that lines up with the outer edge of the small gable-end windows on the northwest elevation.

The northeast elevation, on the first story, has a typical six-over-six sash in the east, east-east-center, and east-center bays. The east-east-center bay has seams in the siding below the sill, and there are many small pieces of siding, especially to the east side of the east seam, as though the window was converted to a door and then back to a window. There is a one-story, shed-roofed addition on the north-center bay, with weatherboards and asphalt shingles on the roof. The roof is carried over the north-north-center and north bays as an open porch. The addition has a six-light sash on each elevation. The north-north-center bay has a door with one light over two panels with quirked ogee and bevel panel moulds. The door has been altered and appears to be an interior door moved to this location. The north bay has a six-over-three sash. The second story has six six-over-six sash.

House, southeast + northeast elevations

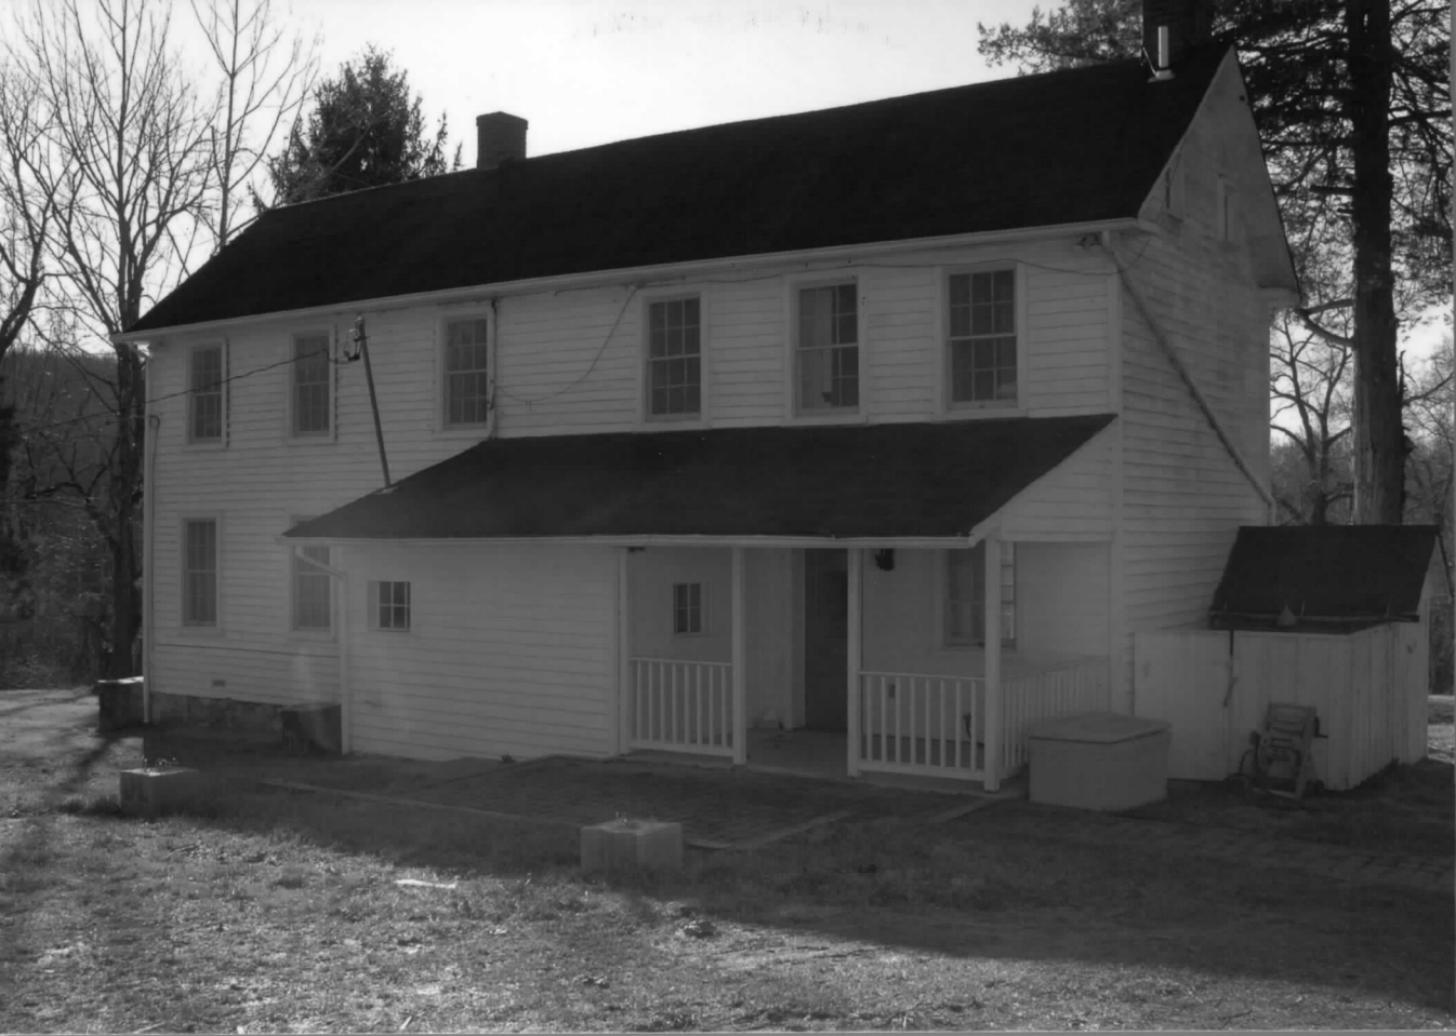
3 of 6

The northwest elevation has no opening on the first or second stories. There is a cellar entrance enclosure with a gable roof and board-and-batten siding, and it has a vertical board door to the west end. The gable end of the house has two four-light sash.

House, northeast + northwest elevations

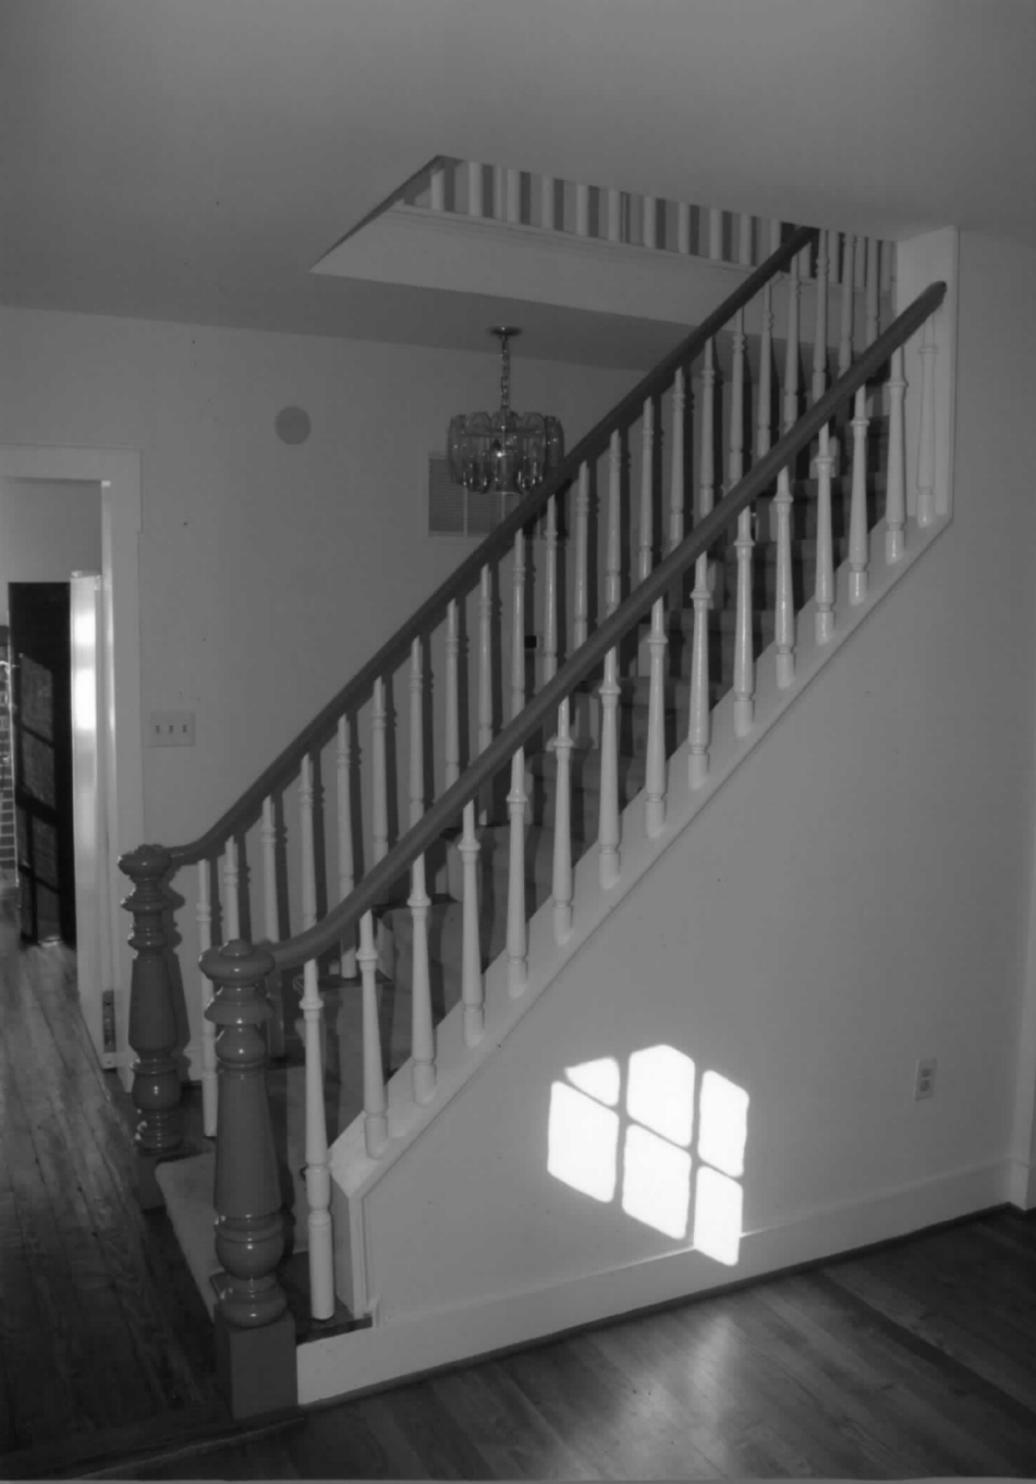
4 of 6

The second story has the same basic floor plan as the first story, but with a cross passage on the southwest that runs to the southeast. The passage stair has a ramped handrail that turns at the landing, with a single newel at the turn that has a hybrid turned column and urn profile. The stair details match the first story, northwest side. There is all new trim, carpeting, and a cathedral ceiling. The doors all have four panels with sunken double fields.

House, Stairway, view north

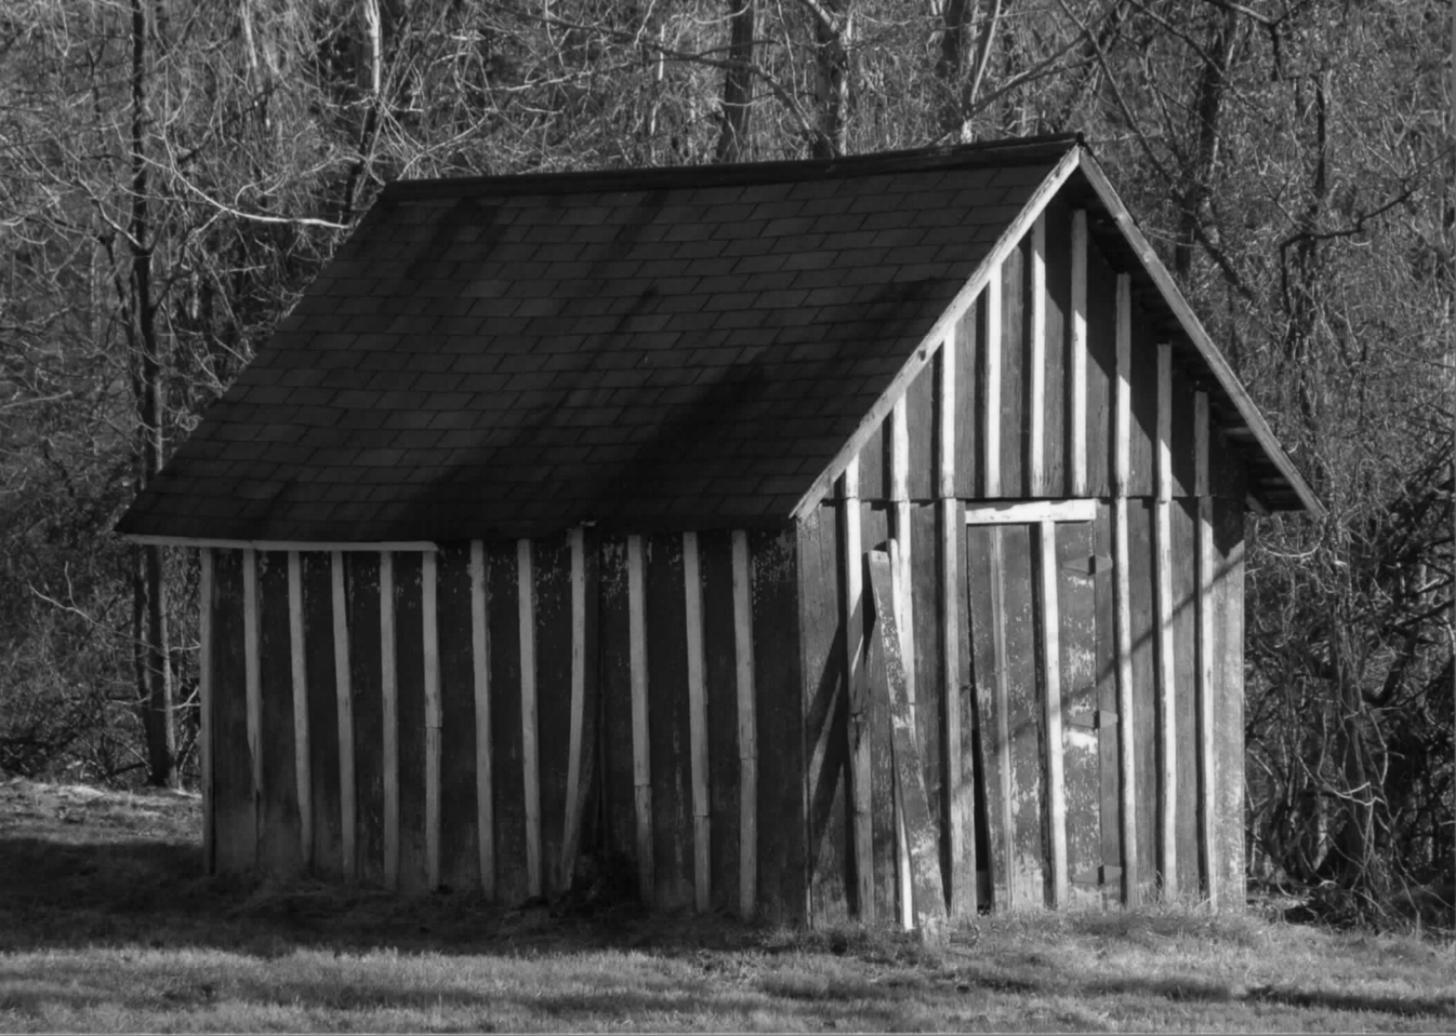
5 of 6

The shed is located about 100 feet east of the house and is a one-story, one-bay by one-bay frame structure with board and batten siding and a gable roof with asphalt shingles and a southwest-northeast ridge. There is a door on the southwest elevation, a pair of four-light sash on the southeast, and double doors on the northeast. The doors are now inoperable. The interior has horizontal board sheathing and sawn attic joists, with an attic that is mostly floored.

Shed, northwest + southwest elevations

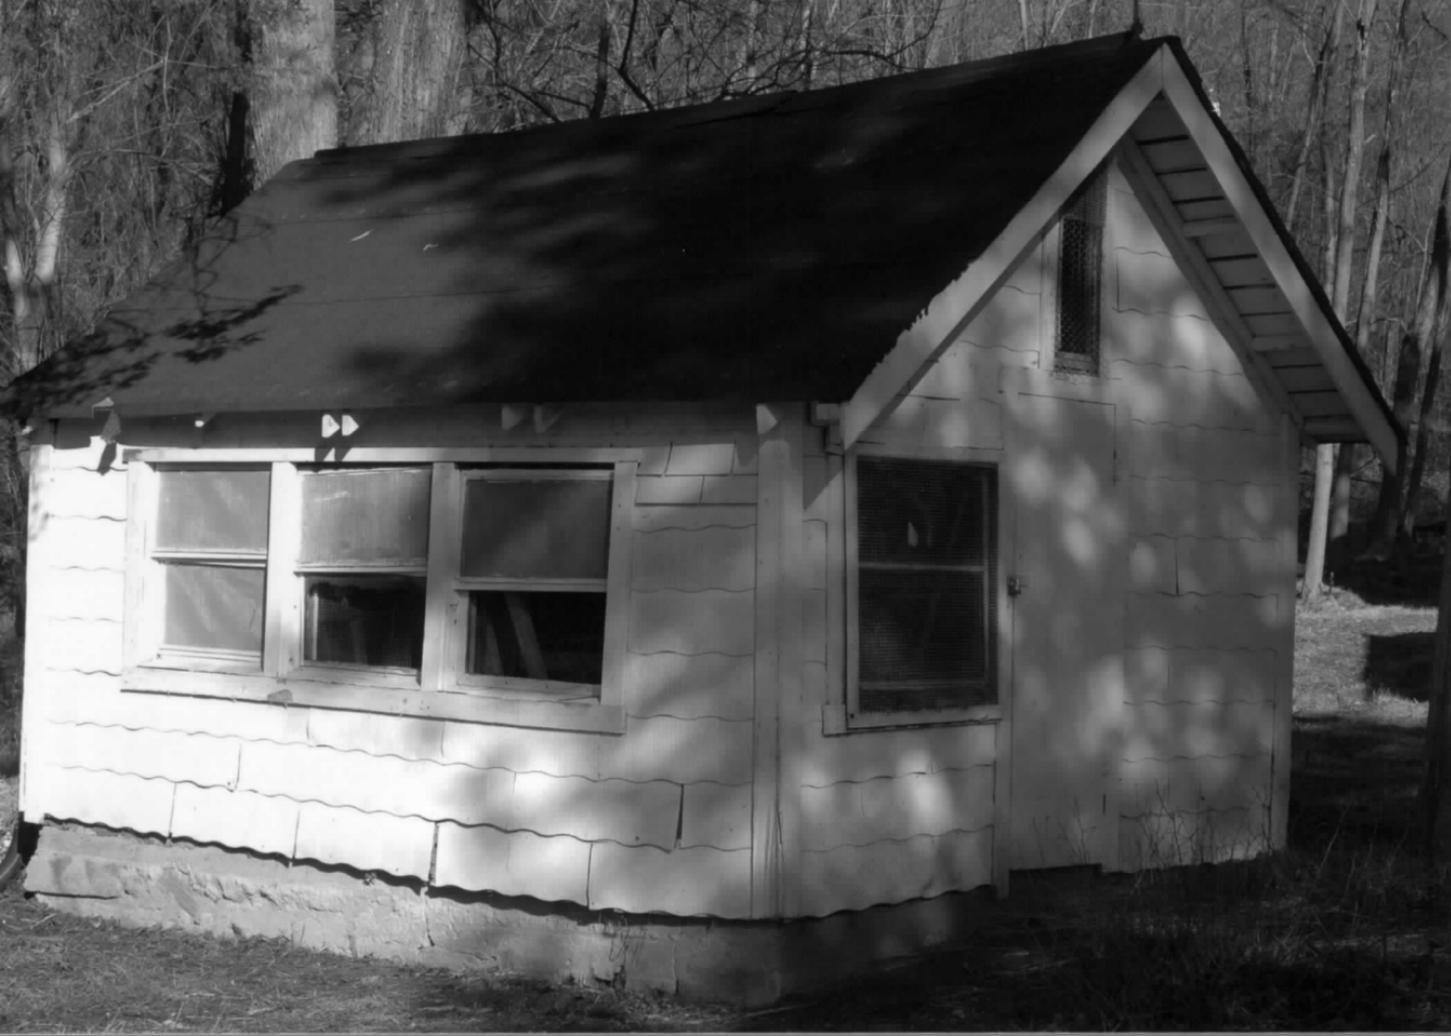
6 of 6

The chicken house is located about 50 feet northwest of the house and has a concrete foundation, asbestos shingle siding, and a gable roof with asphalt roll roofing. It is a one-story, three-bay by one-bay structure with a vertical-board door on the southeast and window openings on the southeast and southwest.

Chicken house, southwest + southeast
elevations
