HO-147
THE EKLOF HOUSE
Ellicott City
Private

MARYLAND HISTORICAL TRUST WORKSHEET

NOMINATION FORM
for the
NATIONAL REGISTER OF HISTORIC PLACES, NATIONAL PARKS SERVICE

1. NAME			
COMMON: The Eklof House			
AND/OR HISTORIC: Chews Vineyard			
2. LOCATION			
STREET AND NUMBER: 494 New Cut Road			
CITY OR TOWN: Ellicott City			
STATE: Maryland		COUNTY: Howard

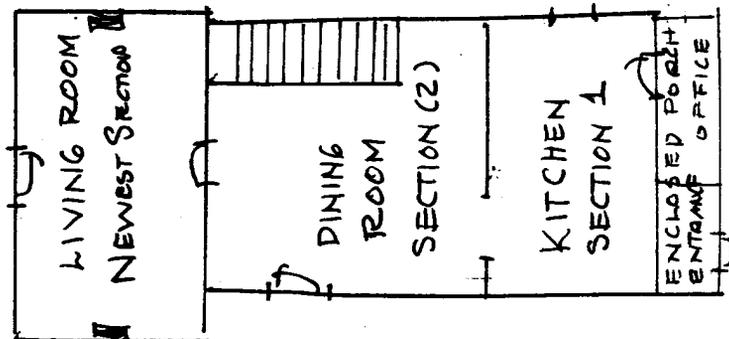
Plan of the House

Mr. and Mrs. Eklot have owned this lovely old Howard County frame farmhouse for some thirty years. On both the Martinette Map of 1860 and the Hopkins Atlas of 1878 (see attachments 3 and 4) it is identified as a 25 acre tract with residence belonging to Mr. Christ Rappanior. The earliest part of the house, the kitchen west wing may date back to the 18th century. The stone foundation is built in three sections (see plan): 1) the kitchen section, 2) the dining room section, and 3) the living room section (1887).

Section 1

The kitchen section had a large cooking fireplace in the basement which is now blocked off. It had one first floor room and one second floor room and was built with weatherboard German siding. The ceilings and doorways are uneven. An open hearth was originally on the first floor, but has since been covered in. The supporting beams in the basement are of log and continue through to the second section, indicating a very early addition. The bedroom above the kitchen has a lower ceiling than the bedroom above the dining room, indicating a separate period of construction. Both, however, are quite modest in scale, revealing a circa 1820 construction date. No stairs went down to the basement. The outside cellar steps on the south wall are made out of old, granite blocks.

The newest section of the house, the east wing has random width floors and north and south chimneys. The brick chimney on the north has a date cut into one of the bricks in the attic which looks like the date 1887. These chimneys were used for stoves rather than fireplaces. This fact, as well as the three inch thick supporting beams in the basement reveal this to be the newer part of the house.

A three bay wide, one bay deep gabled roof (running east-west) two story frame west wing springs from the west wall. In an examination of the basement and the height of the roof rafters it is certain that the present kitchen or the west bay of this section of the house was the earliest structure with a wide central stone chimney on the east wall, and staircase along the south wall. Two rectangular doors were located on the west wall

PLAN OF ORIGINAL HOUSE

when the Eklofs bought the house some thirty years ago. The other two bays were added soon after as the log supporting beams in the basement give evidence that both these sections were built at very nearly the same time.

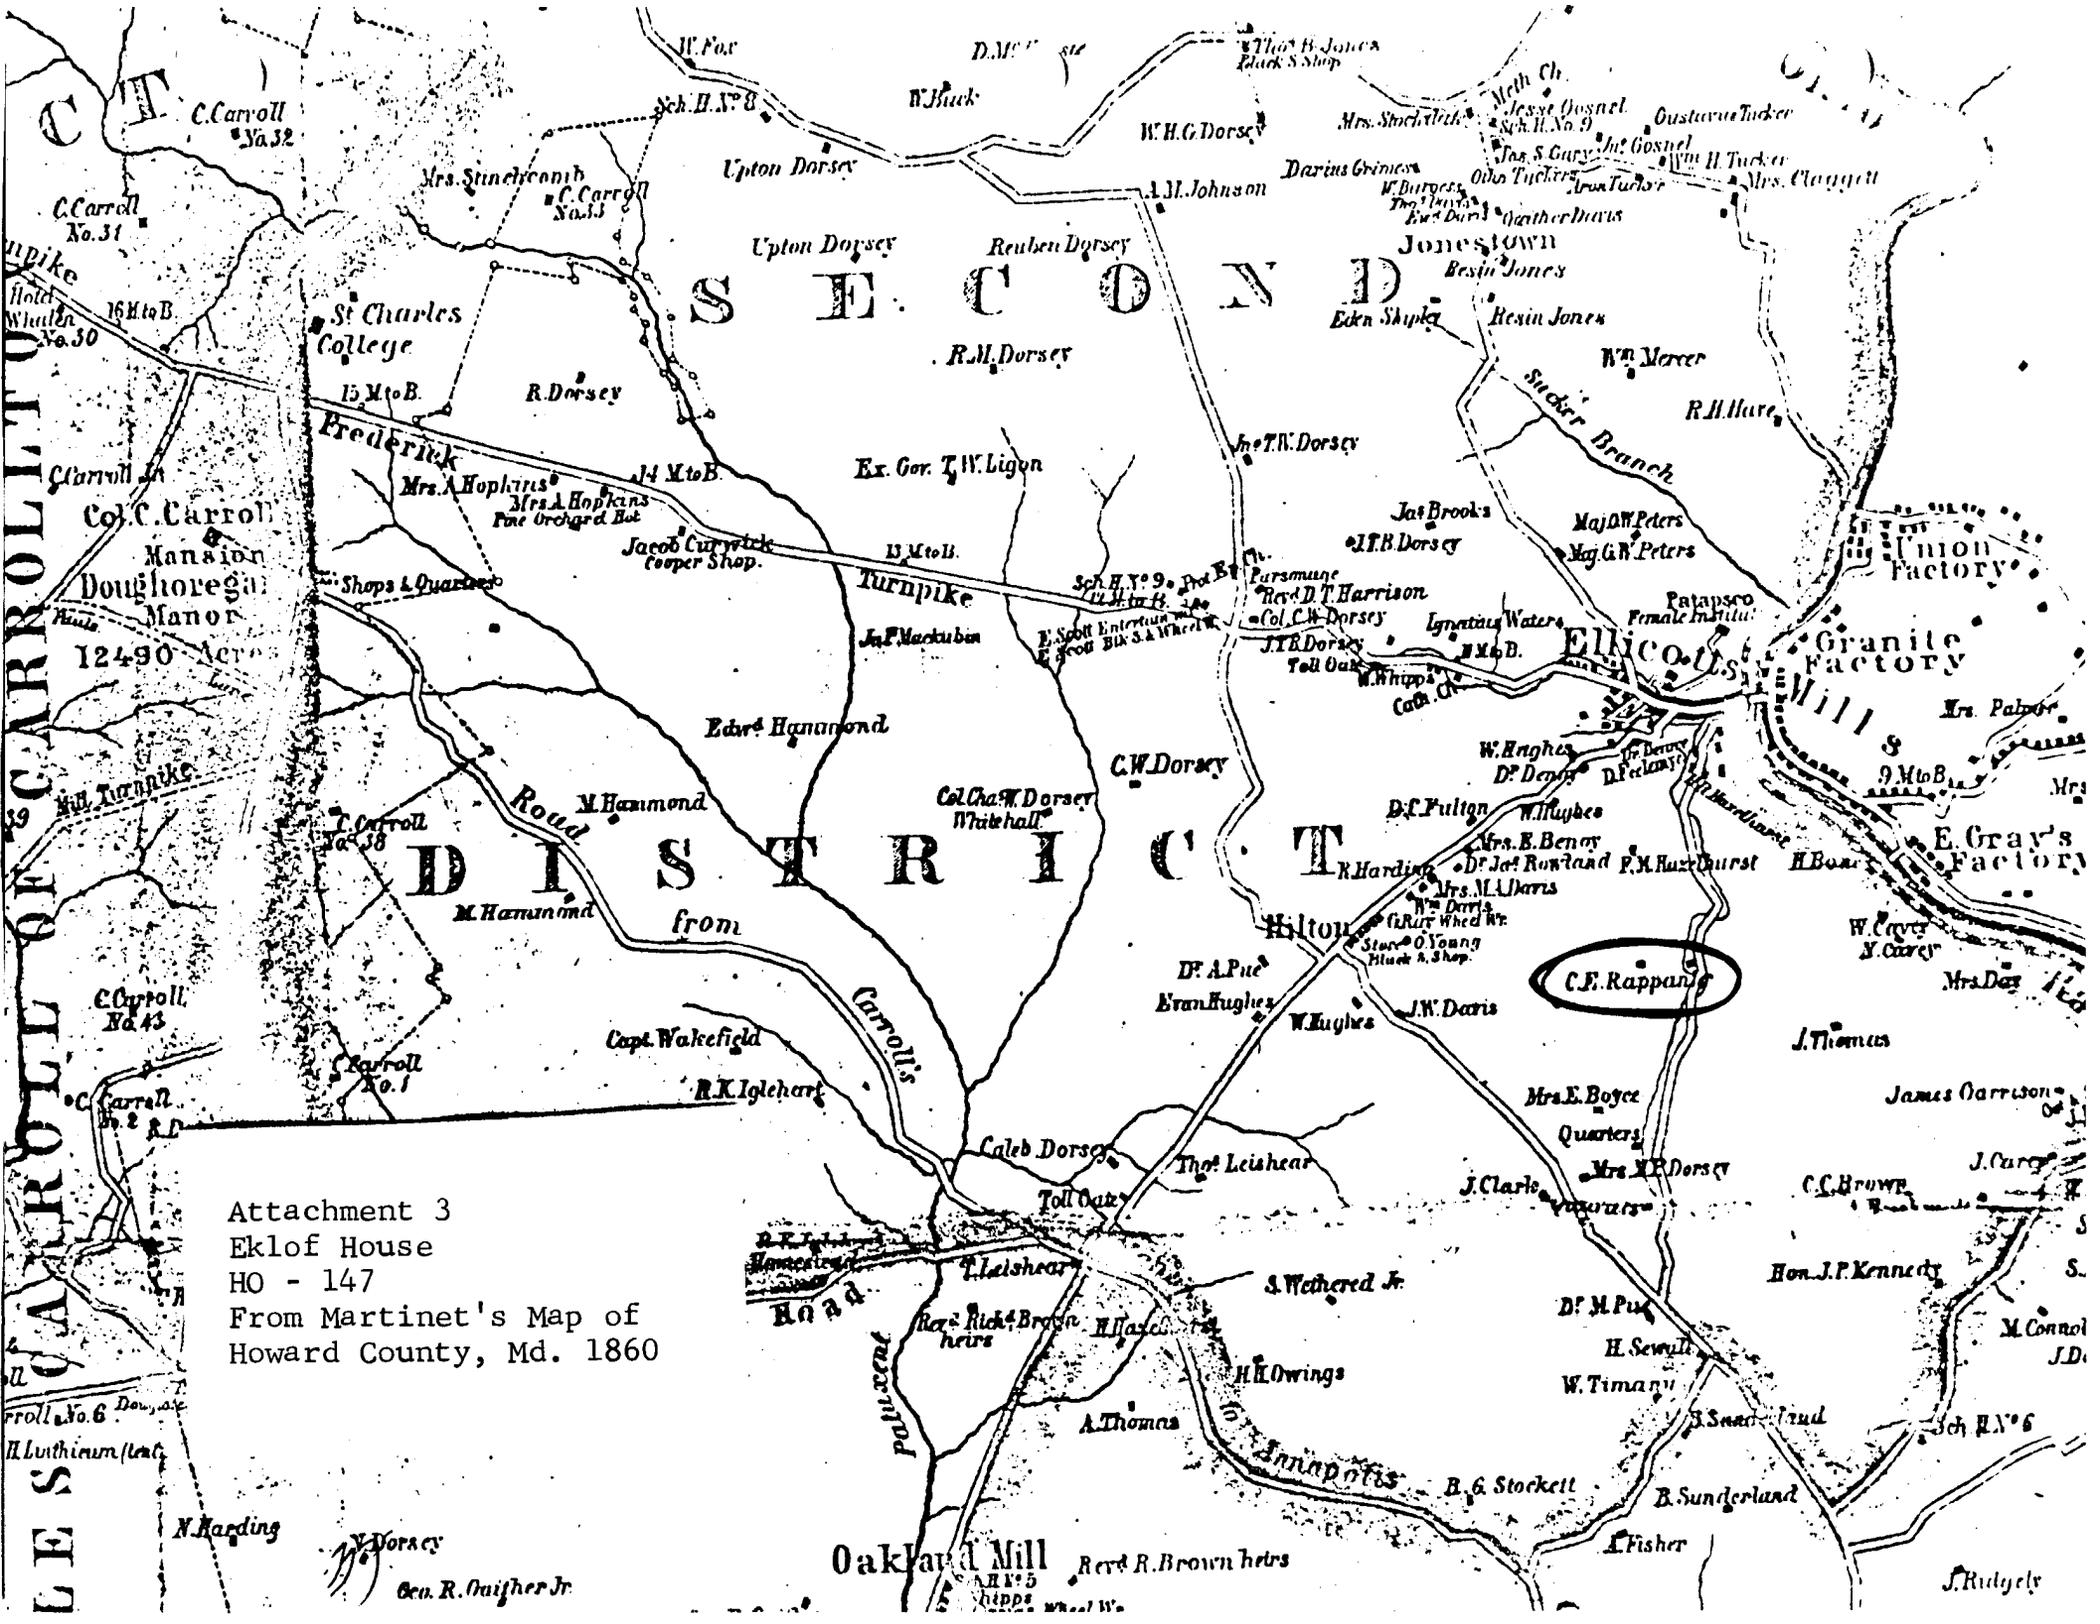
Attachment 3
 Eklof House
 HO - 147
 From Martinet's Map of
 Howard County, Md. 1860

It is noted on the Martinet Map of 1860 and the Hopkins Atlas of 1878 as belonging to Chris Rappanier
