HO-29
ARLINGTON
Private
Columbia

MARYLAND HISTORICAL TRUST WORKSHEET

**NOMINATION FORM
for the
NATIONAL REGISTER OF HISTORIC PLACES, NATIONAL PARKS SERVICE**

ATTACHMENT #1
ARLINGTON
HO-29
TAX MAP #30

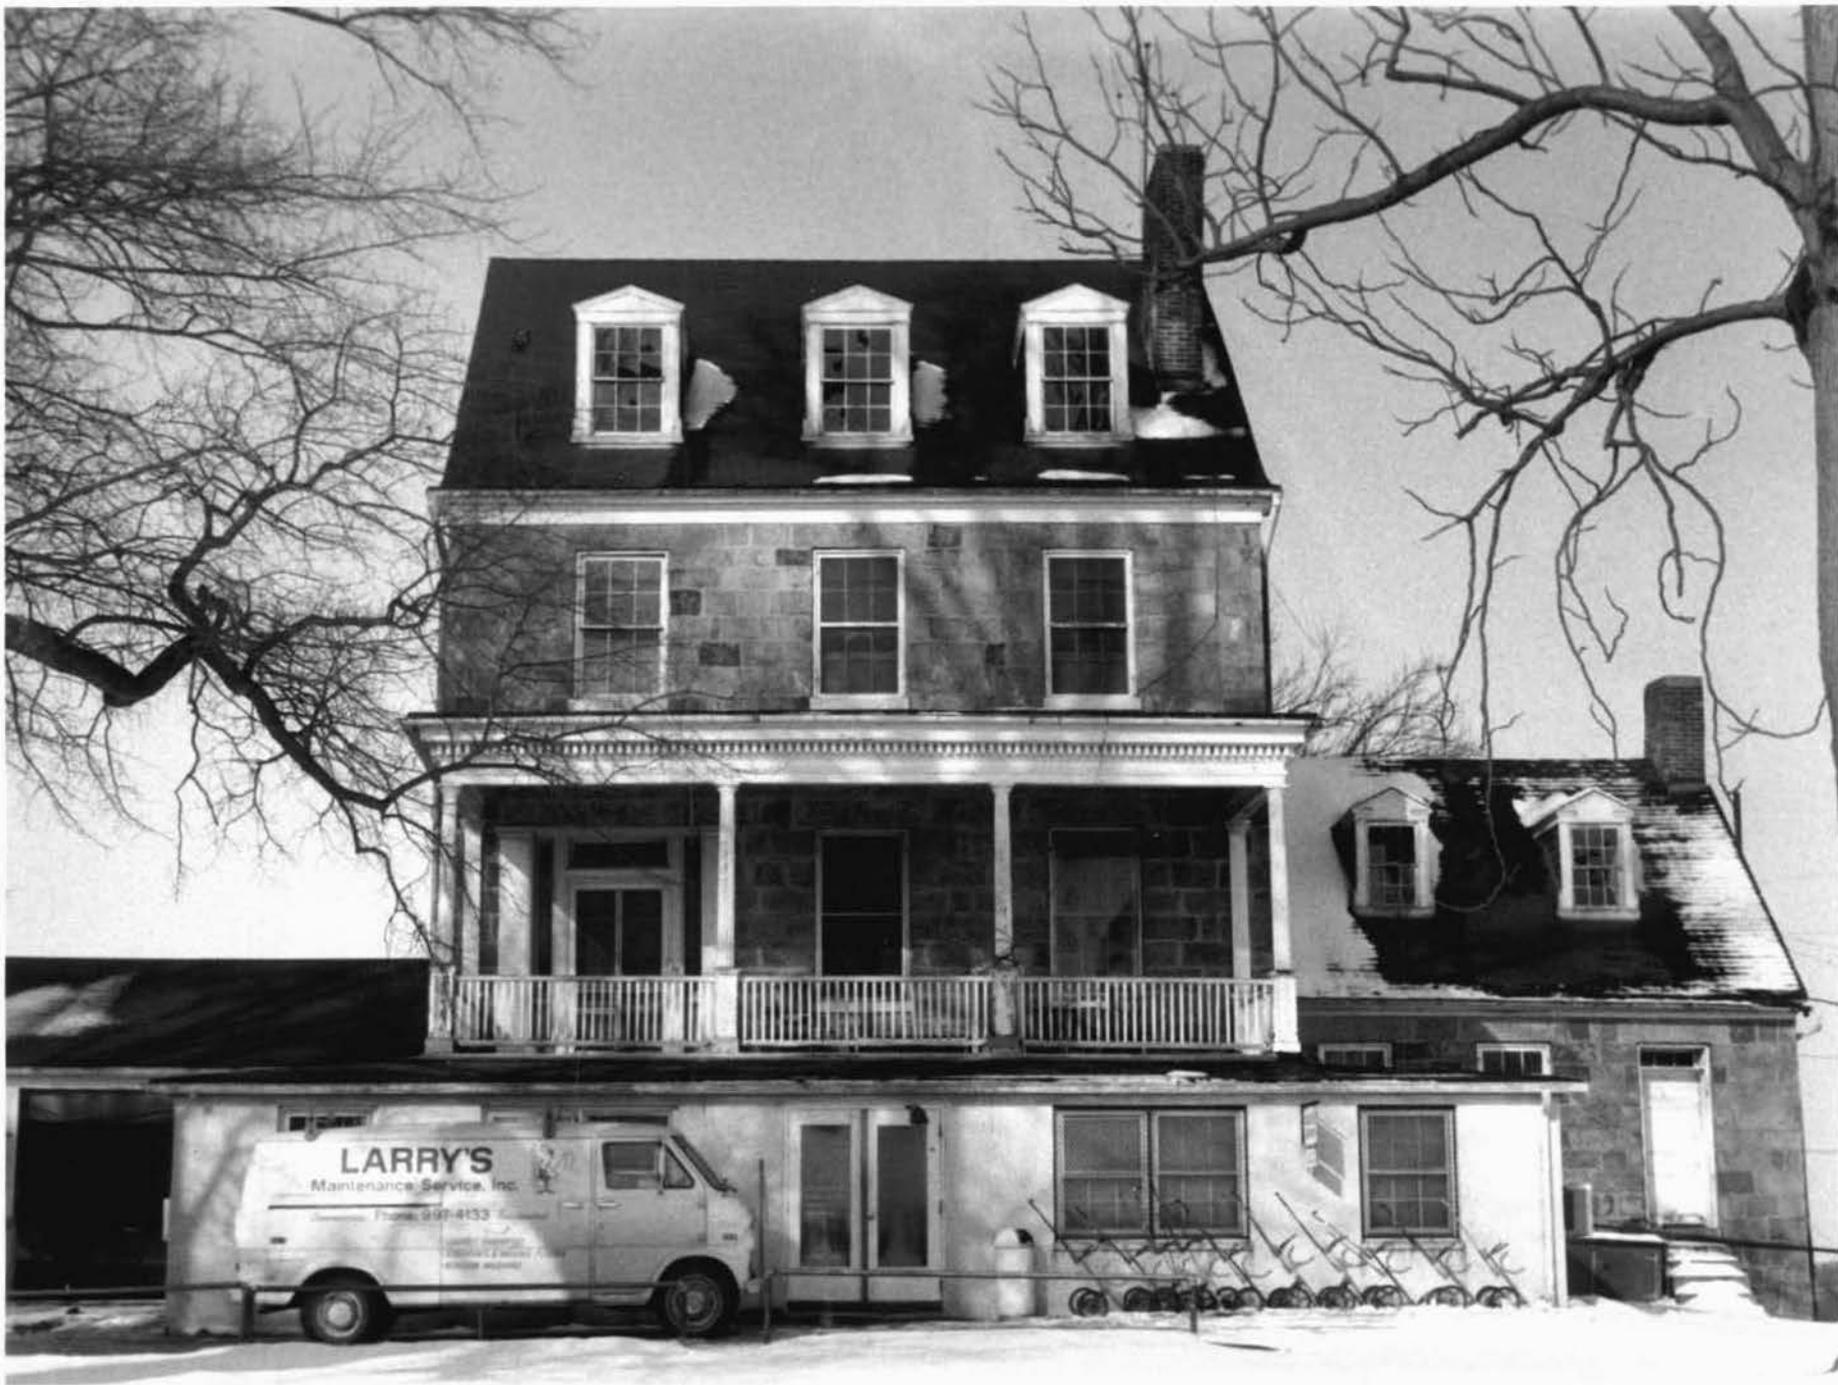
HO-29
ARLINGTON
(EAST)
CLEORA THOMPSON
JAN. 1977

Arlington is a three and a half story granite block structure which rests on a stone foundation and is now utilized as a Pro Shop for the Allview Golf Course with restaurant, locker, and storage facilities. The main house is three bays wide and two bays deep with hall on the south wall and a three bay wide, two bay deep one and a half story, granite block, gabled roof structure. It features unusually fine marble mantles, crown molding, federal plaster work, and chair rails as well as a staircase which runs from first floor to attic.

A one story flat roofed wooden shed extends from the south west corner of the old house used for storage. The second floor west porch of the main house rests on the roof of the first floor pro shop which projects out from the east elevation of the house and extends southward and northward. Its east elevation holds a central double entrance door, each of which holds a large glass pane. This central door is flanked by a double rectangular window and a similar single rectangular window. Each component holds six-over-six lites. The north and south elevation holds a single rectangular entrance similar in treatment to the central door and two rectangular double-hung windows holding six-over-six lites. The south side of the west wall rests against a double garage whose gabled roof runs north-south. A public telephone box stands in front.
