Thompson House/Kraft Cottage
3896 Old Columbia Pike
HO-328

INVENTORY FORM FOR STATE HISTORIC SITES SURVEY

HISTORIC The Kraft Victorian Cottage

STREET & NUMBER 3896 Old Columbia Pike (MD987)

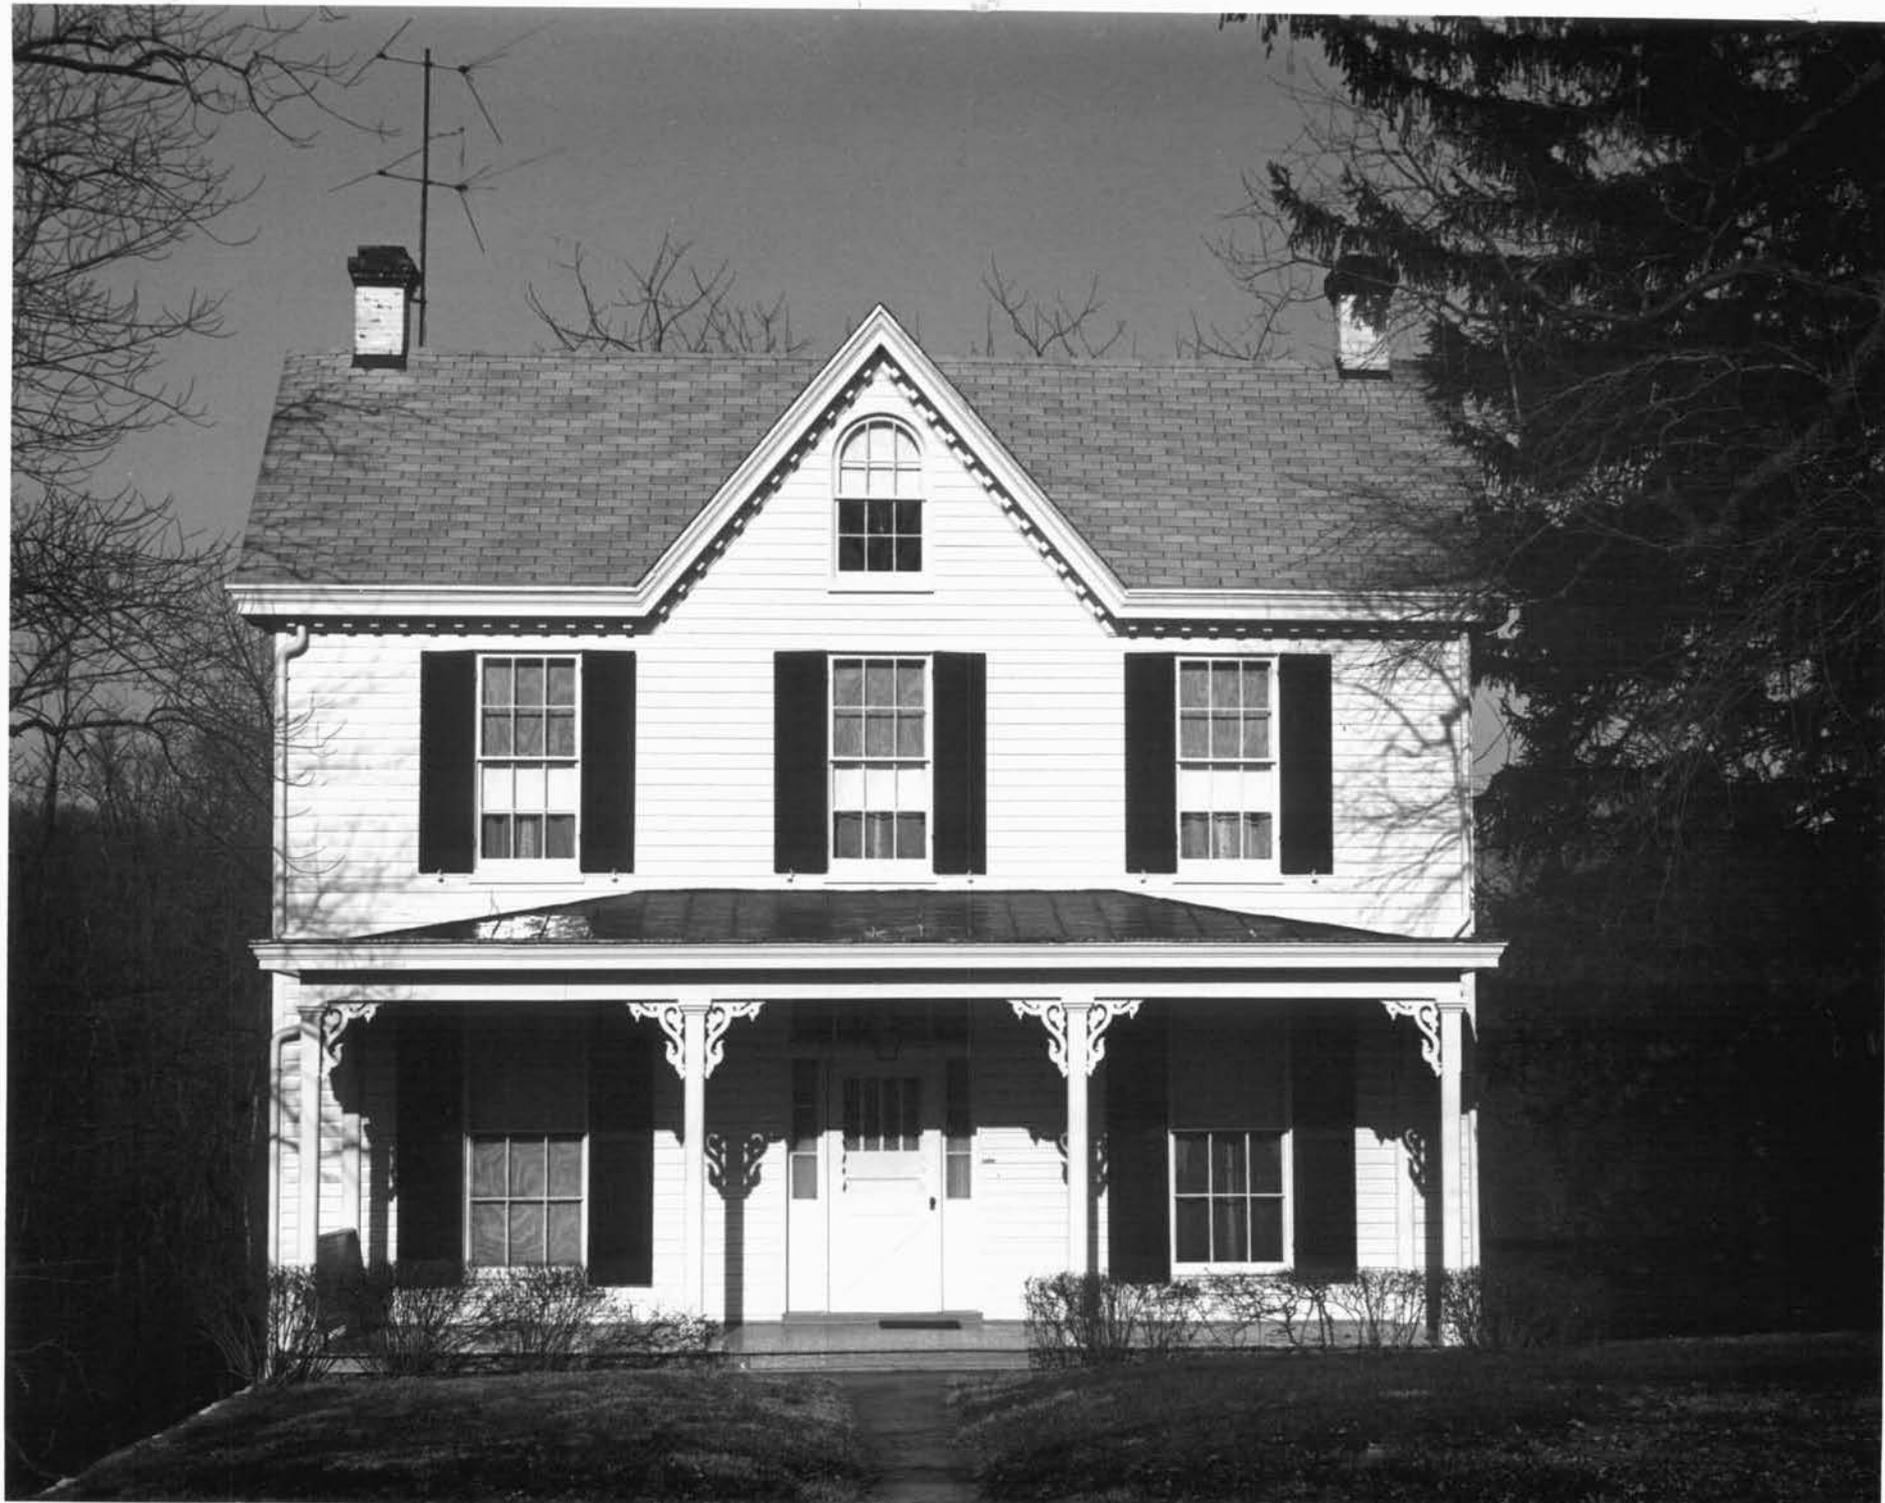
H0-328
THE KRAFT VICTORIAN COTTAGE
SOUTH
JAN '80

SOUTH ELEVATION

This elevation has been pretty well described in the general description of the front facade, its entrance and central intersecting gable.

The south facade of this house, which faces very close to the old pike is a study in symmetry, scale and detail.

The south facade is perfectly symmetrical with its fine central entrance flanked by a first floor window and its intersecting gable terminating the central bay of the front facade. This symmetry is continued on the east and west elevation of the main building block, which are identical.
