HO-388, Crosswinds
7255 Montgomery Rd., Elkridge
Surveyed by: Kristin Hill
December 2003

HO-388, Crosswinds
7255 Montgomery Road, Elkridge
Surveyed by: Kristin Hill
June 2003

INVENTORY FORM FOR STATE HISTORIC SITES SURVEY

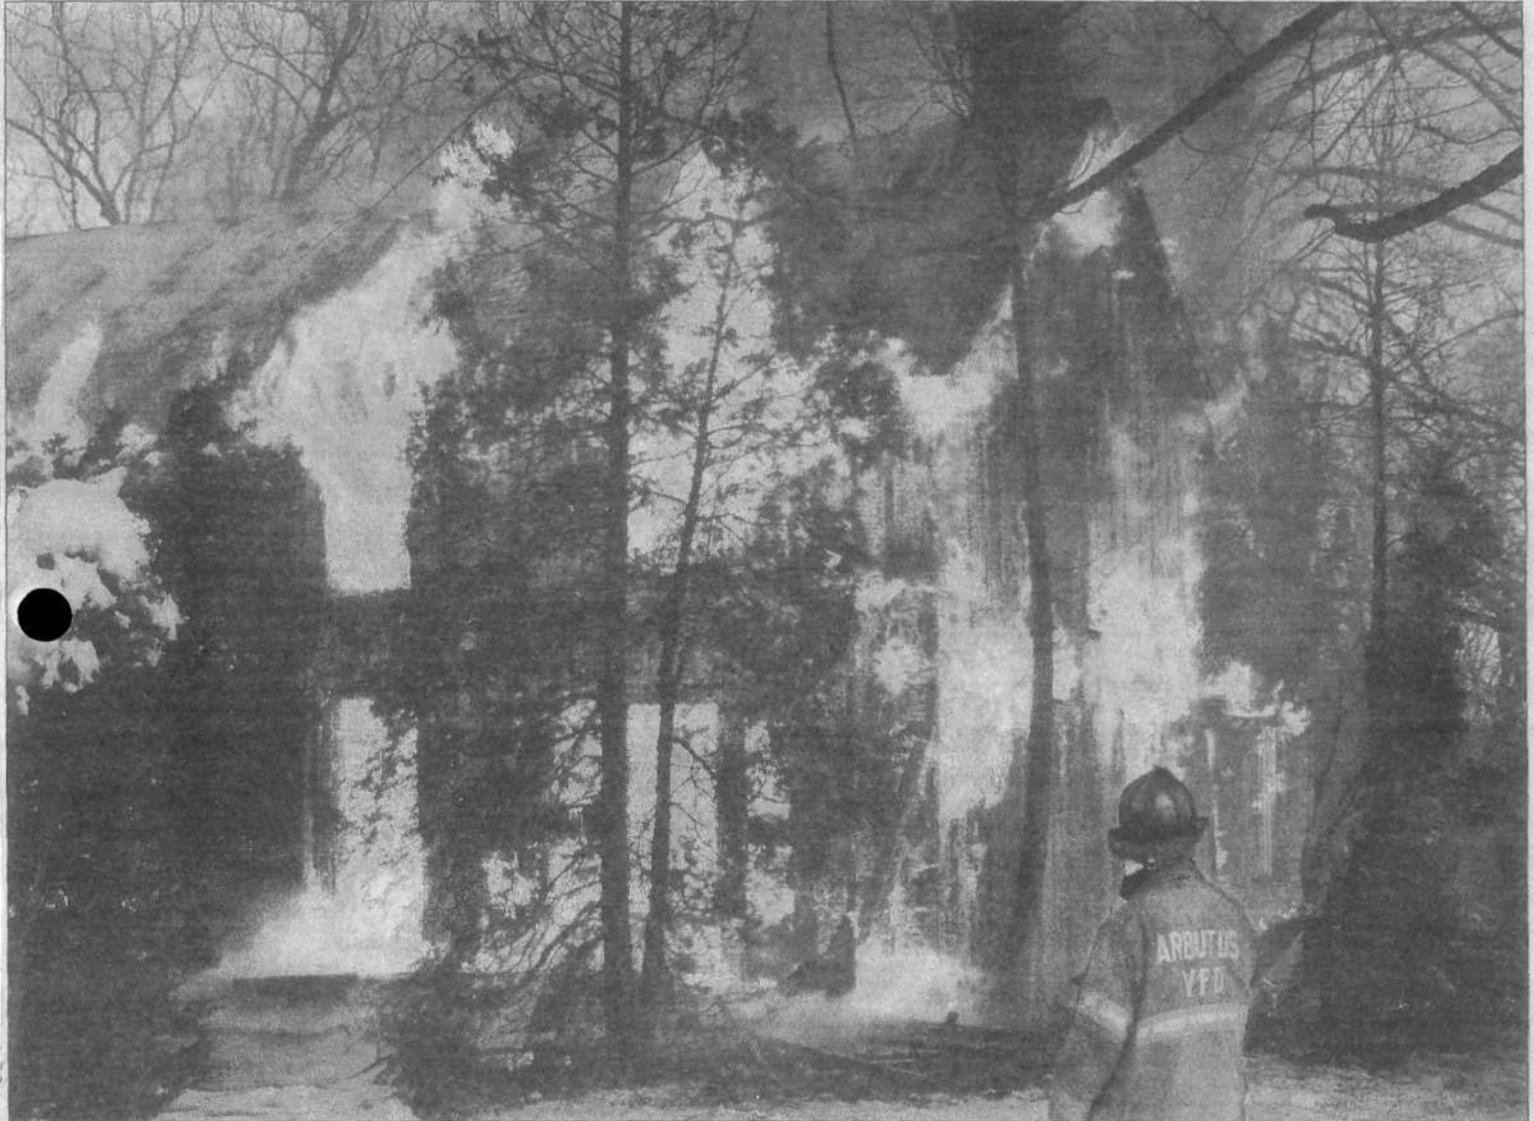
Howard County Times Dec. 11, 2003
HO-388

NO INJURIES IN FIRE Firefighters responded at 11:47 a.m. Dec. 7 to a fire in an abandoned house in the 7200 block of Montgomery Road in Elkrige. It took about 25 firefighters 20 minutes to confine the blaze, which claimed no injuries or deaths, fire department spokesman Bill Mould said. Officials continued to investigate the fire's cause this week.

Unfortunately, on December 7, 2003 this historic structure burned to the ground. The house had been vacant for over a year while the development company that owned the property attempted to get it rezoned to build multi-family housing. The county had asked the developers to preserve the historic structure.

According to the fire department, the fire started in the garage, the only portion of the house that was not secured. The cause of the fire remains undetermined. The attached photograph of the burning building appeared in the Howard County Times the following week and clearly shows the catastrophic nature of the fire. A visit to the site the week following the fire revealed nothing but a blackened area where the building used to be.

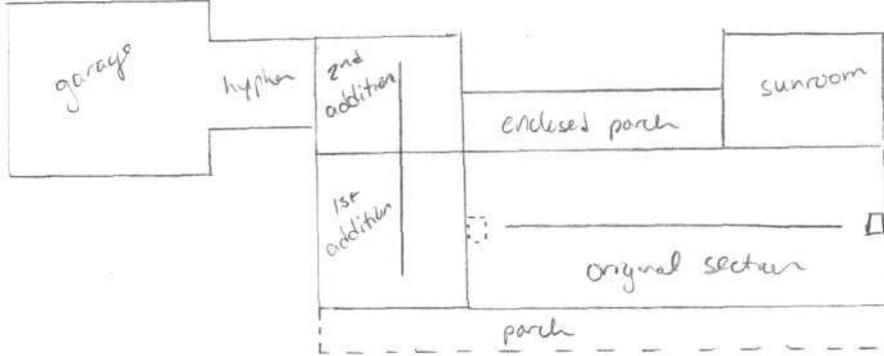
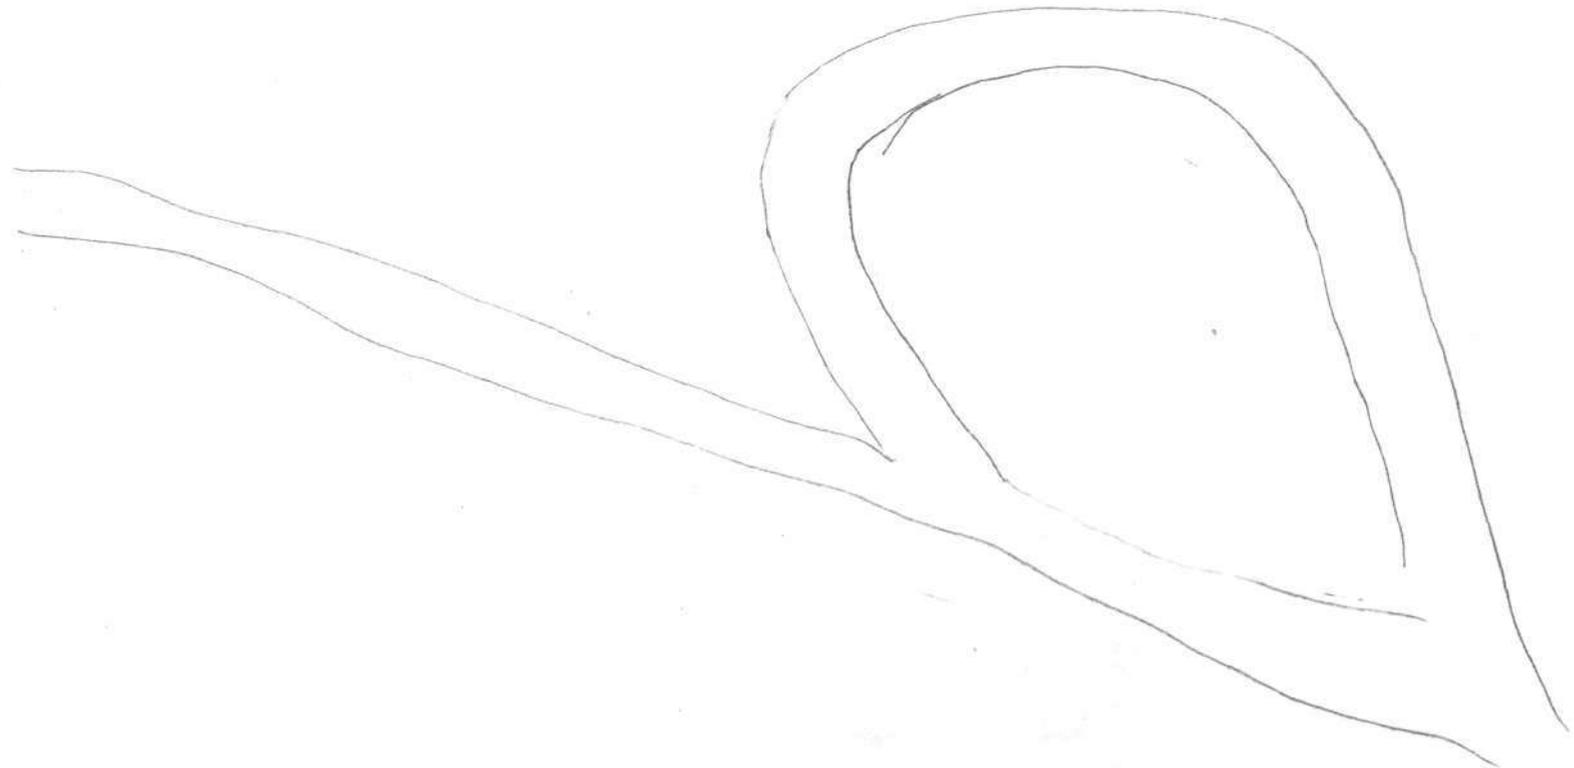
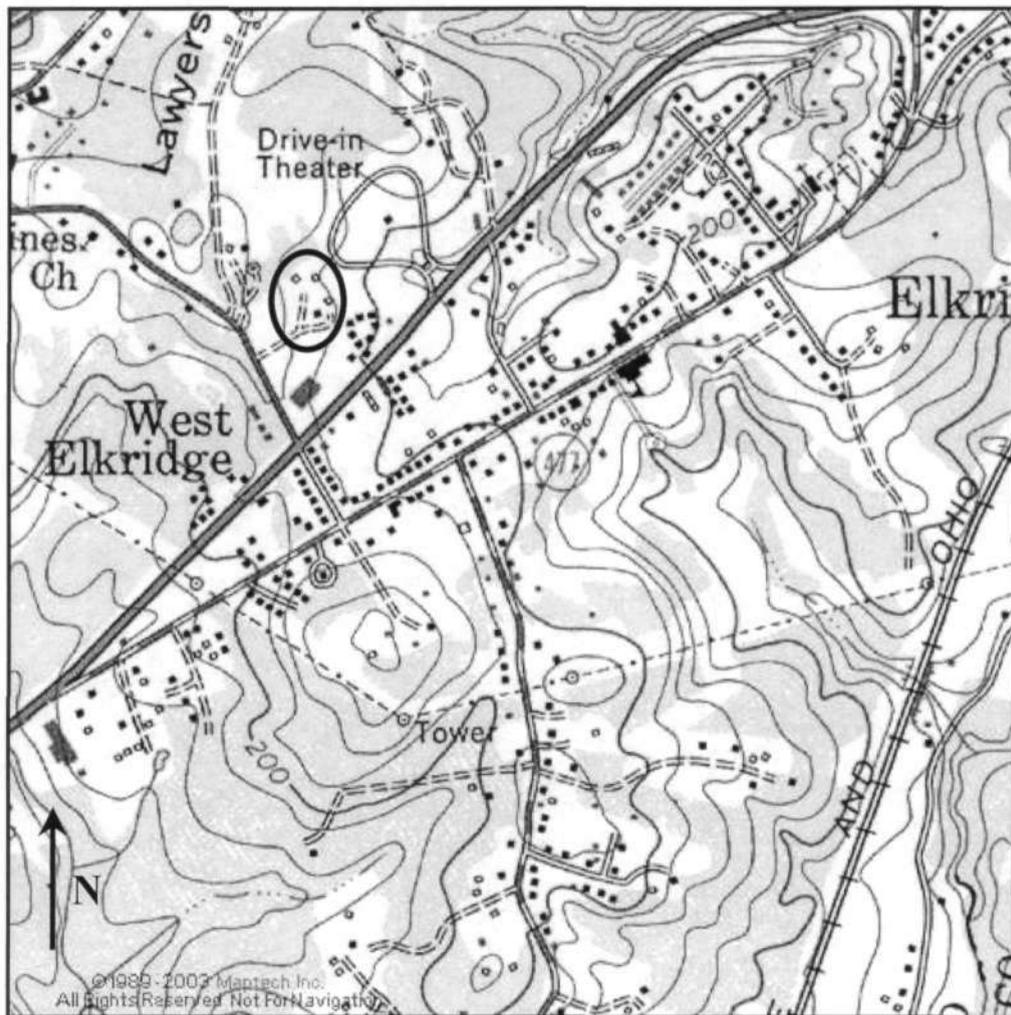
Resource Sketch Map
HO-388, Crosswinds
7255 Montgomery Road, Elkridge
Howard County, Maryland
NOT DRAWN TO SCALE

Recorded as 'Crosswinds' in the 1970's, this two-story frame house shows a variety of building periods. The building faces west on almost 10 acres off of Montgomery Road surrounded by trees and open fields in the immediate vicinity, and a variety of different types of development on surrounding parcels, including commercial and high density residential. The property has been vacant for several years, is in good condition and is currently owned by a developer. There are three structures on the property: the main dwelling house, a small frame cottage, and a collapsed log structure.

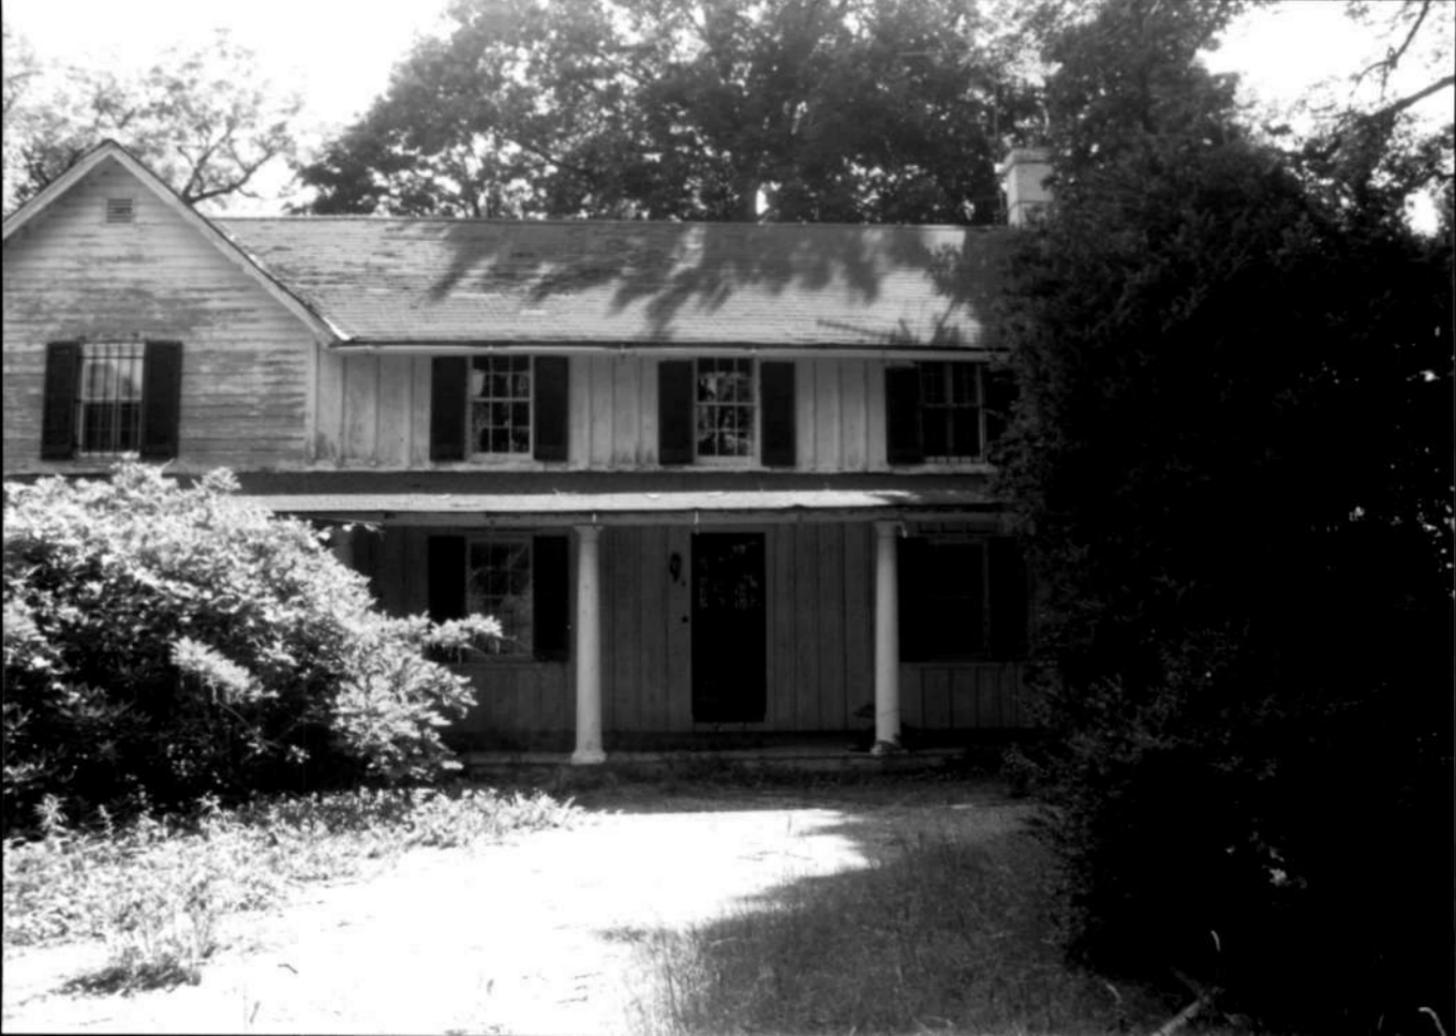
1 of 12

West elevation of original section + part of first
addition (on left).

The front (west) façade of the original portion of the structure has a central entry flanked by a window on either side with three windows vertically aligned above. The door is glazed with multiple panes of glass and is obviously a 20th century alteration. Four of the five windows are 6/6 with rippled old glass. The other window is a 10 by 10 casement. The original section of the building is clad in board and batten siding and the battens are affixed with cut nails. The front façade of the gable front section has a glazed door (matching the existing front door) centered on the first floor and a 10 by 10 casement on the second floor. This portion of the building is clad in wooden German siding. A single story shed roofed porch runs across the front of the original building and the gable front addition. The porch is supported by Doric style columns, has a wood

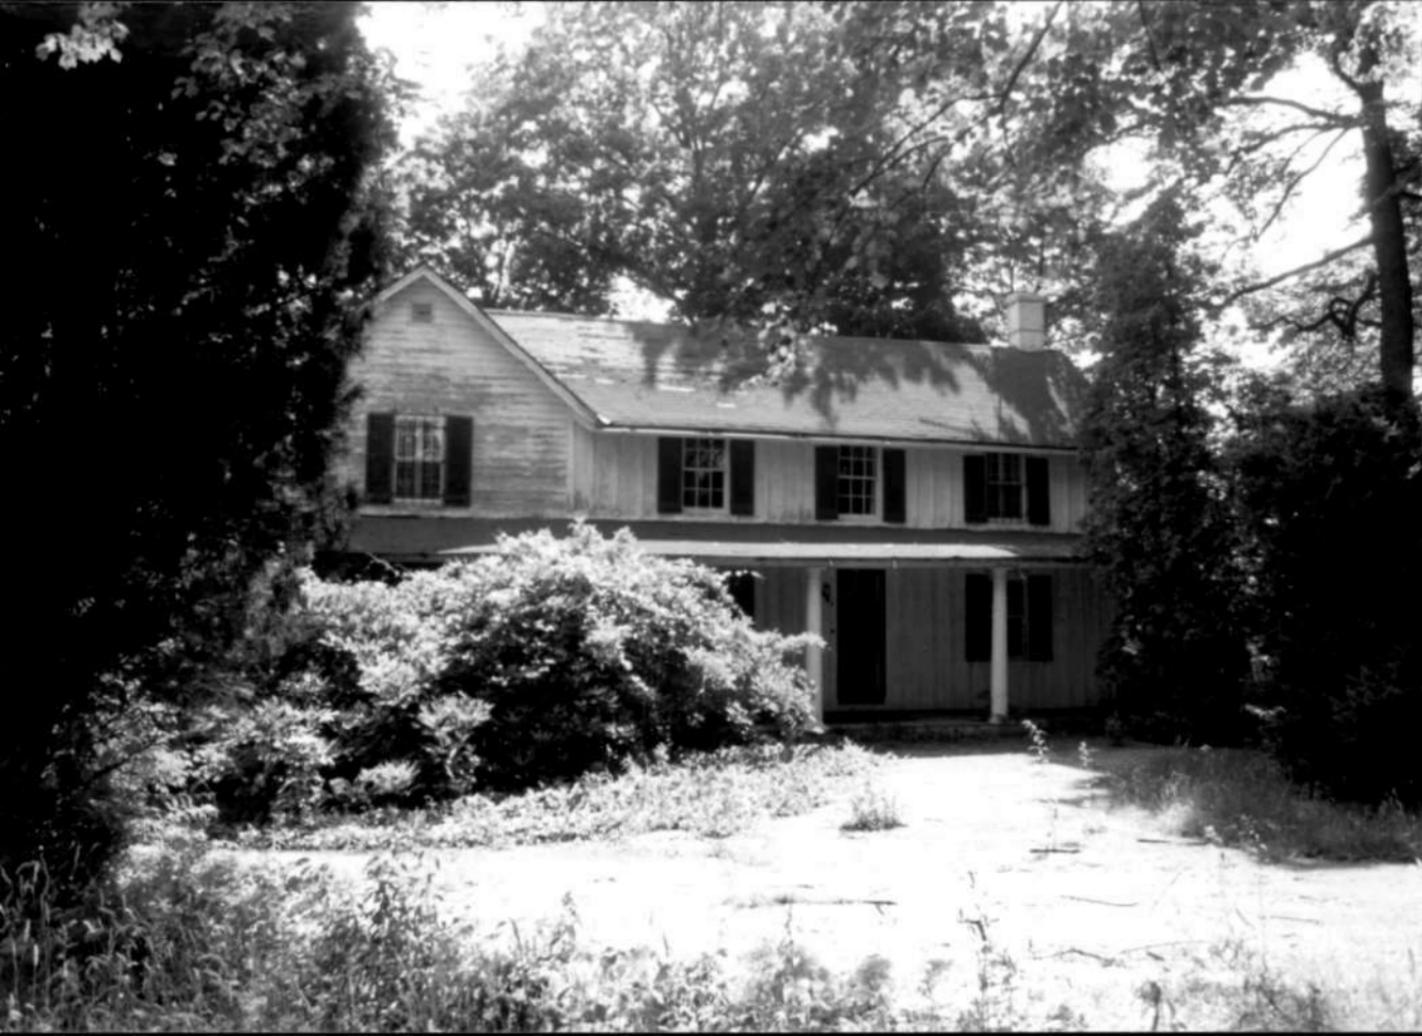
2 of 12

West elevation of original section (on right) + first
addition (gable front on left).

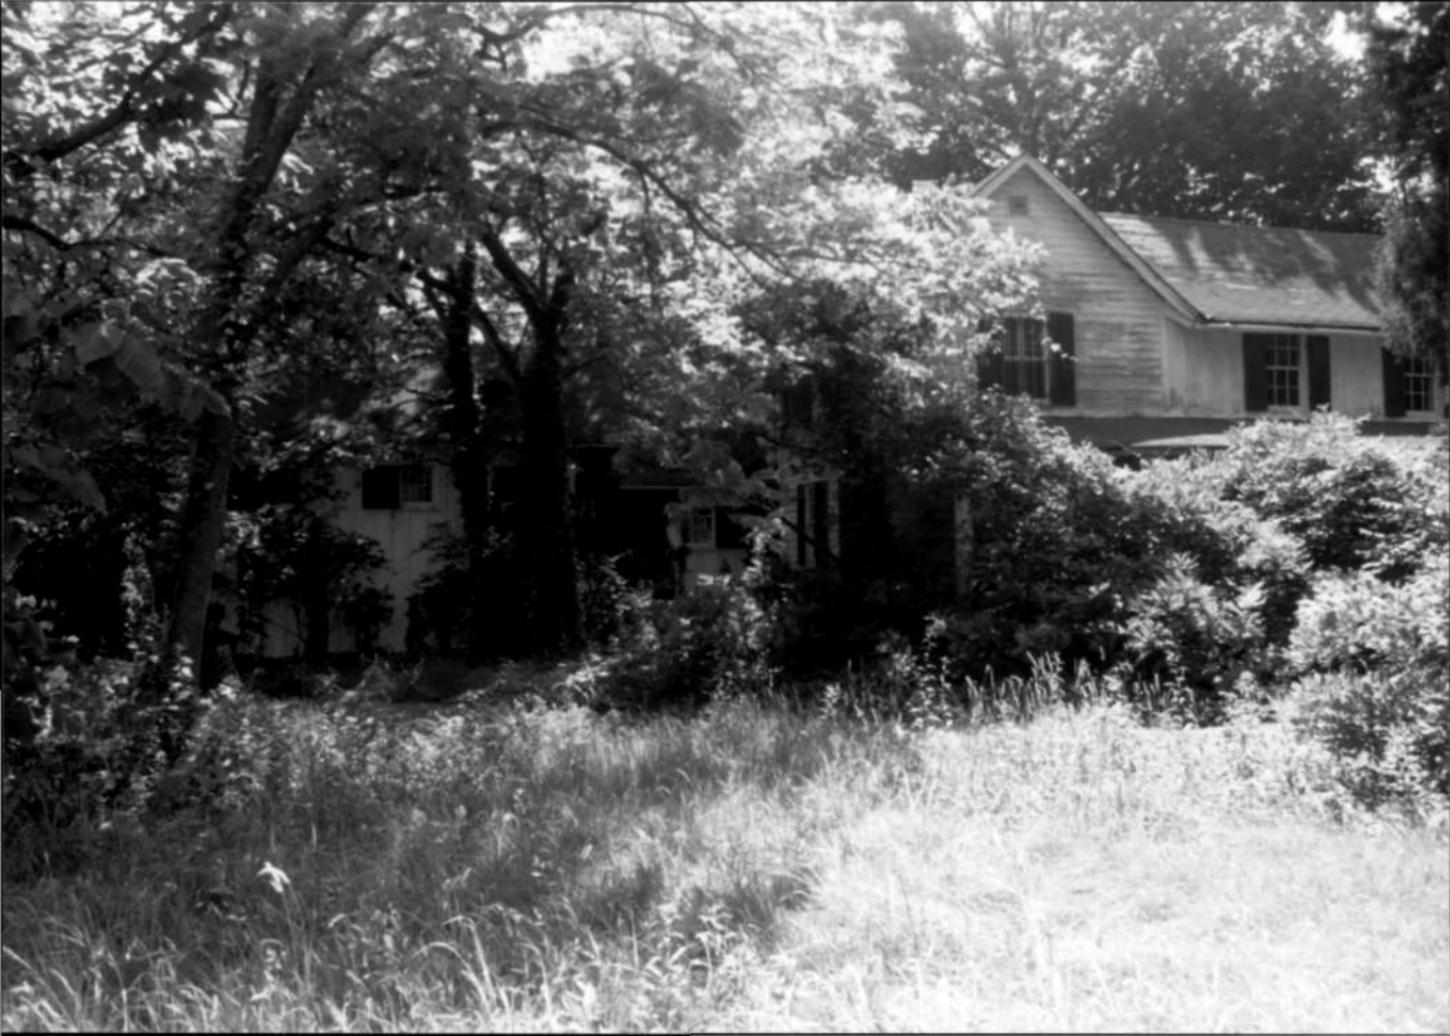
3 of 12

West elevation. Showing garage, hyphen, + first gable
front addition on left + original section on far right.

floor and no balustrade. Wooden louvered shutters are found on all the windows on these two sections of the house. The hyphen connecting the main house to the garage is located towards the rear of the main house and has a 16-light casement window on the west wall. The garage has three 16-light casement windows on the second story. Both the hyphen and the garage are covered with board and batten siding.

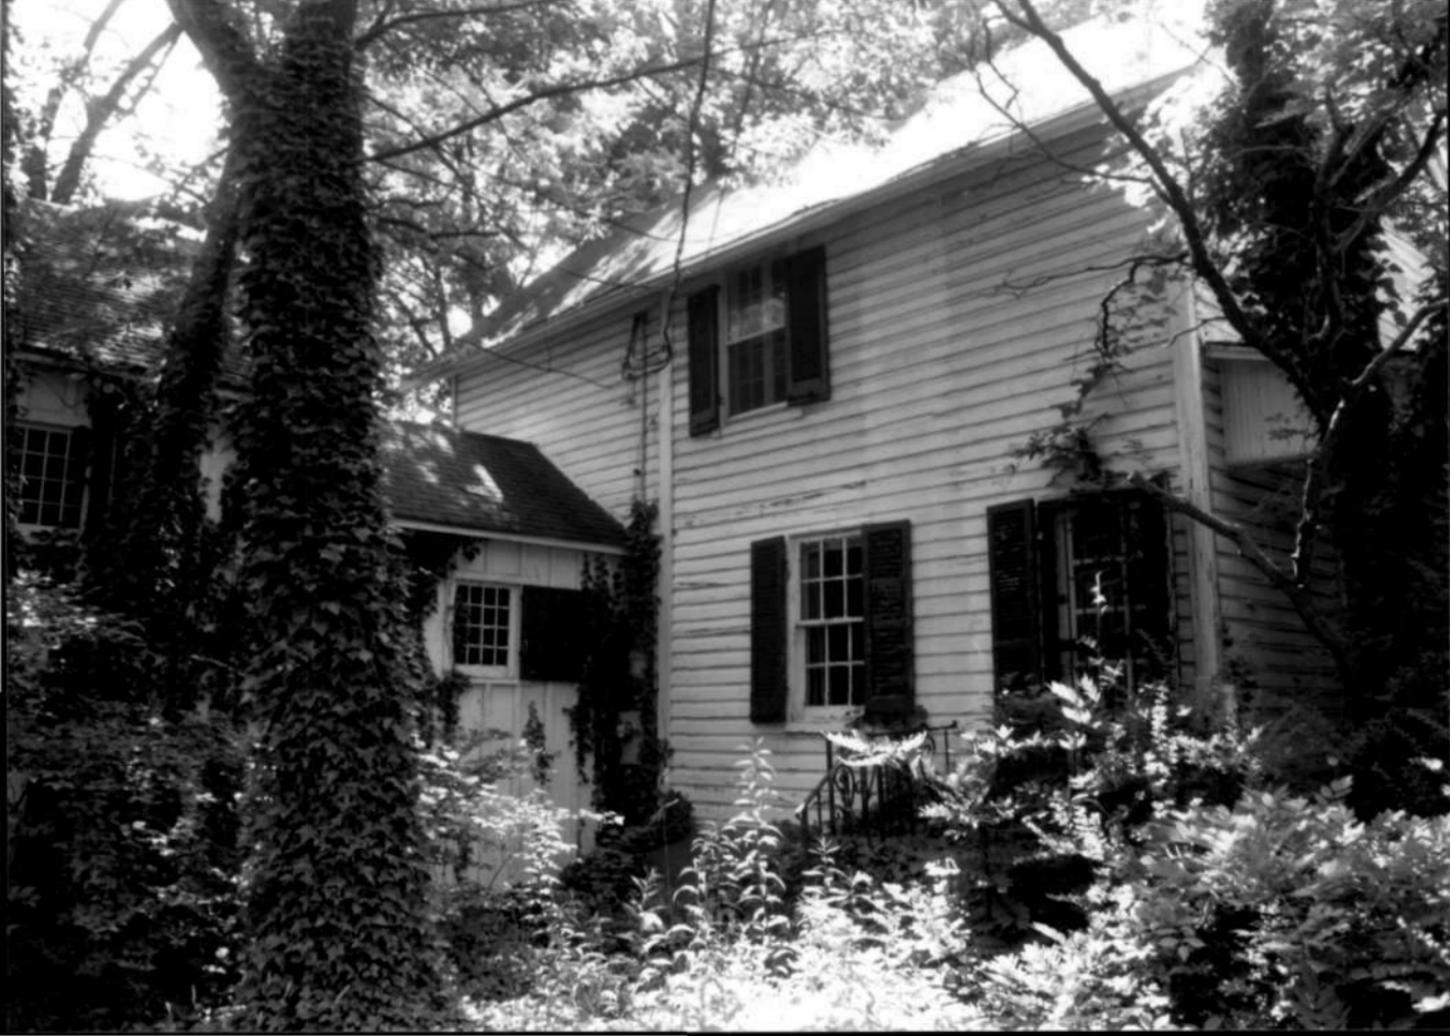
4 of 12

North elevation of first gable front addition. Showing
second addition on rear + hyper attaching to garage.

The north façade of the building shows both of the gable front additions, one behind the other, and the garage. The north façade of the original building is completely obscured behind the additions. The first gable front addition has one 10 by 10 casement on the second floor, one 6/6 window on the first floor and a glazed door on the first floor. There is also bulkhead access to the basement on this façade. The seam between the first gable front addition and the later rear extension is clearly visible on this façade. The rear extension is blank but most of the first story is obscured by the hyphen which connects to the garage. The north façade of the garage has two open bays with two windows above in the loft.

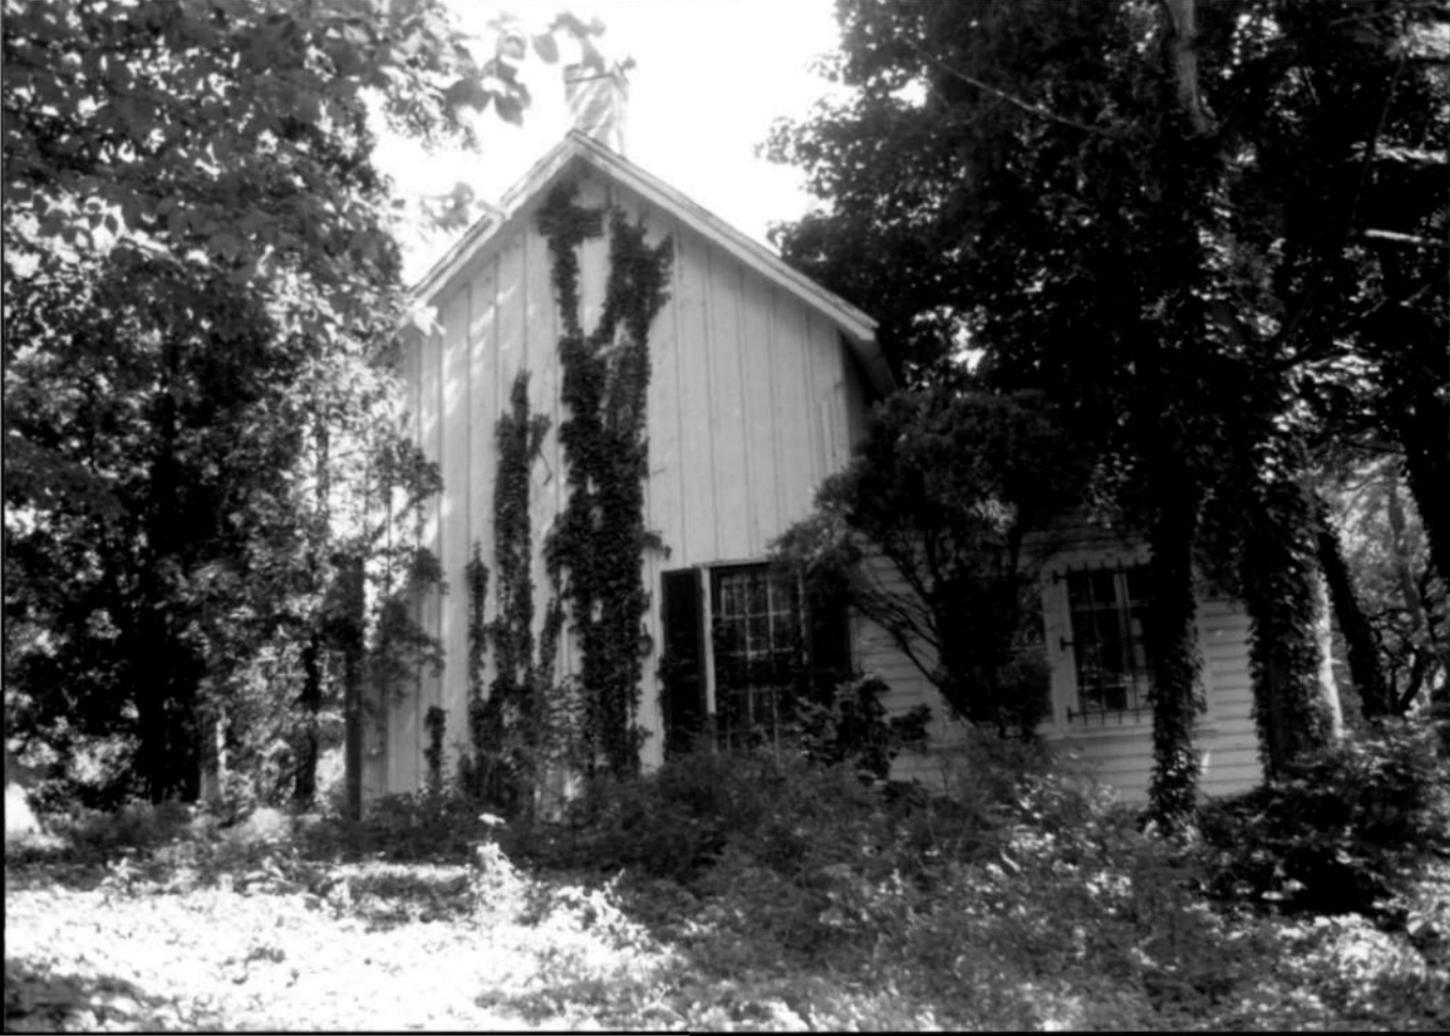
5 of 12

South elevation, original portion of structure
on left, 1 story addition on right

The south façade of the original portion of the building reveals a steeply pitched gable with a wide eave overhang. An interior brick end chimney is centrally located on this wall. Like the other facades of the original portion of the structure, this one is also clad in board and batten siding. There are no windows but there is a door located to the rear of the chimney on the first story. This door is a modern glazed door like the ones on the front façade and the opening is probably not original either. The one-story, shed roofed sunroom is covered with wooden German siding and has several casement windows on the south façade.

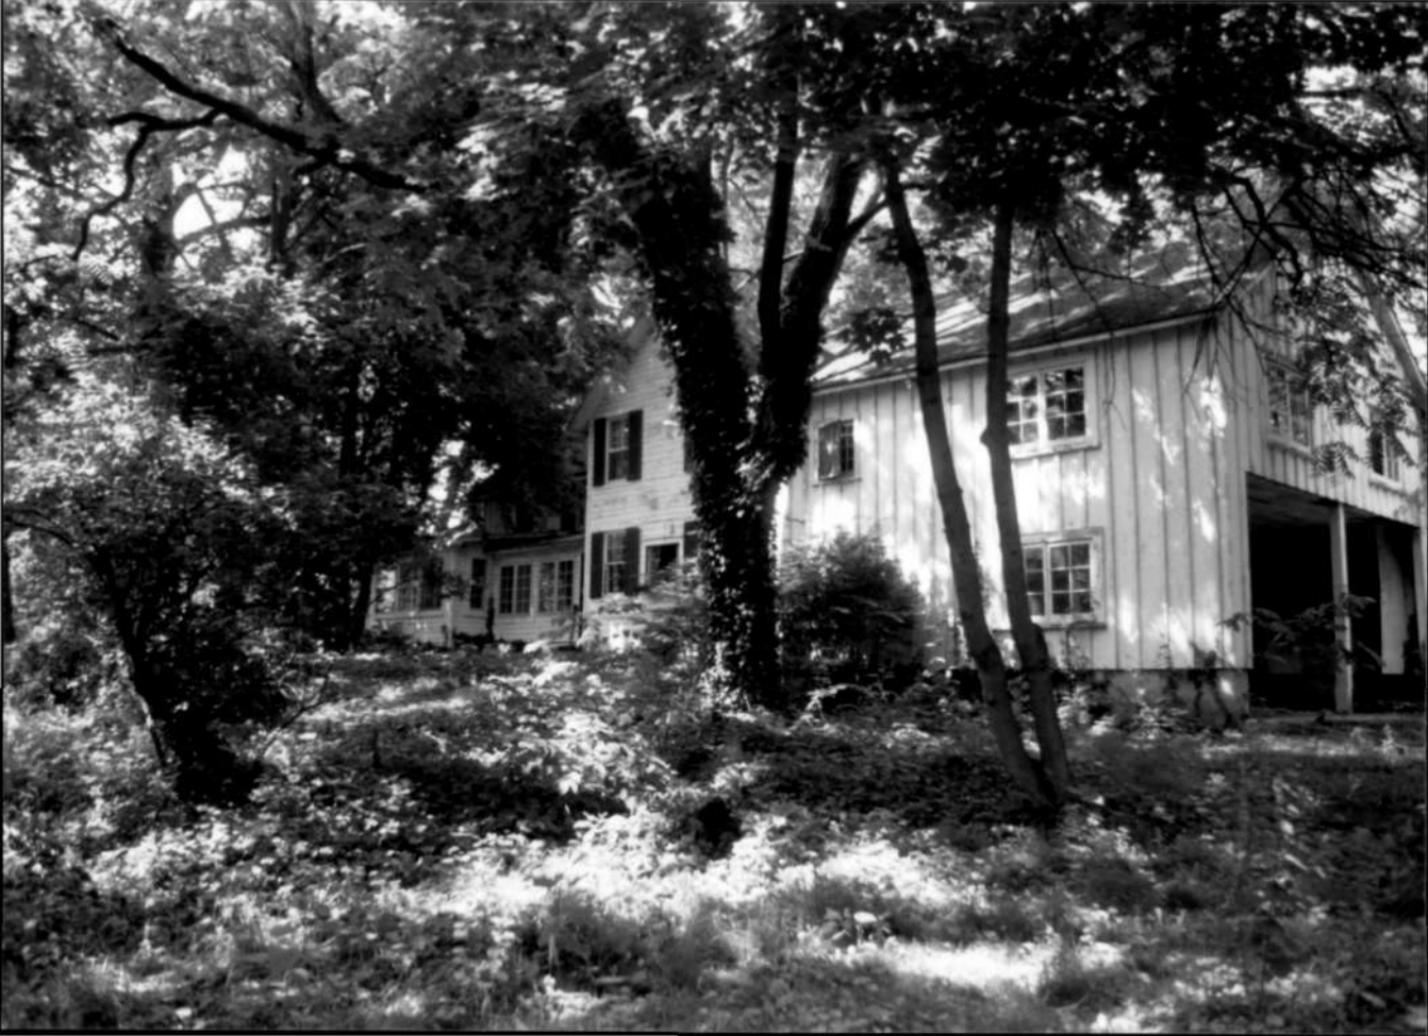
6 of 12

East elevation

The rear (east) façade of the original portion of the structure has three windows on the second story, one of which is an original 6/6 window while the other two are later 10 by 10 casements. The first story of the original portion of the building is obscured by a one-story, shed roofed, sun room addition on the south end and an enclosed porch on the north end. The rear of the gable front addition (which is actually the rear of the second of the two front gabled additions) has two 6/6 windows on the first floor flanking a large picture window in the middle, and two 10 by 10 casement windows on the second floor. The hyphen has one 16-light casement window on this façade and the garage has two windows on the second floor and two on the first, all 16-light casements. Wooden louvered shutters are found on most window openings.

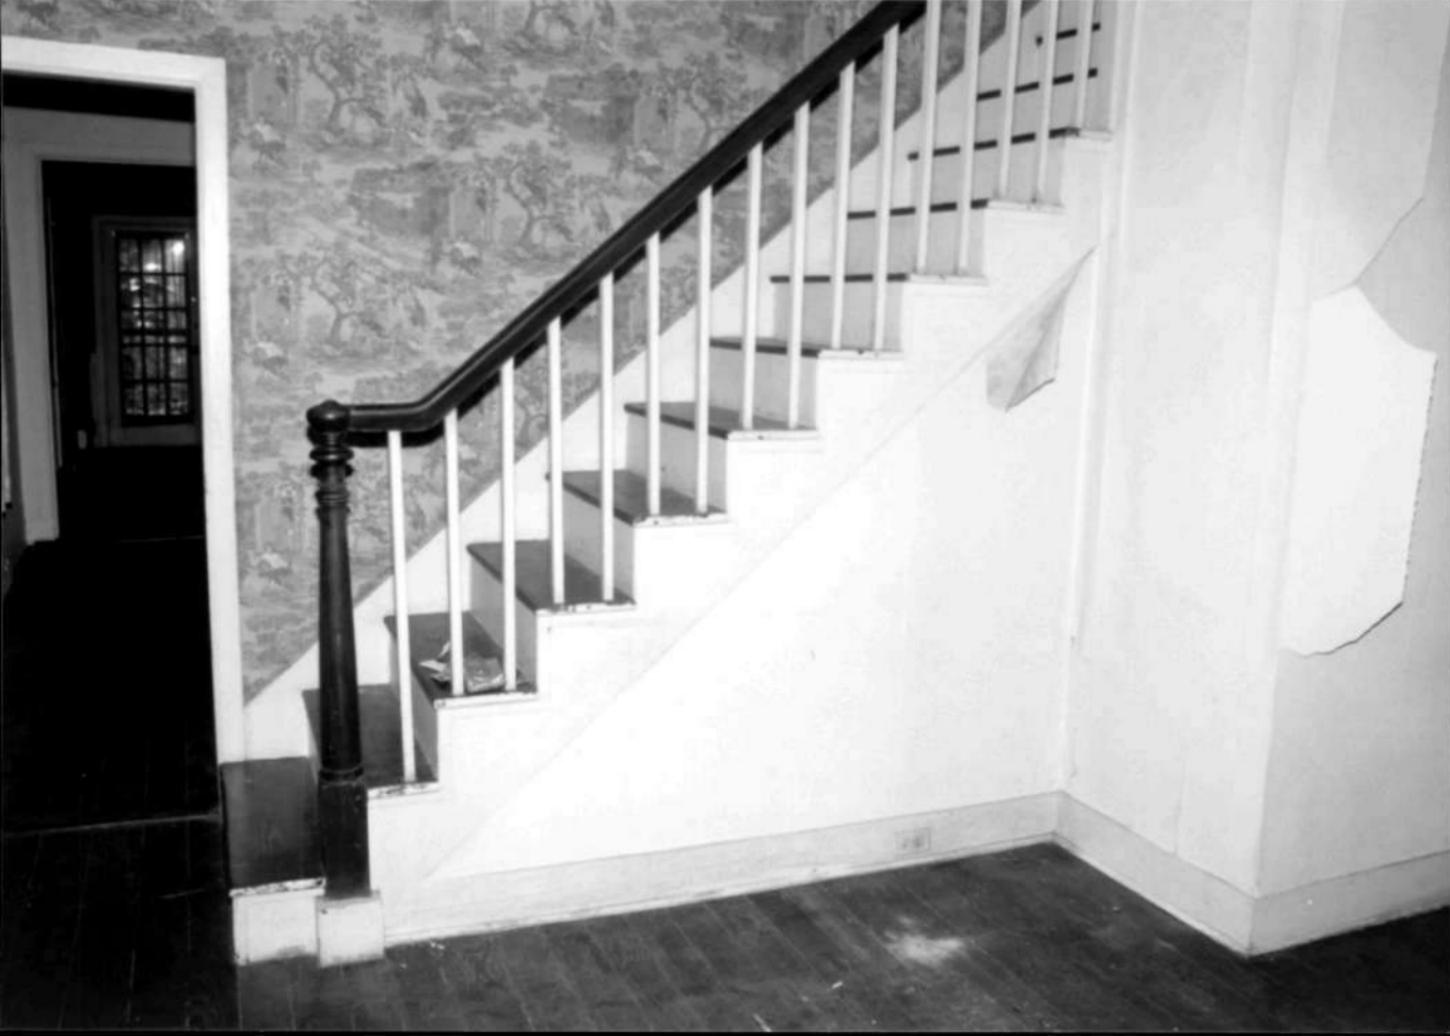
7 of 12

Stair in original section.

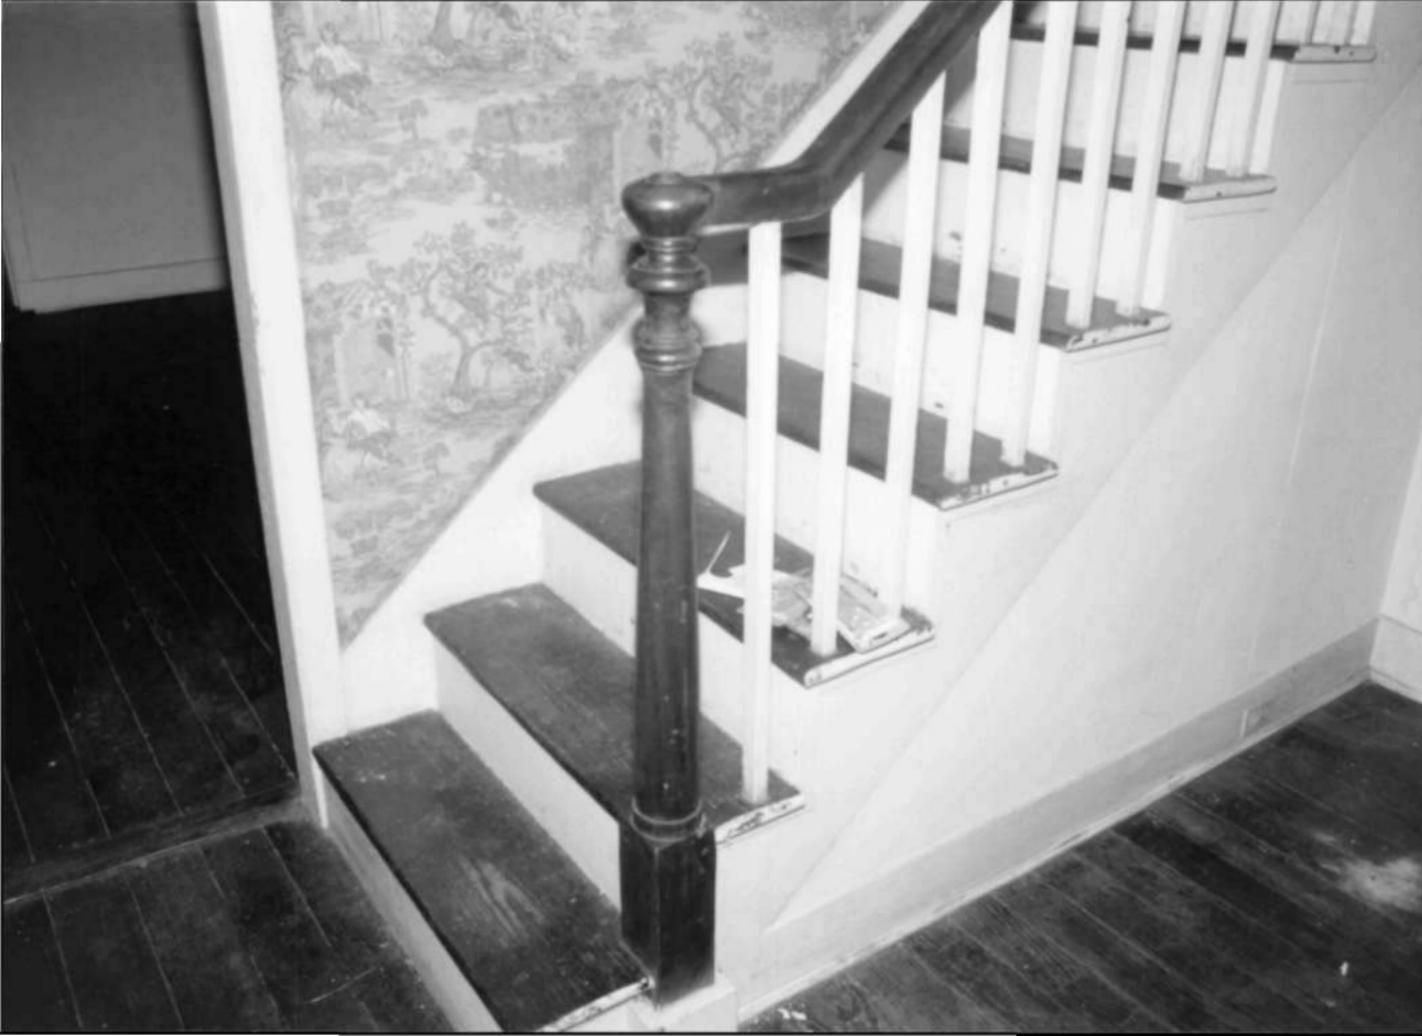
8 of 12

Stair + newel in original section.

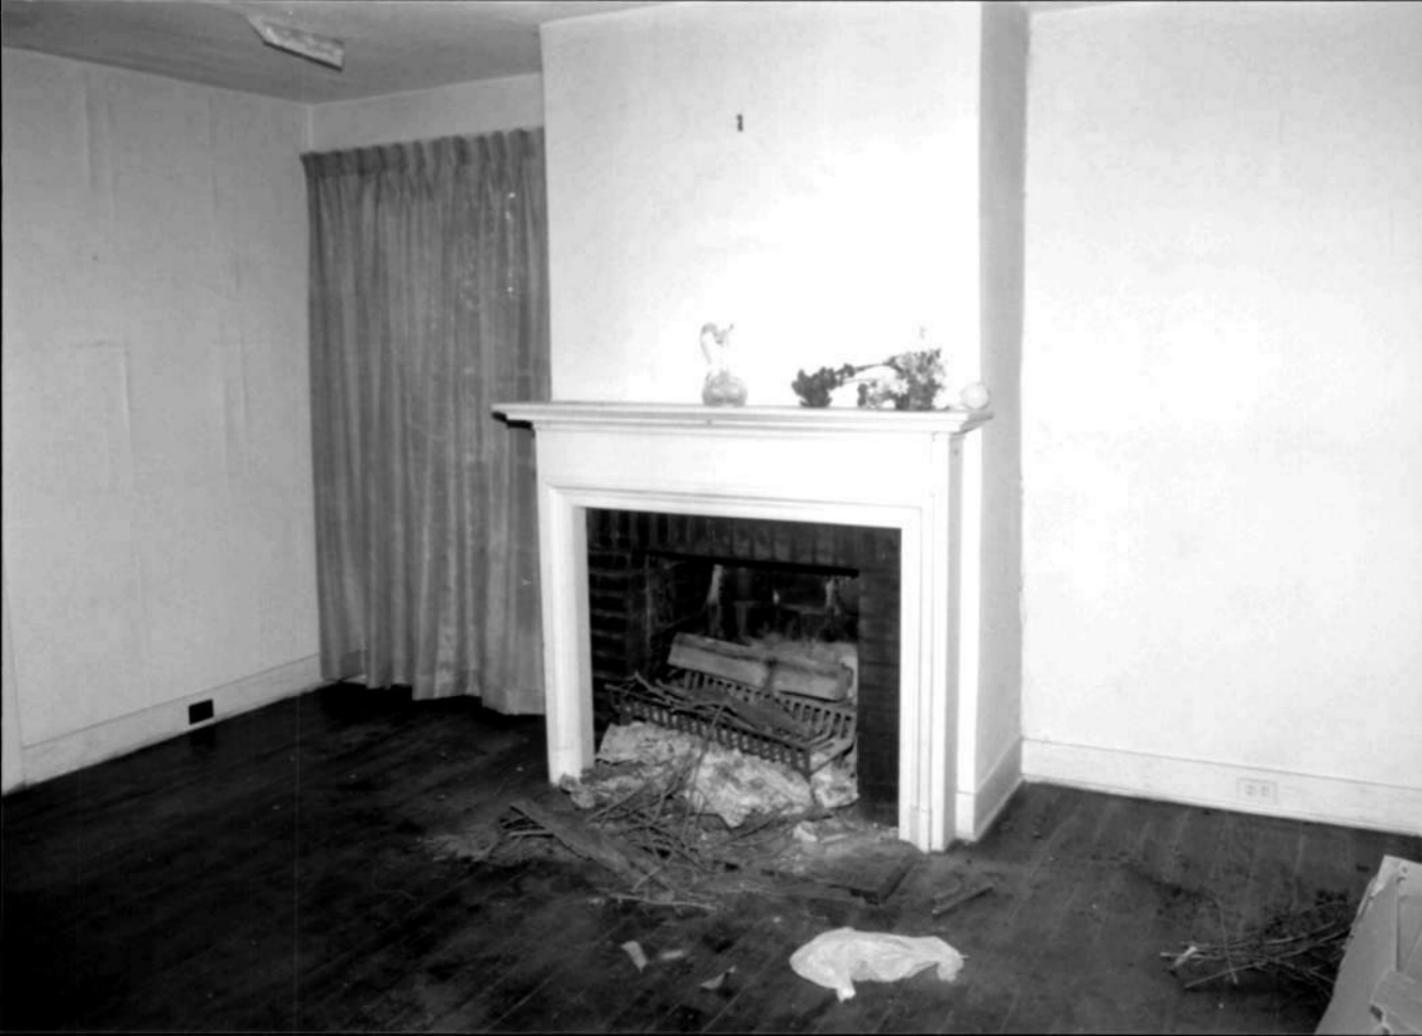
9 of 12

Existing fireplace in south room of original section.

south room appears to have been heavily reworked with the firebox entirely rebuilt and it seems doubtful that the existing mantle is original. Compared to the very simple door trim, the mantle seems too elaborate. There is evidence that there was originally a fireplace in the north room. There is a patch in the floor located along the north wall that is the appropriate size for a hearth. It would make sense for a house of this plan to have two end chimneys for heat. This fireplace was probably removed when the addition was made along the north wall. Floors throughout the original portion of the house are random width boards between 4-6". Muntins on original 6/6 windows have steep ovolo muntin profiles. The 10 by 10 casement windows are all later replacements. The 6/6 windows found in the gable front addition to the house have a wider muntin profile – more quarter round than ovolo.

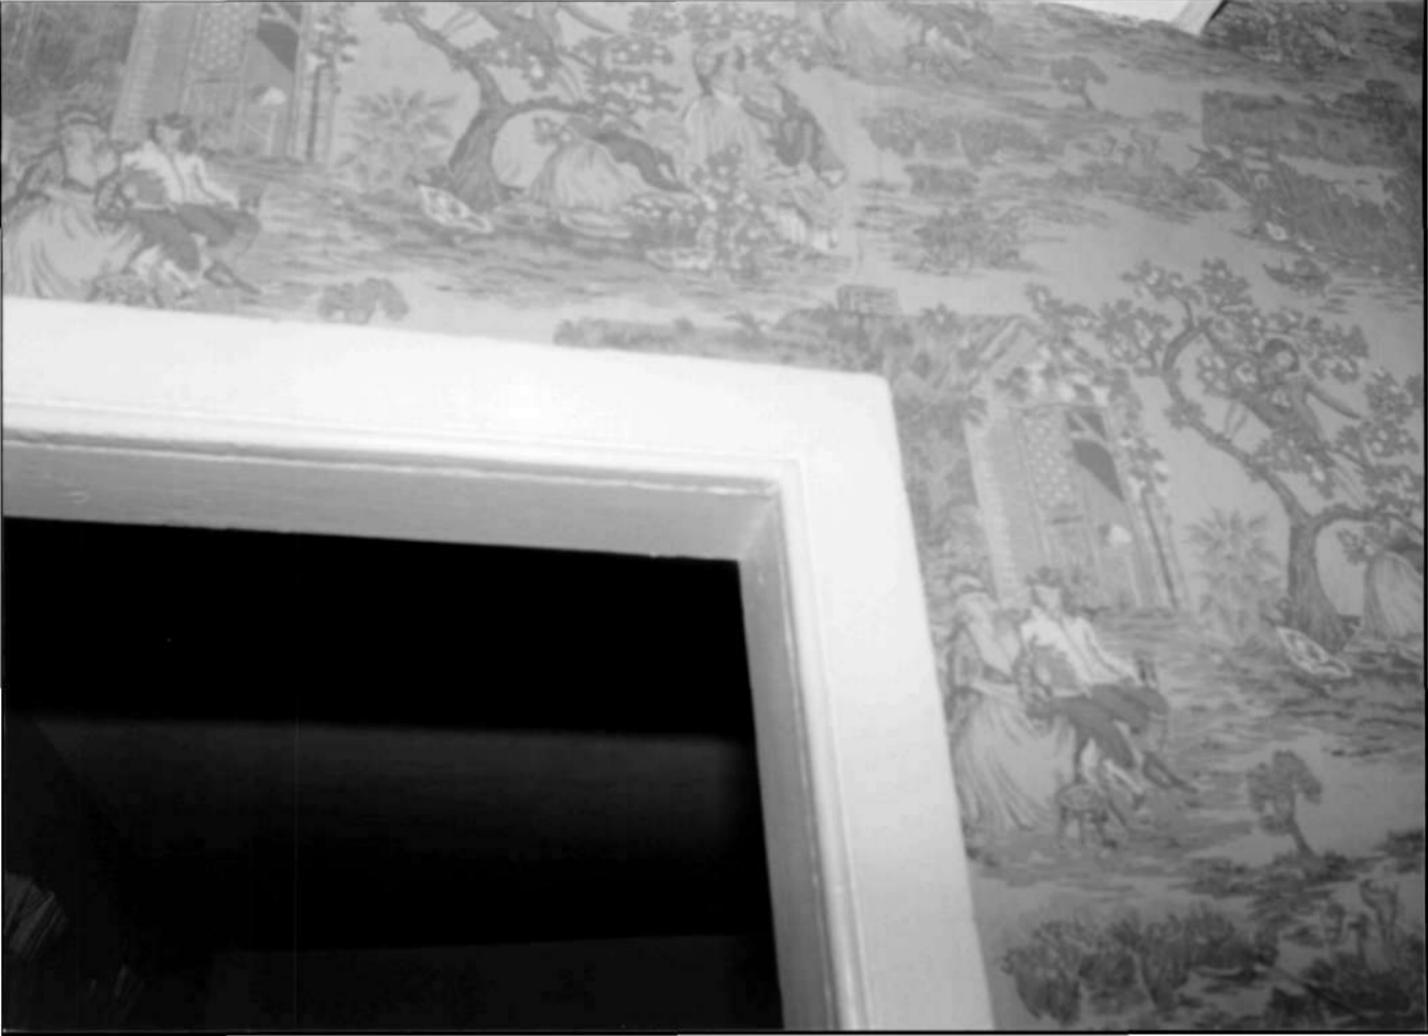
10 of 12

Original door trim on doorway between two original
rooms.

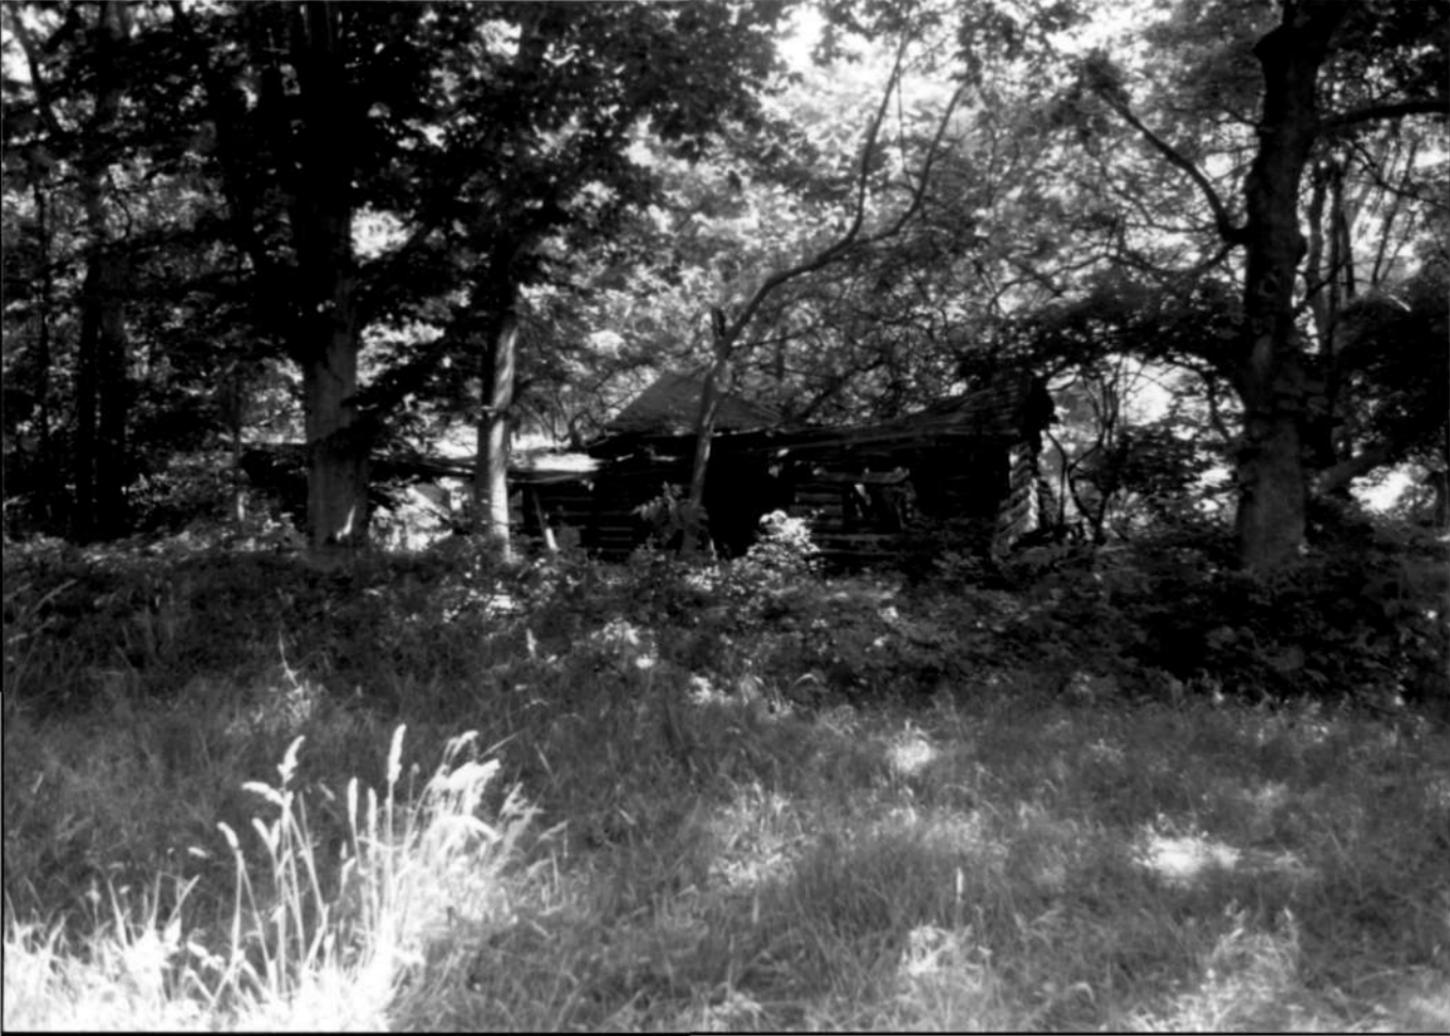
11 of 12

collapsed log structure behind main house, west elevation

Also located on the property are two smaller structures. A one-story frame cottage is located north of the main house. This building dates no earlier than the early 20th century. A collapsed log building is located northeast of the main house. The roof and several walls have fallen but the round logs with saddle notching, the circular sawn lumber, and the concrete floor do not indicate an early date for the building. The structure probably dates to the late 19th or early 20th century.
