HO-388, Crosswinds
7255 Montgomery Rd., Elkridge
Surveyed by: Kristin Hill
December 2003

HO-388, Crosswinds
7255 Montgomery Road, Elkridge
Surveyed by: Kristin Hill
June 2003

INVENTORY FORM FOR STATE HISTORIC SITES SURVEY

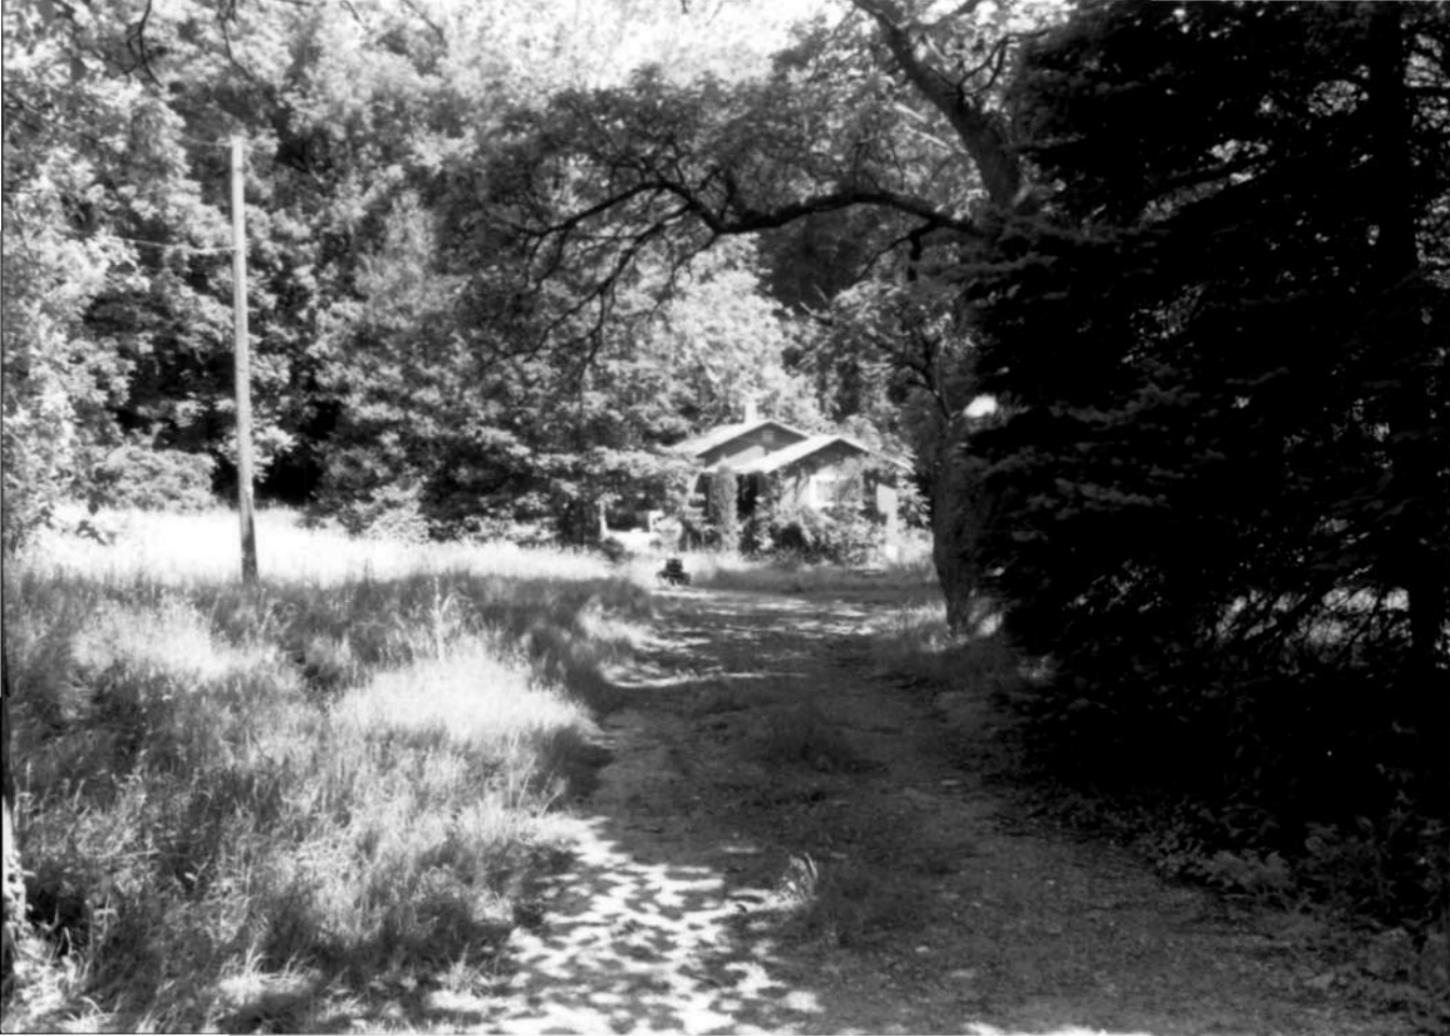
12 of 12

Frame cottage, looking north

Also located on the property are two smaller structures. A one-story frame cottage is located north of the main house. This building dates no earlier than the early 20th century. A collapsed log building is located northeast of the main house. The roof and several walls have fallen but the round logs with saddle notching, the circular sawn lumber, and the concrete floor do not indicate an early date for the building. The structure probably dates to the late 19th or early 20th century.
