HO-469

The Keilholtz Residence
Clarksville
Private

INVENTORY FORM FOR STATE HISTORIC SITES SURVEY

The Keilholtz House

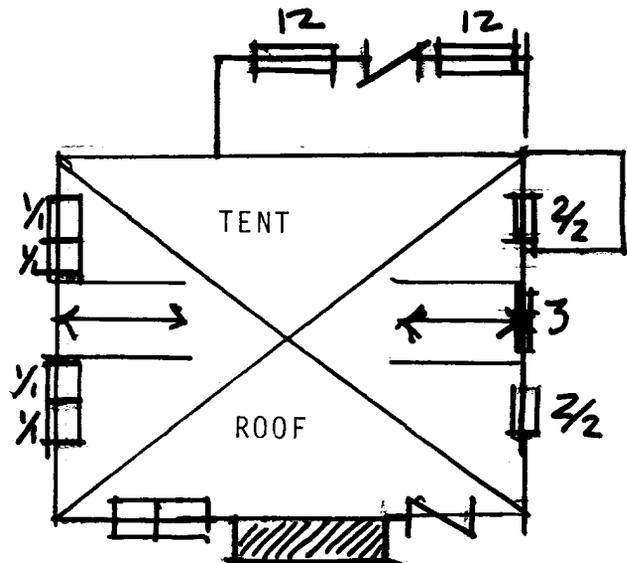
FIGURE #1
 H0-469
 The Keilholtz House
 Site Plan

OUTBUILDINGS

DENSE TREES

Route 108

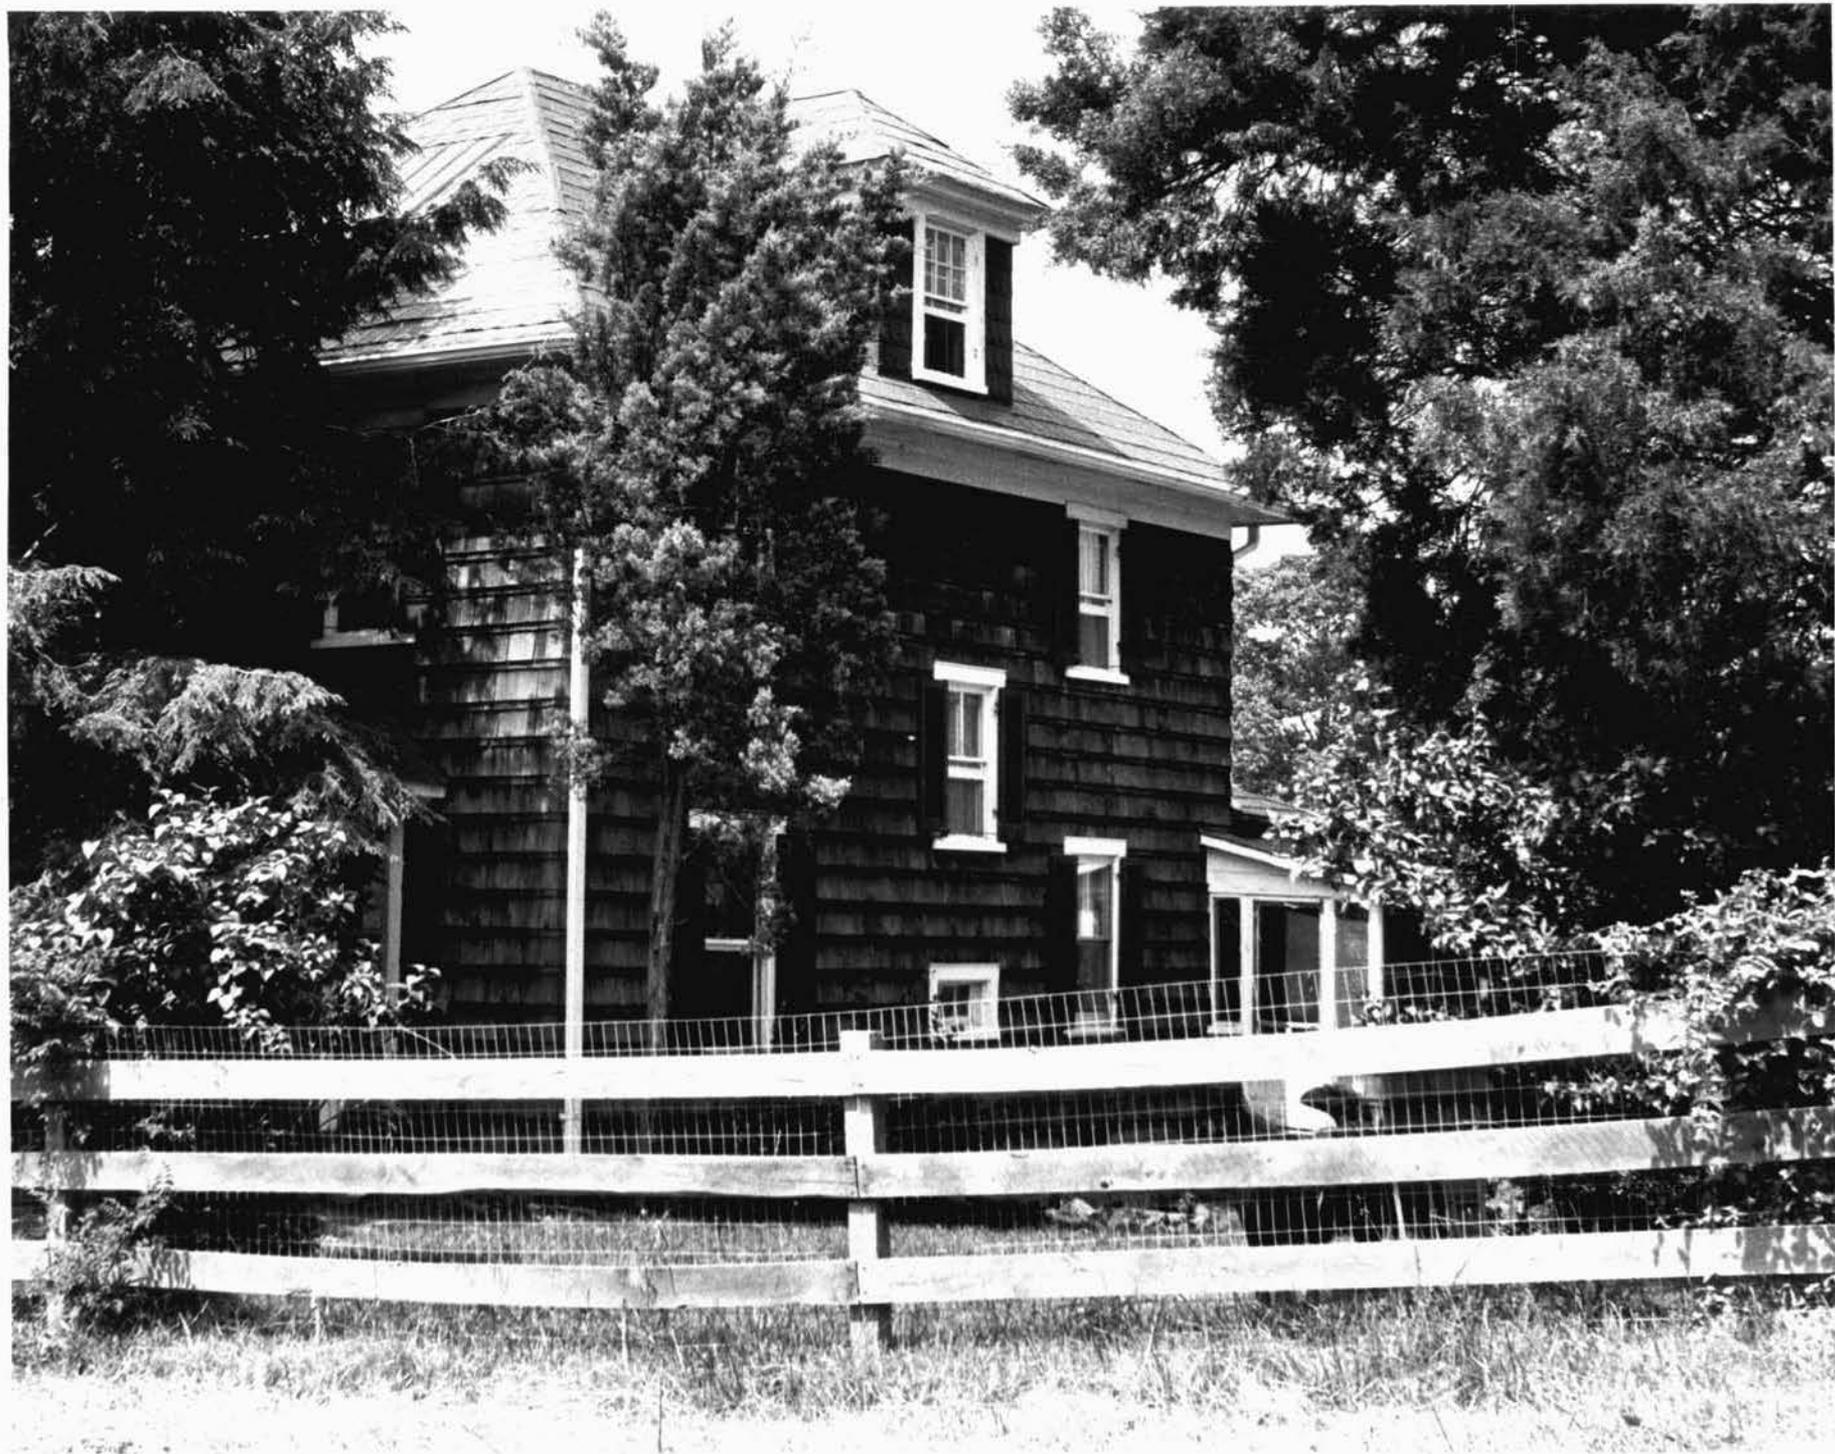
HO-469
THE KEILHOLTZ HOUSE
(LIVE OAK FARM)
SOUTHEAST JUNE 1978
CB THOMPSON, AIP

Live Oak Farm is a two bay wide, three bay deep, two and a half story high, tent roofed, square double oak shingled structure, which rests on a stone foundation, the southeast corner of which is solid rock.

The main entrance is rectangular in shape and located in the east bay of the south elevation. It is fronted by a brick stoop composed of three brick steps and covered by a gabled roof portico, supported by two square posts. A double first floor window rests in the west bay composed of two rectangular double hung, one-over-one light windows, separated and flanked by flat pilasters and surmounted by a single flat lintel with rain withholder. This window and all the windows of the east, west and south elevations are decorated with green wooden shutters. Two second floor windows, similar to the components of the double window, but holding two-over-two lights, rest above. A wide brick exterior chimney is centered between the entrance and the double window.

The east elevation is perfectly symmetrical, holding two first and second floor windows, vertically aligned and proportionally scaled, similar to the second floor windows on the south elevation. They are divided by a staircase window, similar to the others, beneath which rests a first floor three light window.
