Ho 545

John Layman Farmhouse

Howard Co., MD

## State Historic Sites Inventory Form

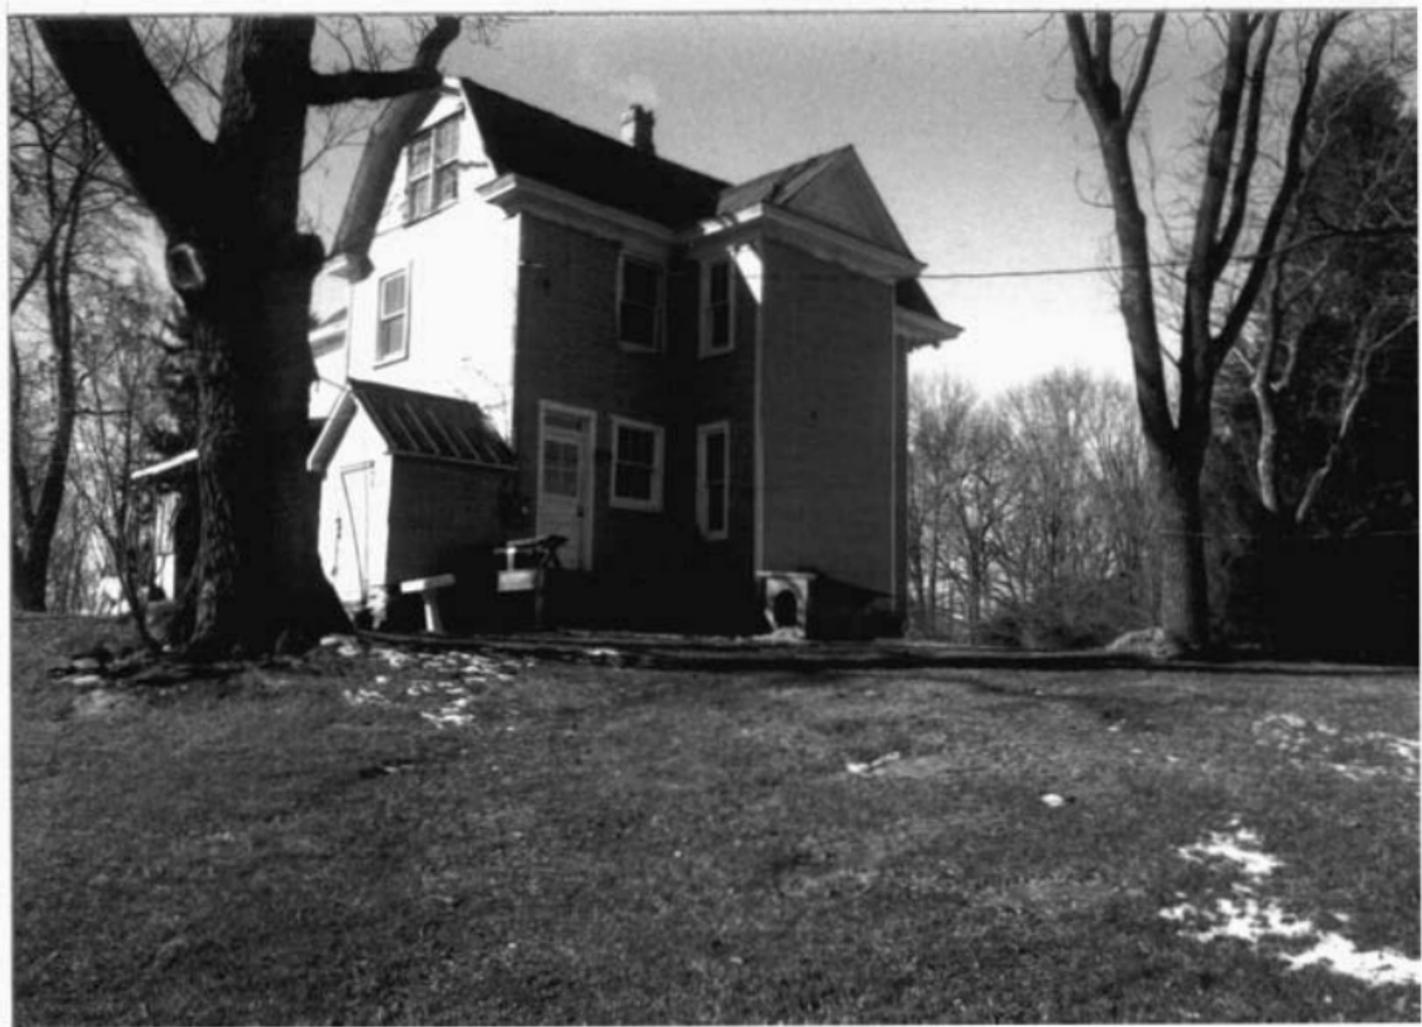
S.W. ELEVATION

The south elevation is divisible into two parts: the southwest gable end of the main block is pierced upstairs and down by single 1// windows. The southeast corner of the house is fleshed out by the addition of a one-story porch, subsequently screened in. This porch houses a back door entrance to the kitchen, located at the southeast corner of the gambrel roofed block.

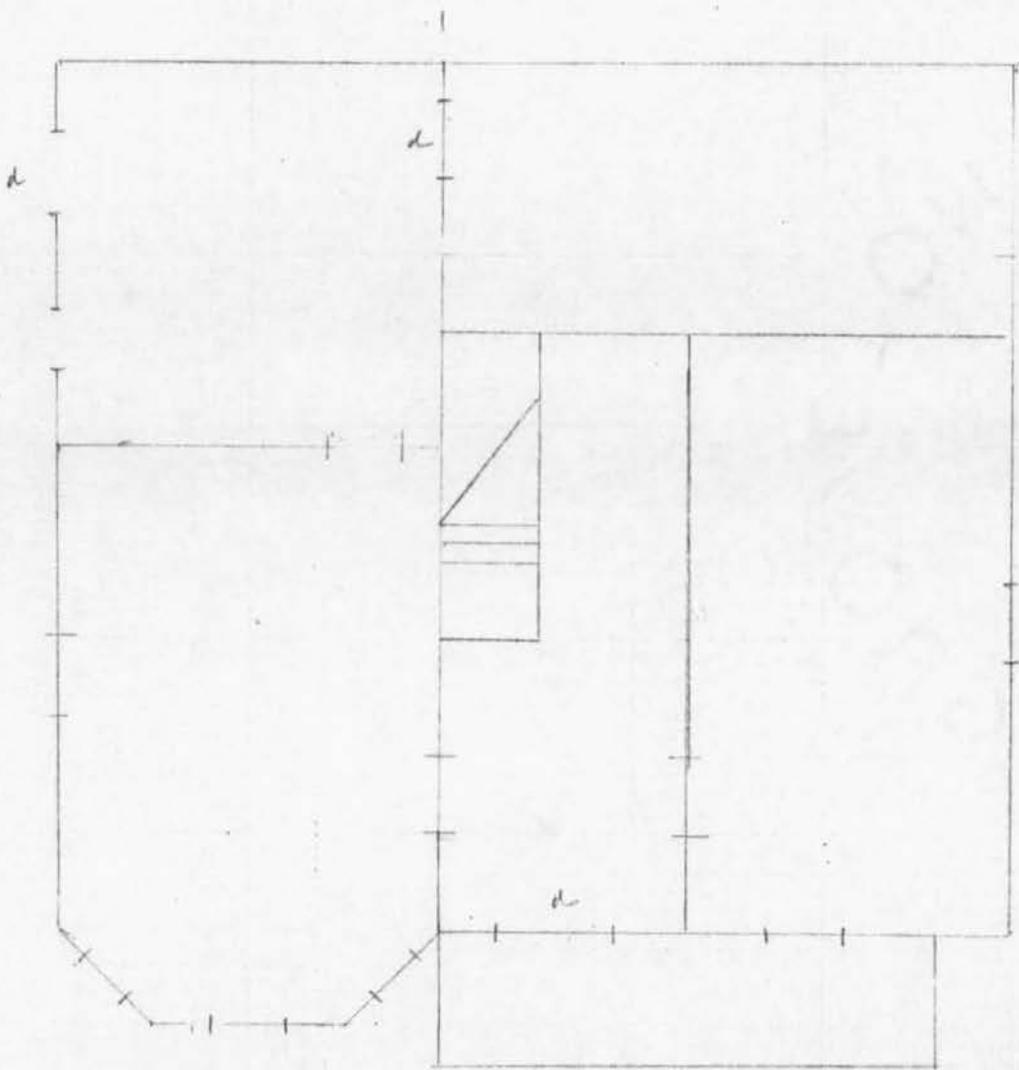
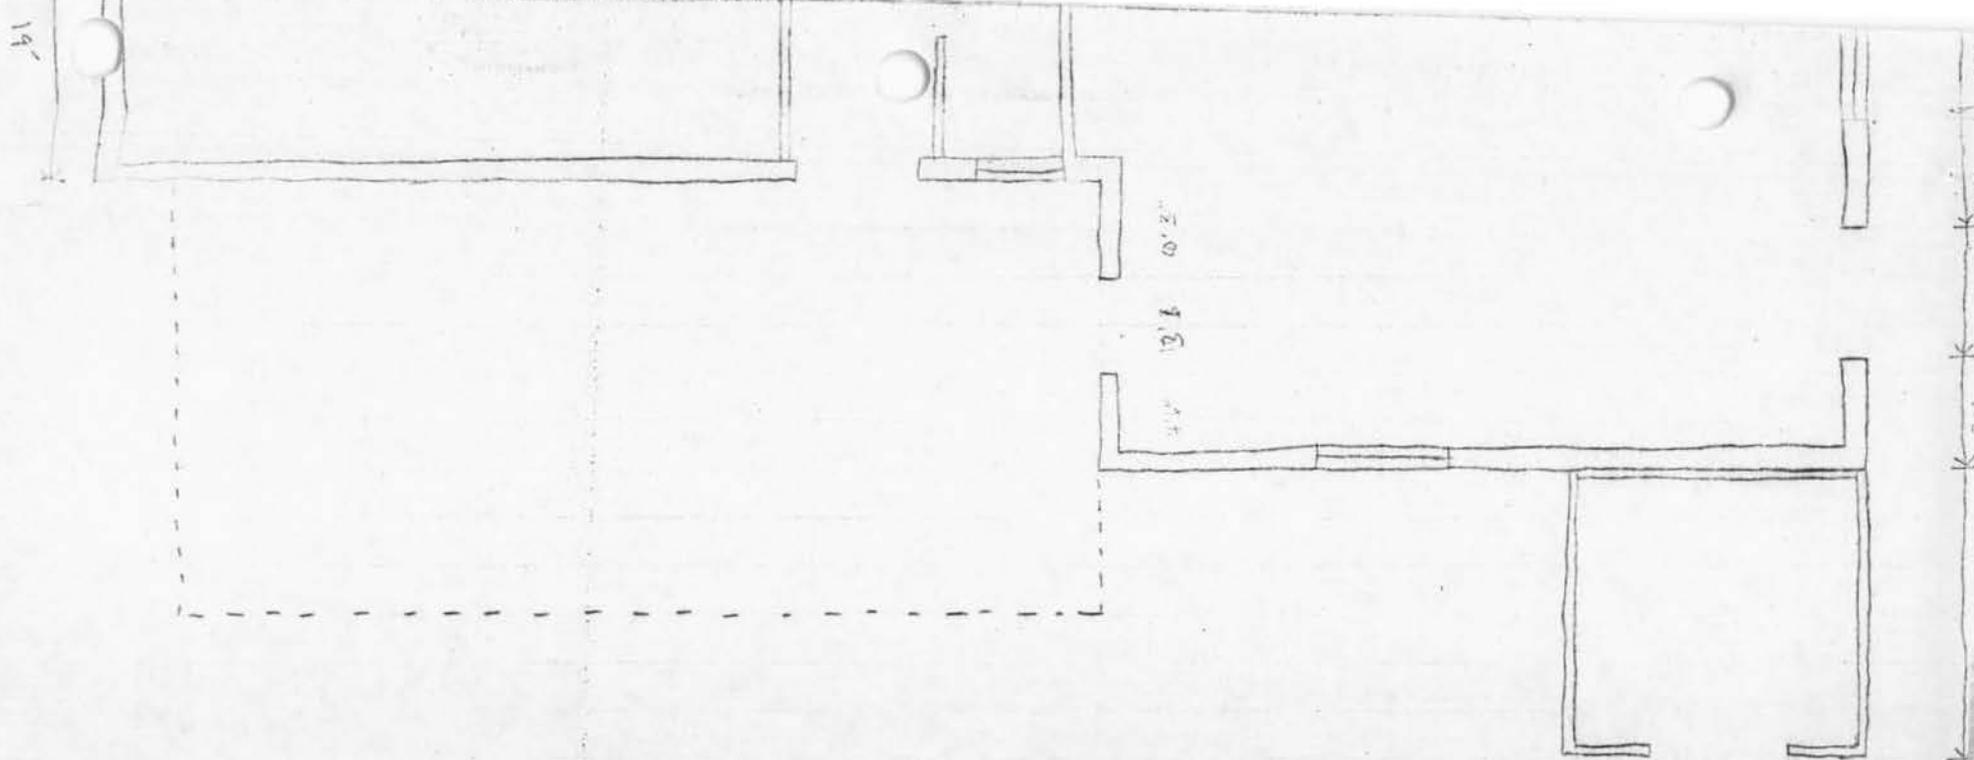
first floor plan

The interior space (see attached plan) is organized axially around a central hall, entered via the front porch and centered doorway. To the left facing the stair is the door to the parlor. On the opposite side is a living room or study. Both rooms feature fireplaces but the parlor version is the more elaborately detailed with a wooden, carved Victorian surround. Additionally, the parlor features mahogany wainscoting to the level of the chair rail. Door surrounds throughout the house consist of bullseye corner blocks hinged into straight sections of plain molding.

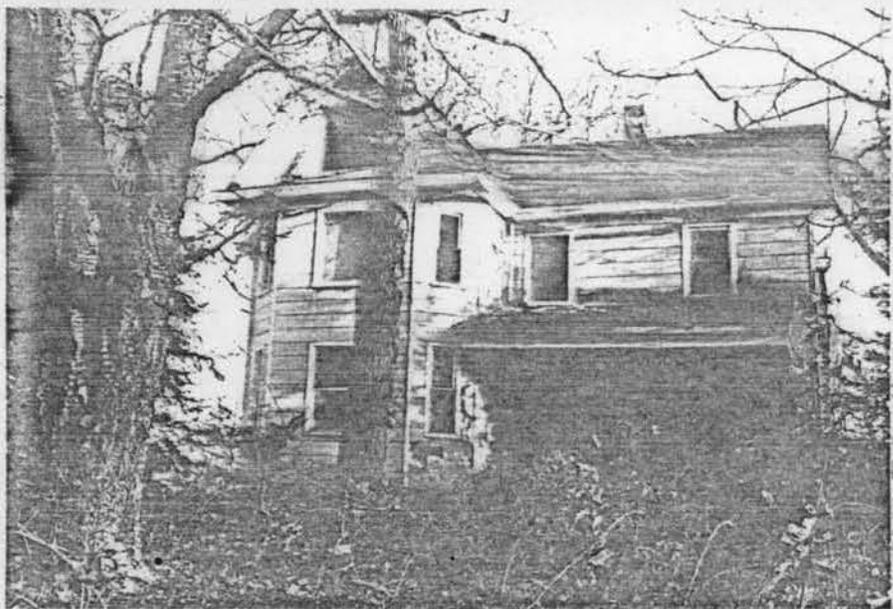
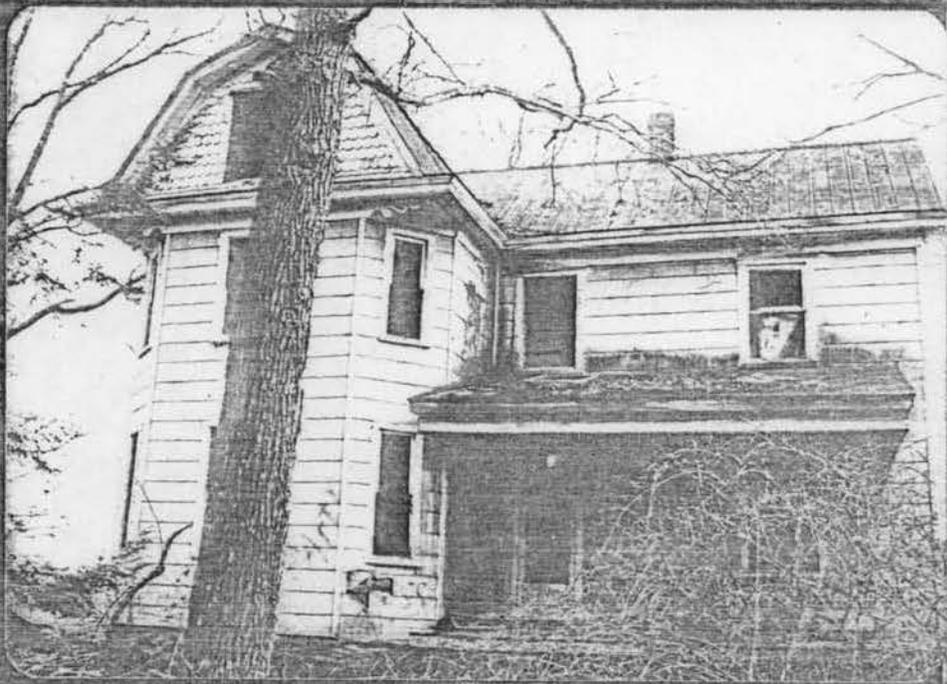
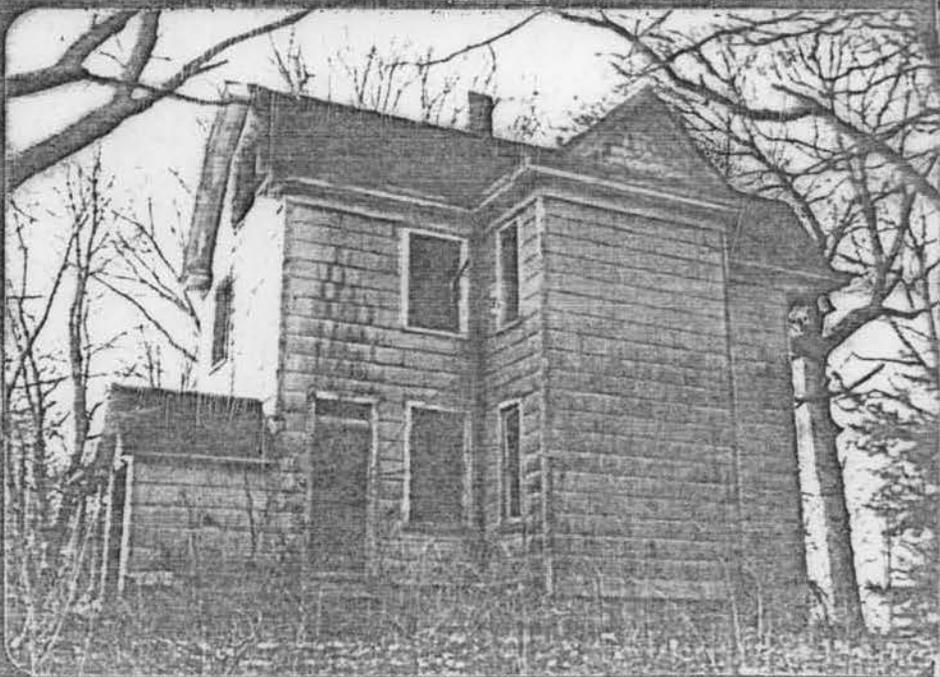
This tripartite bay is gambrel-roofed on the west facade and divides this 5-bay facade into two unequal parts so that the resultant progression from left to right is on the first story level; window, window, window (all with one/one sash) within the projection, thence to the door which is topped with plain transom and flanked by another one-over-one window. The door and southwest window are sheltered by a one-story high, shed roofed porch supported by three Tuscan columns and approached by a short flight of steps.

HO-545 John Kayman House  
Top - West Facade HO-545  
Mid - West Facade  
Bot - North Facade

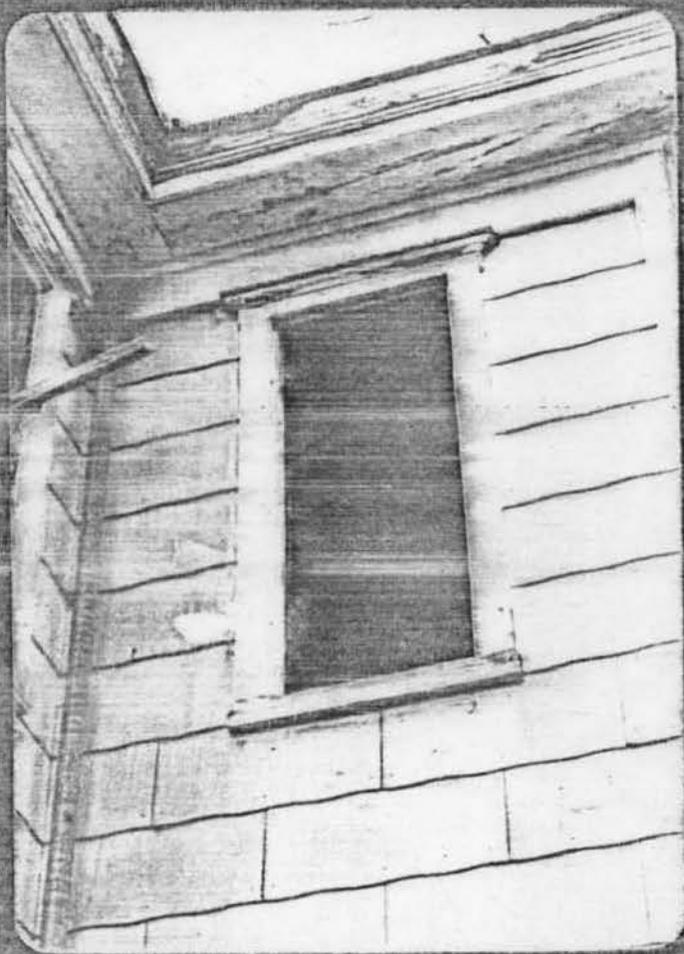
H0-5+5 John Hayman House  
top - South & East Facades  
bot. rt. - West Facade Window Frame Detail  
bot. left - Outbldg - Water Tower

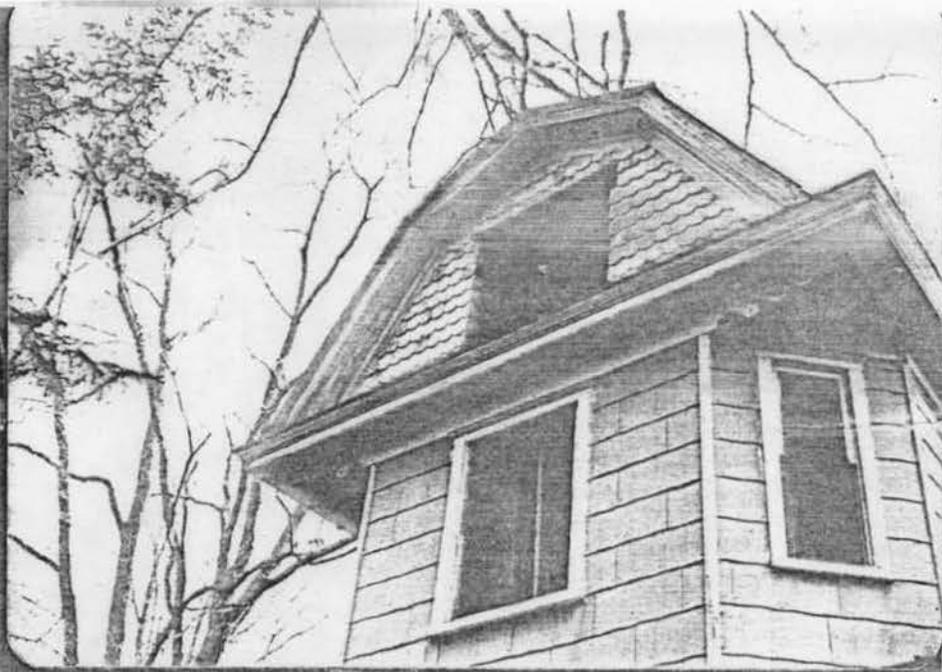
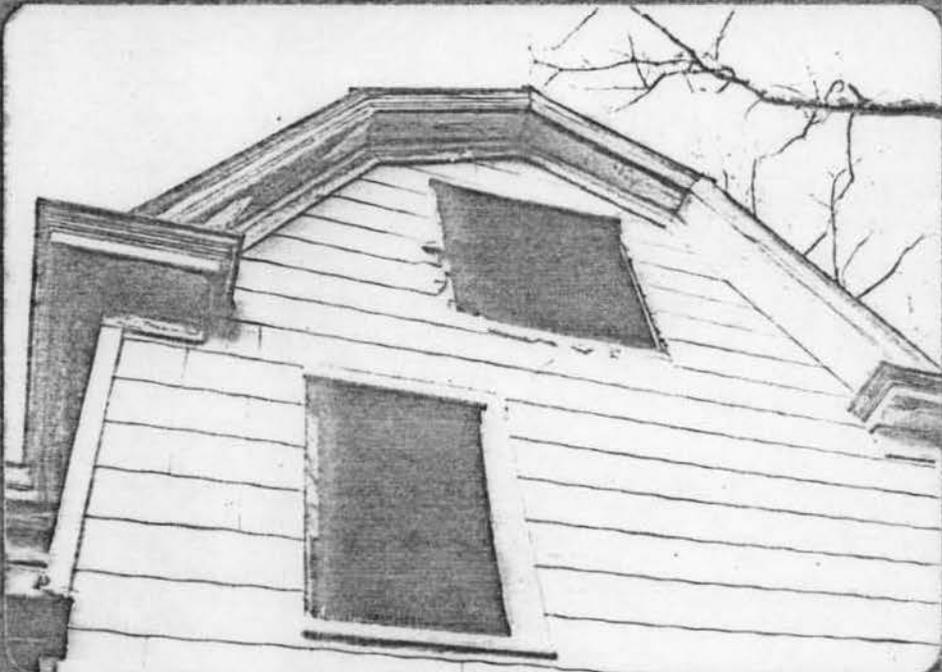
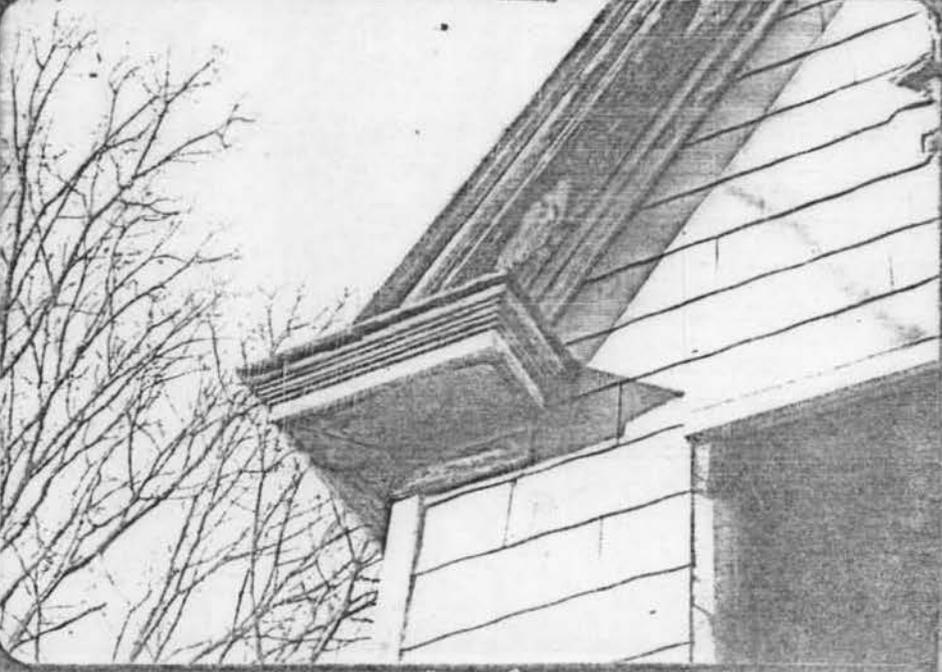
In corresponding positions in the second story level are: three windows (same one/one sash) in the projection and two windows (with 2/2 sash) located directly above the first floor entrance and southwest window. A small window on axis with the central bay of the projection is located in the pediment of the gable of the gambrel roofed portion; this pediment area is sheathed in imbricated or beveled shingles. The remainder of this frame structure, once simply clapboarded, has since been covered with neutral gray asbestos shingling. The cornice is characterized by a plain fasciaed frieze which wraps around the building continuously just below the moderately overhanging eaves.

HO-545  
John Layman House  
Top - West Facade - Gambrel Roof over Bay  
Mid - East Facade " "  
Bot - " " Cornice Detail

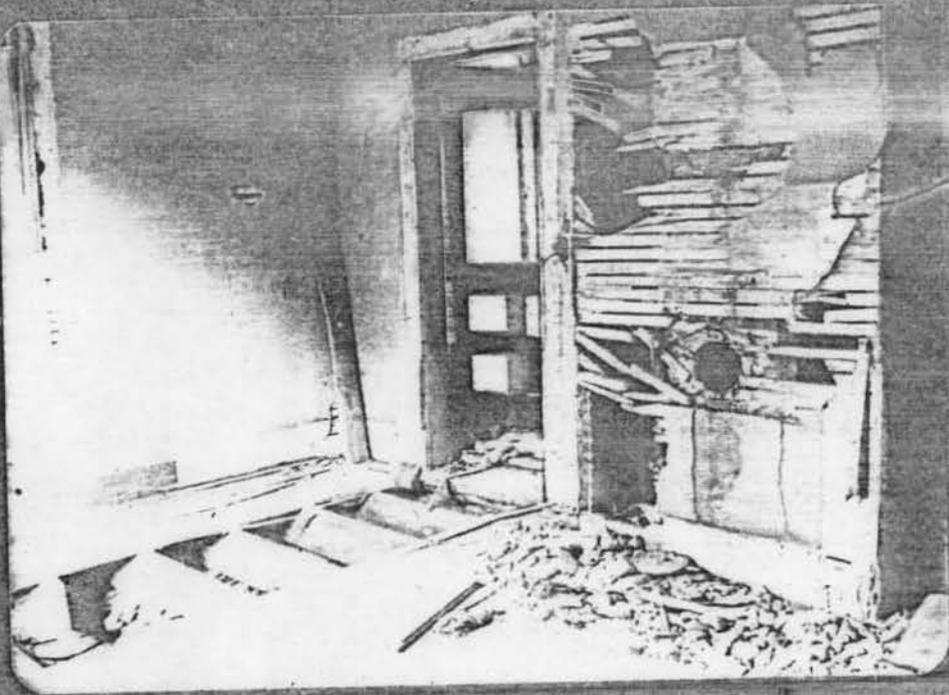
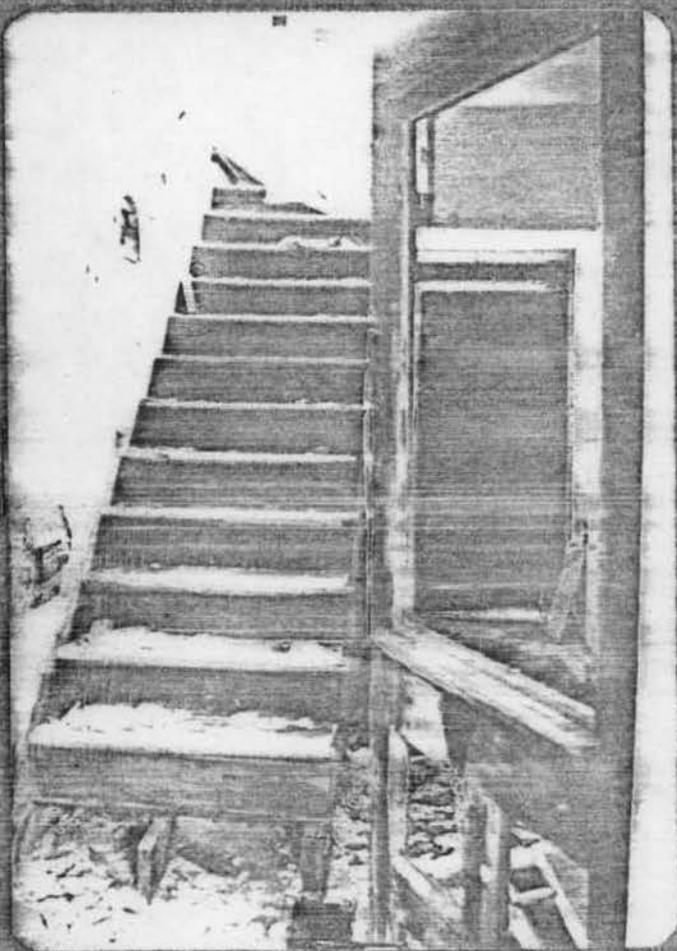
0-545 John Kayman House HO-545  
top - Interior - South Room  
bottom - Interior - Stair Hall

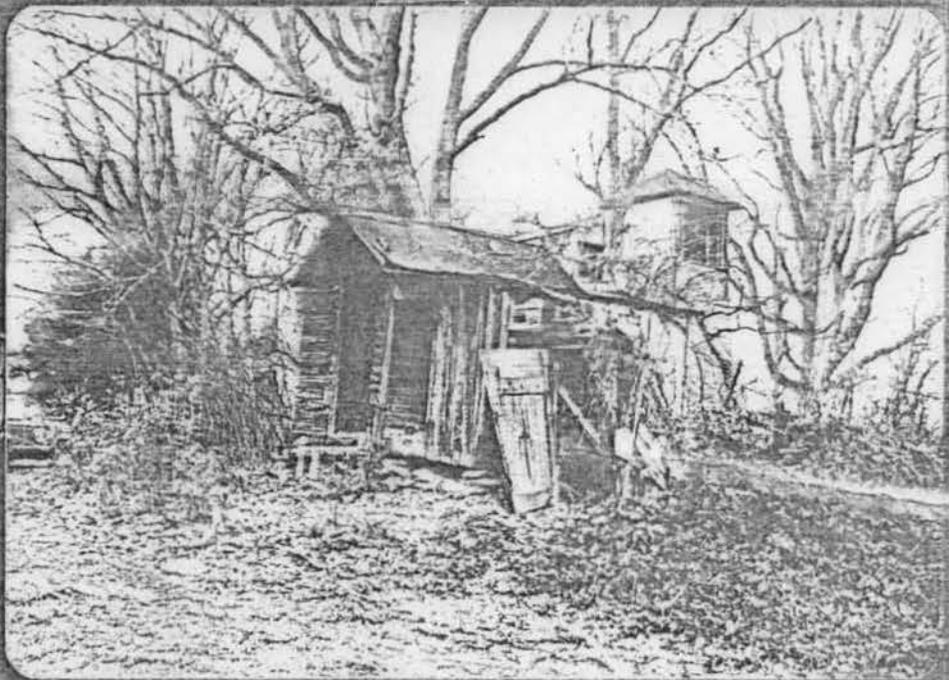
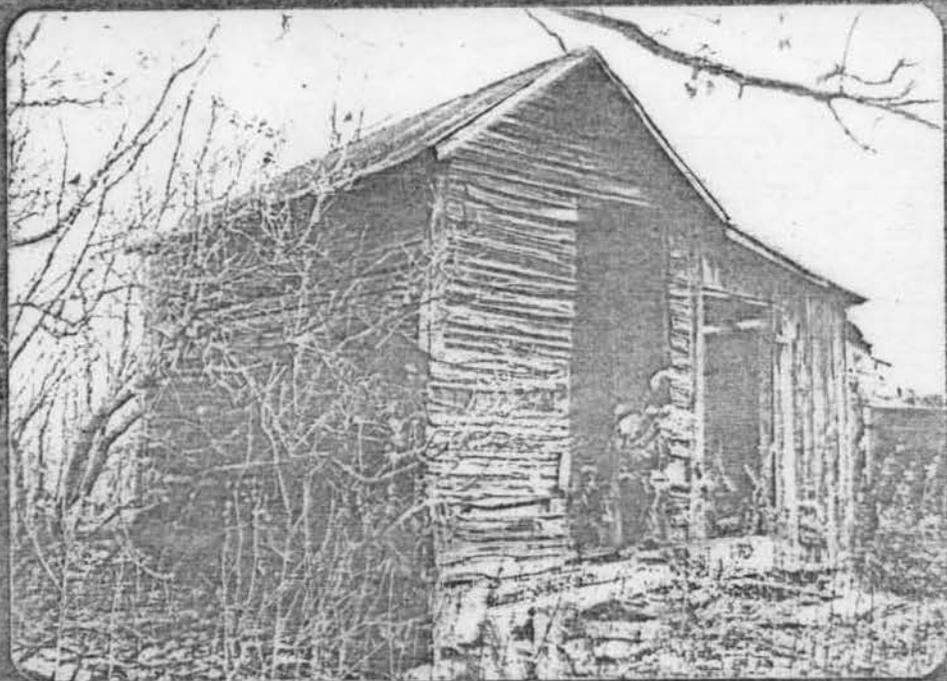
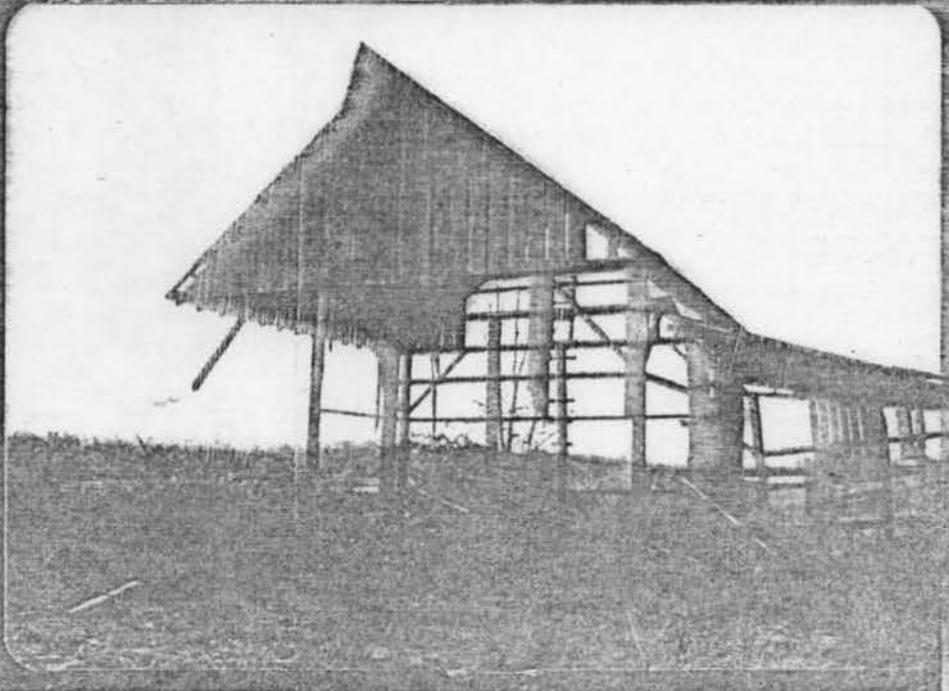
Shed. A frame shed is located south of the water tower and has a gable roof covered in sheet metal. The shed is a rectangular structure that has a gable front with a single entrance. It is a frame structure on stone piers that is covered in German siding. On the east side is a shed addition constructed of frame with a vertical siding. A smaller shed addition was also attached on the east side of the earlier shed. These sheds were used as a woodshed and for storage of tools.

Frame Barn. A vertical siding has been removed from a small frame barn that stood southeast of the shed. The exposed framing shows an unelaborate early twentieth century structure with a gable roof. On its south side was a shed addition that served as a livestock pen.

-545 John Kayman House HO-545  
sp - Oct 1845 East of House  
ce - Sued  
on - Ben frame

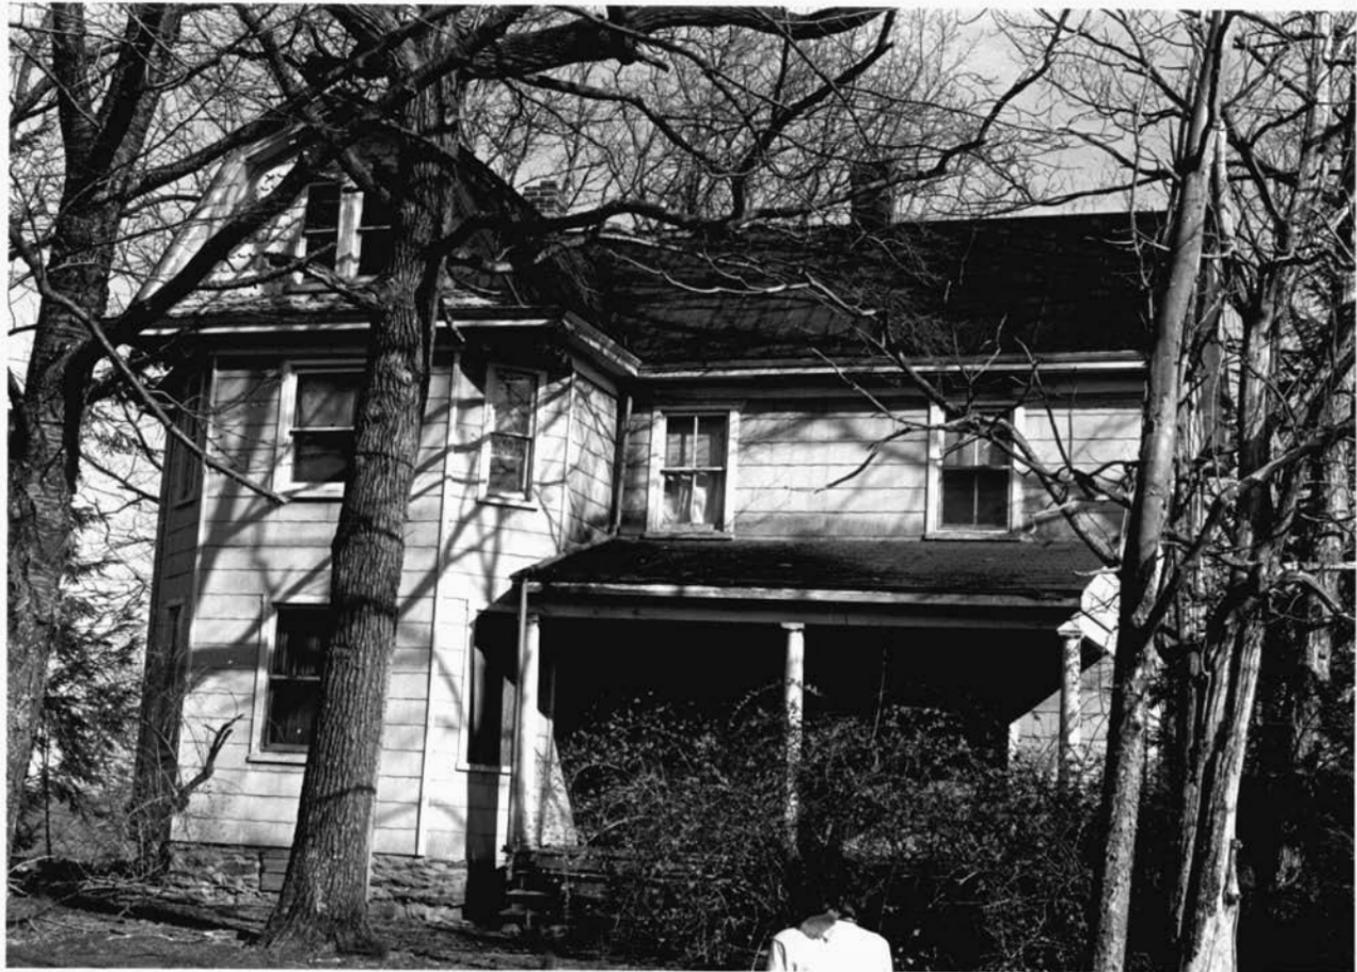
HO-545

The John Layman house, located on the east side of Hipsley Mill Road, is a two-story frame farmhouse set on a stone foundation. Its plan consists of two intersecting blocks in a "T" configuration distinguished by the triple sided bay system on the asymmetrical east facade which contains the main entrance.

east facade,      B. Deale      4/79

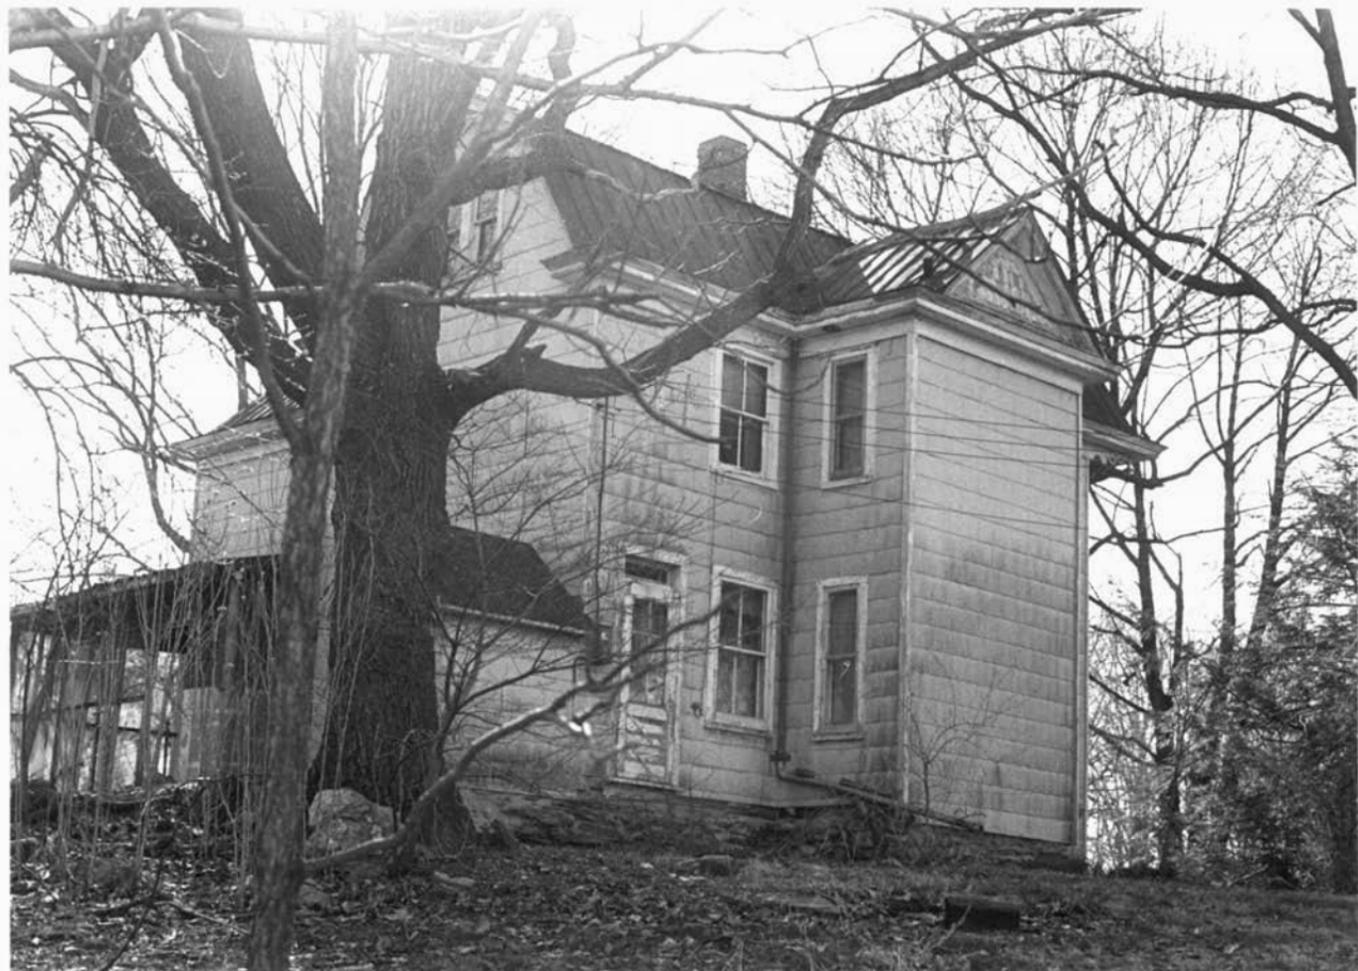
northwest elevation  
B. Deale 4/79

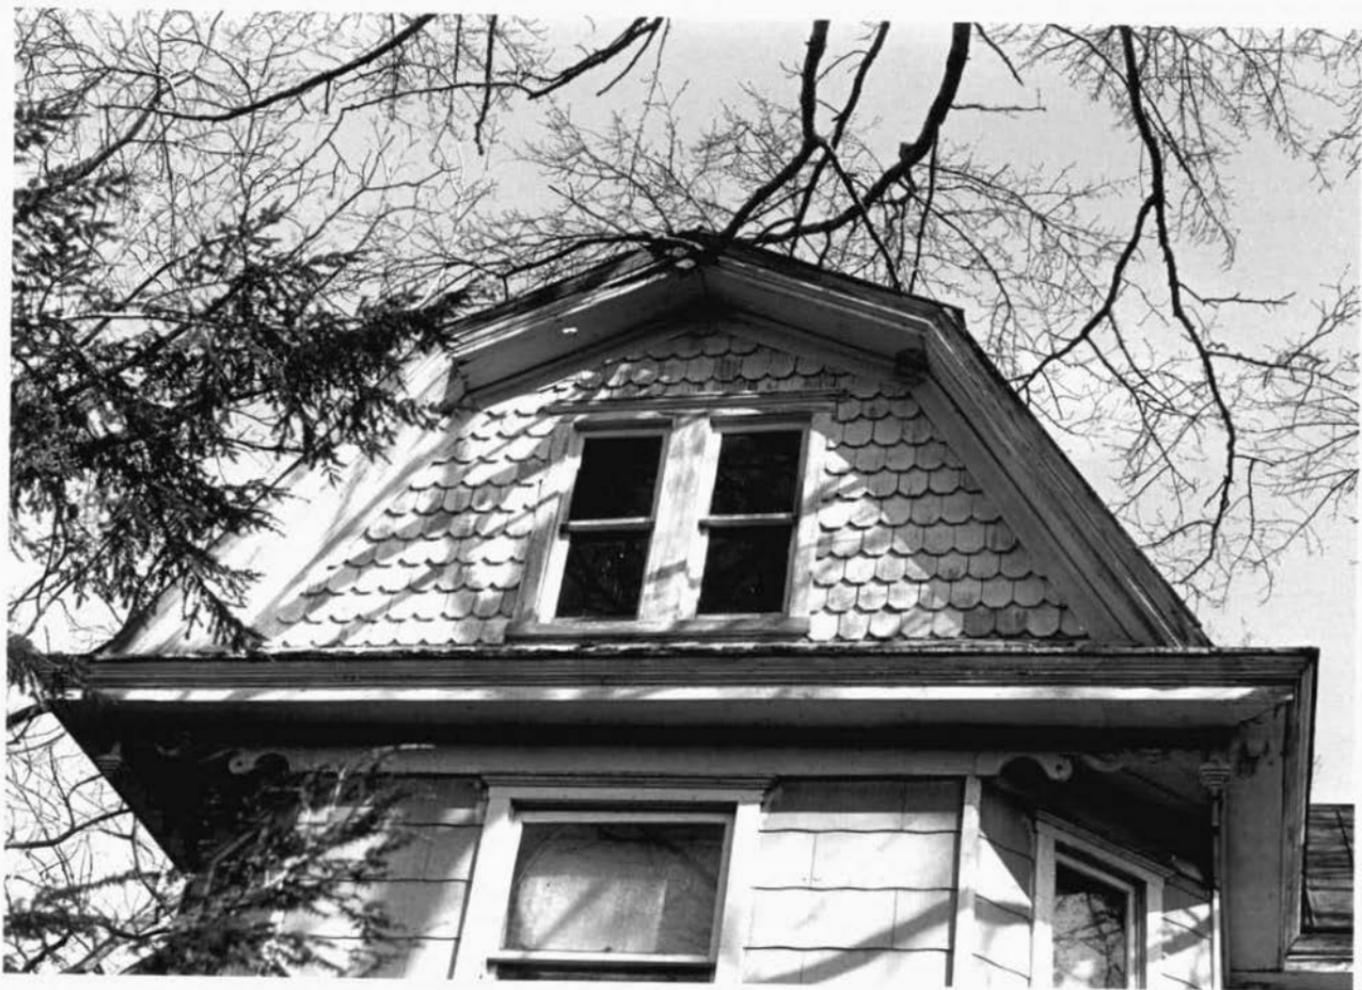
HO-545

east gable; B. Deale 4/79

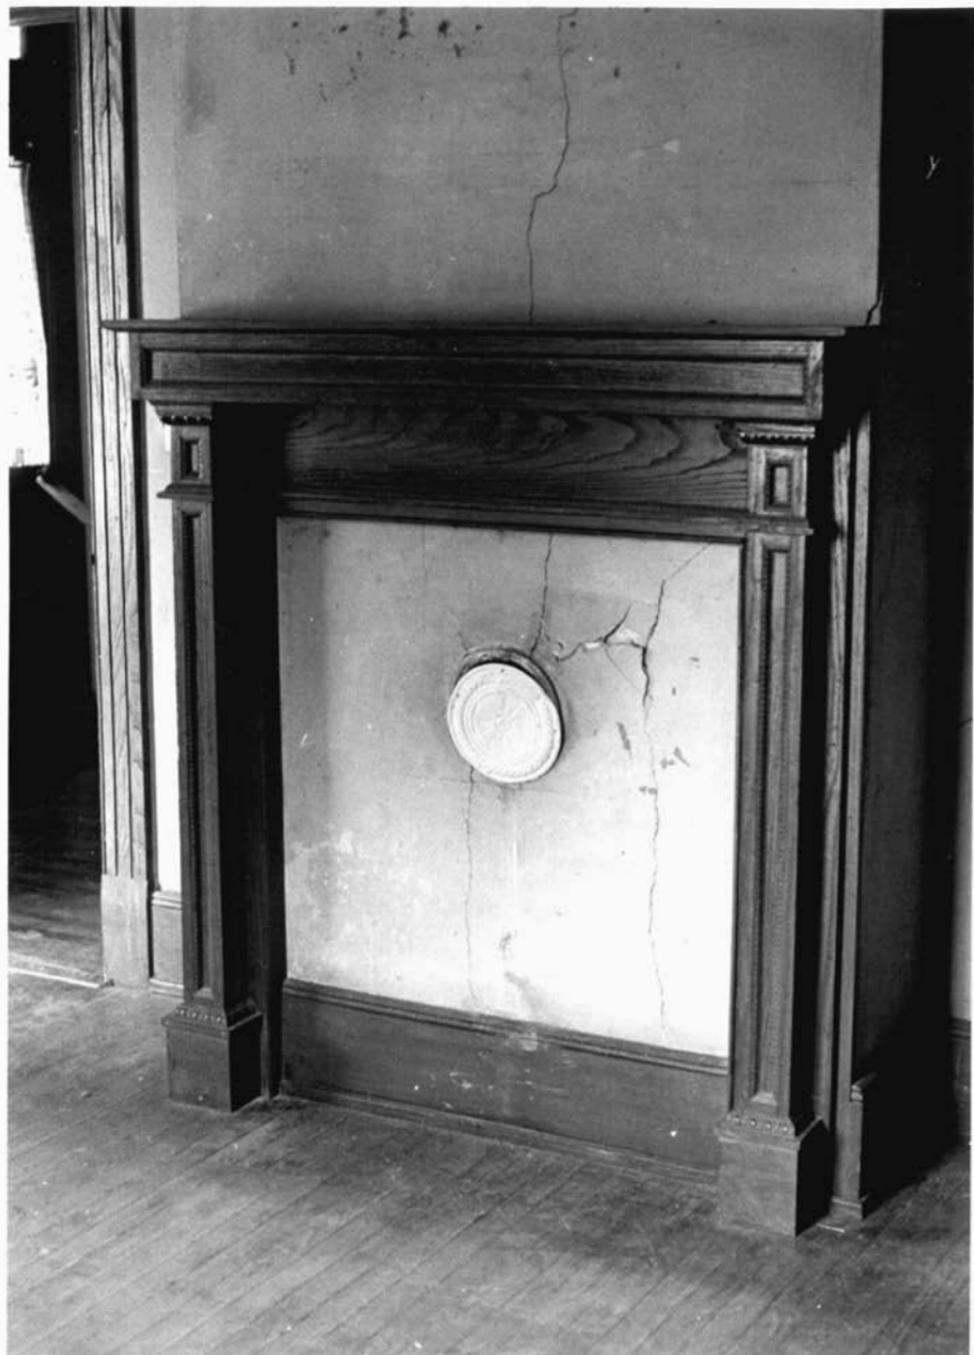
John Layman was a carpenter by trade and farmer by necessity. His carpentry skills are evident by the mantels in both parlors, the center staircase and the interior door and window surrounds. All reflect a fine degree of wood craftsmanship for such a modest rural dwelling. The surrounding 70-acre farm produced a variety of crops--corn, wheat, barley, etc.

int.: parlor fireplace  
B. Deale 4/79
