**INDIVIDUAL PROPERTY/DISTRICT
MARYLAND HISTORICAL TRUST
INTERNAL NR-ELIGIBILITY REVIEW FORM**

Property/District Name: 10571 Scaggsville Road Survey Number: HO-701

Project: Maryland 216/29 Project Planning Study Agency: MDOT-SHA

Inventory No. HO-701

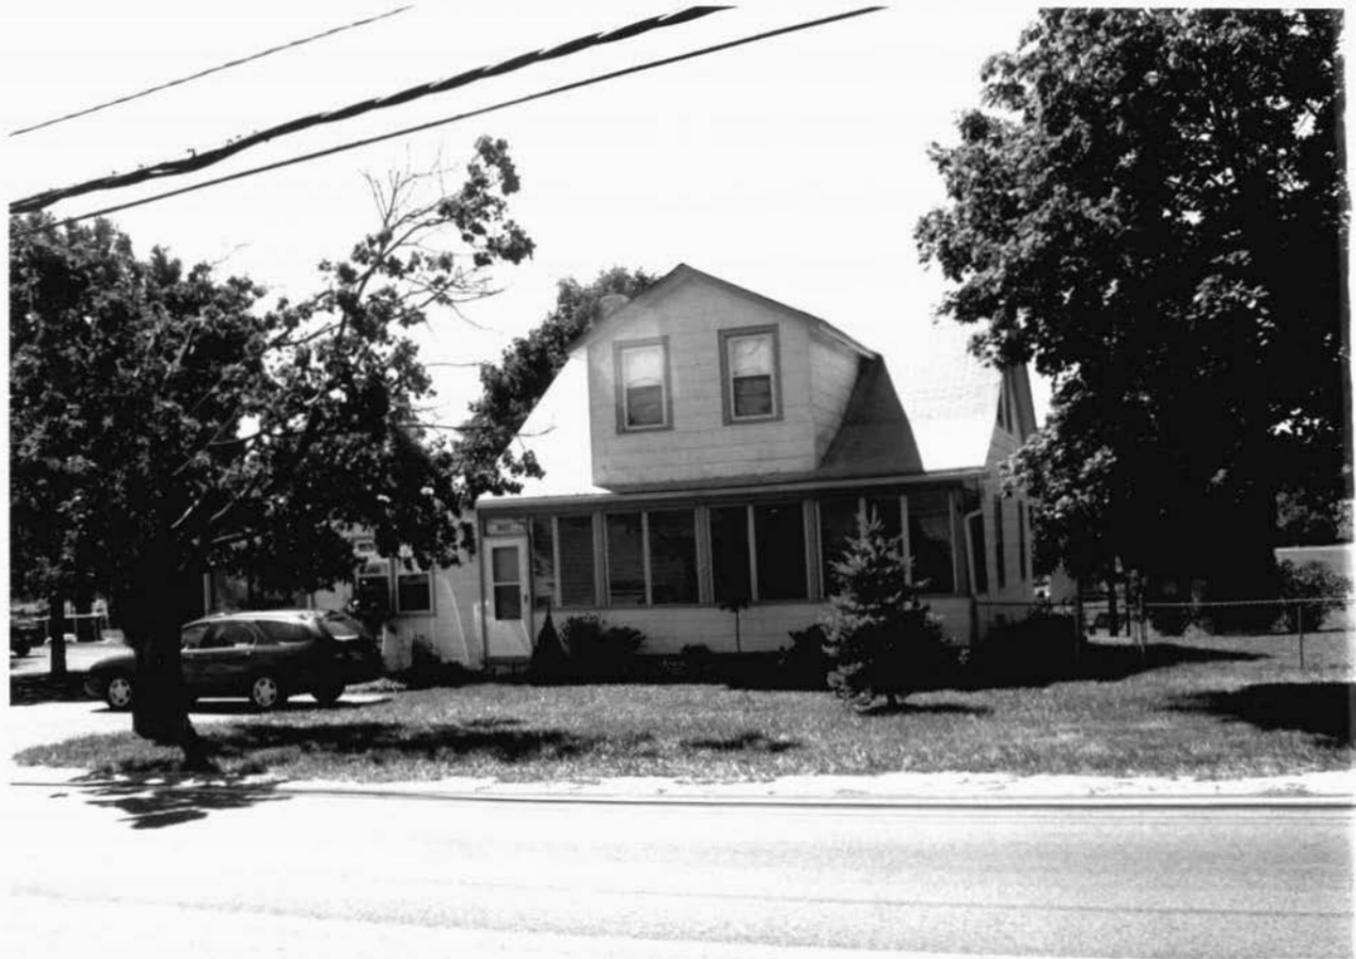
1 of 5

House, NE 1/4 Elevation

The northeast elevation, the facade of the house, is one-and-one-half stories in height and contains a one story enclosed porch at the first story. The side gable roof with a hip extension features a centered, front gable dormer. The one-story southeast addition is flush with the front elevation on the eastern corner of the house. The entrance to the house, within the enclosed porch, is marked with a single leaf, flush metal door with a metal surround. The first story is pierced by two replacement, 1/1 metal sash windows with wood surrounds and molded sills. The porch is enclosed by nine non-original, jalousie windows. The dormer is pierced by two replacement, 1/1 metal sash windows with wood surrounds and square-edged sills.

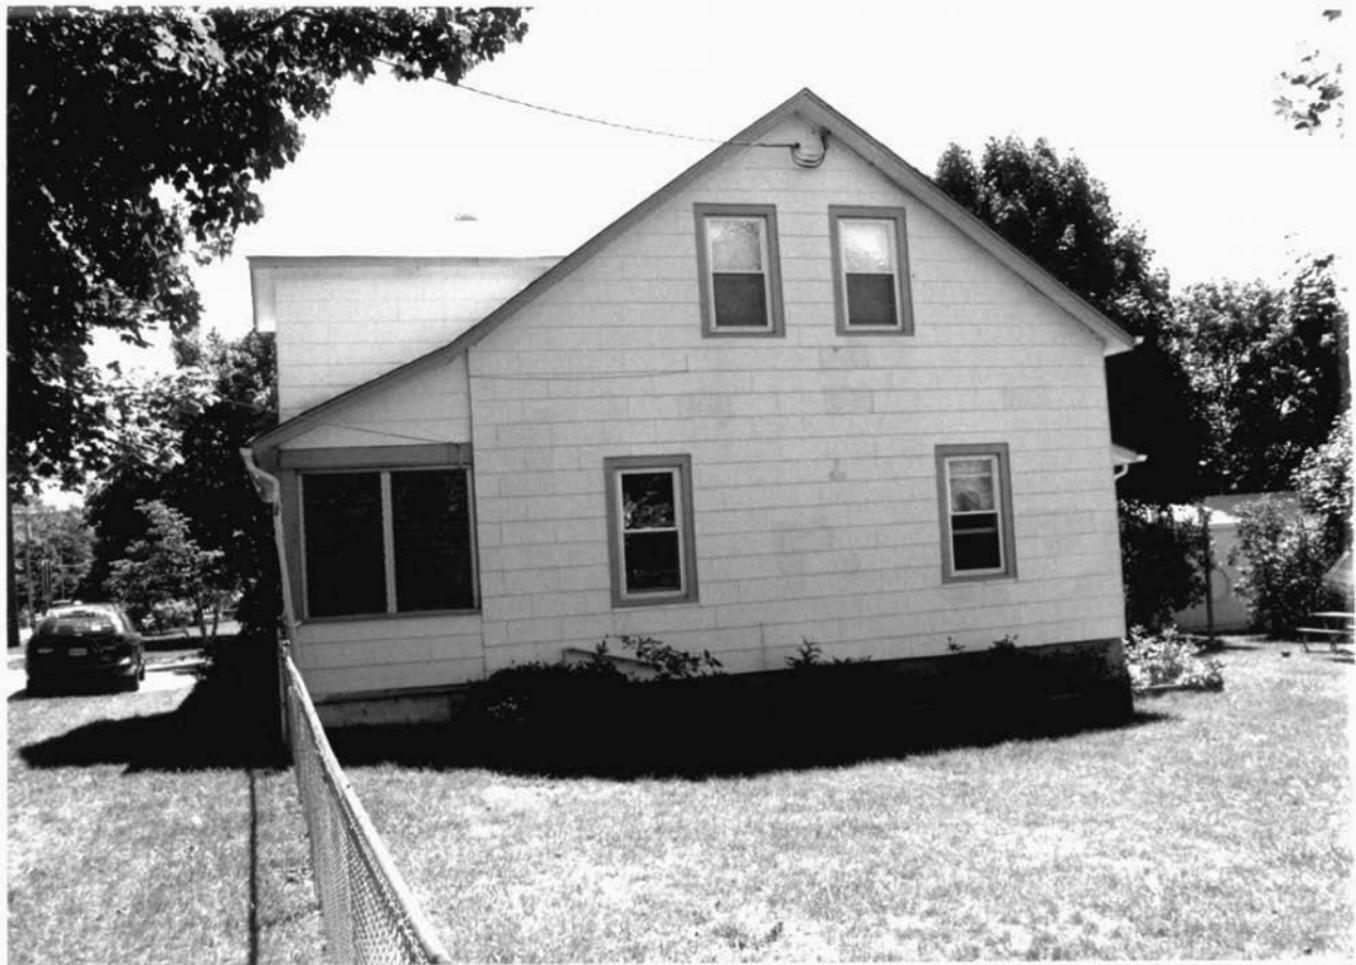
2 of 5

House, NW - Elevation

The northwest elevation is pierced at the first story by two non-original, jalousie windows on the enclosed porch, two replacement, 1/1 metal sash windows with square-edged casings on the original section of the house, and one non-original, 1/1 metal sash window with square-edged casings on the southwest addition. The upper half-story of the original house is pierced by two replacement, 1/1 metal sash windows with square-edged casings.

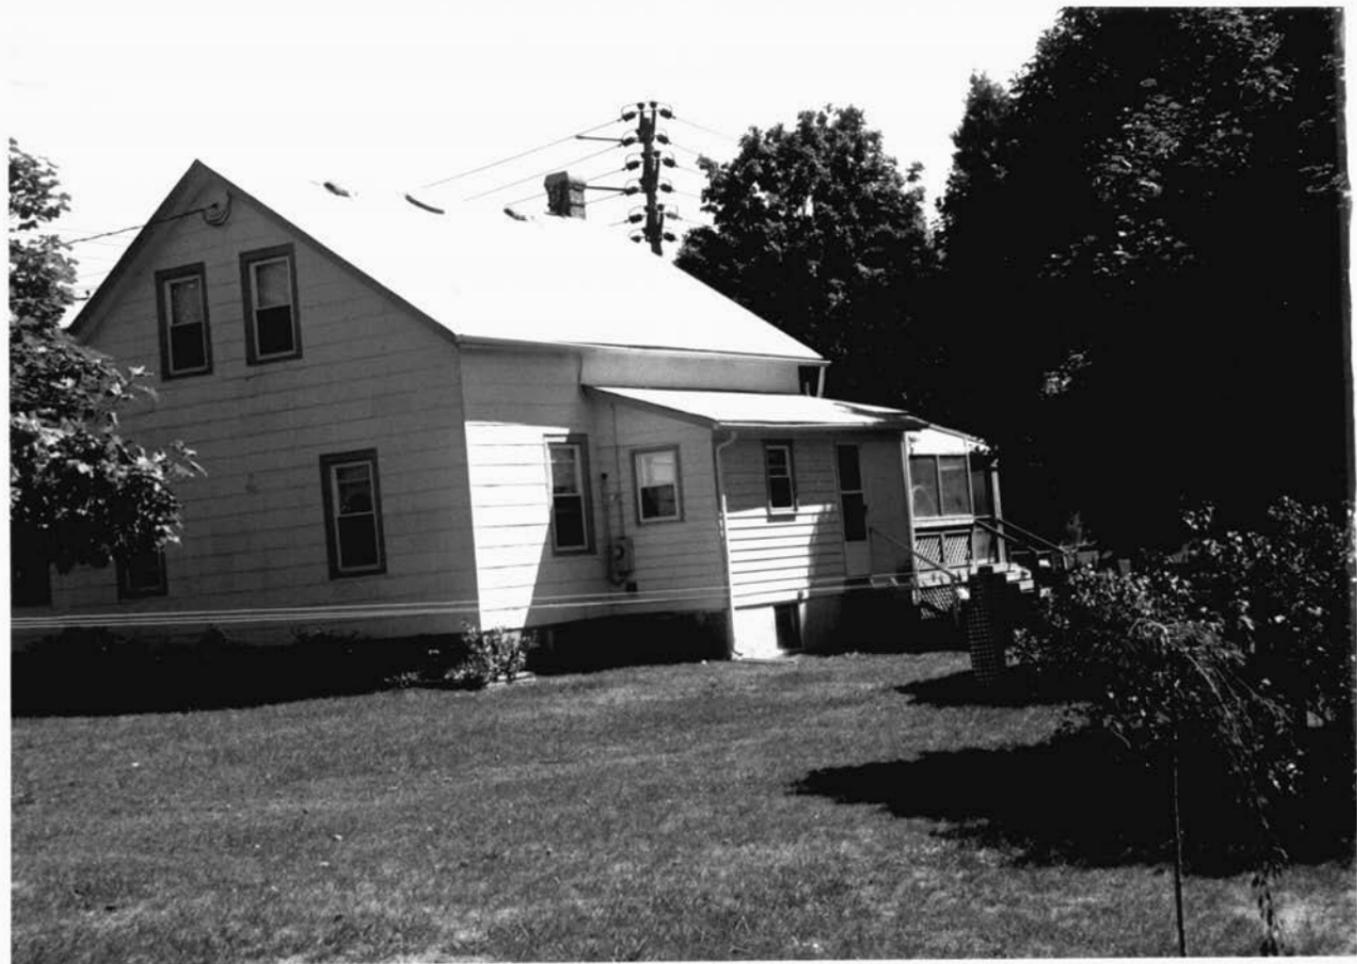
3 of 5

House, W Corner

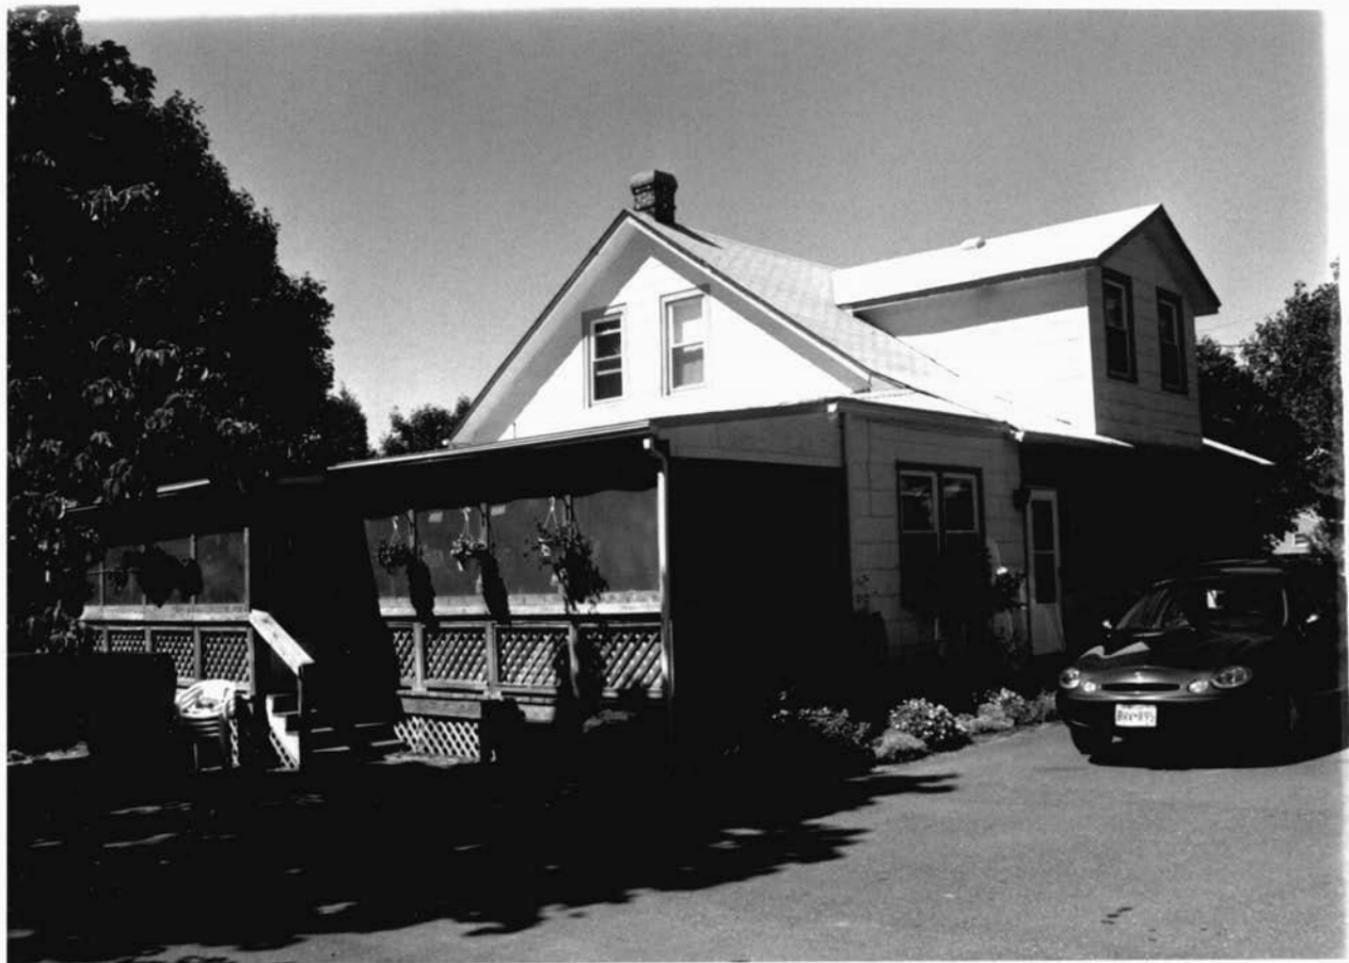
4 of 5

House, E corner

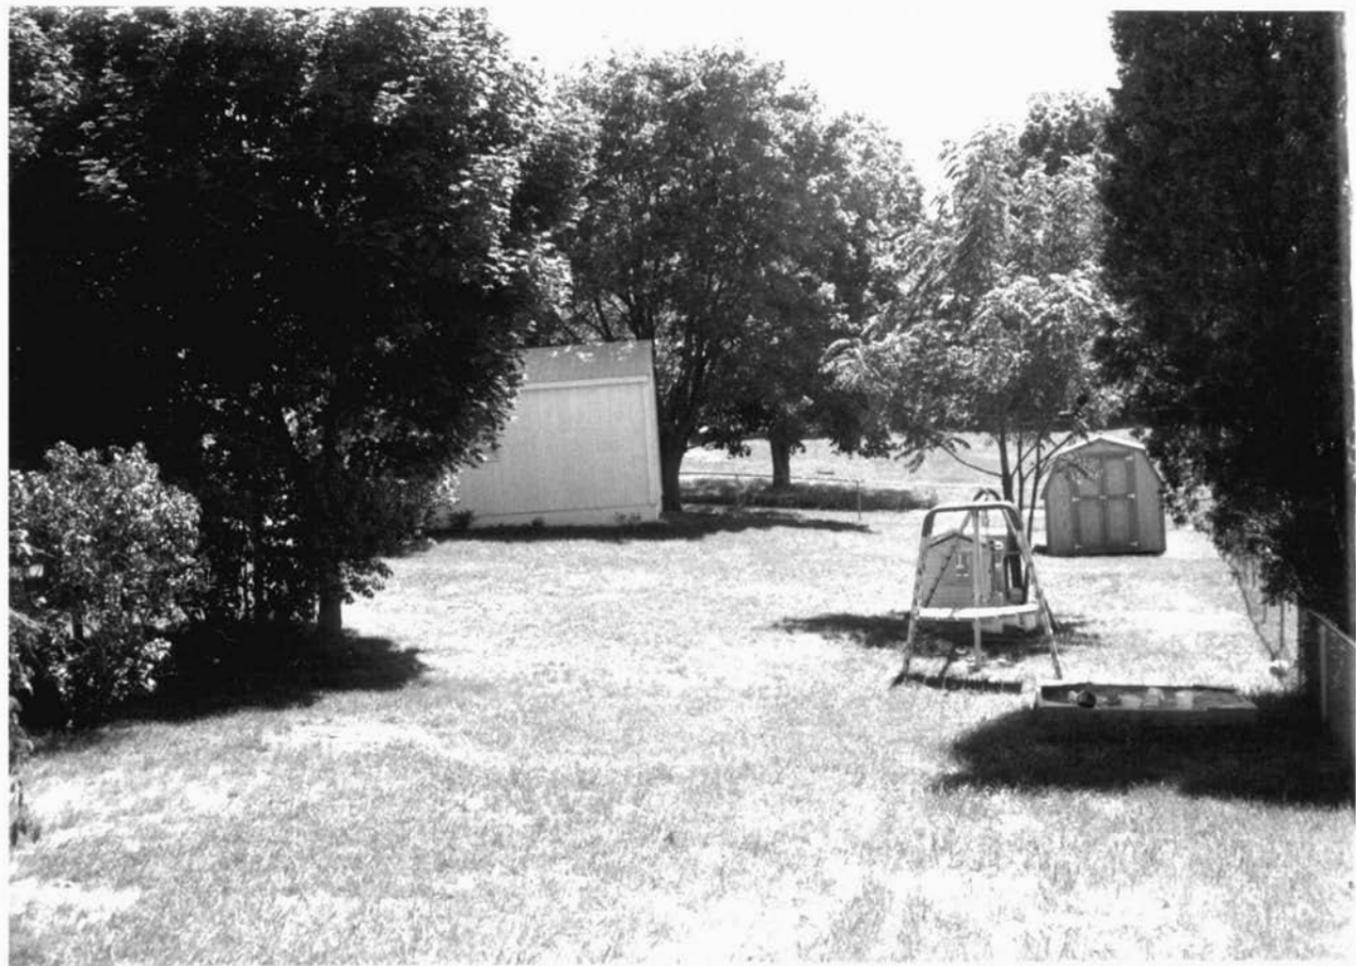
5 of 5

Sheds, looking SE

Two outbuildings stand to the south of the main house. The first one is a wood frame garage constructed in the 1950s with a front gable roof and vertical board siding. The second outbuilding is a pre-fabricated wood frame shed with a gambrel roof and vertical board siding.
