HO-788, First Discovery
6270 Winters Lane, Hanover
ca. 1857
Private

Maryland Inventory of Historic Properties Form

Inventory No. HO-788

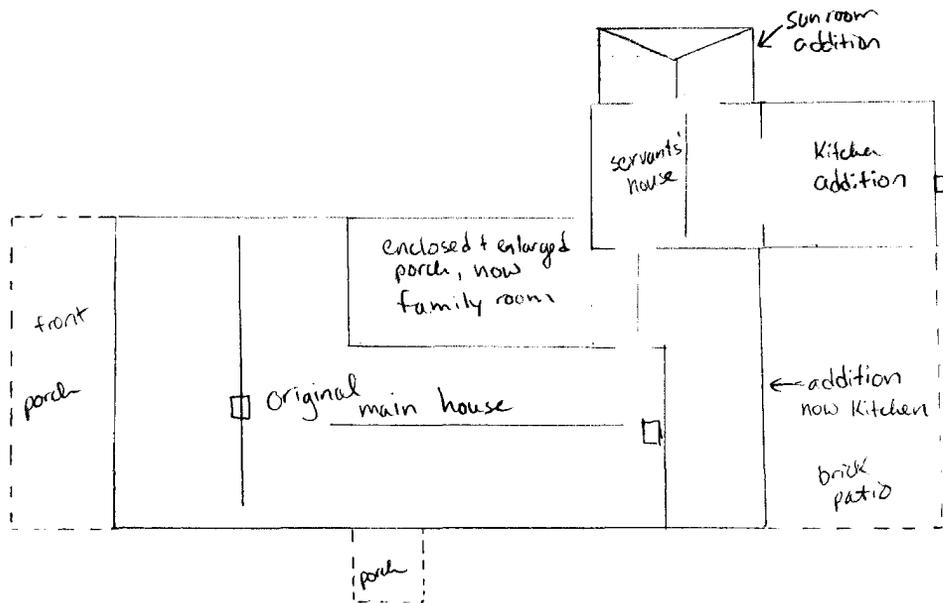
Resource Sketch Map
 HO-788, First Discovery
 Hanover, Howard County
 NOT DRAWN TO SCALE

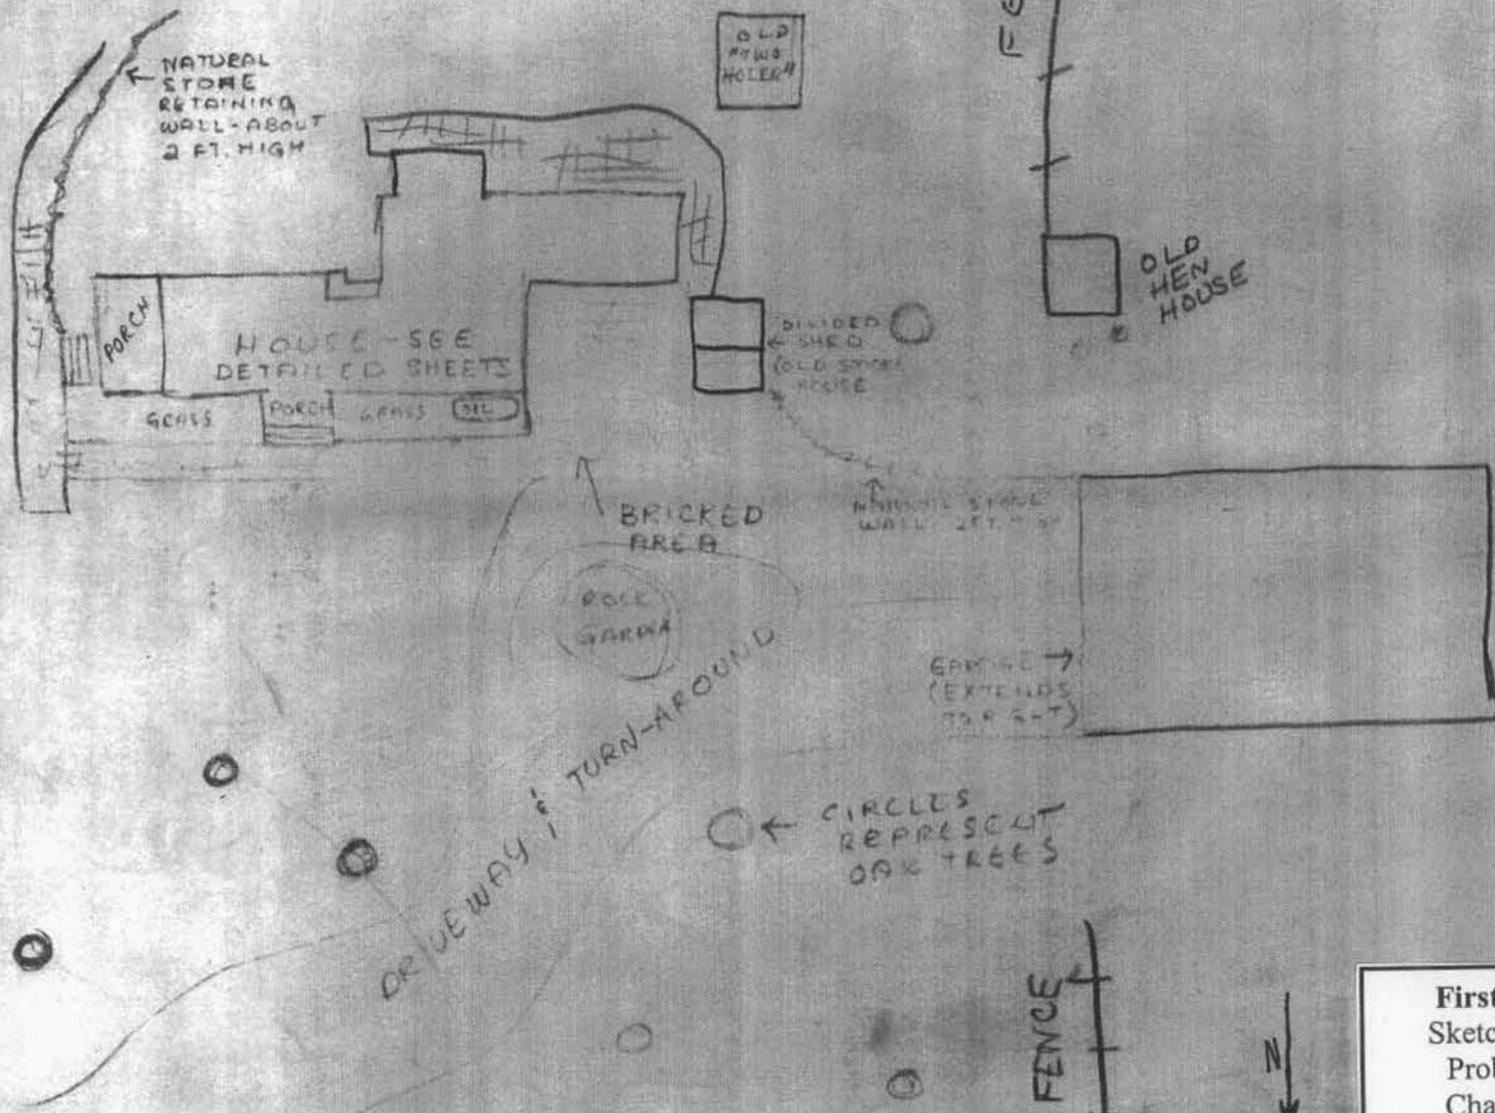
First Discovery, HO-788
 Sketch map of the property
 Probably drawn by Mrs.
 Charlotte Gran, ca. 1966

The current owners of the house also found several sketches of the floor plan of the house and the layout of the larger property. These are not dated or drawn to scale but they show features of the house and property that are no longer evident. They were probably done around 1966 when the Grans purchased the property. They were probably done by Mrs. Charlotte Gran since one bedroom is labeled "my sewing room" and a note above the second floor of the servant's house says it "will be Dave's study." According the sketches, in the 1960's the main house was connected to the servants' house by a small hall and the rear L-shaped porch was still in place. The shed roofed addition on the rear of the rear wing is labeled "workshop" and the kitchen is actually located in the rear addition to the servants' house. The sketches of the layout of the property indicate that an old smoke house was

located directly behind the main house and the outhouse (labeled "old 'two holer'") was located behind and slightly to the south of the servants' house. An old hen house is noted some distance behind the main house along a fence line with a garage, which may have been an old agricultural building, located beside it. Several brick paths are shown around the house and two stone retaining walls are located in front of and behind the house. A pond and a spring head are shown to the north of the house on the other side of the driveway (what is now Winters Lane). The property is shown as partly wooded and partly fenced open fields.

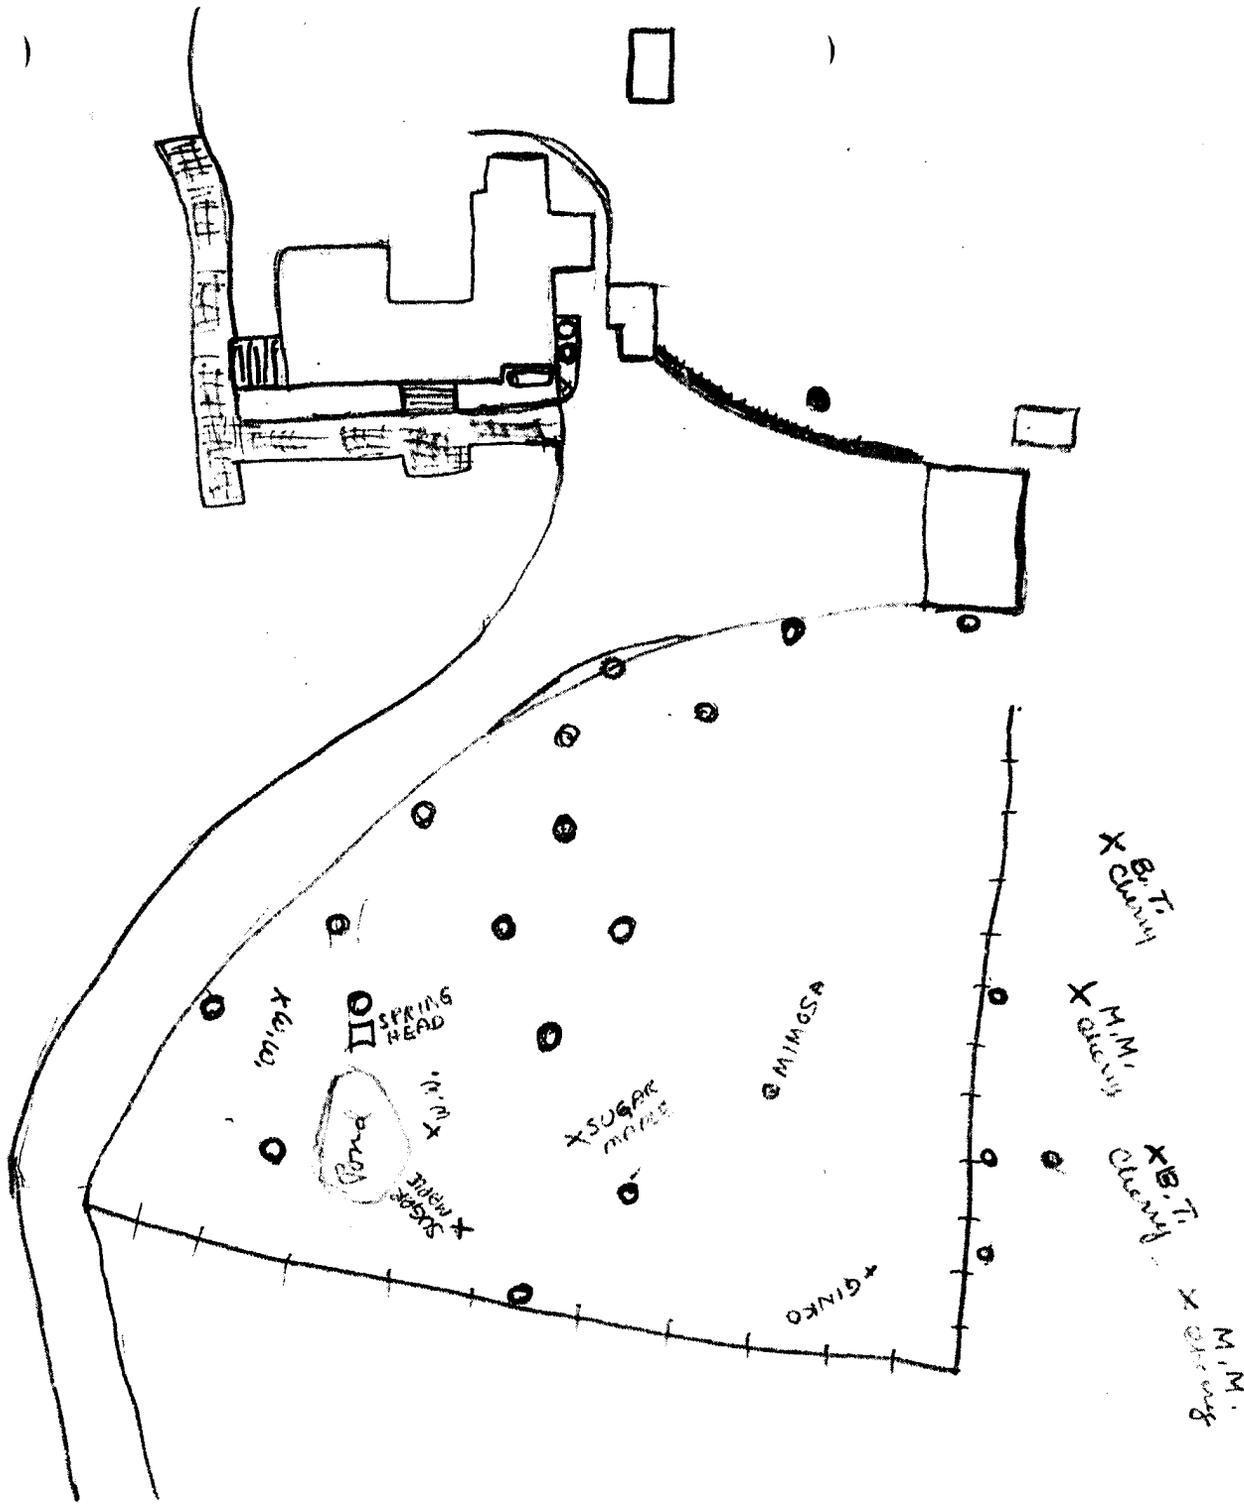
First Discovery, HO-788
 Sketch map of the property
 Probably drawn by Mrs.
 Charlotte Gran, ca. 1966

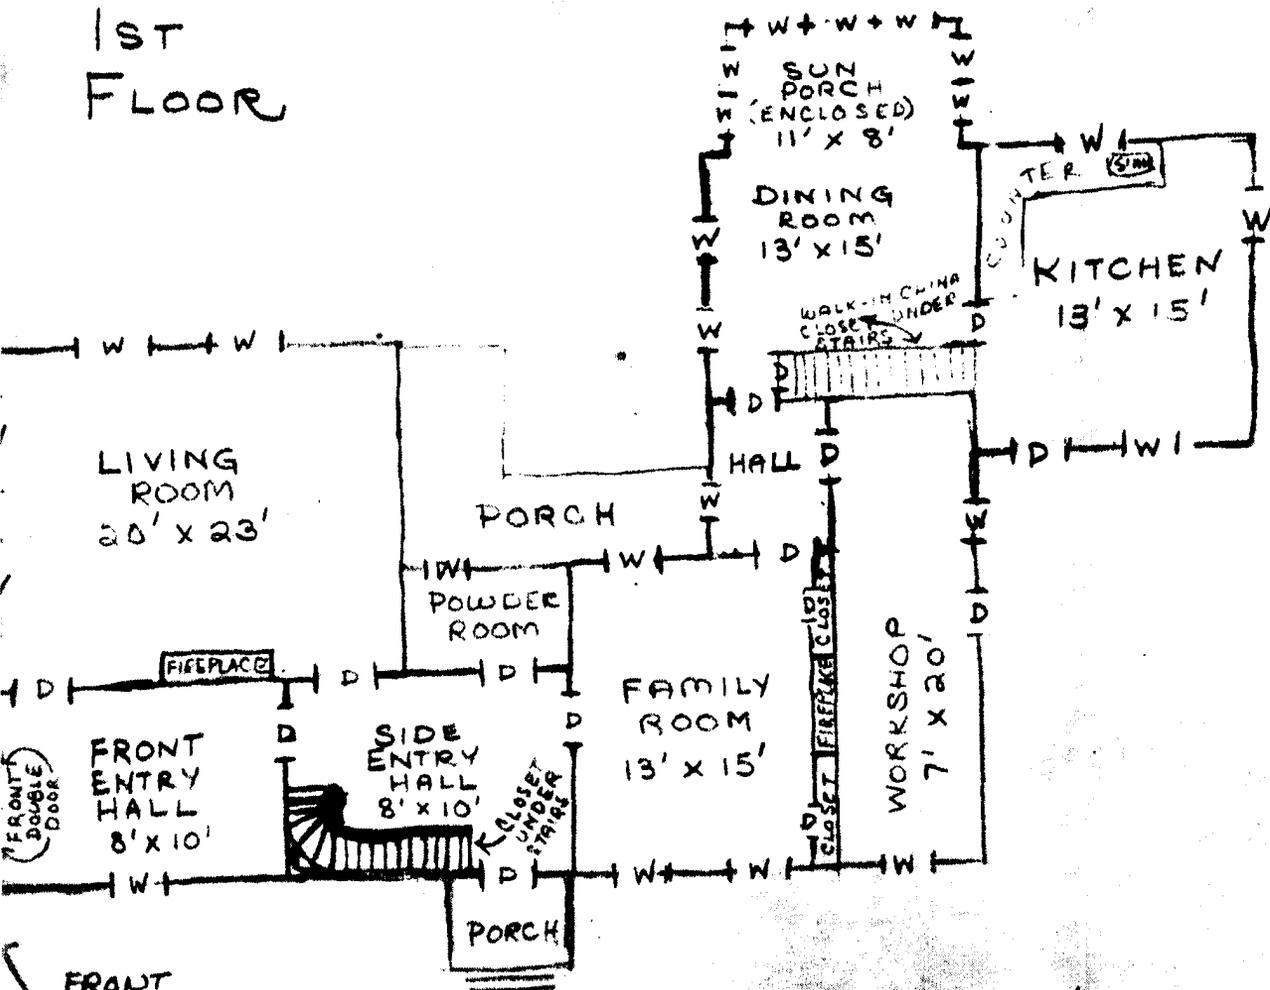
1ST FLOOR

FRONT PORCH EXTENDING WIDTH OF HOUSE

First Discovery, HO-788
Floor plan
Probably drawn by Mrs.
Charlotte Gran, ca. 1966

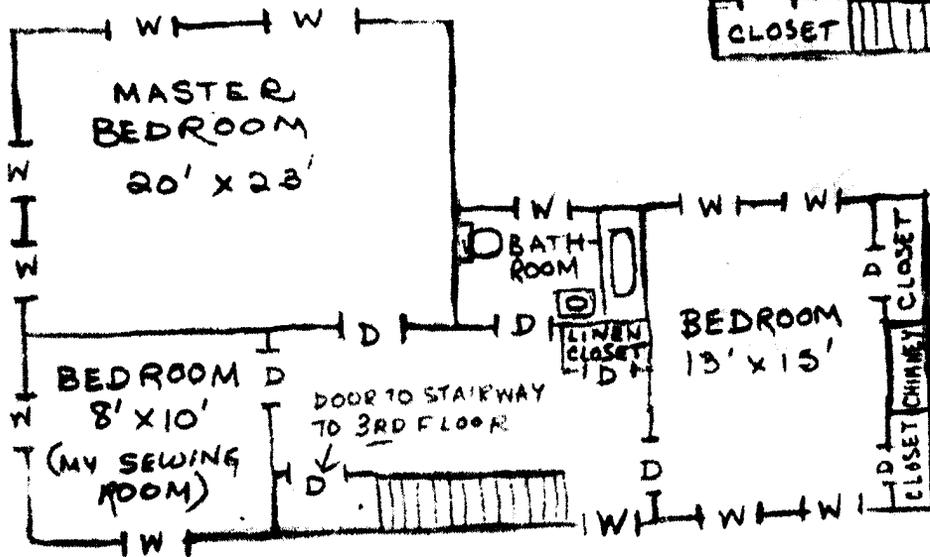
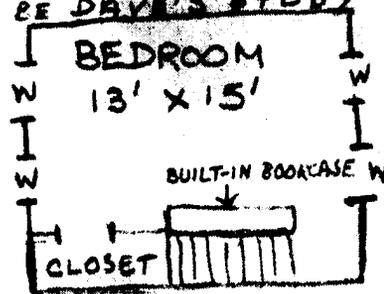
2ND FLOOR

THIS ROOM, ABOVE THE DINING ROOM, IS SEPARATE FROM THE REST OF THE 2ND FL AND WILL BE DAVID'S STUDY

First Discovery, HO-788
Floor plan
Probably drawn by Mrs.
Charlotte Gran, ca. 1966

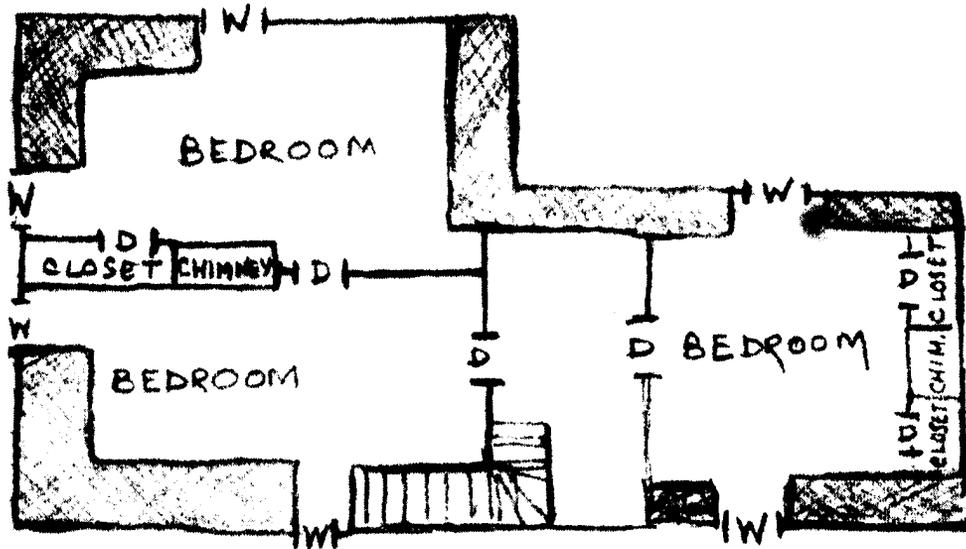
3RD
FLOOR

THIRD FLOOR HAS SLANTED
CEILINGS - AREA BETWEEN INSIDE
WALL AND OUTSIDE WALL ARE
SHADED.

First Discovery, HO-788
Floor plan
Probably drawn by Mrs.
Charlotte Gran, ca. 1966

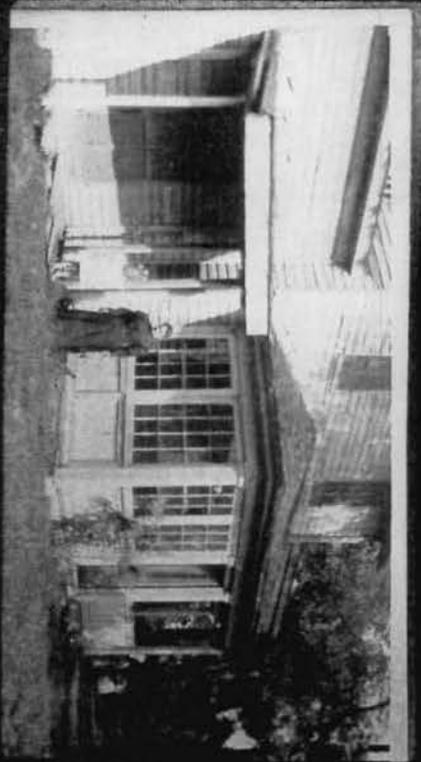
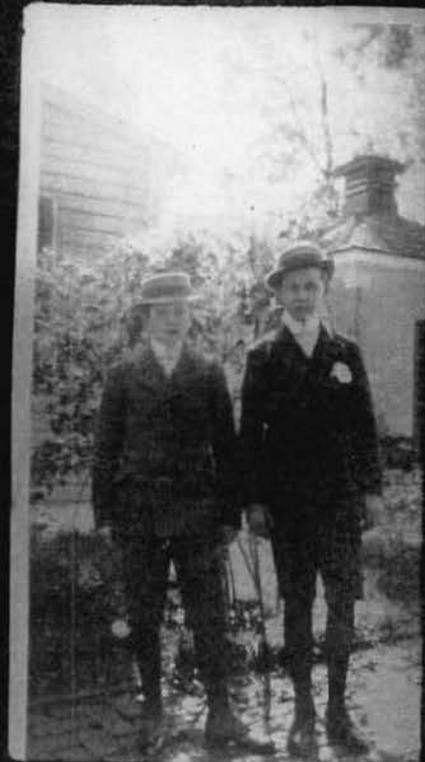
Photograph from the album of Anna Winters,
ca. 1909

The west end of the addition made to the back of the rear wing is visible on the left. The small, hipped roof building in the background on the right is probably the 'old smoke house' noted on one of Mrs. Gran's drawings.

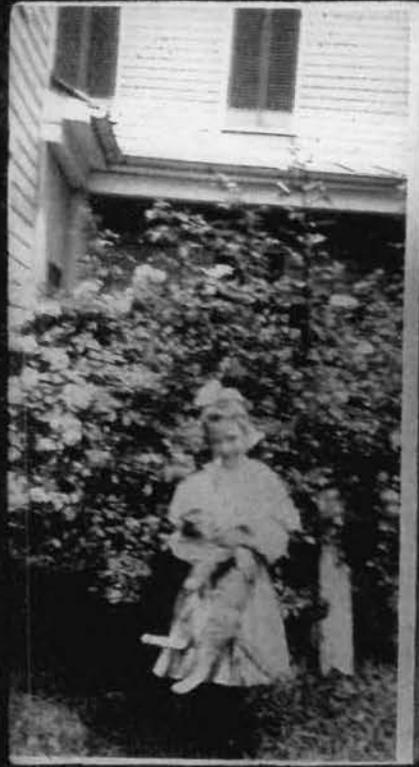
Photograph from the album of Anna Winters,
ca. 1909

House in the background. View is of the south
façade of the rear wing showing porch off the
first story and hyphen to servants' house on
the very left of the photo

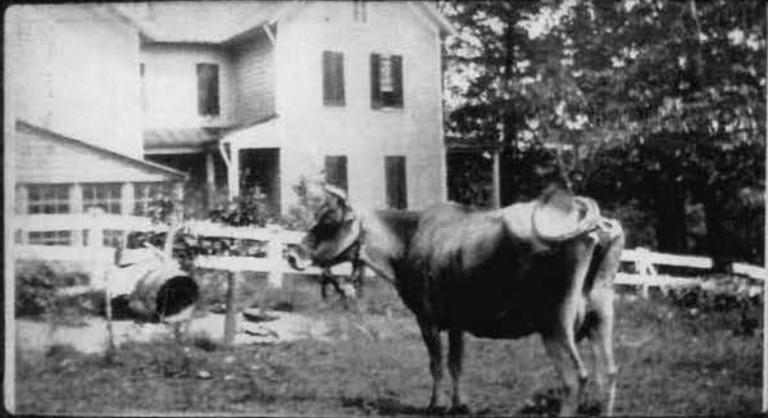
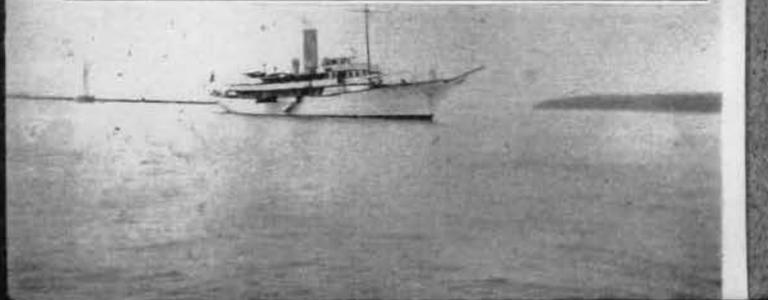
Photograph from the album of Anna Winters,
ca. 1909

View is of the south elevation of the house.
South elevation of the servants' house with sun
room addition is on the far left of the photo.

Notice the front porch.

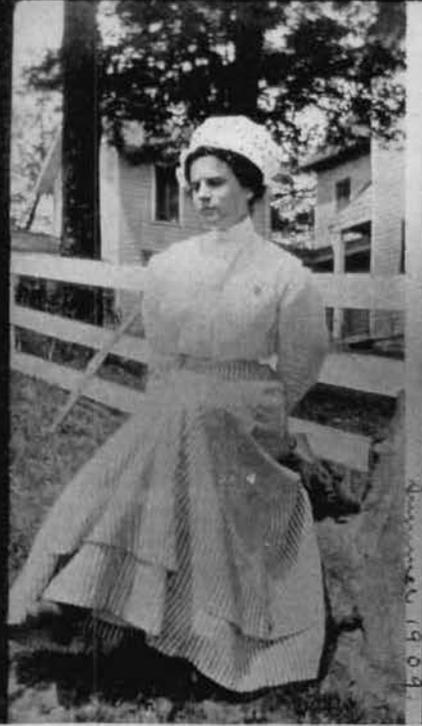
Photograph from the album of Anna Winters,
ca. 1909

In the background is the servants' house on the left,
connected to the south elevation of the main house.

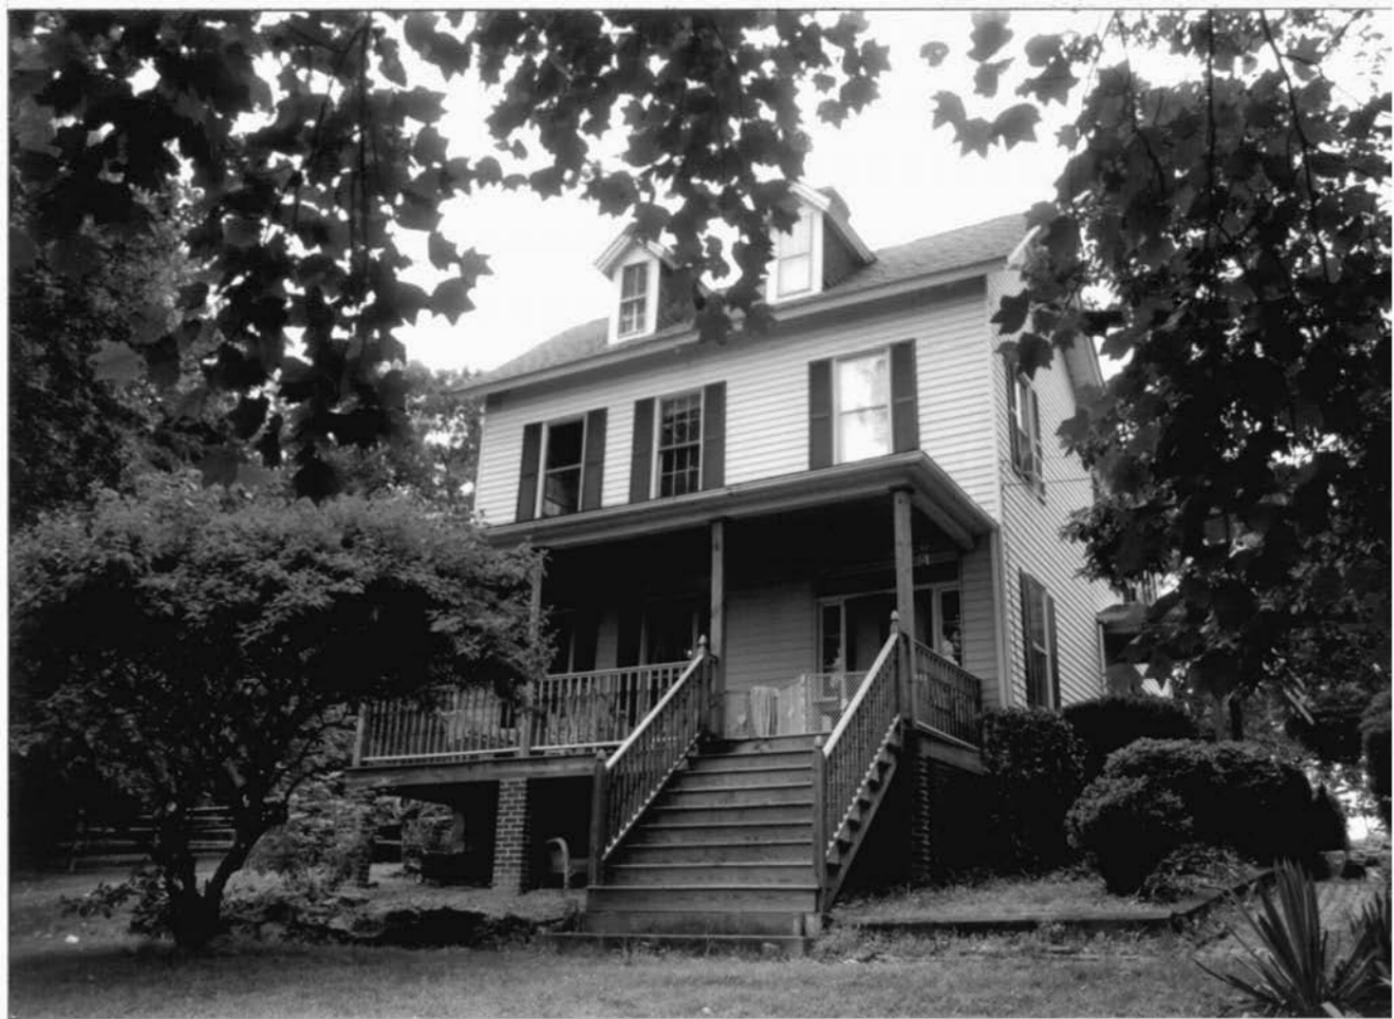
1 of 20

East (front) elevation of main house.

The front of the house faces east and features double paneled doors flanked by three-light sidelights and capped by a five-light transom in the right (north-most) bay. Two original tall 6/6 double hung windows are located to the left of the door, and three more original 6/6 windows are located on the second story. Two 4/4 double hung windows are located in the gabled roof dormers. All of the windows currently have fixed vinyl shutters. A single story full width front porch has recently been rebuilt with modern lumber, a spindle balustrade, and modern brick piers. A photograph from around 1907 indicates that the house did have a full width single story front porch at that time but the view of the photograph does not show the balustrade and does not clearly show the shape of the porch supports. The photograph also shows that all of the windows had functional louvered shutters in 1907.

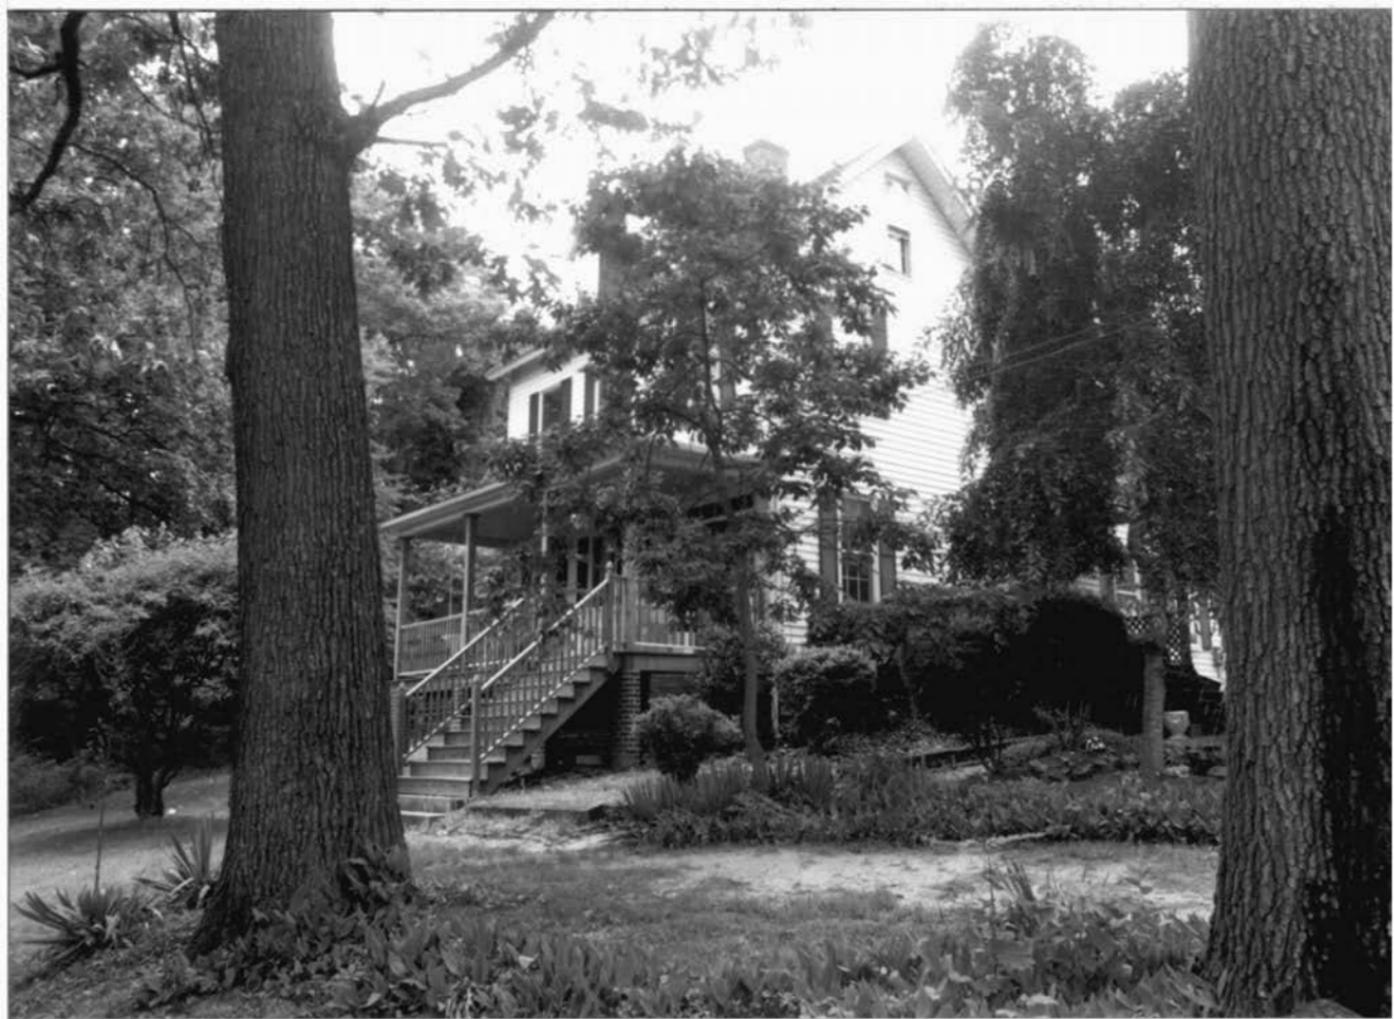
2 of 20

NE elevation of main house.

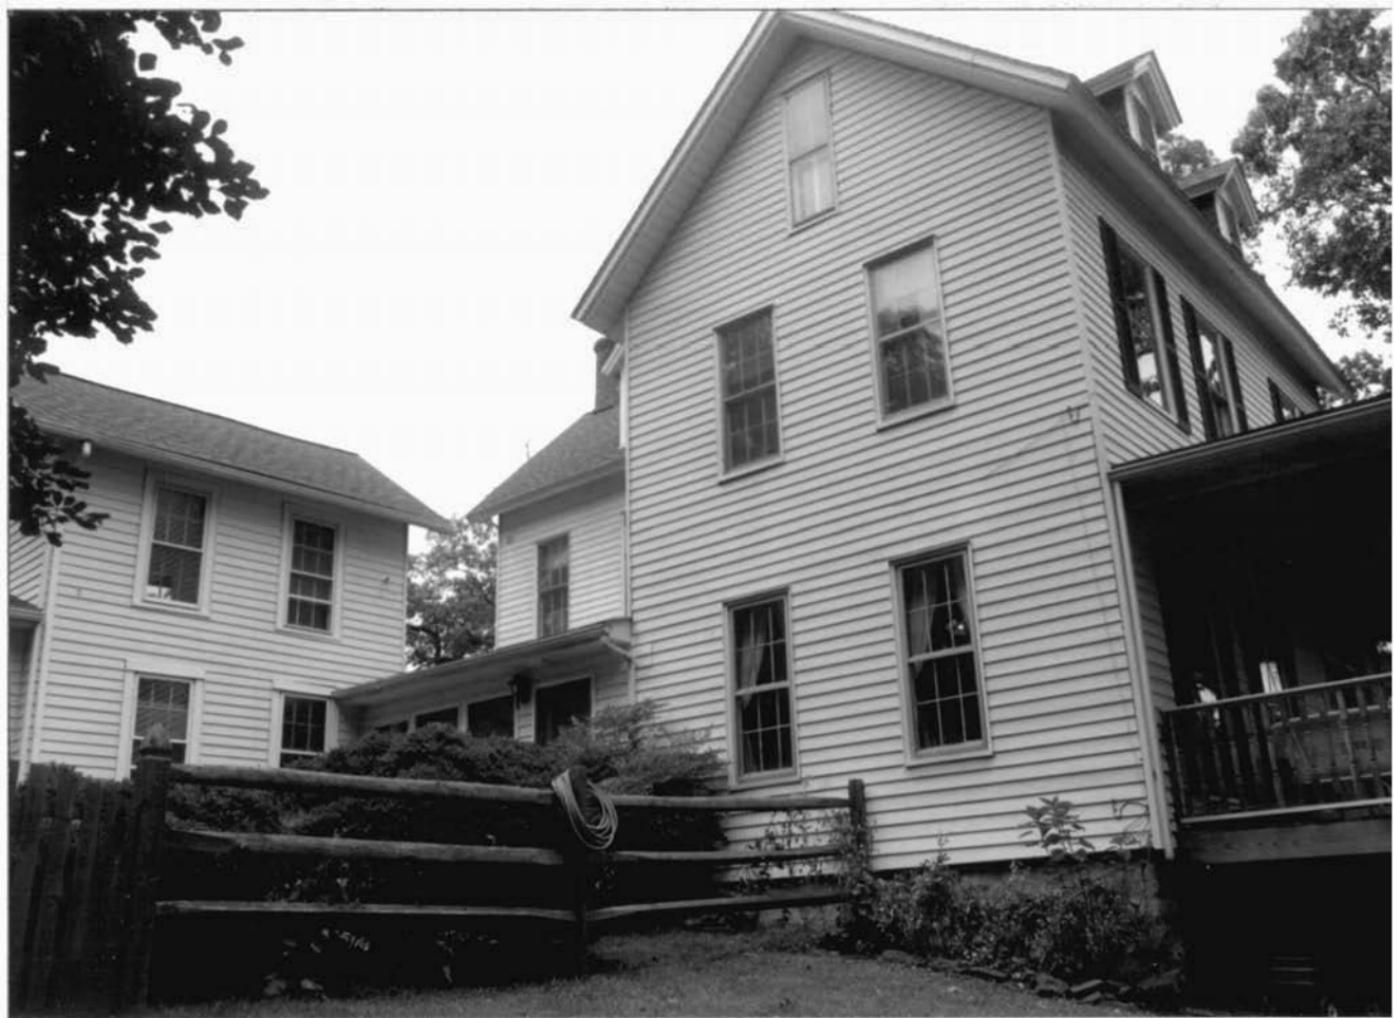
3 of 20

SE view of main house, East facade of main house

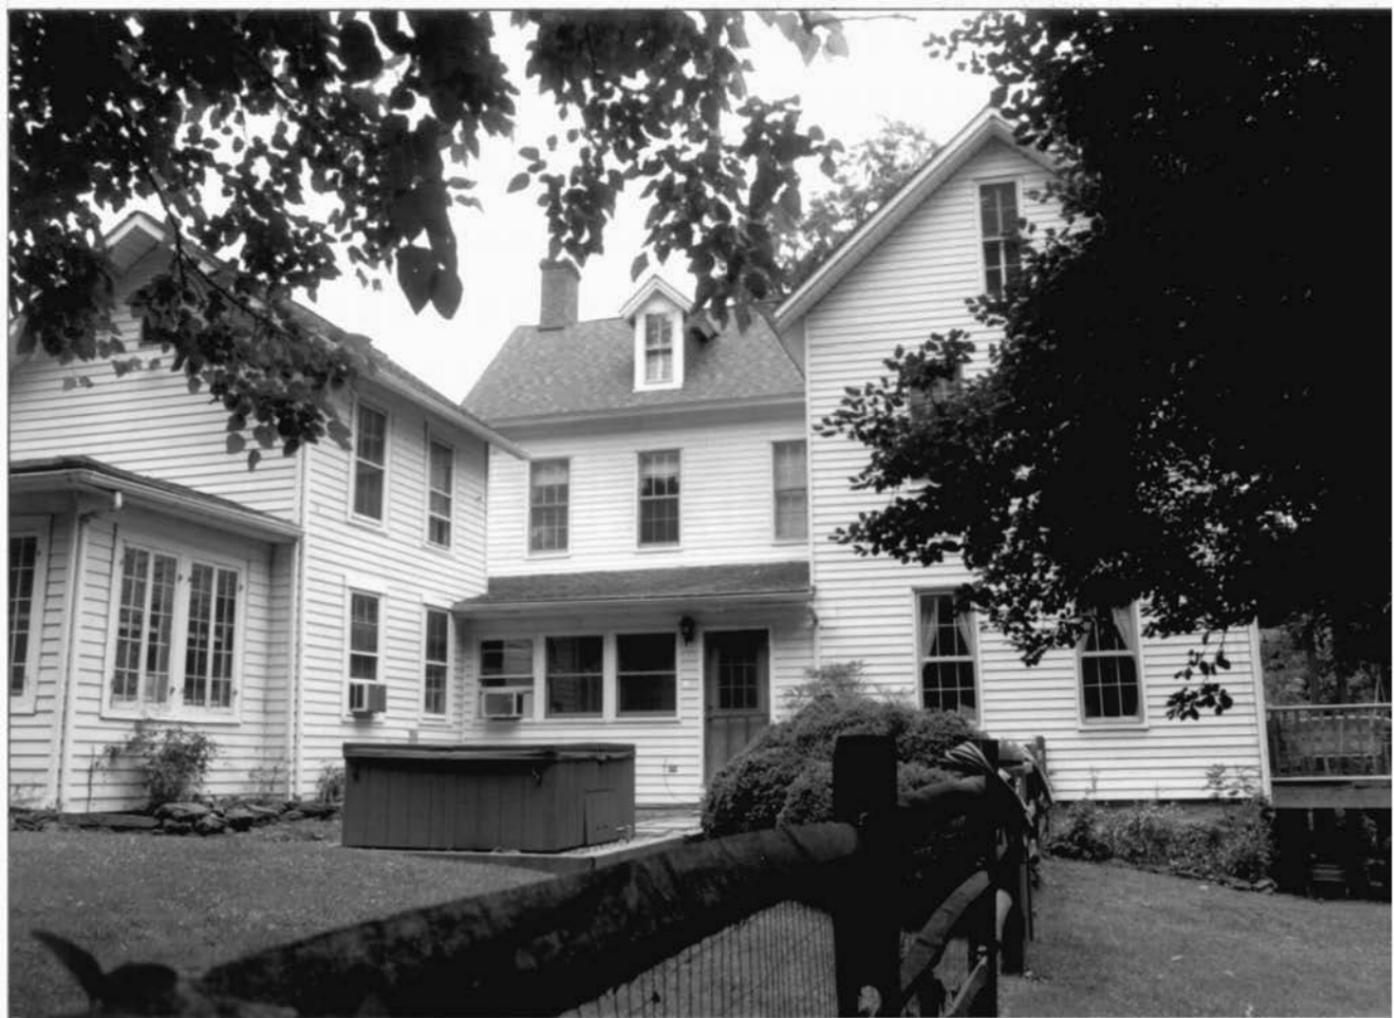
-1 of 20

Se. elevation of main house + 25 elevation
of attached servants house.

The south side façade of the house shows that the front side gabled section is two bays deep while the rear ell has three bays. The front section has two 6/6 windows on each story, with the second story vertically aligned above those on the first story. A 4/4 double hung window is located in the gable. The rear ell has three 6/6 windows on the second story and the first story is obscured by a modern enclosure. A gabled dormer with a 4/4 window is located on the slope of the roof. Photographs from around 1907 indicate that at that time there was a porch inset into the ell on the rear of the house and that a breezeway or hyphen connecting the main house to the servants' house was already in place in some form. The breezeway or hyphen and the rear porch were enlarged and enclosed at some point during the mid-20th century.

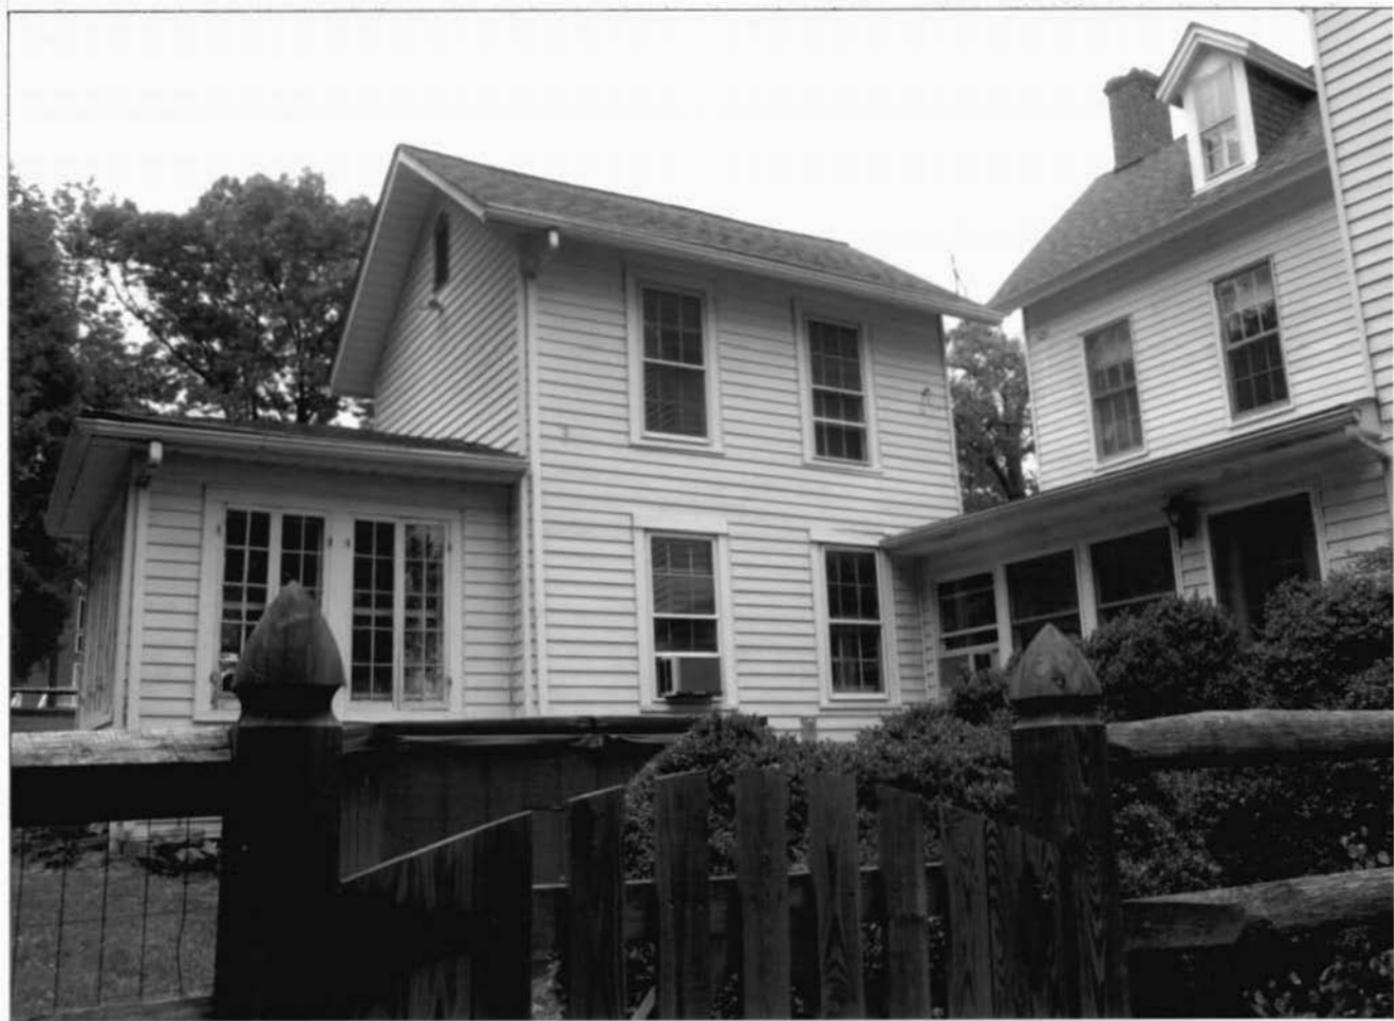
5 of 20

Servants house, east elevation, + rear wing and a horse,
south elevation.

The servants' house is two stories tall and two bays wide. It probably originally contained one room on each floor with a steep enclosed stair connecting them. The building has a side gabled roof that runs parallel with the roof on the front part of the main house. Single story additions have been made to both the south and west facades and the hyphen to the main house obscures the first story of the north façade. The east façade of the building, the only one that is entirely visible, has two 6/6 windows on the first story with two more windows vertically aligned above. The west façade also has two 6/6 windows on the second story and both the north and south façades have blank second stories. Both the north and south facades do, however, have wooden vents in the gables. A single story hipped roof sunroom was added to the south façade, possibly in the very late 19th century. A photograph from 1909 with the building in the background seems to show a single story addition on the south end of the building. Another single story addition was made to the west side of the building. This one has a shed roof and a chimney on its west wall. One 6/6

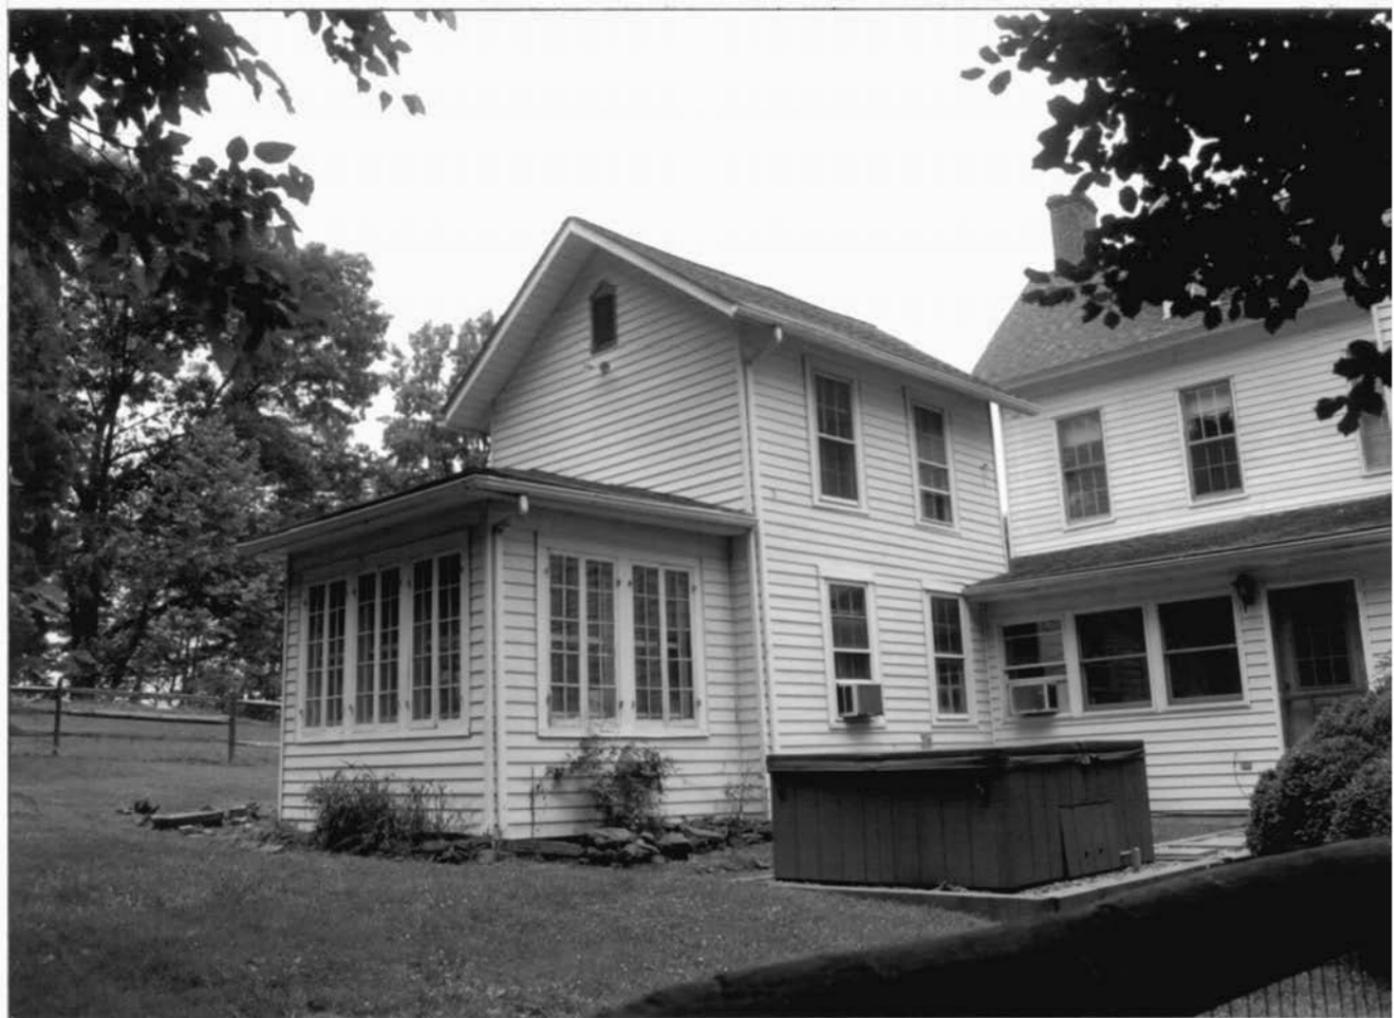
b of 20

Servants house, SE elevation. Rear wing of main
house is in the background on right.

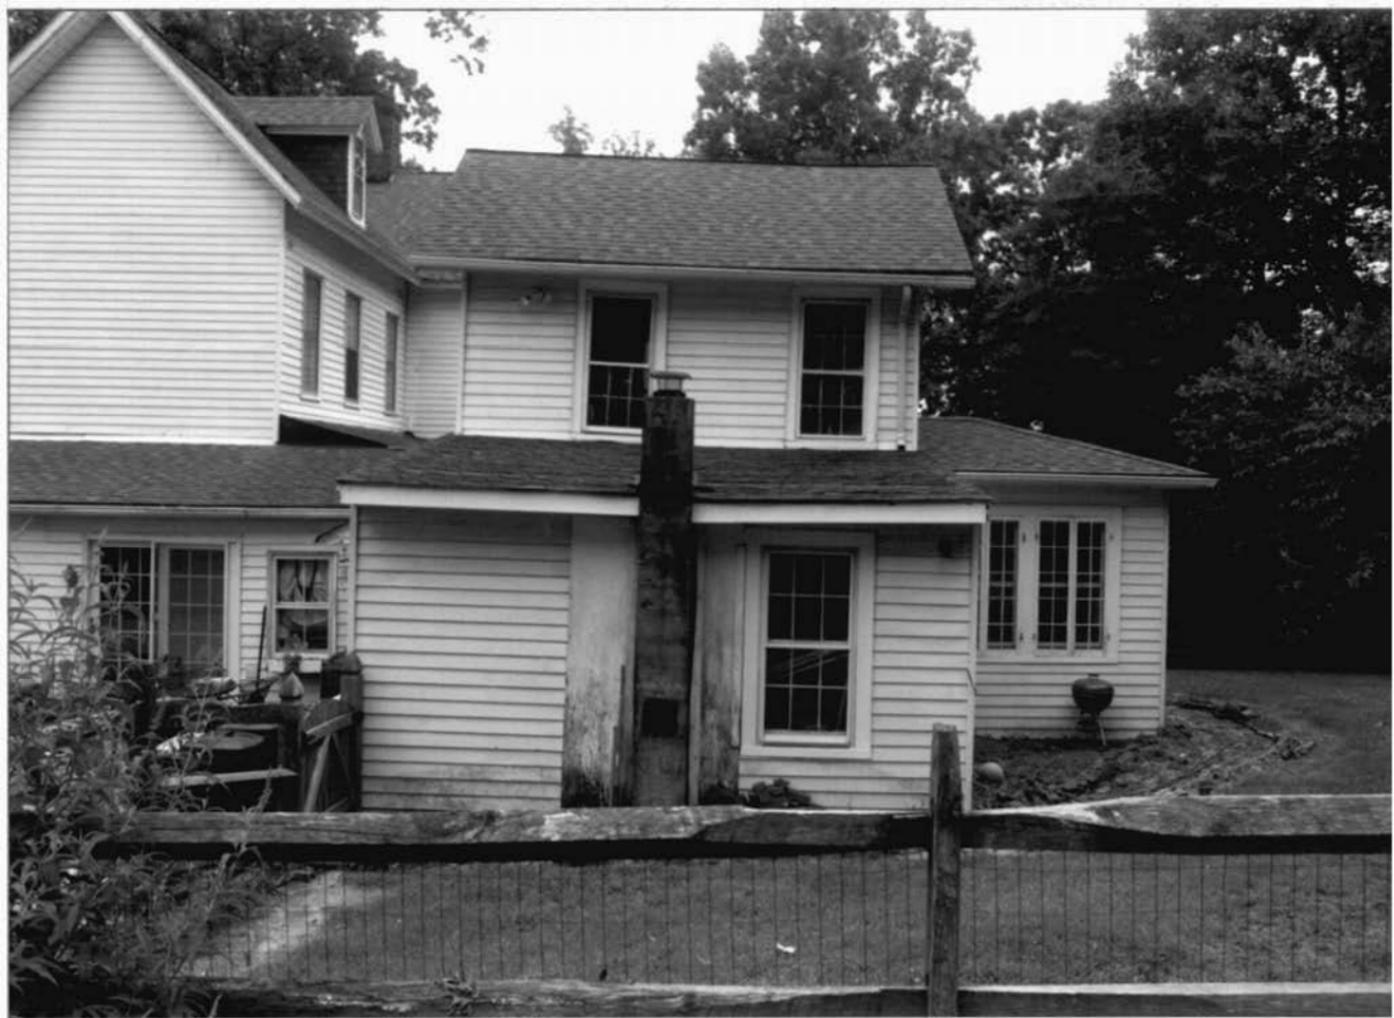
7 of 20

Went eastward of service house with 2nd team, by way
to rear wing of main house is an "off"

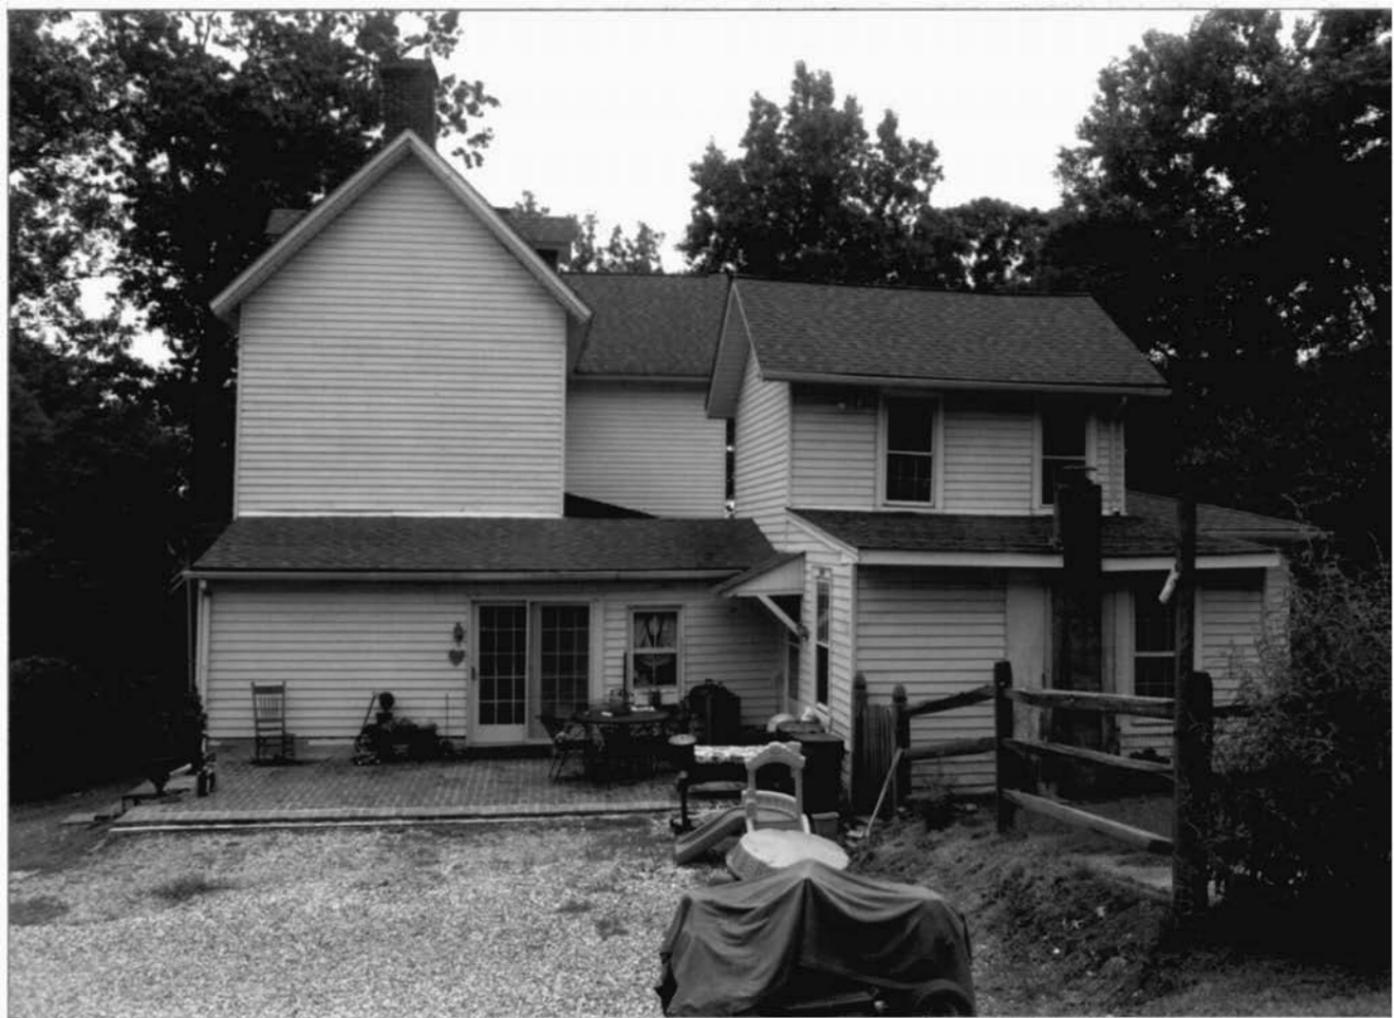
8 of 20

West elevation.

The rear (west) façade of the main house is largely obscured by later additions. The second stories of both the front section and the rear ell are blank on the west façade. The first stories of both sections are concealed behind modern additions.

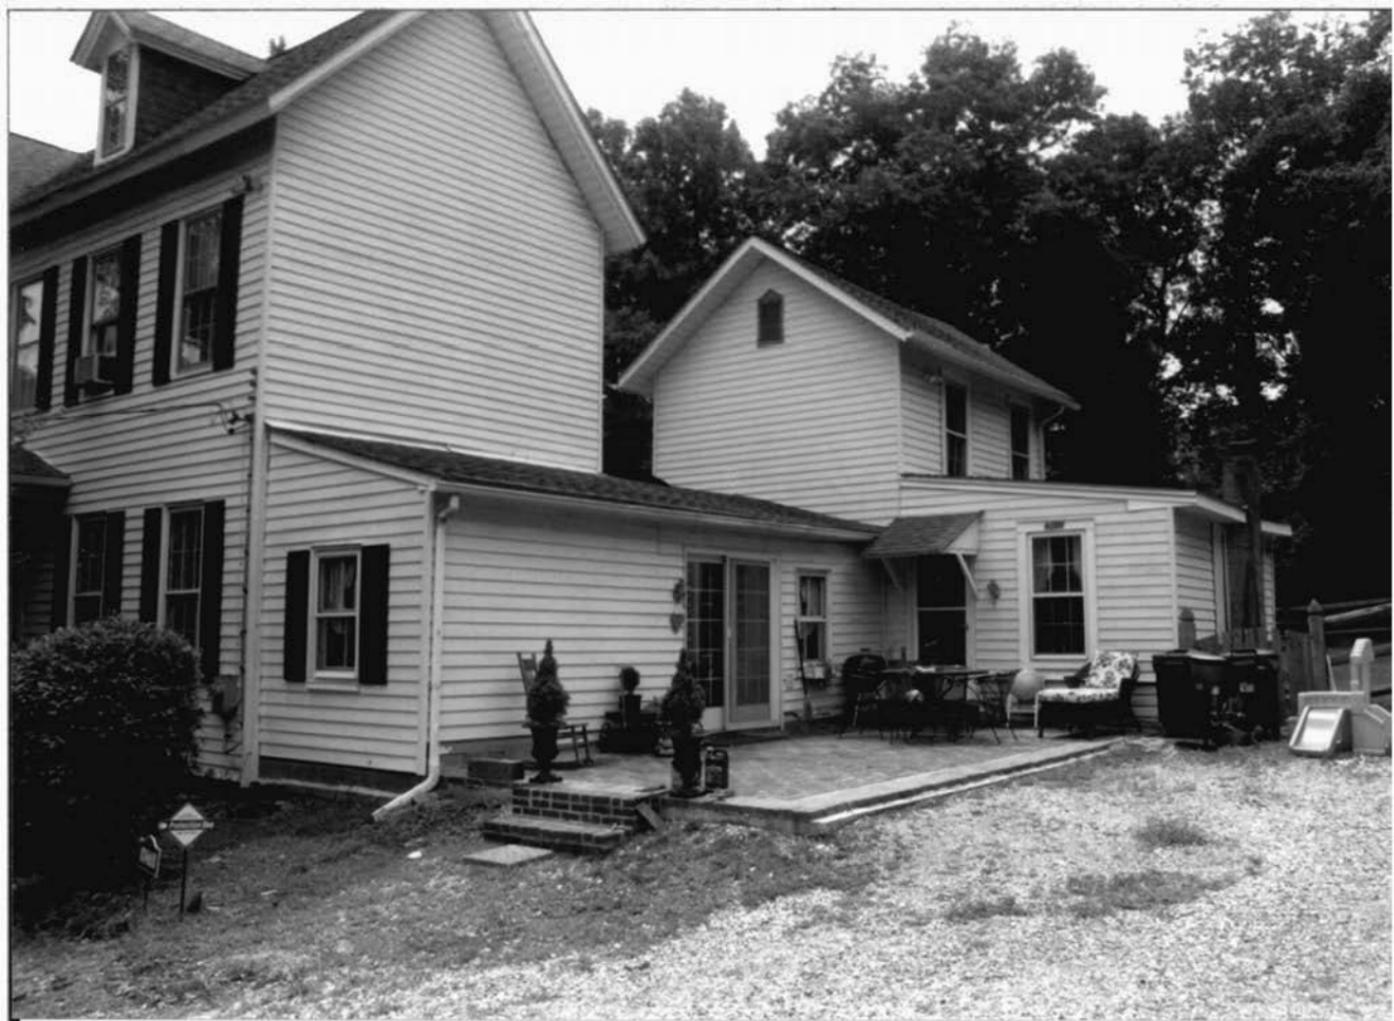
9 of 20

NW elevation of ms. base rear wing + attached
servants house.
