HO-788, First Discovery
6270 Winters Lane, Hanover
ca. 1857
Private

Maryland Inventory of Historic Properties Form

Inventory No. HO-788

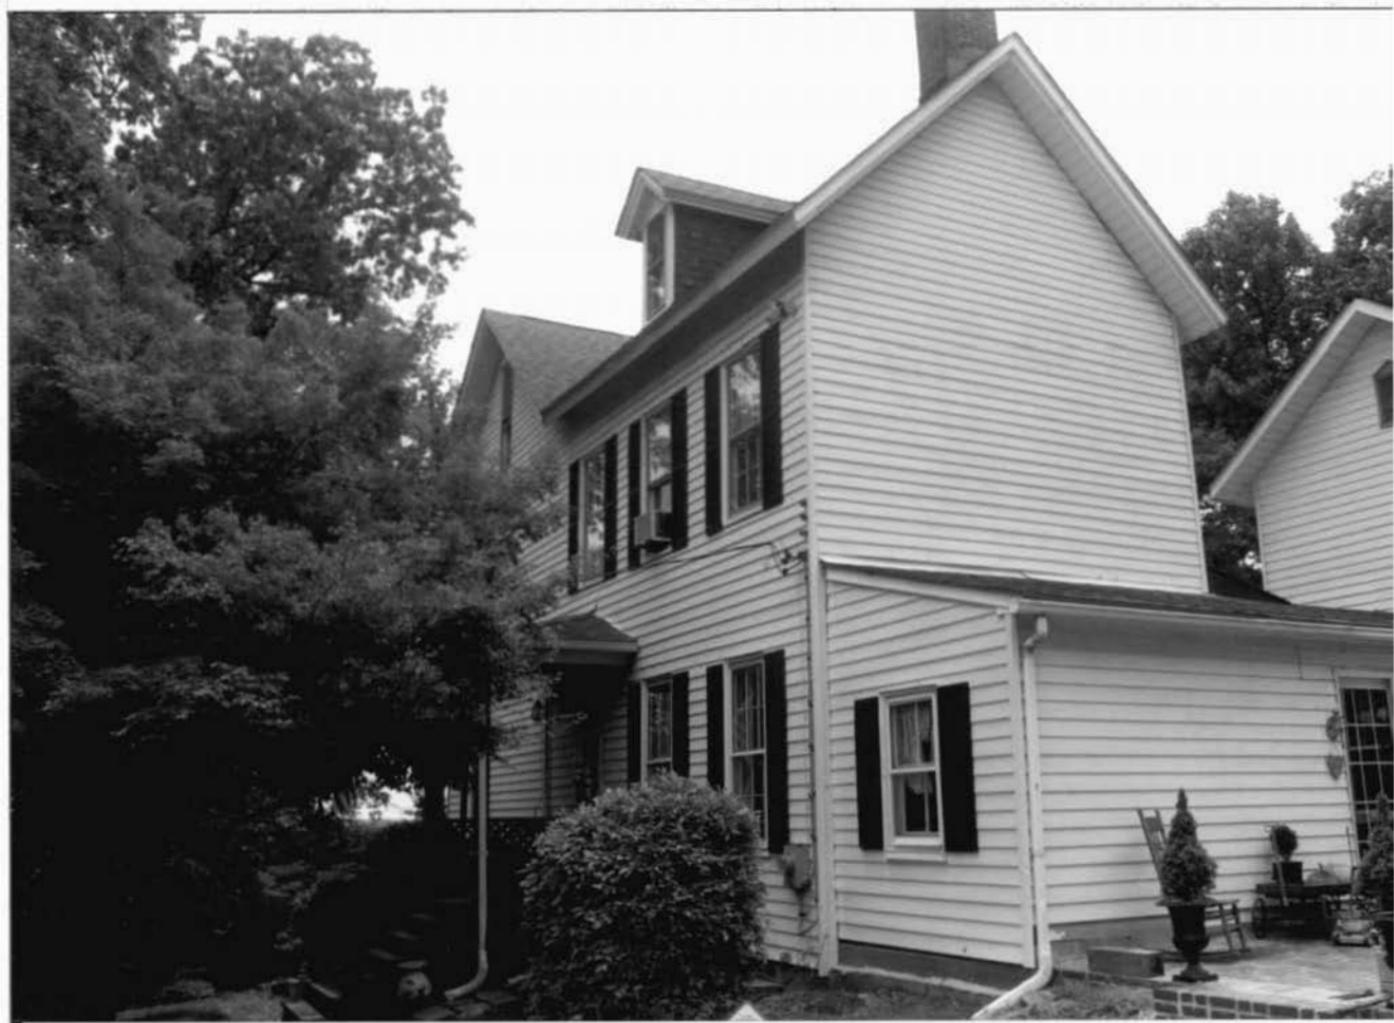
10 of 20

NW elevation of main house + servants house on the
right.

The north side façade of the house has one window on each story towards the front of the side gabled section of the house. These windows are both vertically aligned original 6/6 double hung windows. A 4/4 double hung window is located in the gable. The rear wing has three 6/6 windows on the second story vertically aligned above a door and two windows on the first story. A gabled dormer with a 4/4 double hung window is located on the slope of the roof. The door is sheltered by a hipped roof entry portico which has recently been rebuilt. A narrow one story shed roofed addition was made to the rear of the building and has one 2/2 window on the north side.

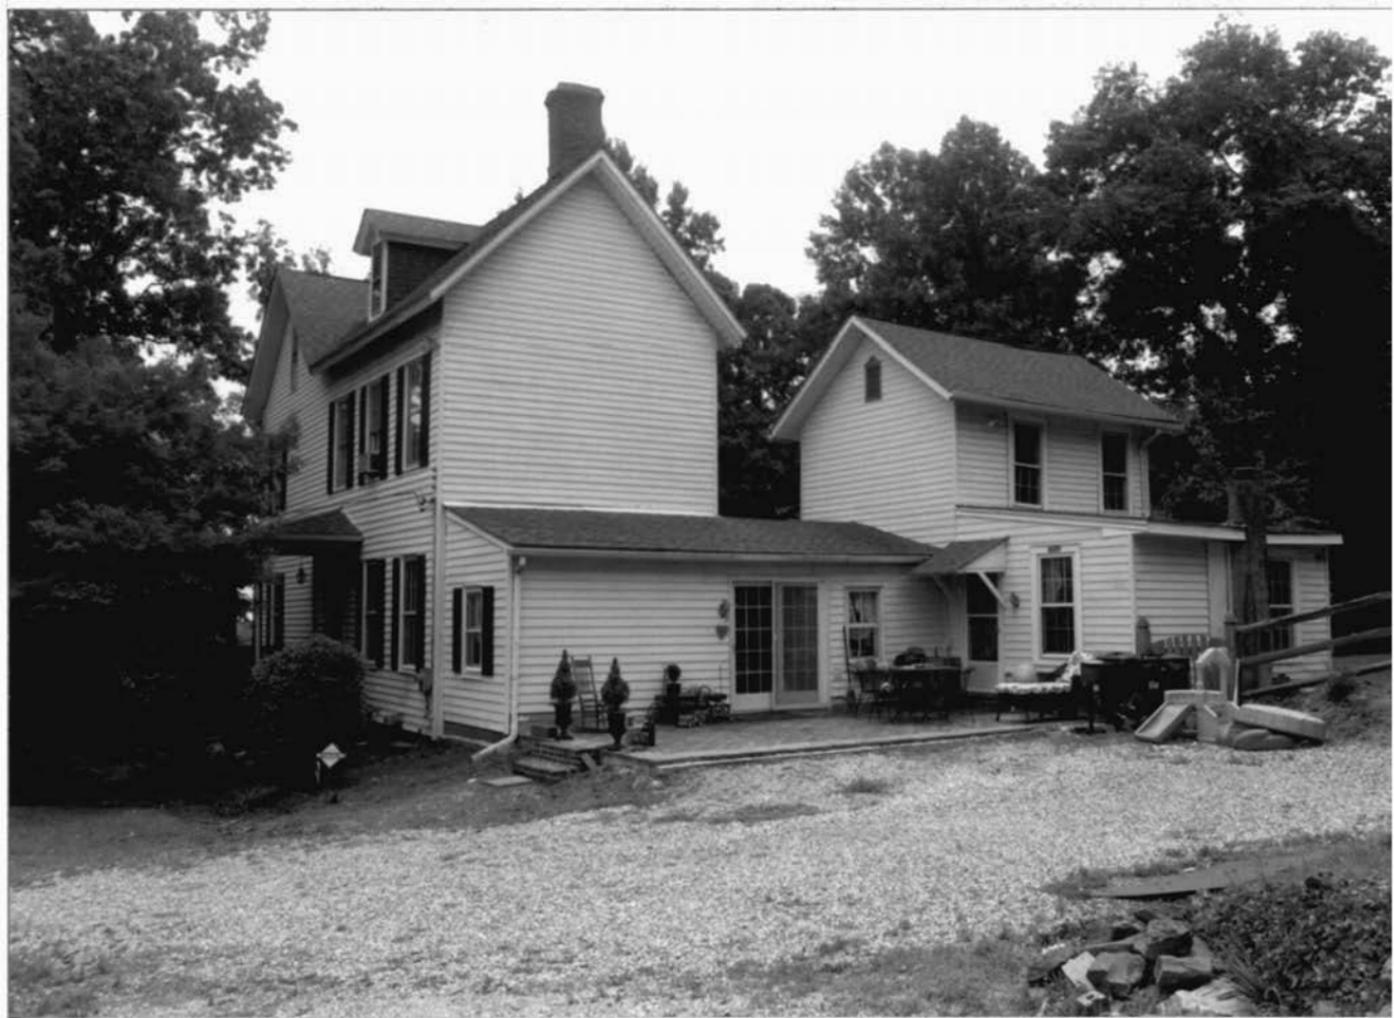
11 of 20

West elevation of main house + attached servants house.

A one-story shed roofed addition was made to the rear of the rear wing. It spans the full width of the wing and continues to connect with the servants' house to the south. The west façade of this addition has a modern sliding glass door and a modern vinyl window. The inset of the ell which originally contained a single story porch on both the west façade of the front section and the south façade of the rear wing according to early photographs, has been filled in with a single story shed roofed addition that runs from the southwest corner of the front part of the house to connect with the northeast corner of the servants' house. These two additions connect in the middle to form the hyphen connecting main house to servants' house.

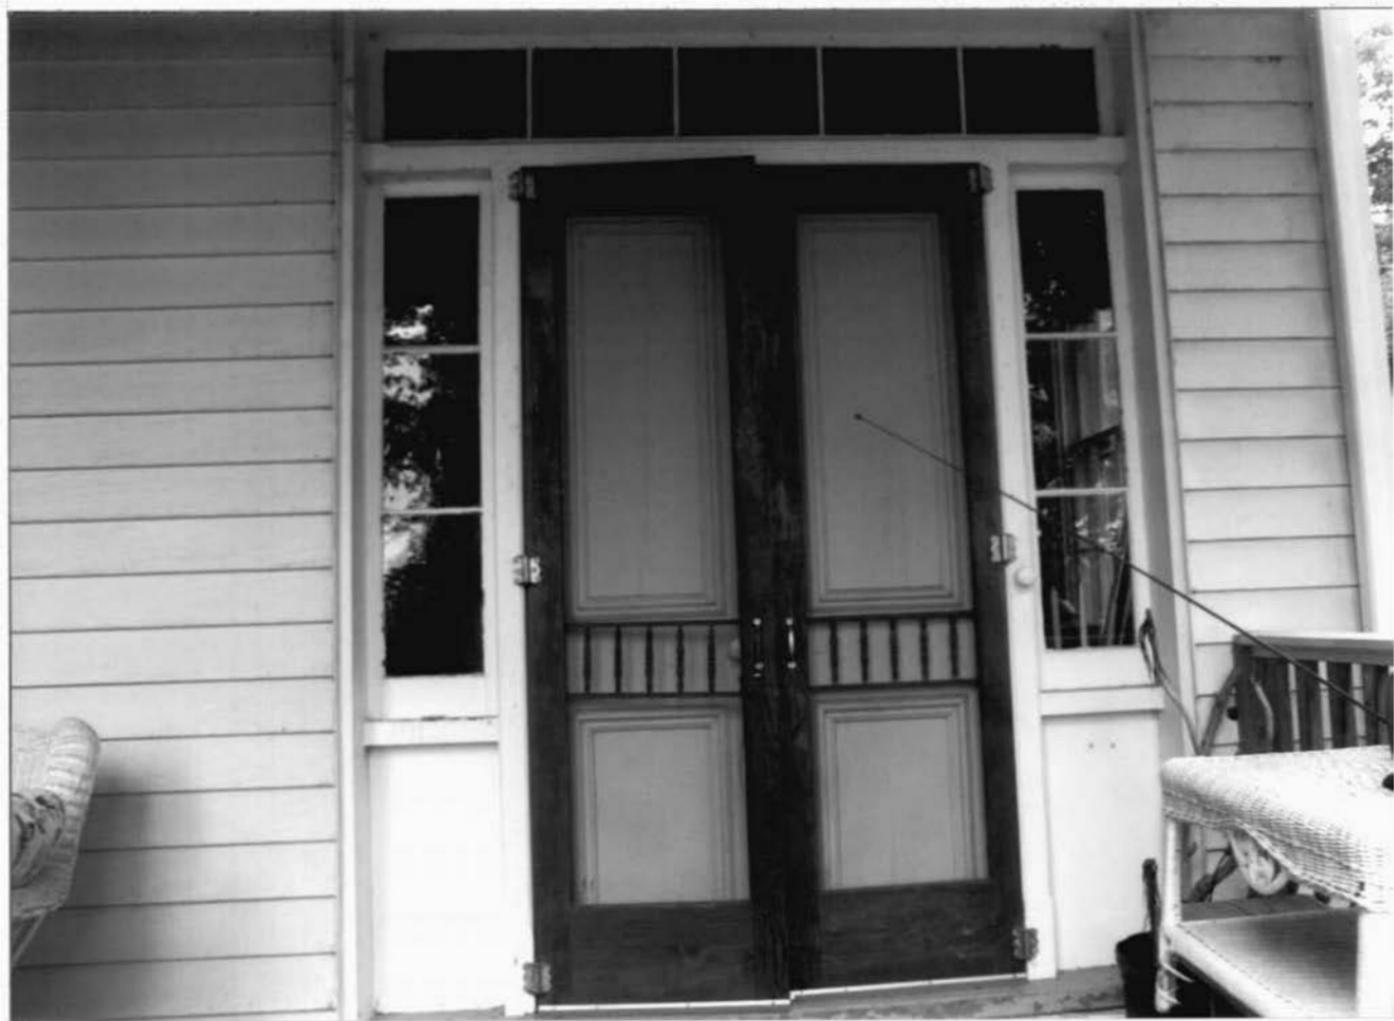
12 of 20

Front entrance, main house.

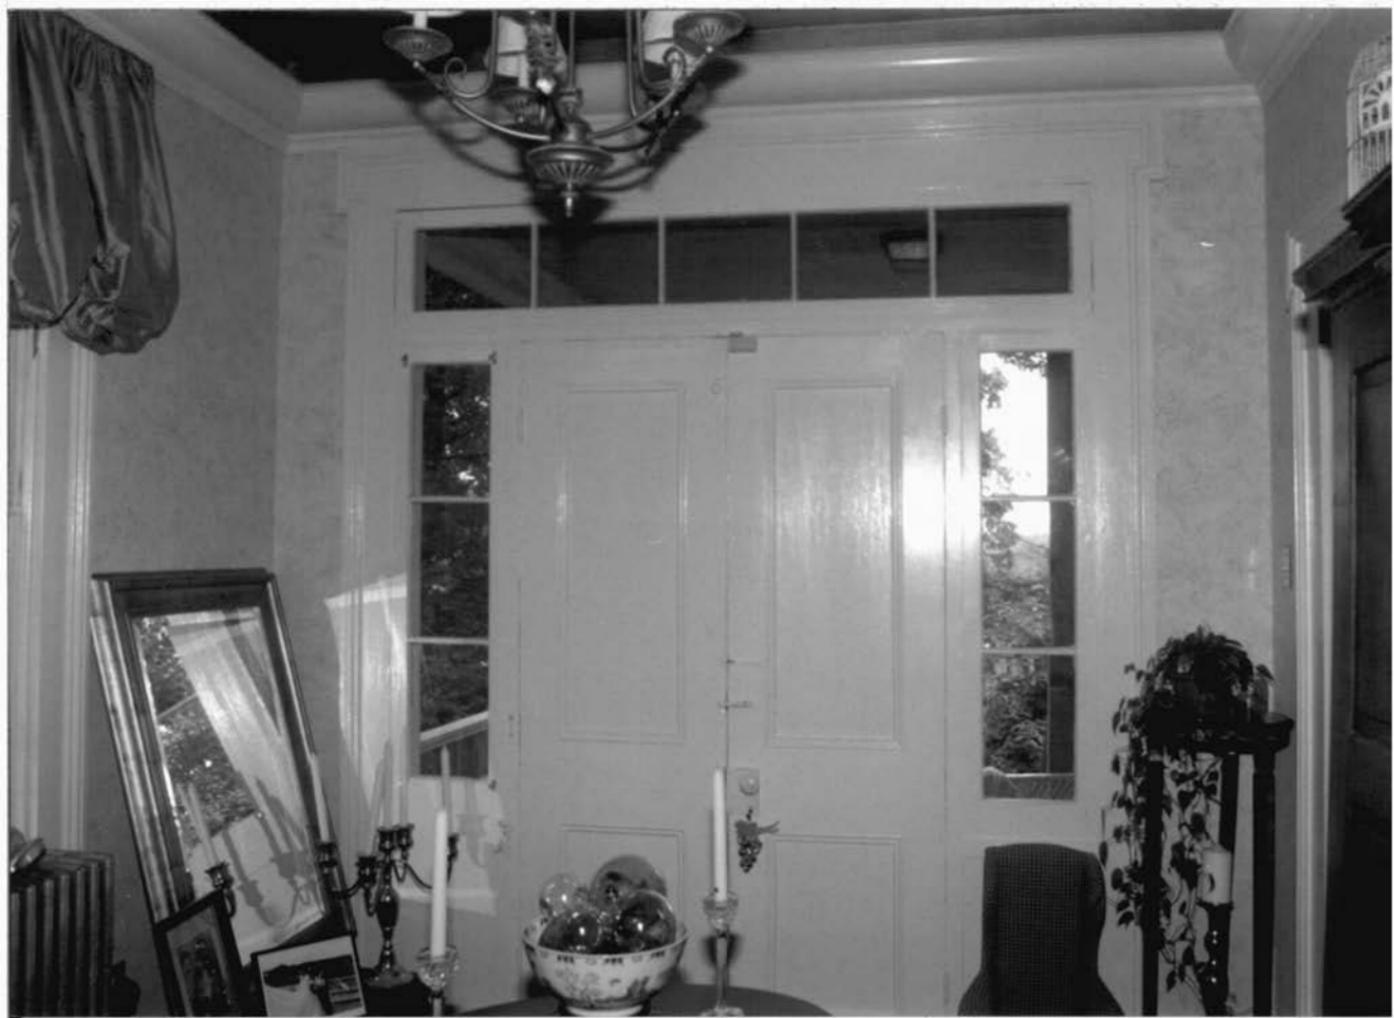
13 of 20

Interior of front entrance

The interior of the main house is in excellent condition and the current owners are carefully restoring its details. The front door enters into a small entry hall off of which doorways lead into the large parlor to the left and the stair hall located directly behind the entry hall. The large parlor features large 6/6 windows, almost floor to ceiling, and a fireplace on the north (interior) wall of the room. Twin doorways on either side of the fireplace lead into the entry hall and the stair hall. A dining room is located behind the stair hall in the rear ell of the house. From the dining room, you enter the redone hyphen which features a family room where the back porch used to be and the kitchen in the single story shed roofed addition on the rear of the rear wing. A step up leads into the servants' house. There are no original mantles left in the main house – story has it that the family needed money in the 1930's and sold the mantles and all the door hardware. The original door and window surrounds do survive, however, and, on the first floor, feature an eared Greek Revival shape with an architrave with an ogee and beveled fillet molding. The baseboards on the first floor also feature an ogee and beveled fillet molding. The original heart pine floors are exposed on the first floor of the main house. The existing crown molding and mantles are not original. The stair, however, is all original and an excellent example of the Greek Revival style. The curving open stringer has scrolled stair end decoration and a large, elaborately turned newel post. Stair balusters are also turned.

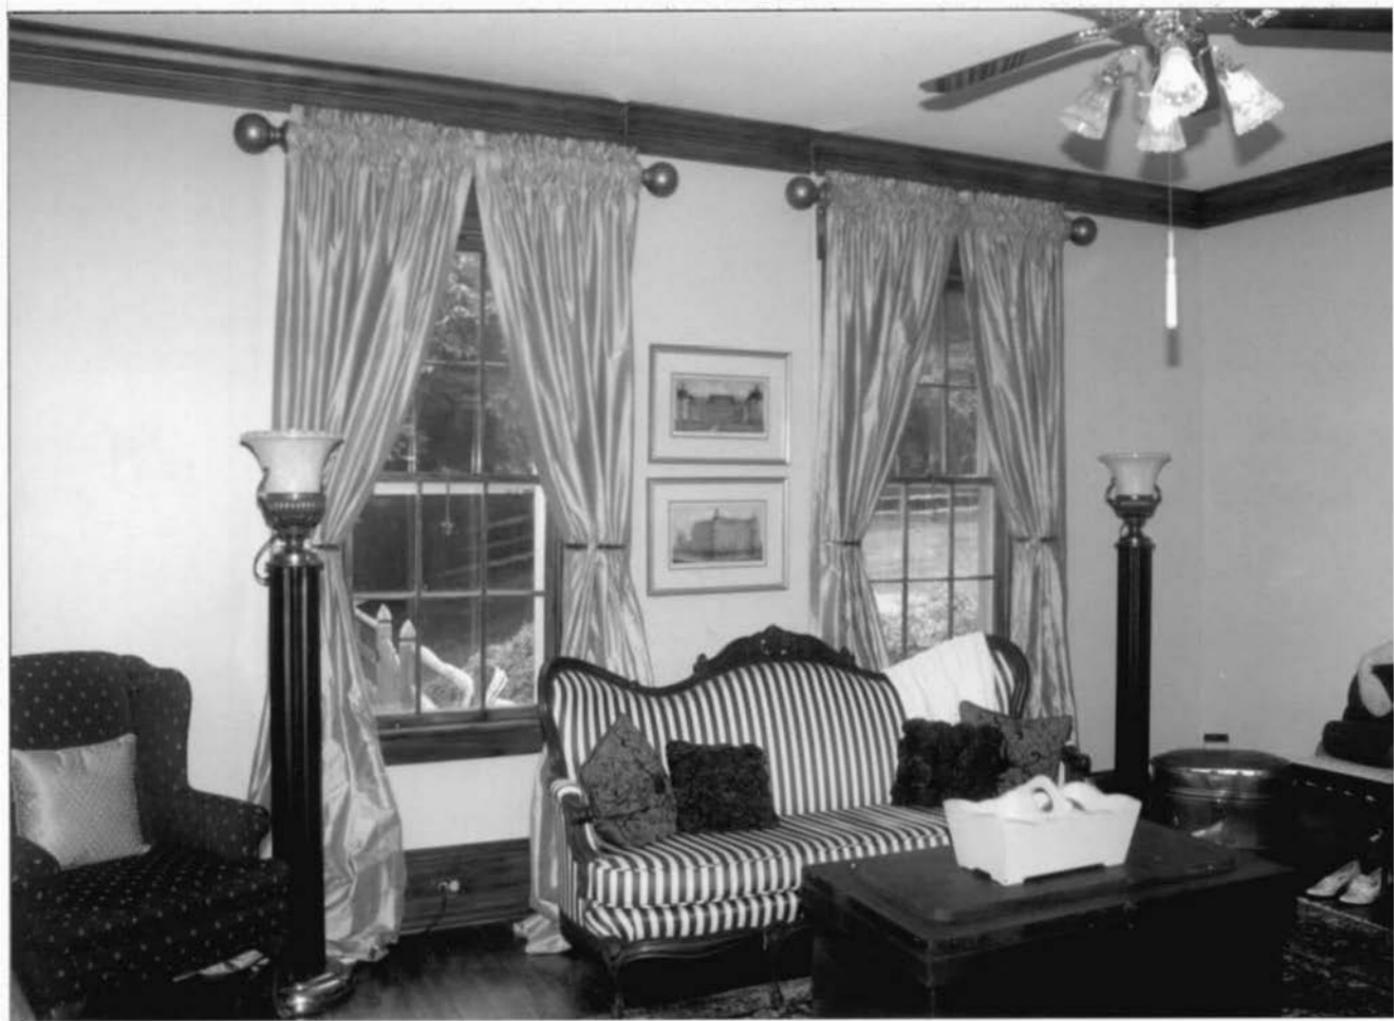
14 of 20

Interior of front parlor.

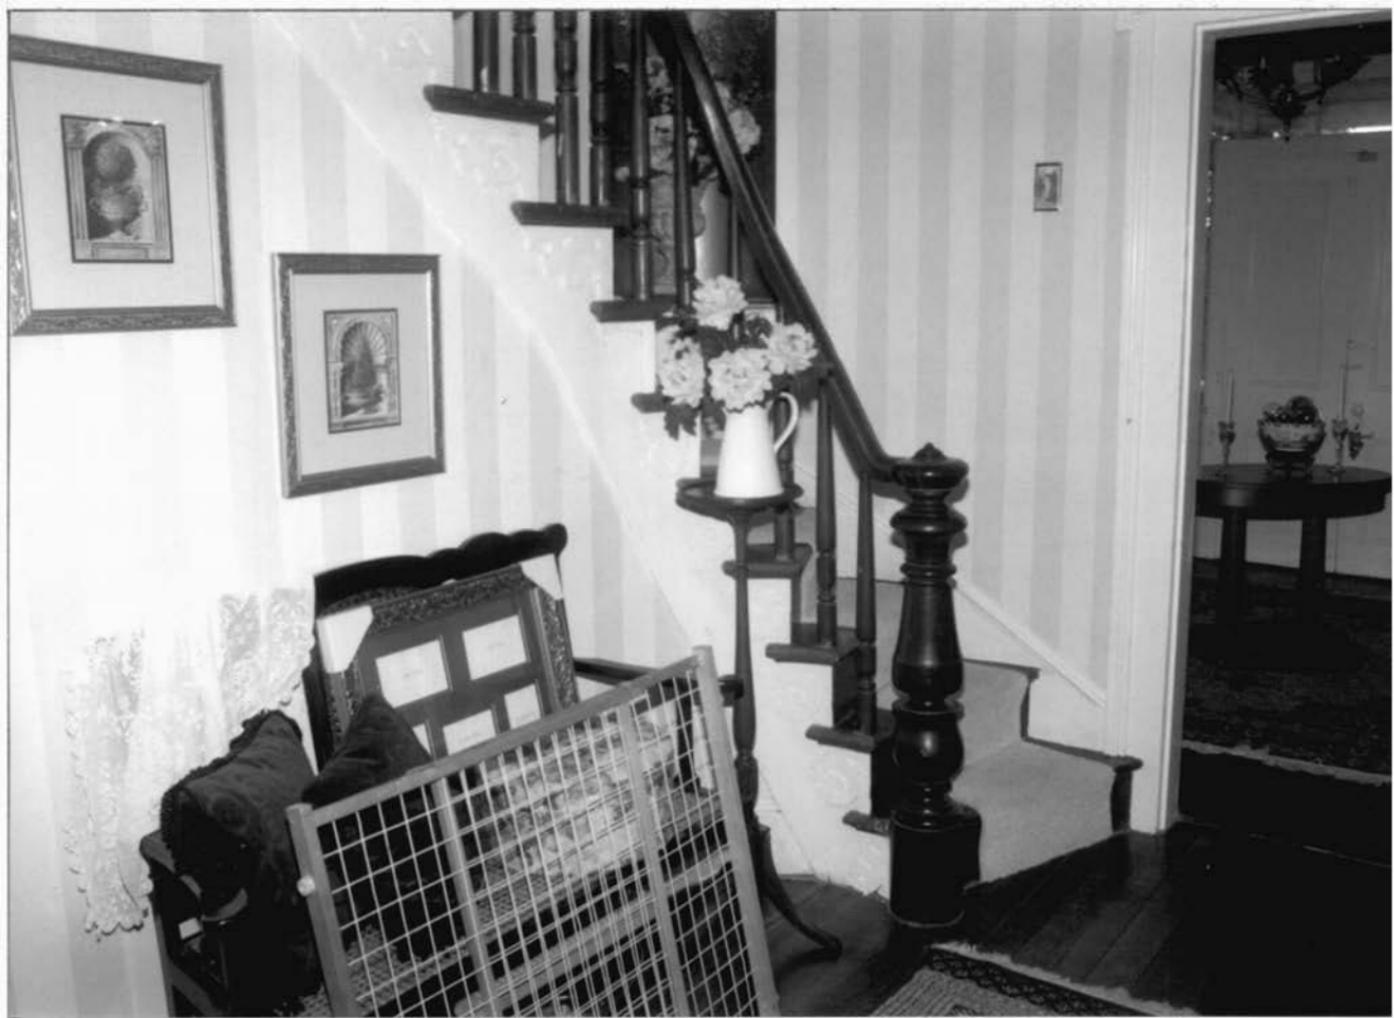
15 of 20

Main Stair.

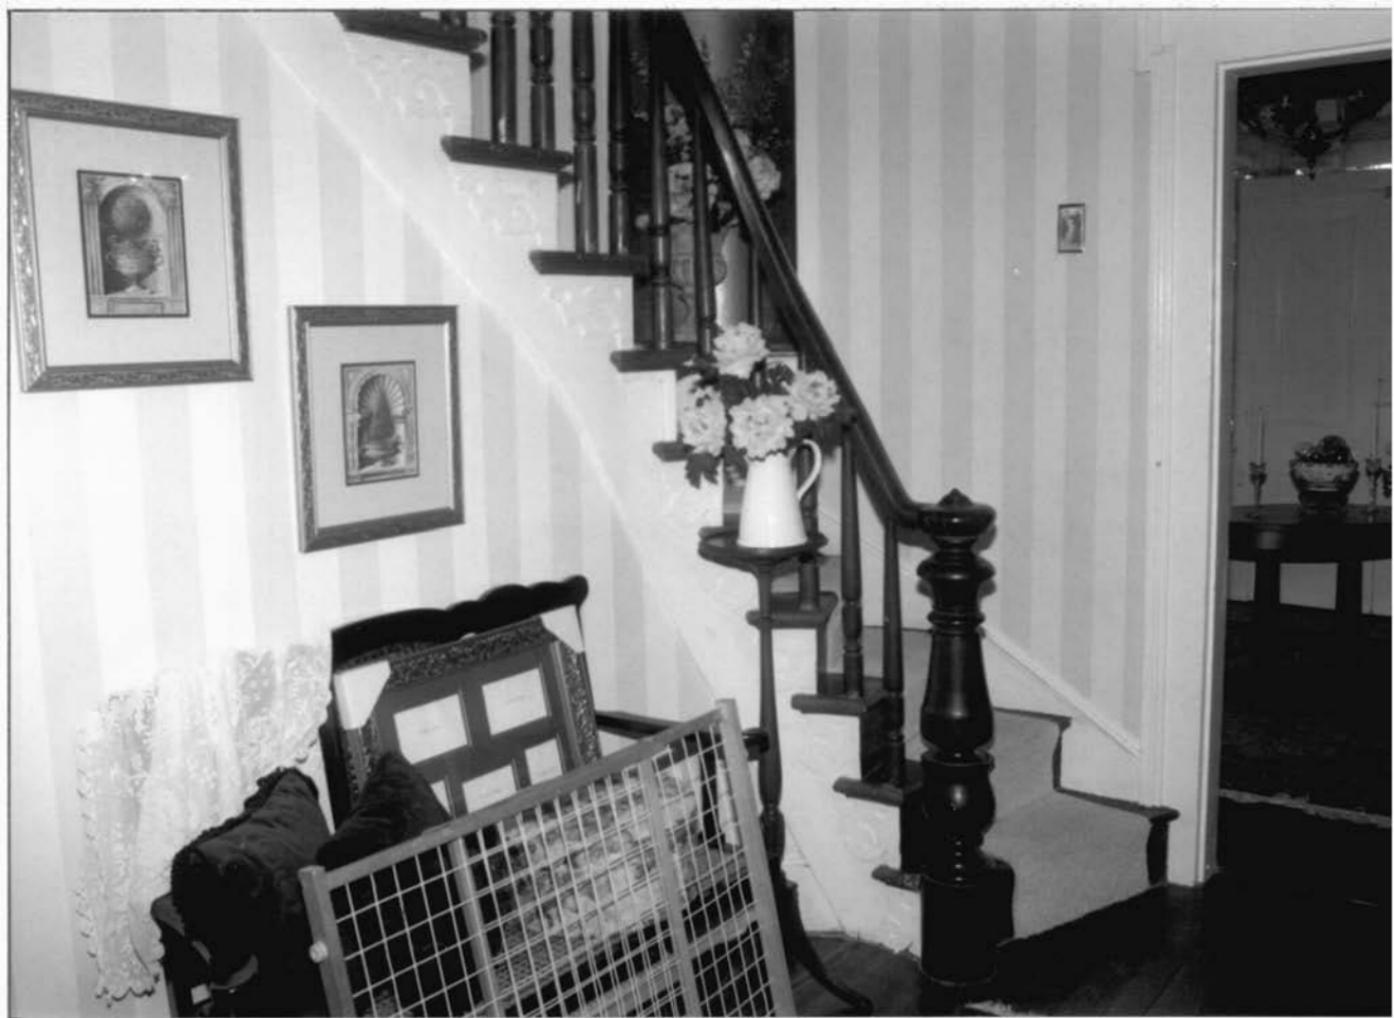
16 of 20

Main stair.

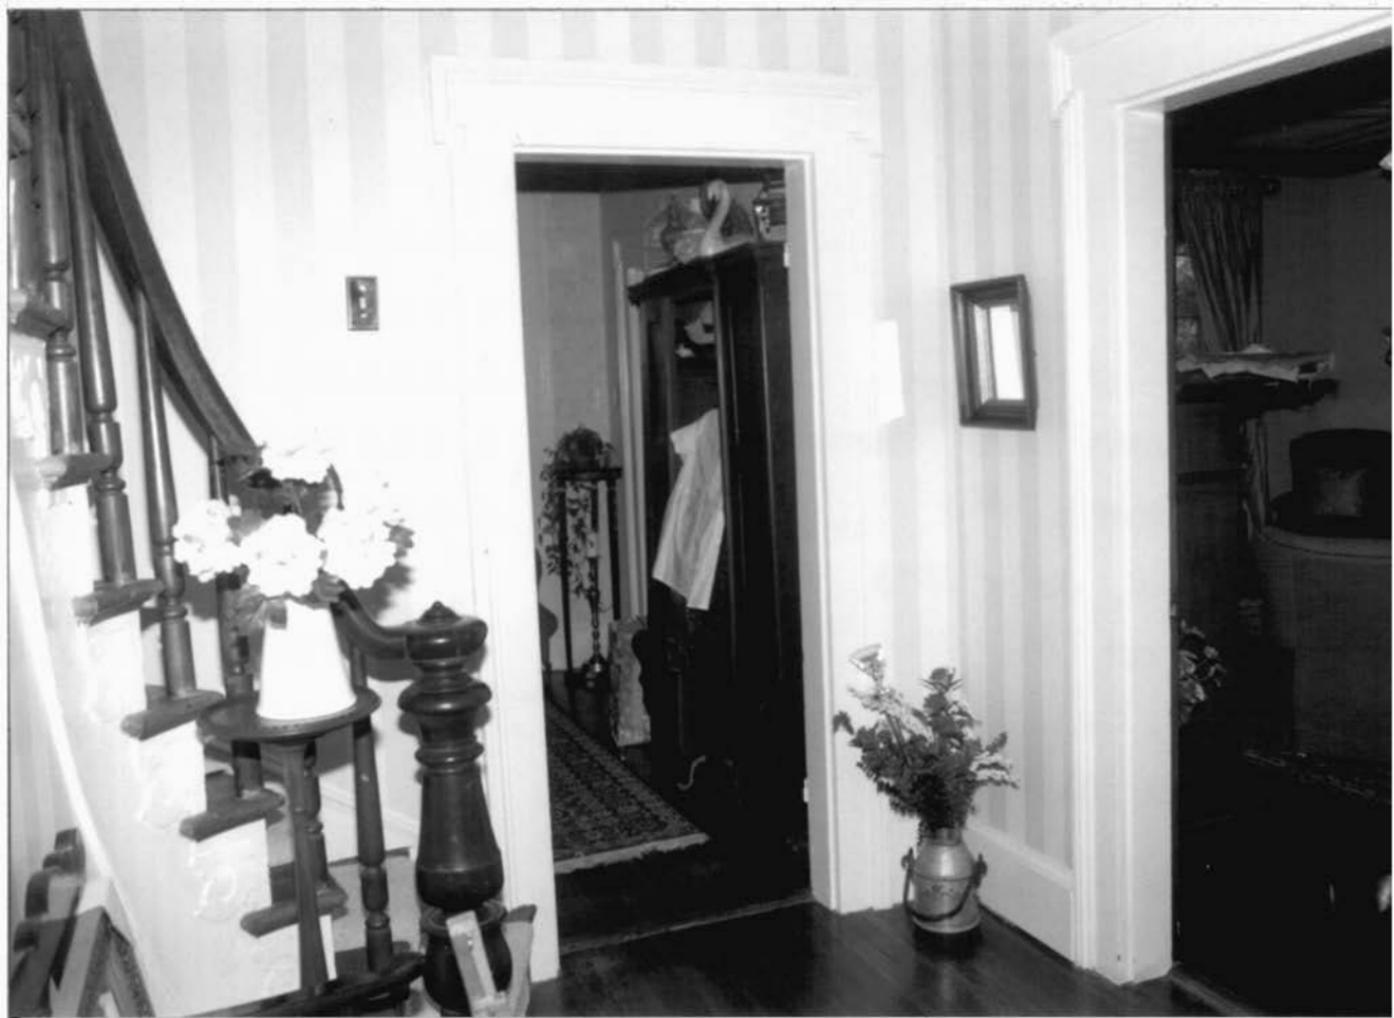
17 of 20

Main house, stair hall. Looking through doorway to
entry hall and parlor.

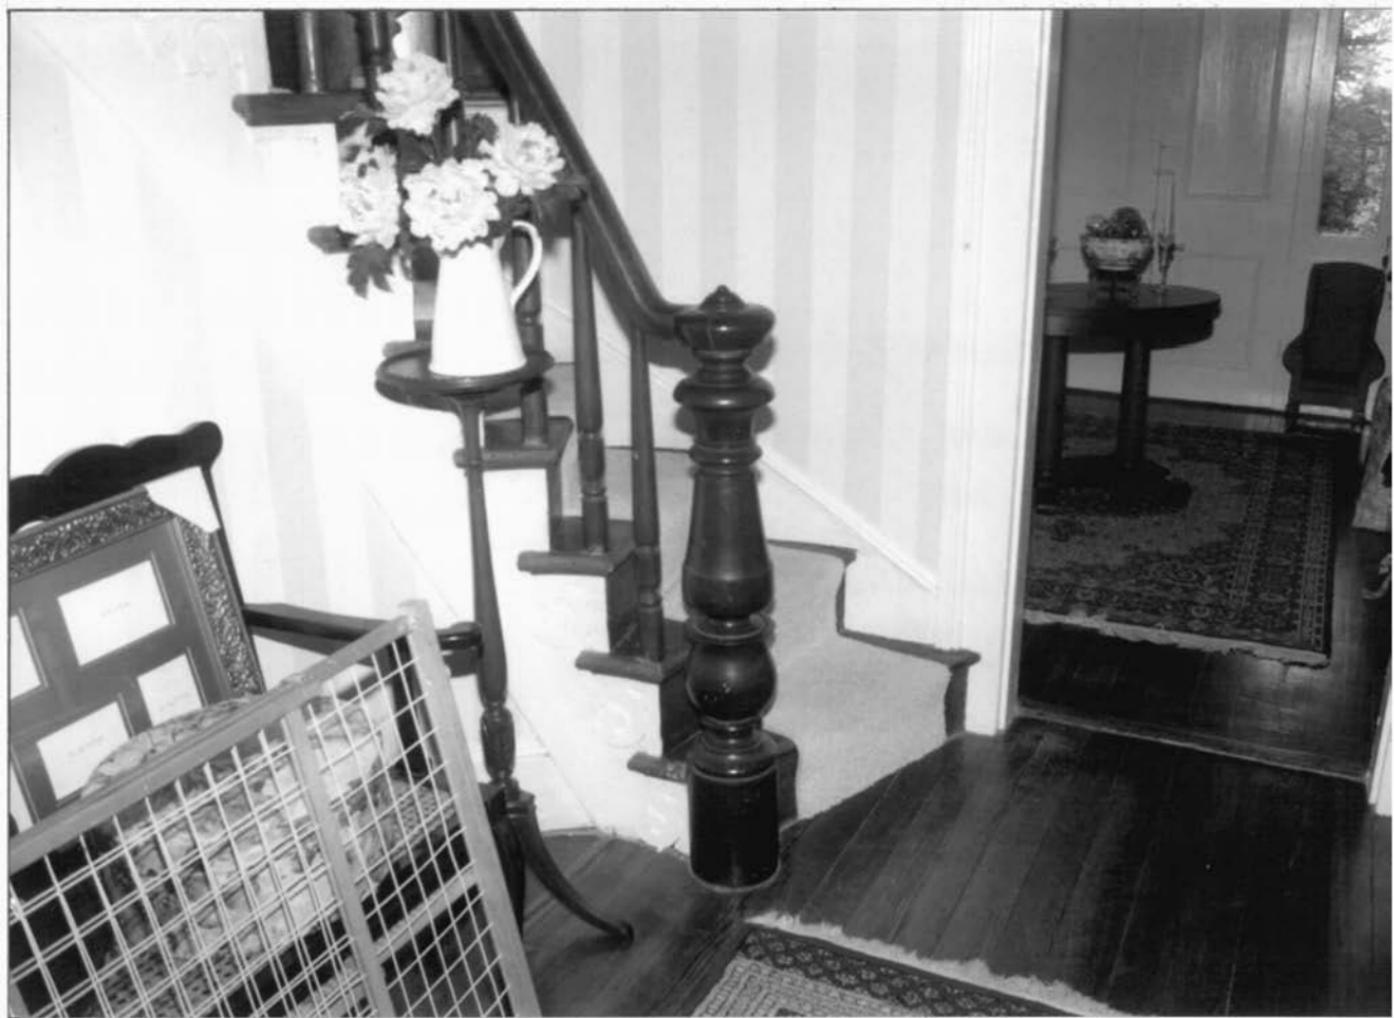
18 of 20

Stair, close up of nest/pest.

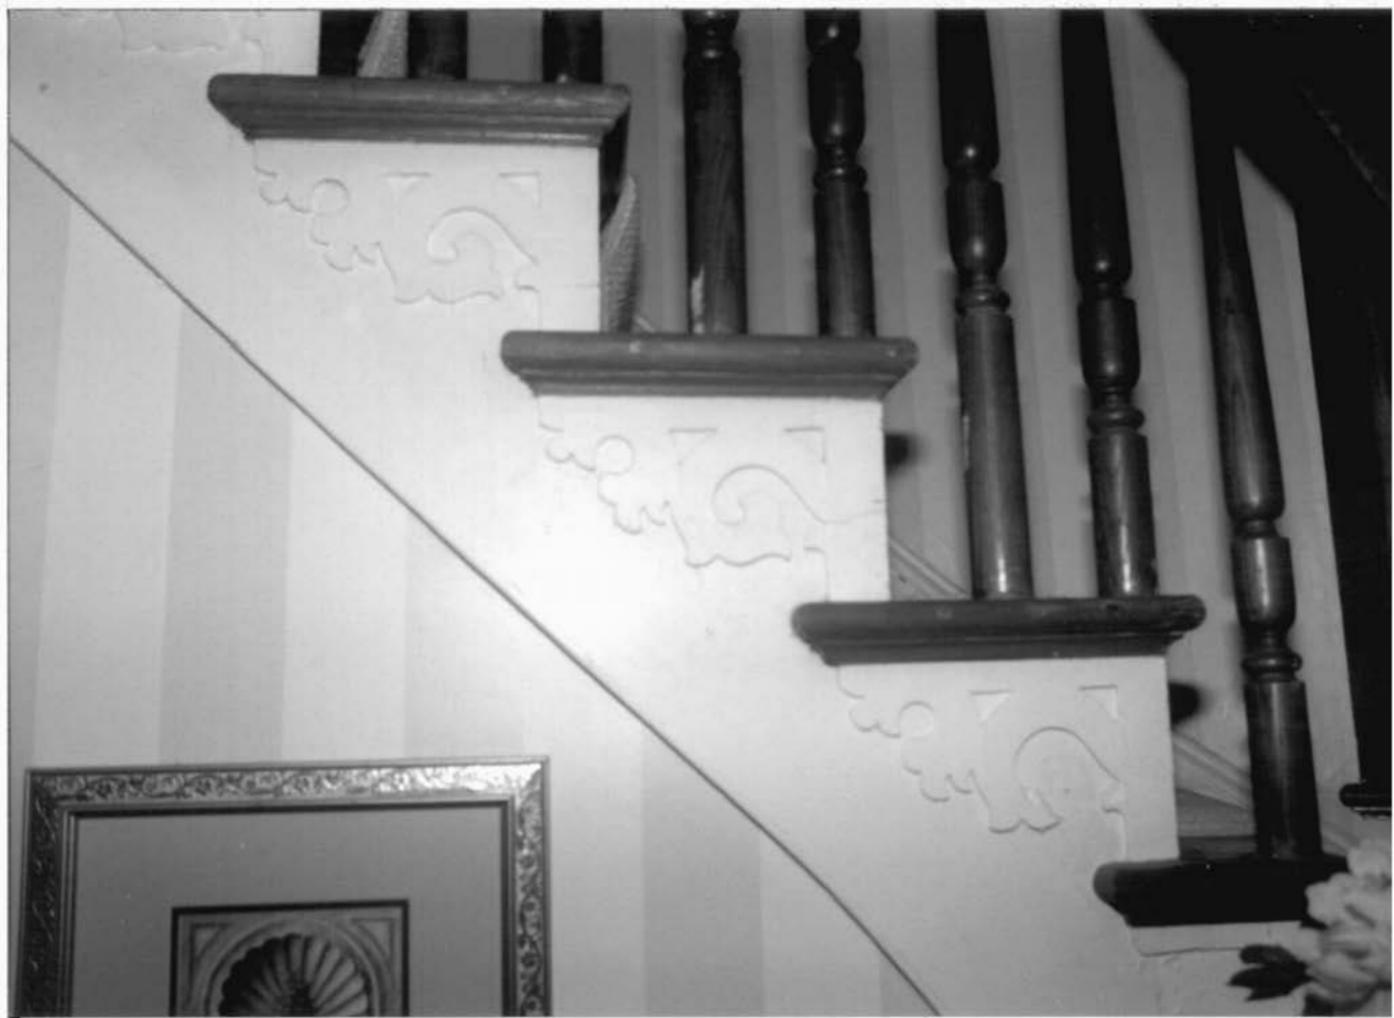
19 of 20

Close up of stair end decoration.

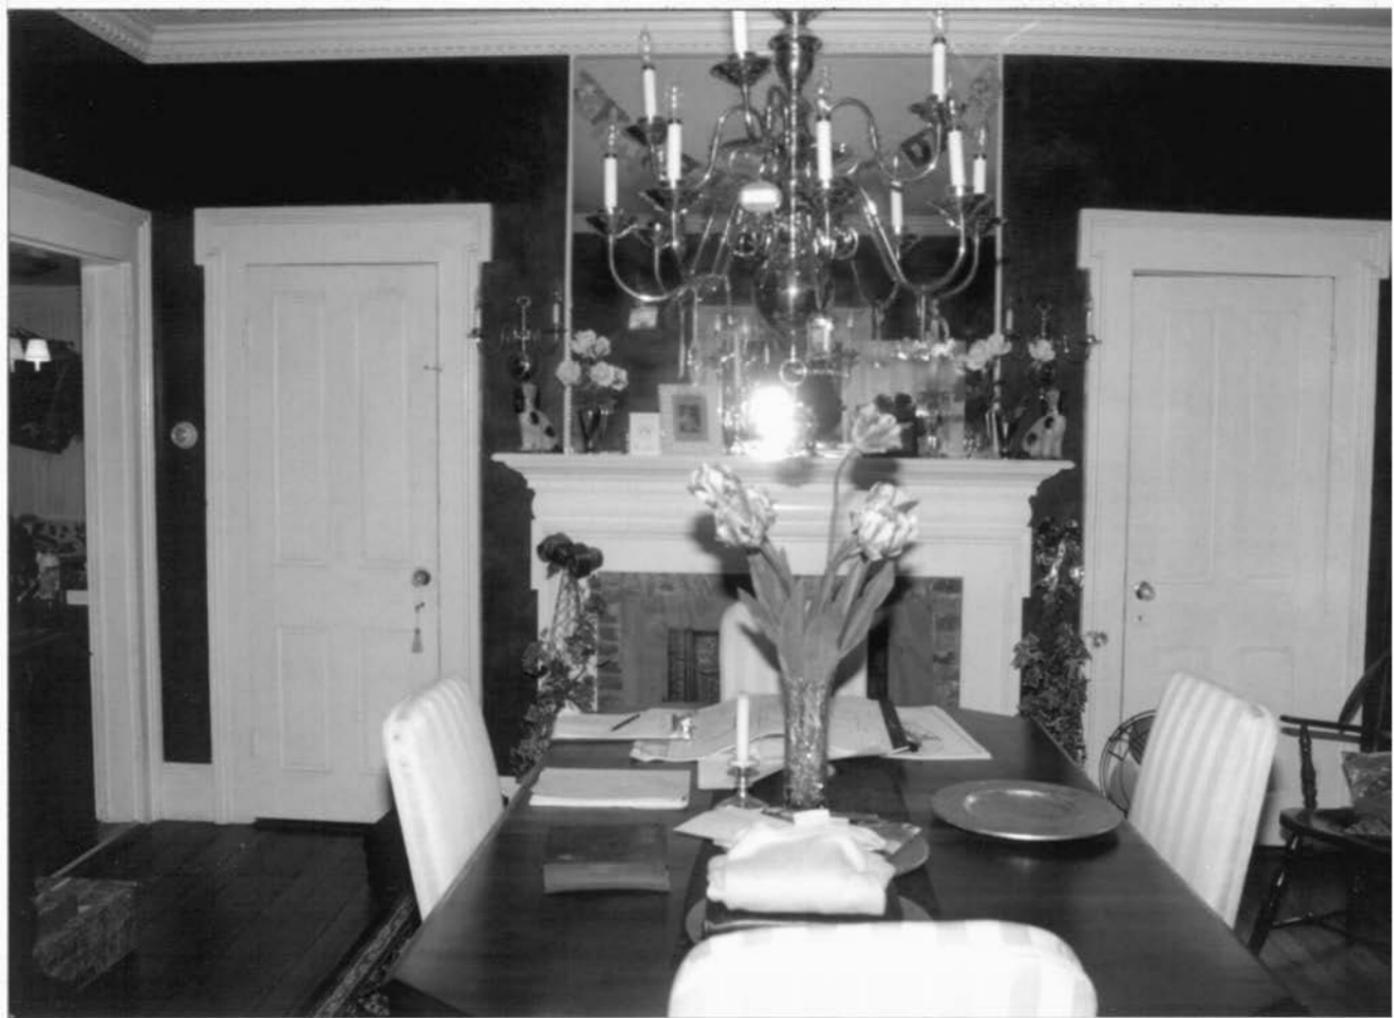
20 of 20

Dining room (located in rear wing). Showing eated
bird. Groove door towards. Mantle is not damaged
