K-183

Chesterville Store and Post Office
Chesterville
4th quarter 18th Century

Maryland Historical Trust State Historic Sites Inventory Form

and/or common Chesterville Store and Post Office

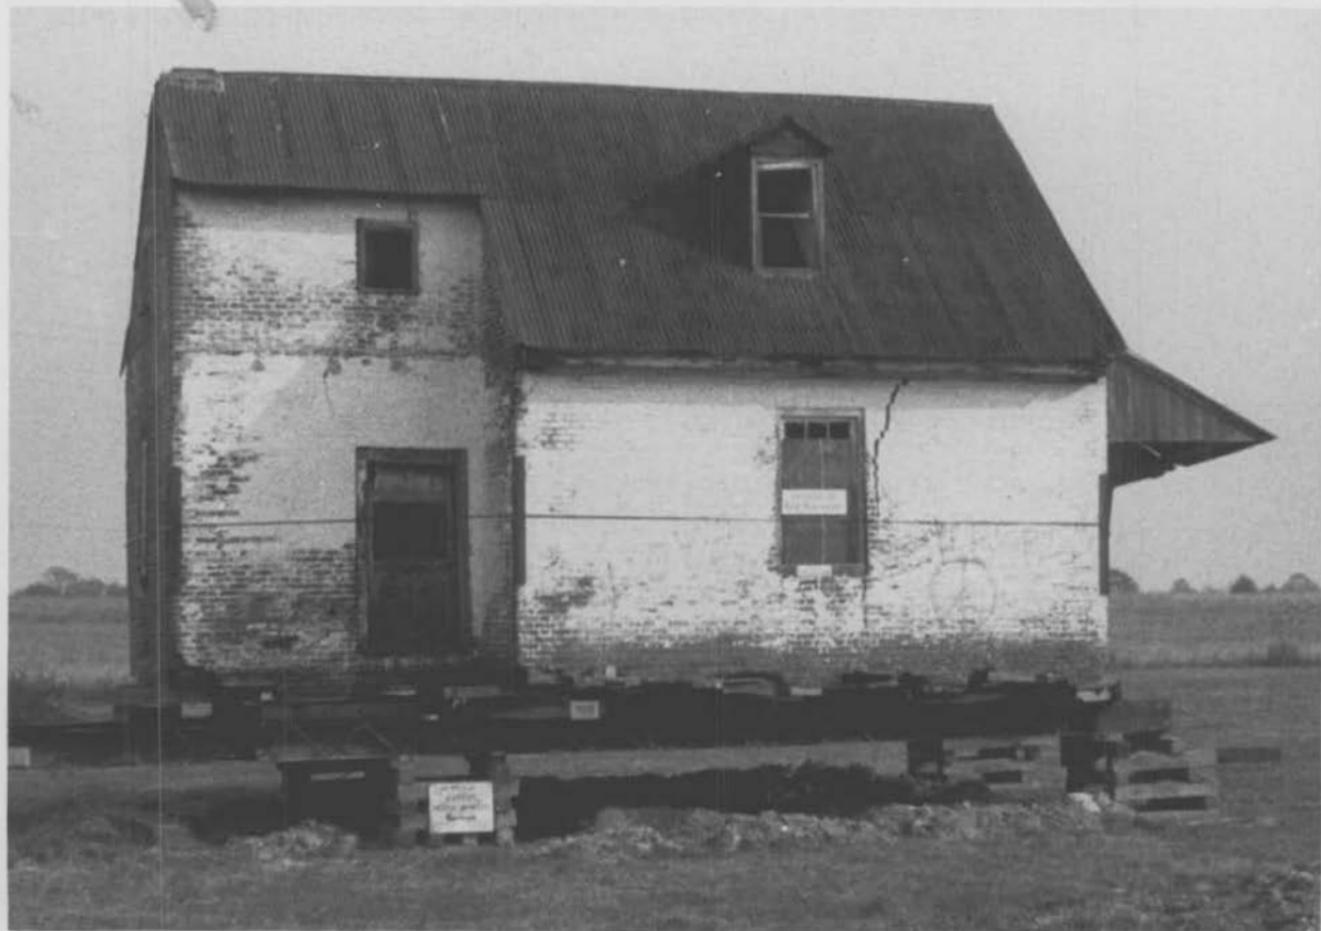
K. 183

This building, once the Chesterville Post Office, has been saved from demolition and will be restored as a Kent County information center at its new site on U. S. Route 301 at Millington.
