# National Register of Historic Places Registration Form

historic name WHITE HOUSE FARM  
other names/site number K-203

street & number State Route 213 N/A  not for publication  
city, town Chestertown  vicinity  
state Maryland code MD county Kent code 029 zip code 21620

United States Department of the Interior  
National Park ServiceNational Register of Historic Places  
Continuation SheetWhite House Farm  
Kent County  
Maryland

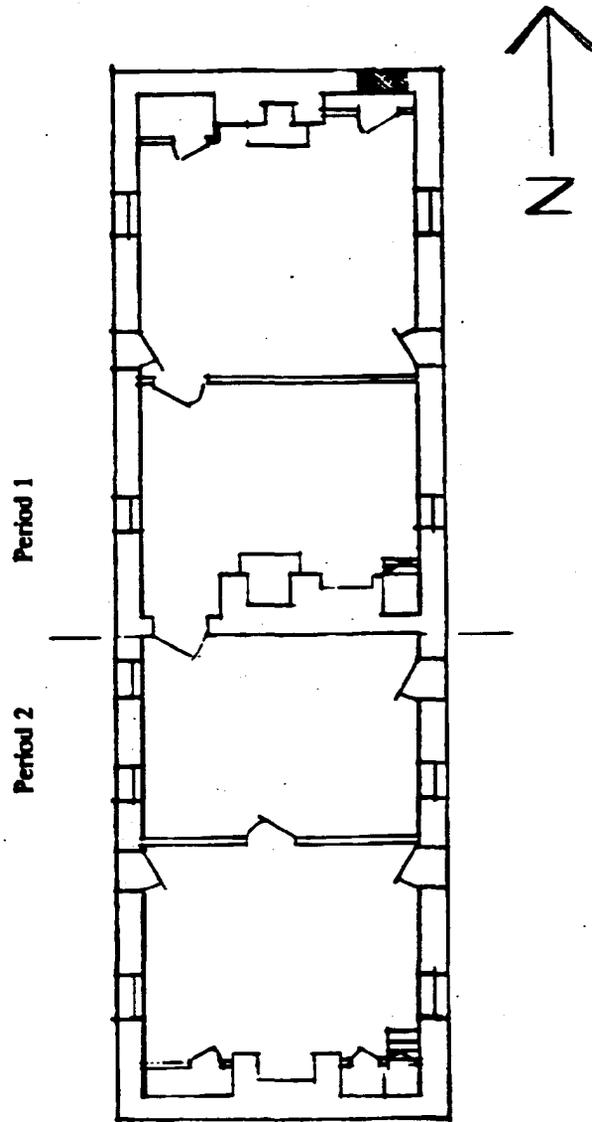
**WHITE HOUSE FARM (K-203)**  
Kent County, Maryland

sketch plan  
not to scale

The interior of the main house consists of a hall-parlor plan with the larger hall to the north and the parlor, or "inner room," to the south. Fireplaces are centered on the exterior gable wall of each of these rooms, and each room also originally had an enclosed winder stair next to the chimney. The stair in the hall has been removed to accommodate a modern bath, but the stair enclosure, door and door trim have been retained on both the main floor and in the hall chamber above.

The wing, four irregular bays wide, extends to the south. The main floor of the wing consists of a dining room one step down from the floor level of the main house, and a kitchen at the south end, now with a brick paved floor set level with the dining room. The trim in both rooms is consistent with that found elsewhere in the house; the kitchen fireplace has been rebuilt. The window in the south bay of the east wall retains early 9/9 sash.

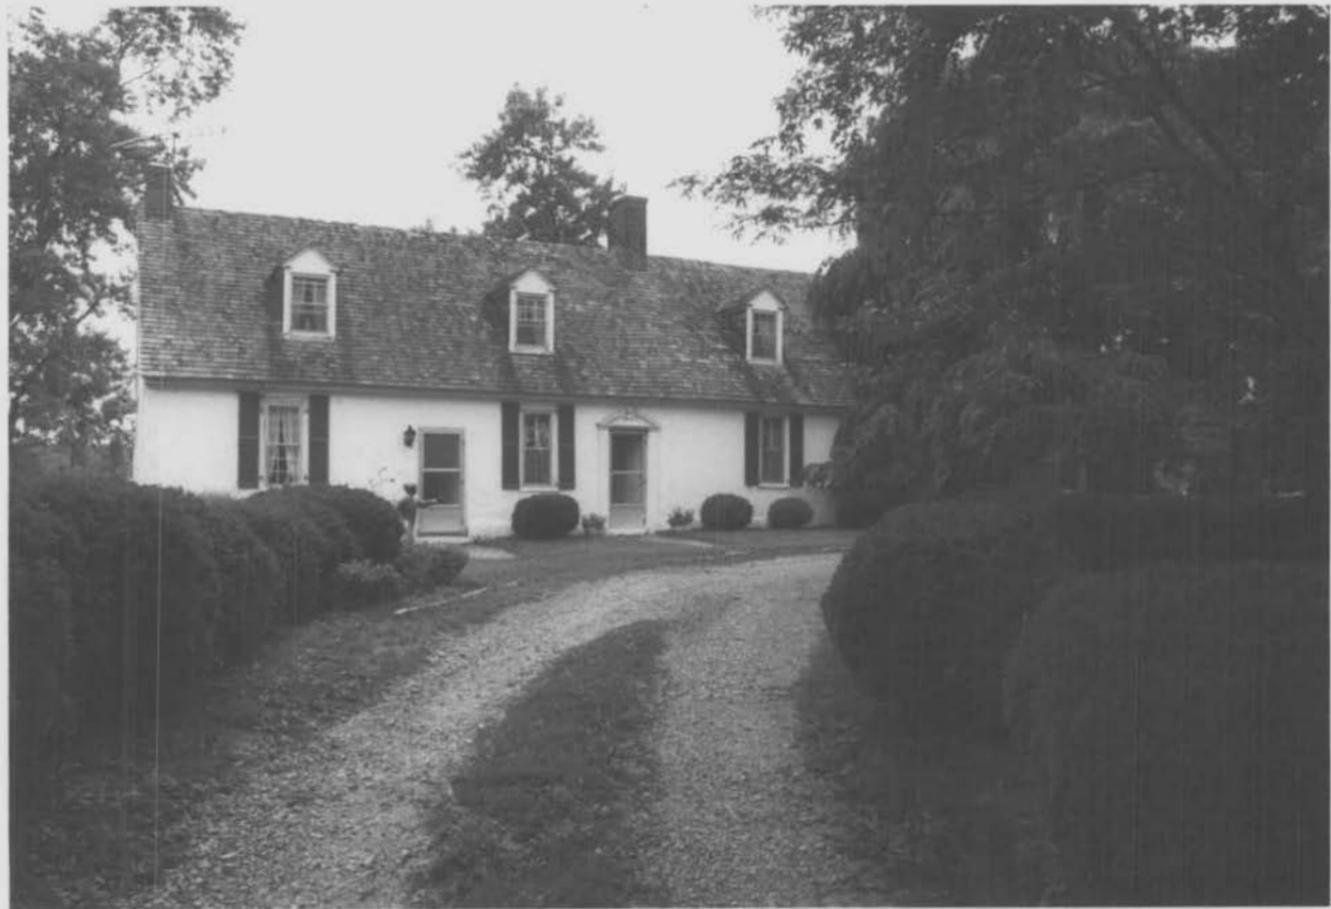
# 1 OF 8

EAST FACADE

The brickwork of the house is partially obscured by stucco rendering. The entire east facade of both parts is covered in this way, but the plain watertable remains evident. Faint traces of rustication are visible in the stucco, largely obscured by thick coats of whitewash, paint, and later plaster. The stucco also provides the outline of a lower gable-roofed wing, approximately 17 feet 6 inches wide, that at one time projected from the north gable of the main house. When this wing was demolished (long ago), it revealed the original Flemish bond brickwork and plain water table of the original north gable, as well as the date 1721 in glazed bricks. A cut-in door that permitted direct access from the original house to the former wing was bricked up but remains visible today.

The fenestration of the original house is typical of early hall-parlor plan houses in this region. The entrance doors are located near the center of the facades, each flanked by a single window to either side. The entrances are fitted with six-panel doors with late Federal or early Greek Revival panel molds. The early window sash was replaced in the 19th century with 4-over-4 sash. There are two pitched dormers on each facade of the main house, each aligned with a first-floor window. The dormers retain 6/6 sash and are decorated with routed pilasters, Greek Revival cap pieces, and cornices that return at the pilasters. Other significant exterior features include a handsome complex cornice with bed mold and crown mold that extends the entire length of both facades, three different periods of shutter dogs including one early hand-wrought rat-tail dog, and a clear outline of the gable-roofed structure that once protected the bulkhead cellar entrance.

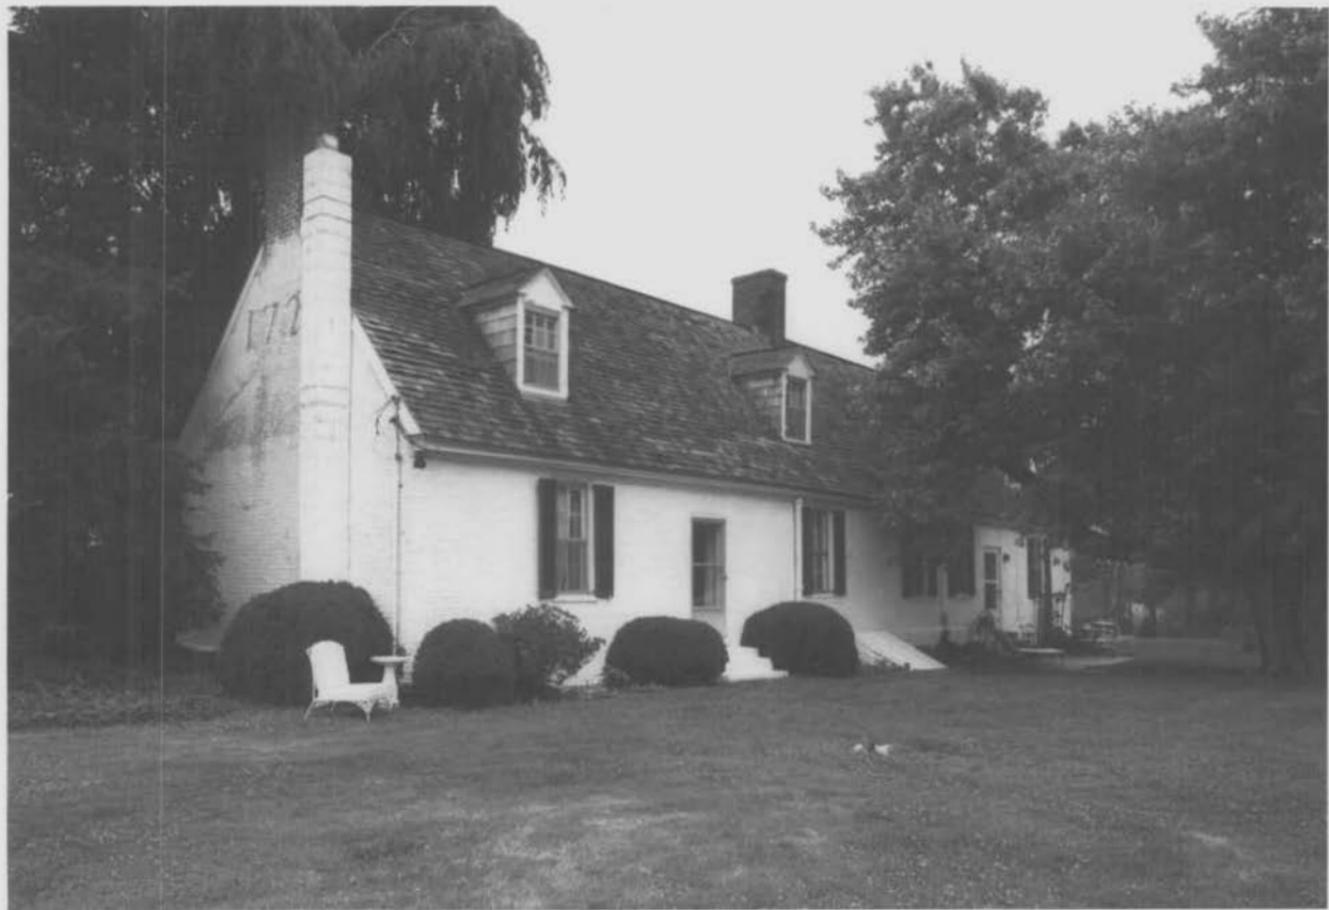
# 2 OF 8

WEST ELEV. & NORTH GABLE

The rear or west facade of the main house has been partially rebuilt, probably in the second quarter of the 19th century. This rebuilt section is not immediately apparent due to the heavy accumulation of whitewash and paint, but a comparison of original work at the south end of this facade, above the bulkhead cellar entrance, reveals early Flemish bond and a plain water table in contrast to the later work, laid primarily in stretcher bond with occasional header courses.

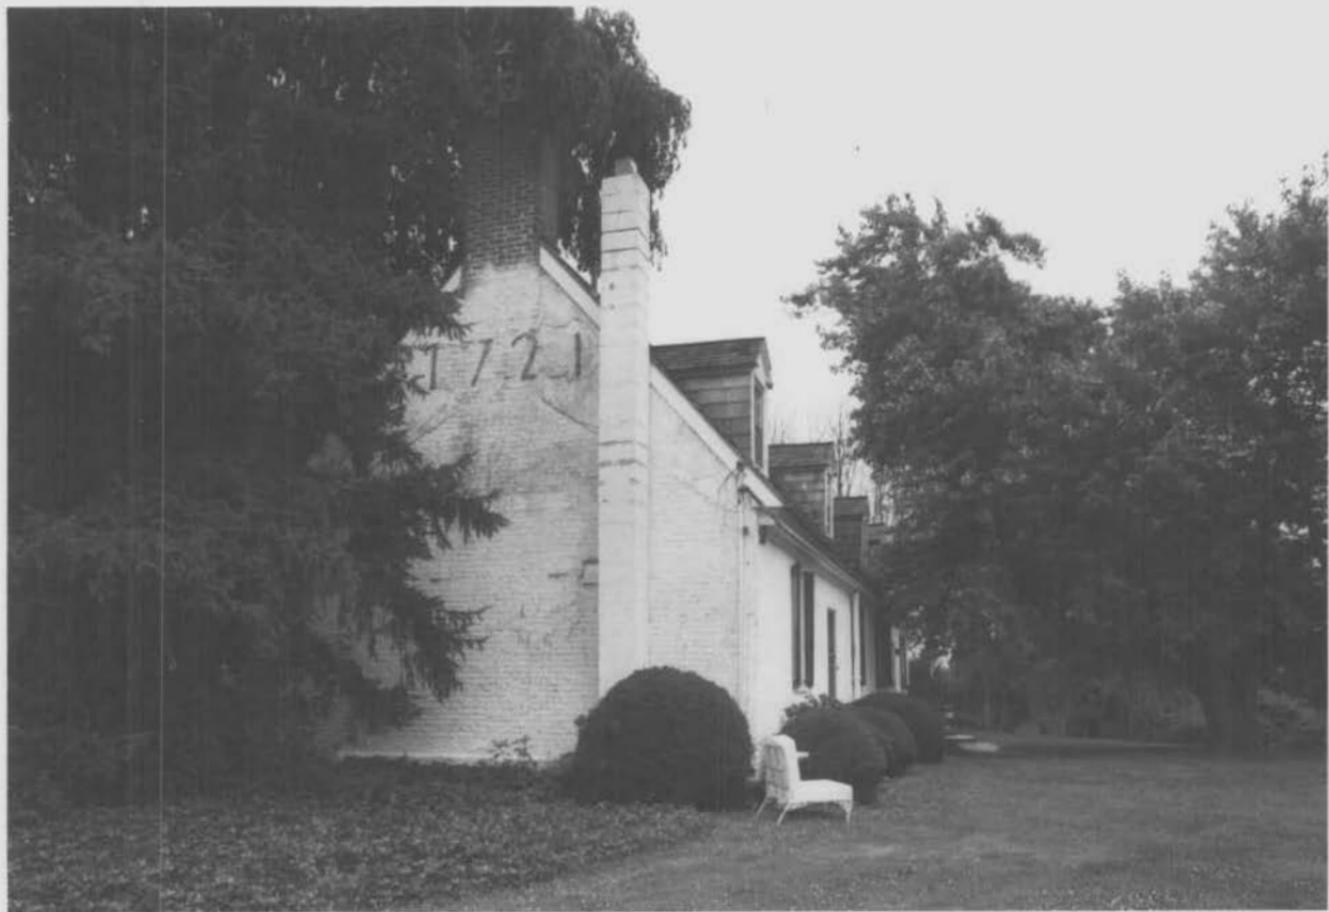
# 3 OF 8

VIEW FROM NORTHWEST

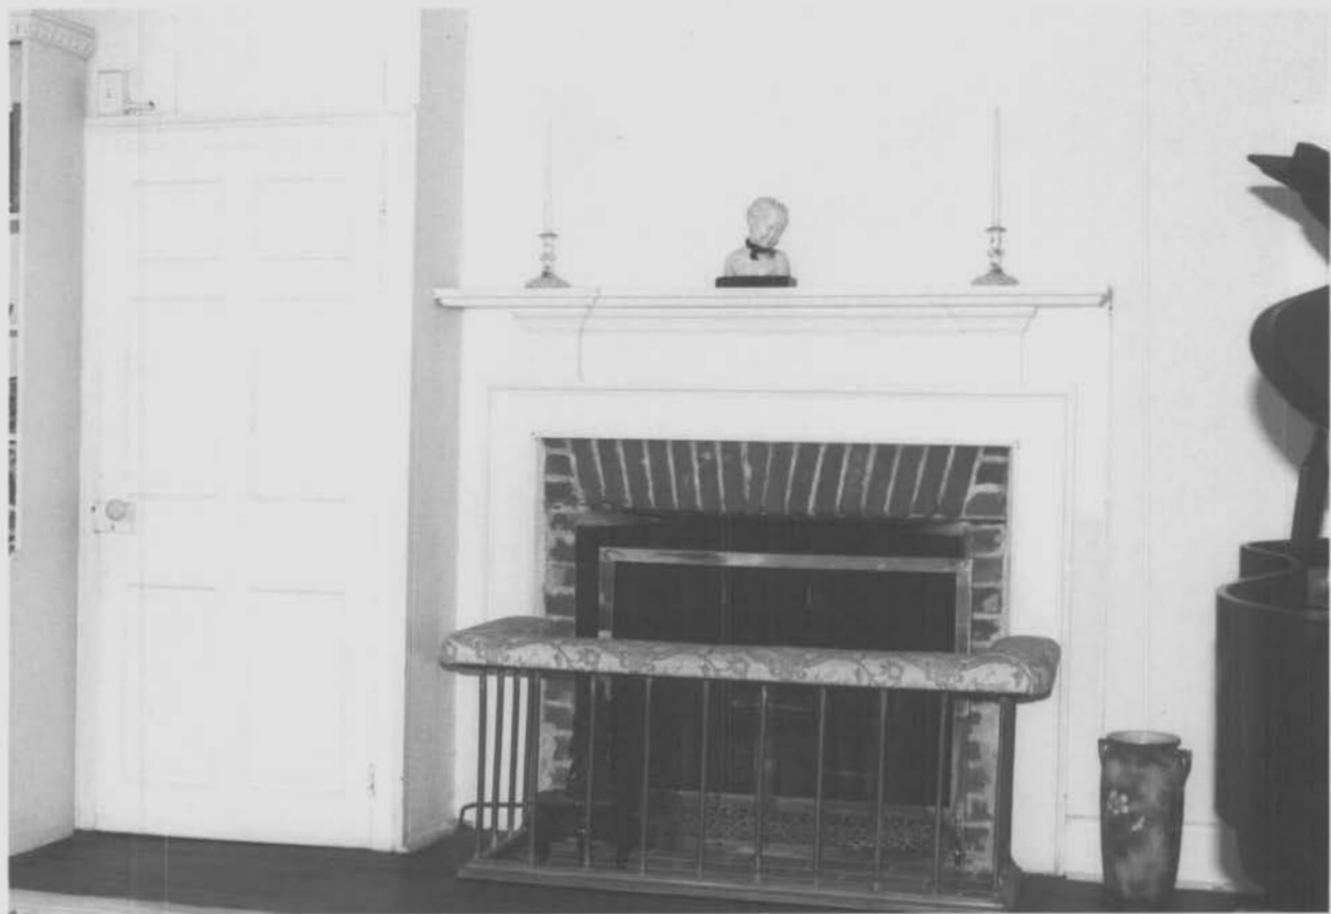
# 4 OF 8

HALL MANTEL & STAIR ENCLOSURE

The mantel in the hall is the largest and most refined in the house. It consists of a board surround with ogee-astragal backband framing the opening. Plain side blocks frame a plain frieze and support a complex molded shelf with late Federal and early Greek Revival details.

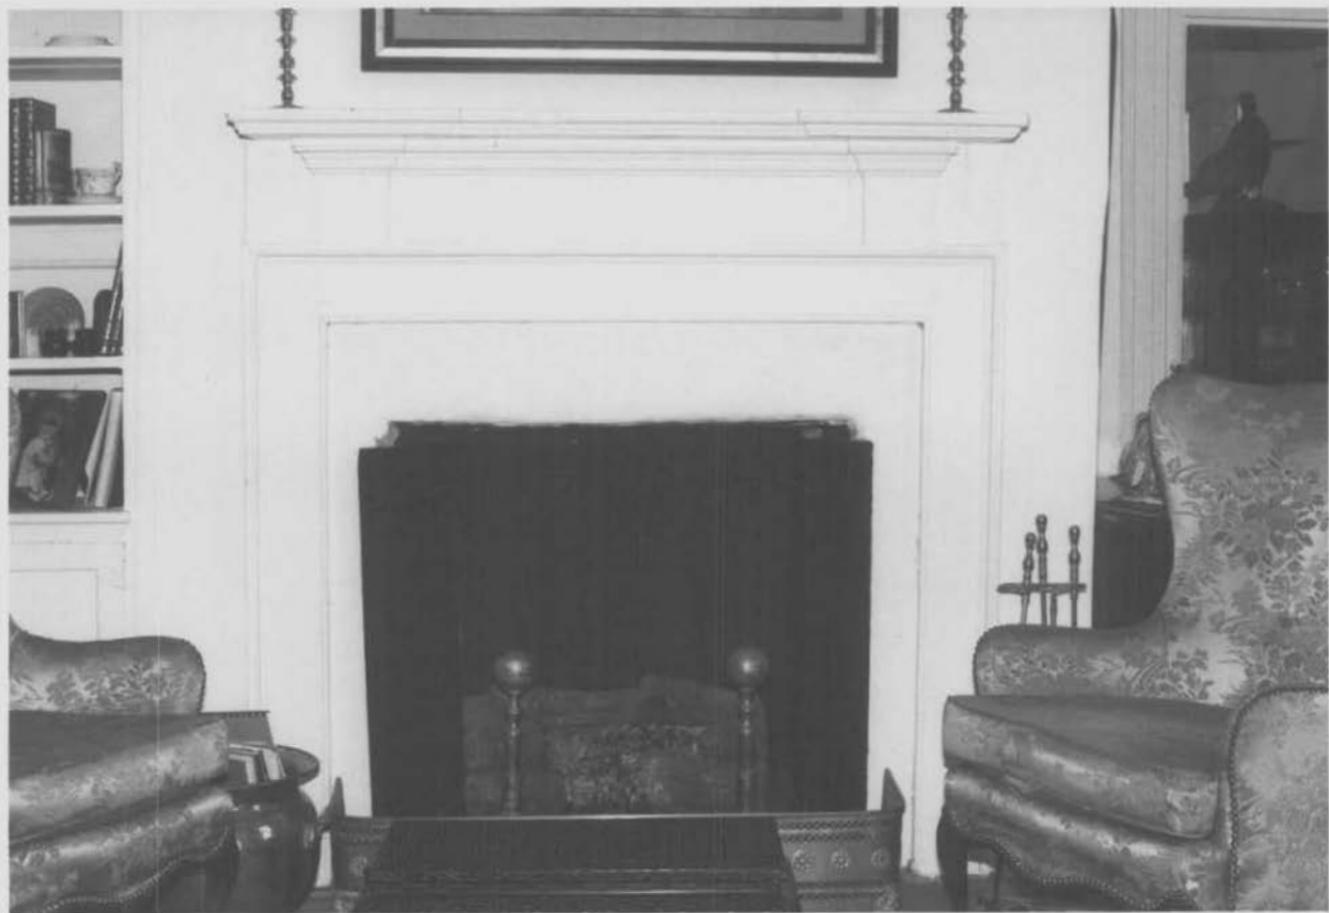
# 5 OF 8

PARLOR MANTEL

The parlor mantel is virtually identical to that in the hall in form and detail but is several inches narrower. This fireplace opening has been fitted with a handsome cast iron fireback and sidepieces embellished with Classical ornament, including fluted pilasters and acanthus motifs. Cast into the center piece is the inscription, "Thomas Chambers, Southampton Furnace." This fireback was found on the premises and installed during the stabilization and repair of the house by the present owners in the 1940s.

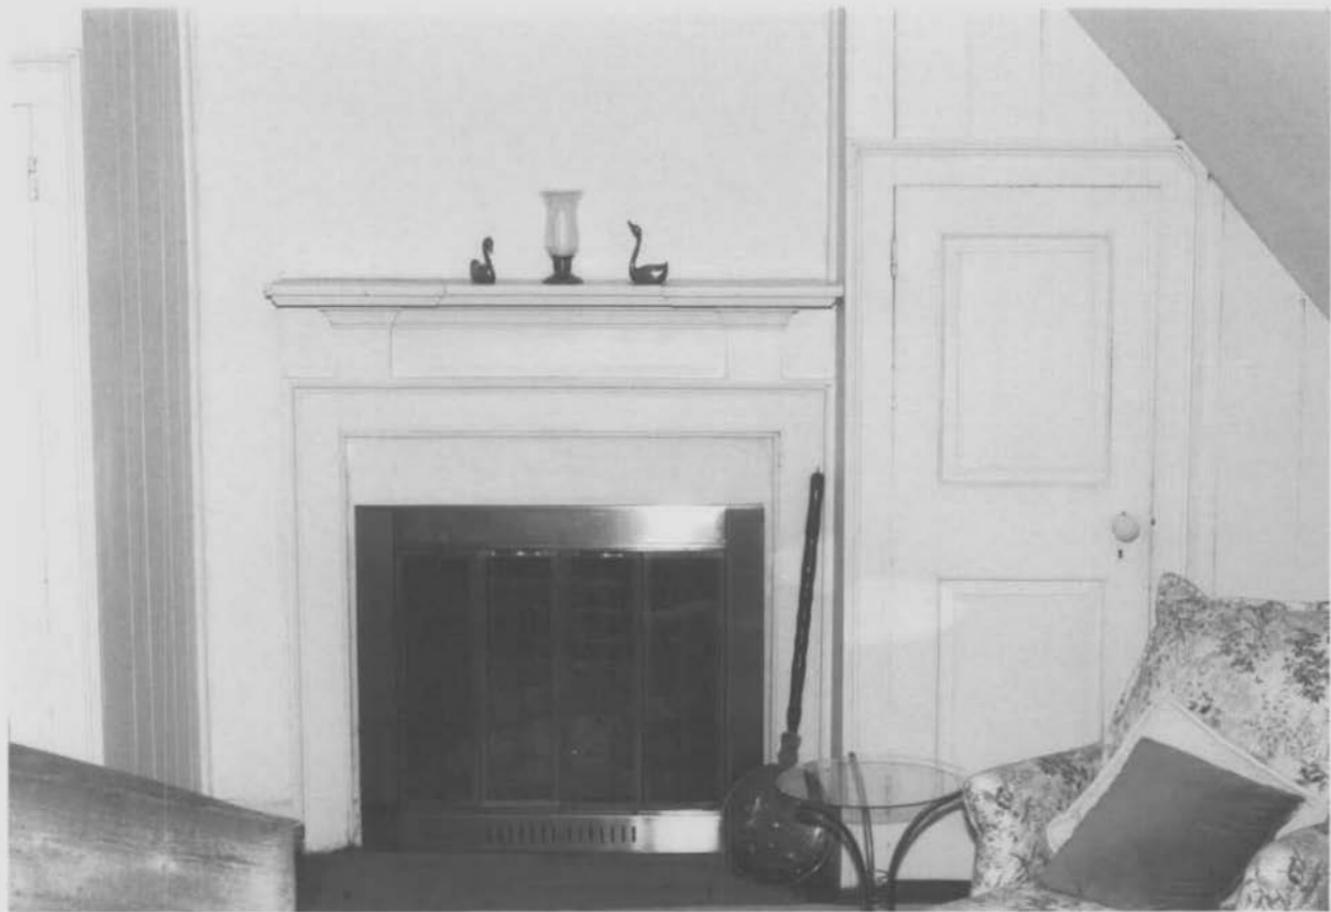
= 6 OF 8

MANTEL & CLOSET DOOR, 2D FL NORTH ROOM

The north chamber fireplace is fitted with a mantel comparable to the first floor mantels but smaller in scale. This fireplace is flanked by the original stair enclosure (now a closet) to the left and a small, early closet to the right. These closets are fitted with doors and architrave trim consistent with the first floor.

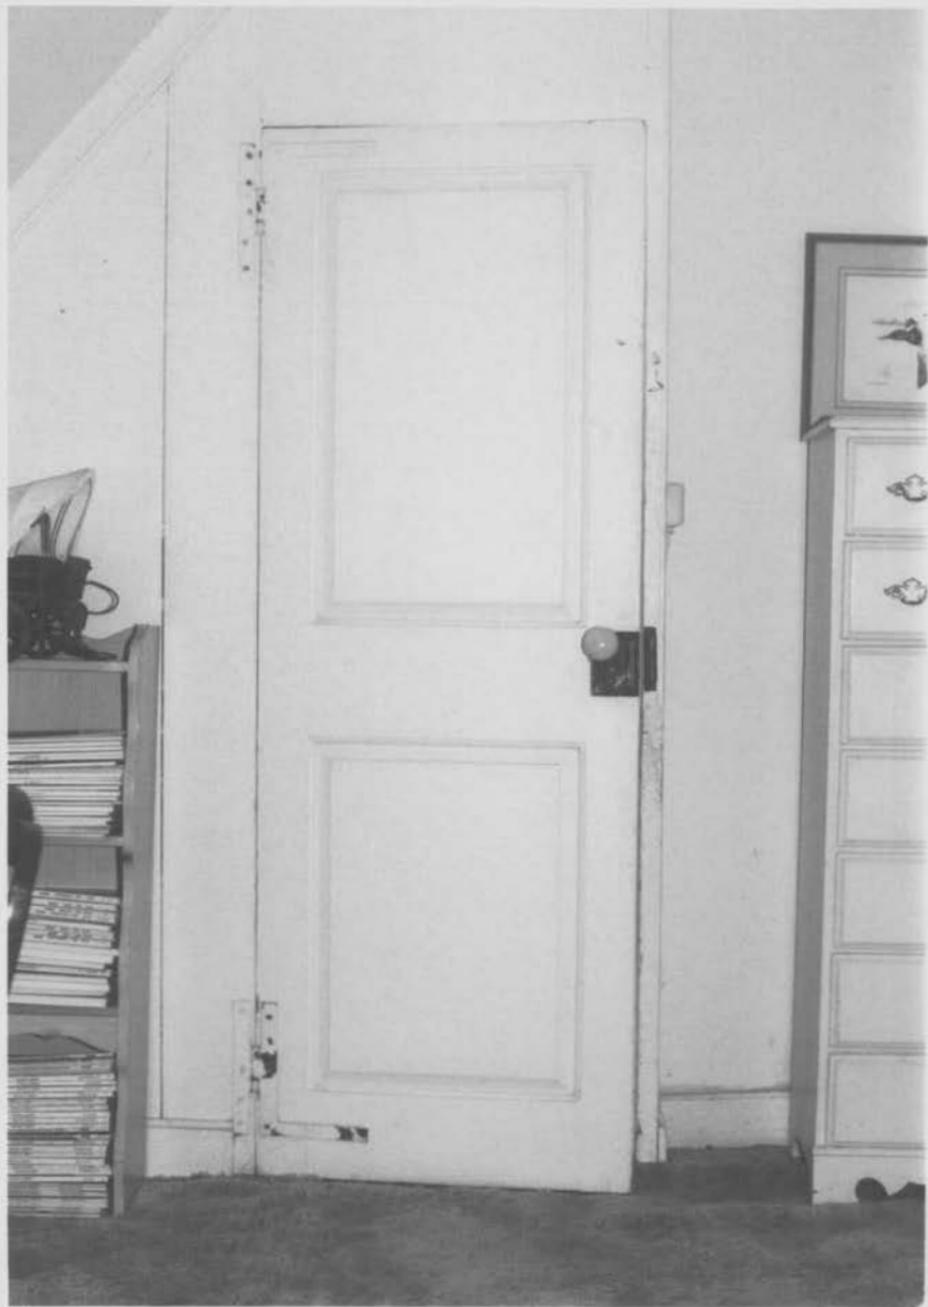
# 7 OF 8

2-PANEL DOOR, 2D FL

An enclosed winder stair to the left of the parlor fireplace leads up to the second story chambers. The second story was originally divided into two bed chambers, each apparently with a separate stair. The door between the two chambers is framed with the same architrave trim as found on the first floor. A two-panel door with fully raised panels is hung on unusual hand-wrought H hinges with three of the four ends foliated. An early 19th century metal box lock with brass knob remains in use.

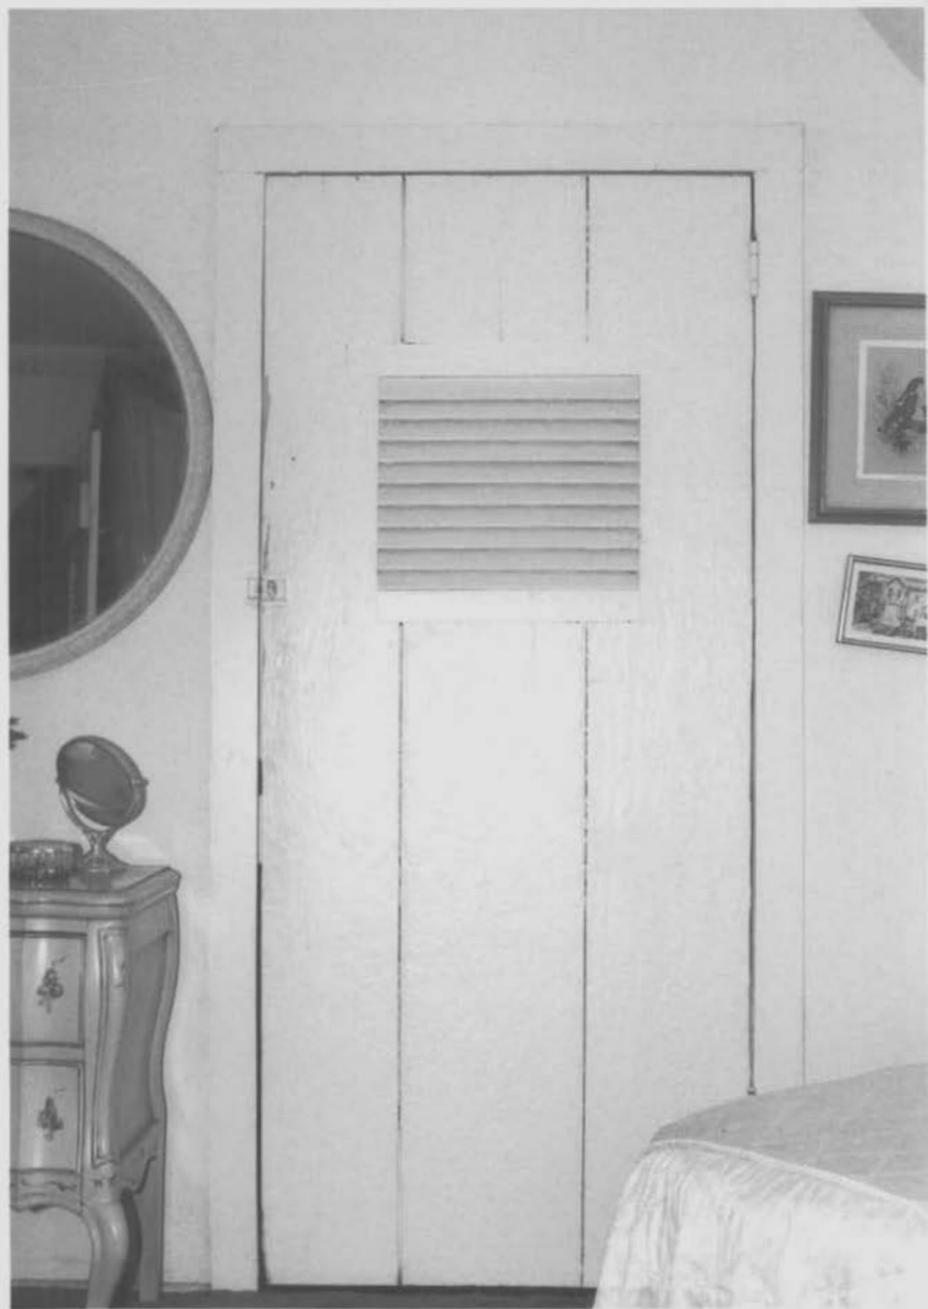
± 8 OF 8

LOUVERED BATTEN DOOR, 2D FL

An enclosed winder stair to the left of the kitchen chimney leads up to a room above the kitchen. This space is partitioned off from the room above the dining room by a beaded board partition. Originally, it was divided into two rather plain chambers for the kitchen servants. The ghost of the original partition remains visible on the ceiling. An interesting feature of the servants' rooms are the doors, which are of beaded batten construction with louvered vent panels fitted into the upper portion of each door.

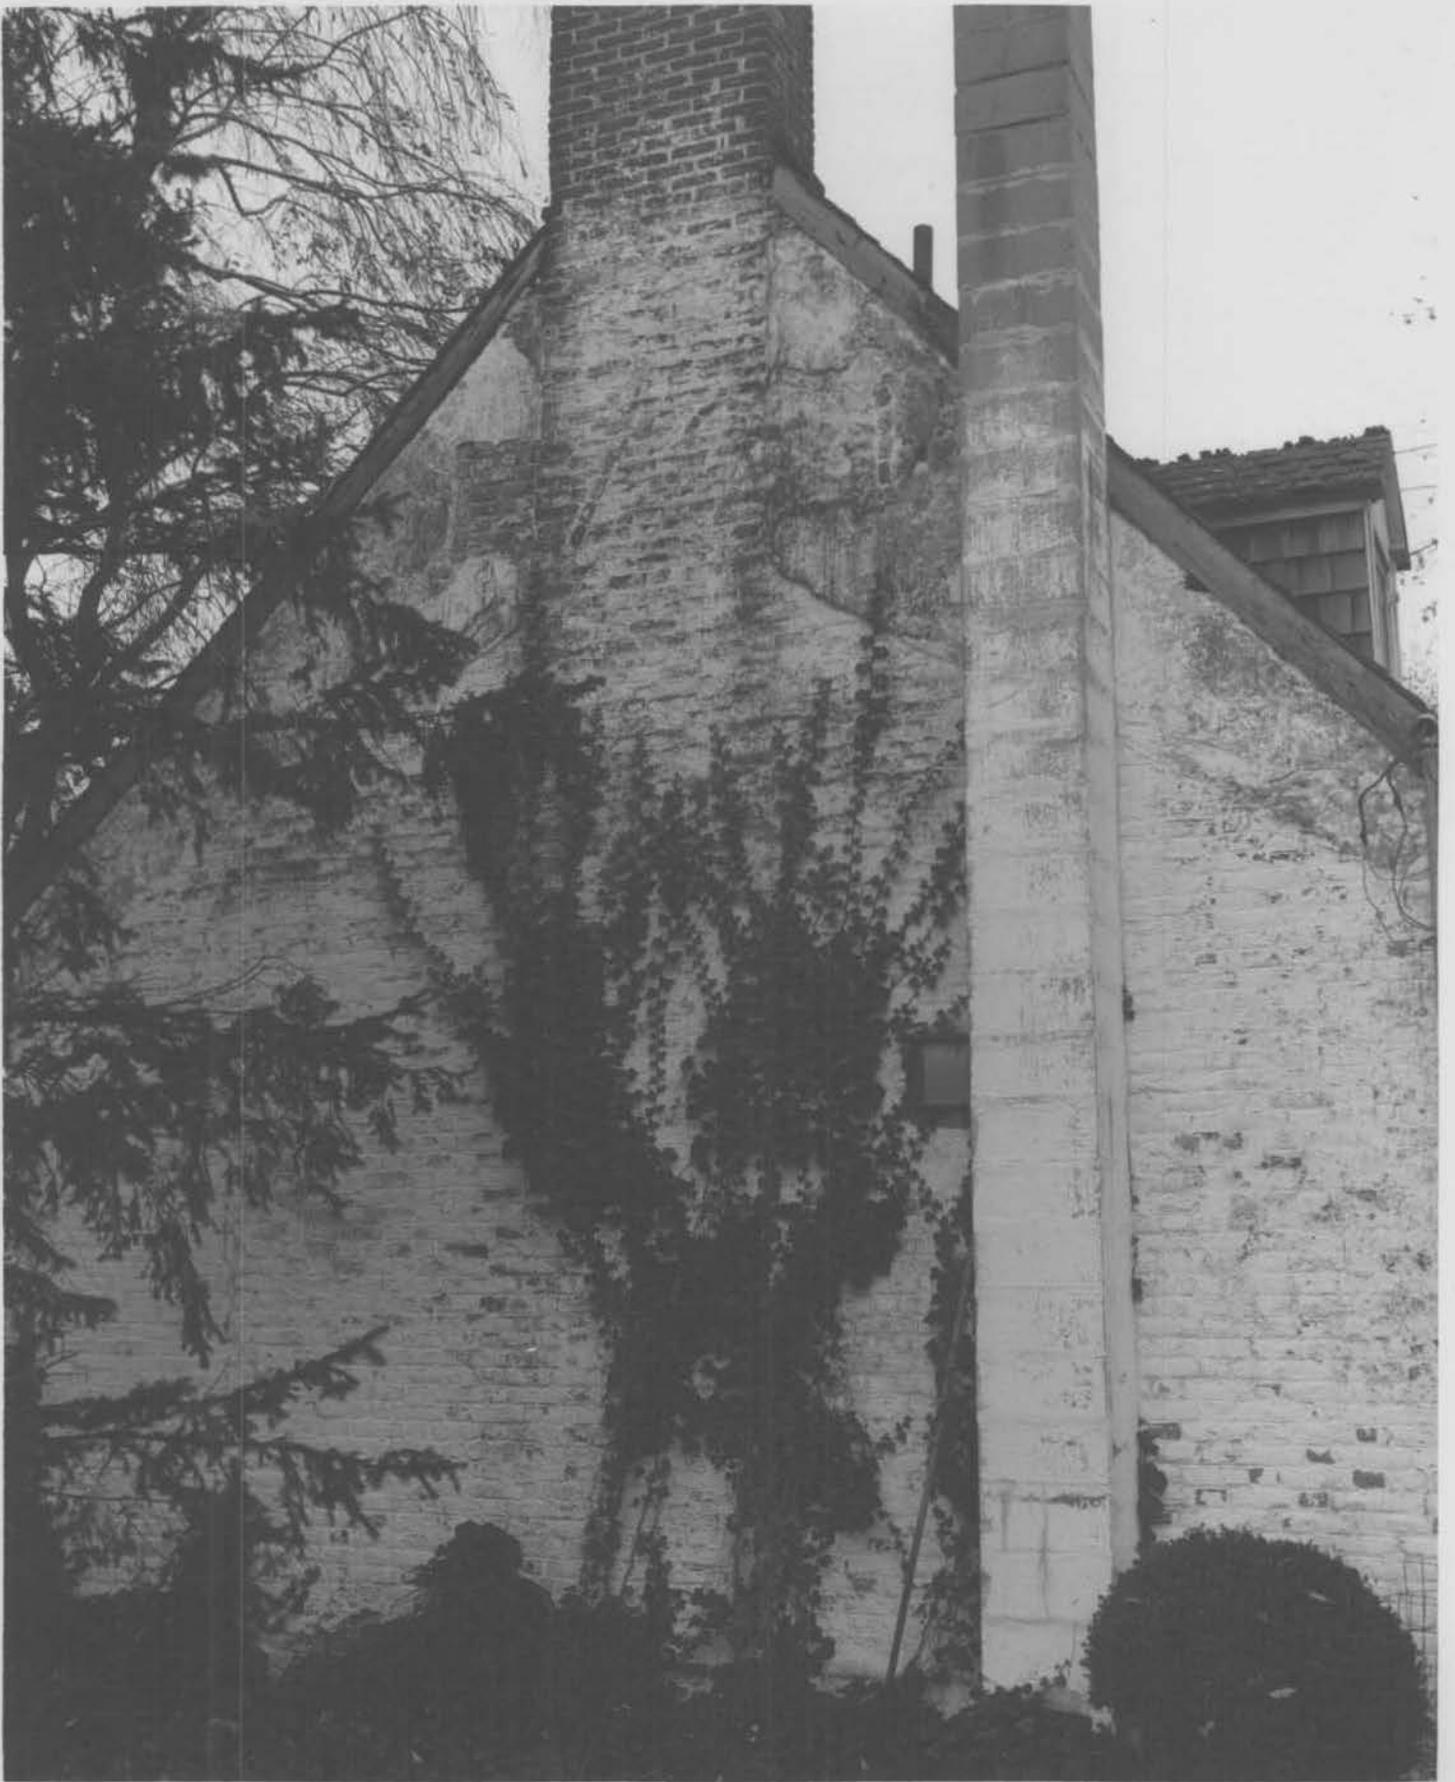
WHITE HOUSE FARM

END SHOWING DATE "1721"

On the west gable of White House Farm is a date in glazed brick, 1721, the earliest such designation known on the Eastern Shore. The building is a four room long, one and one-half story brick structure with a very steeply pitched roof with dormers; the building is the same width along its length. Inside the hall and parlor plan building are paneled fireplace walls and board partitions.

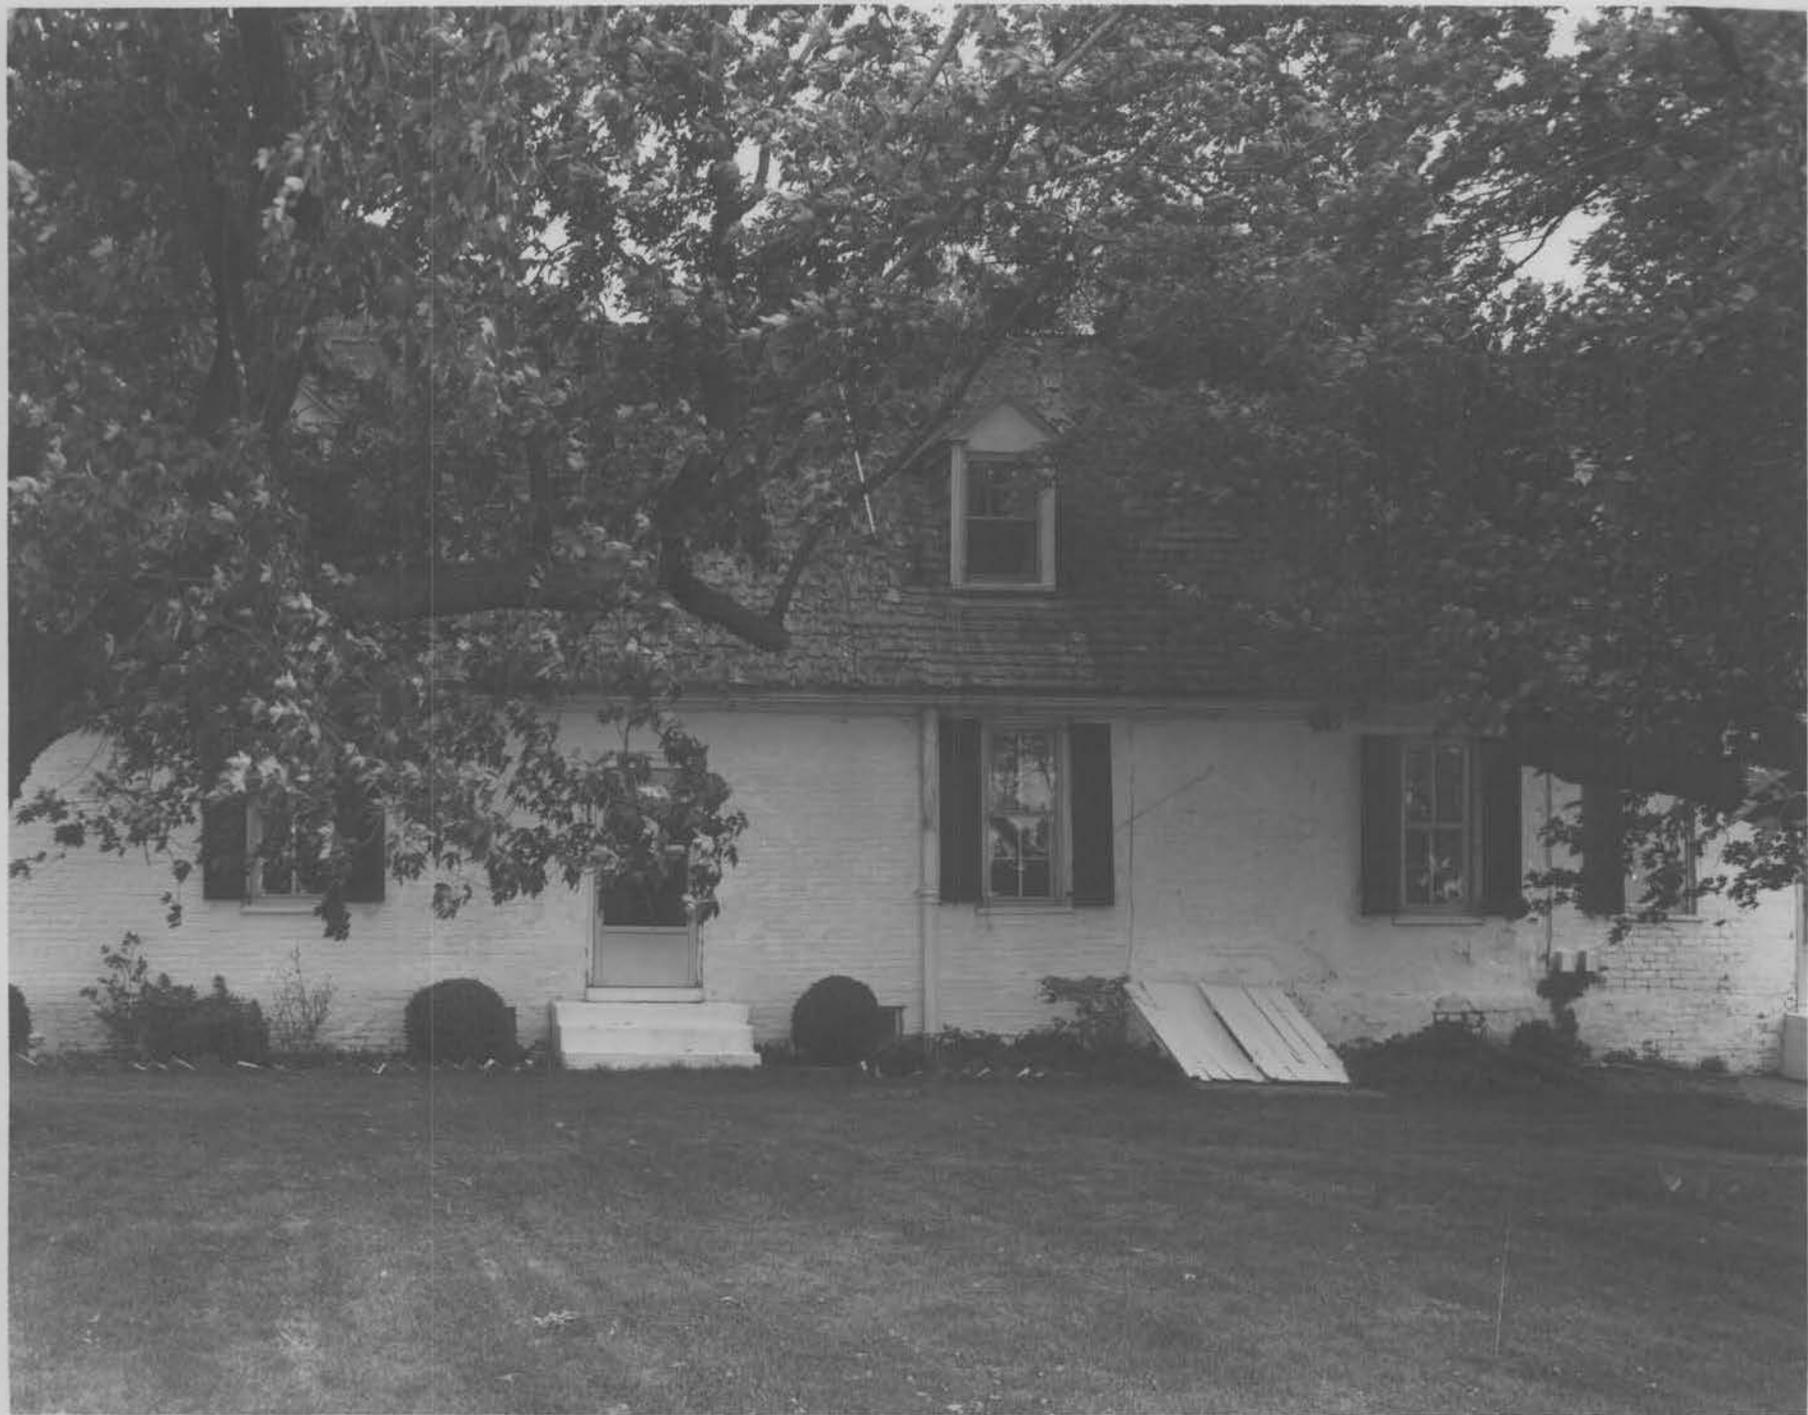
White House Farm K-203

South Uvatin

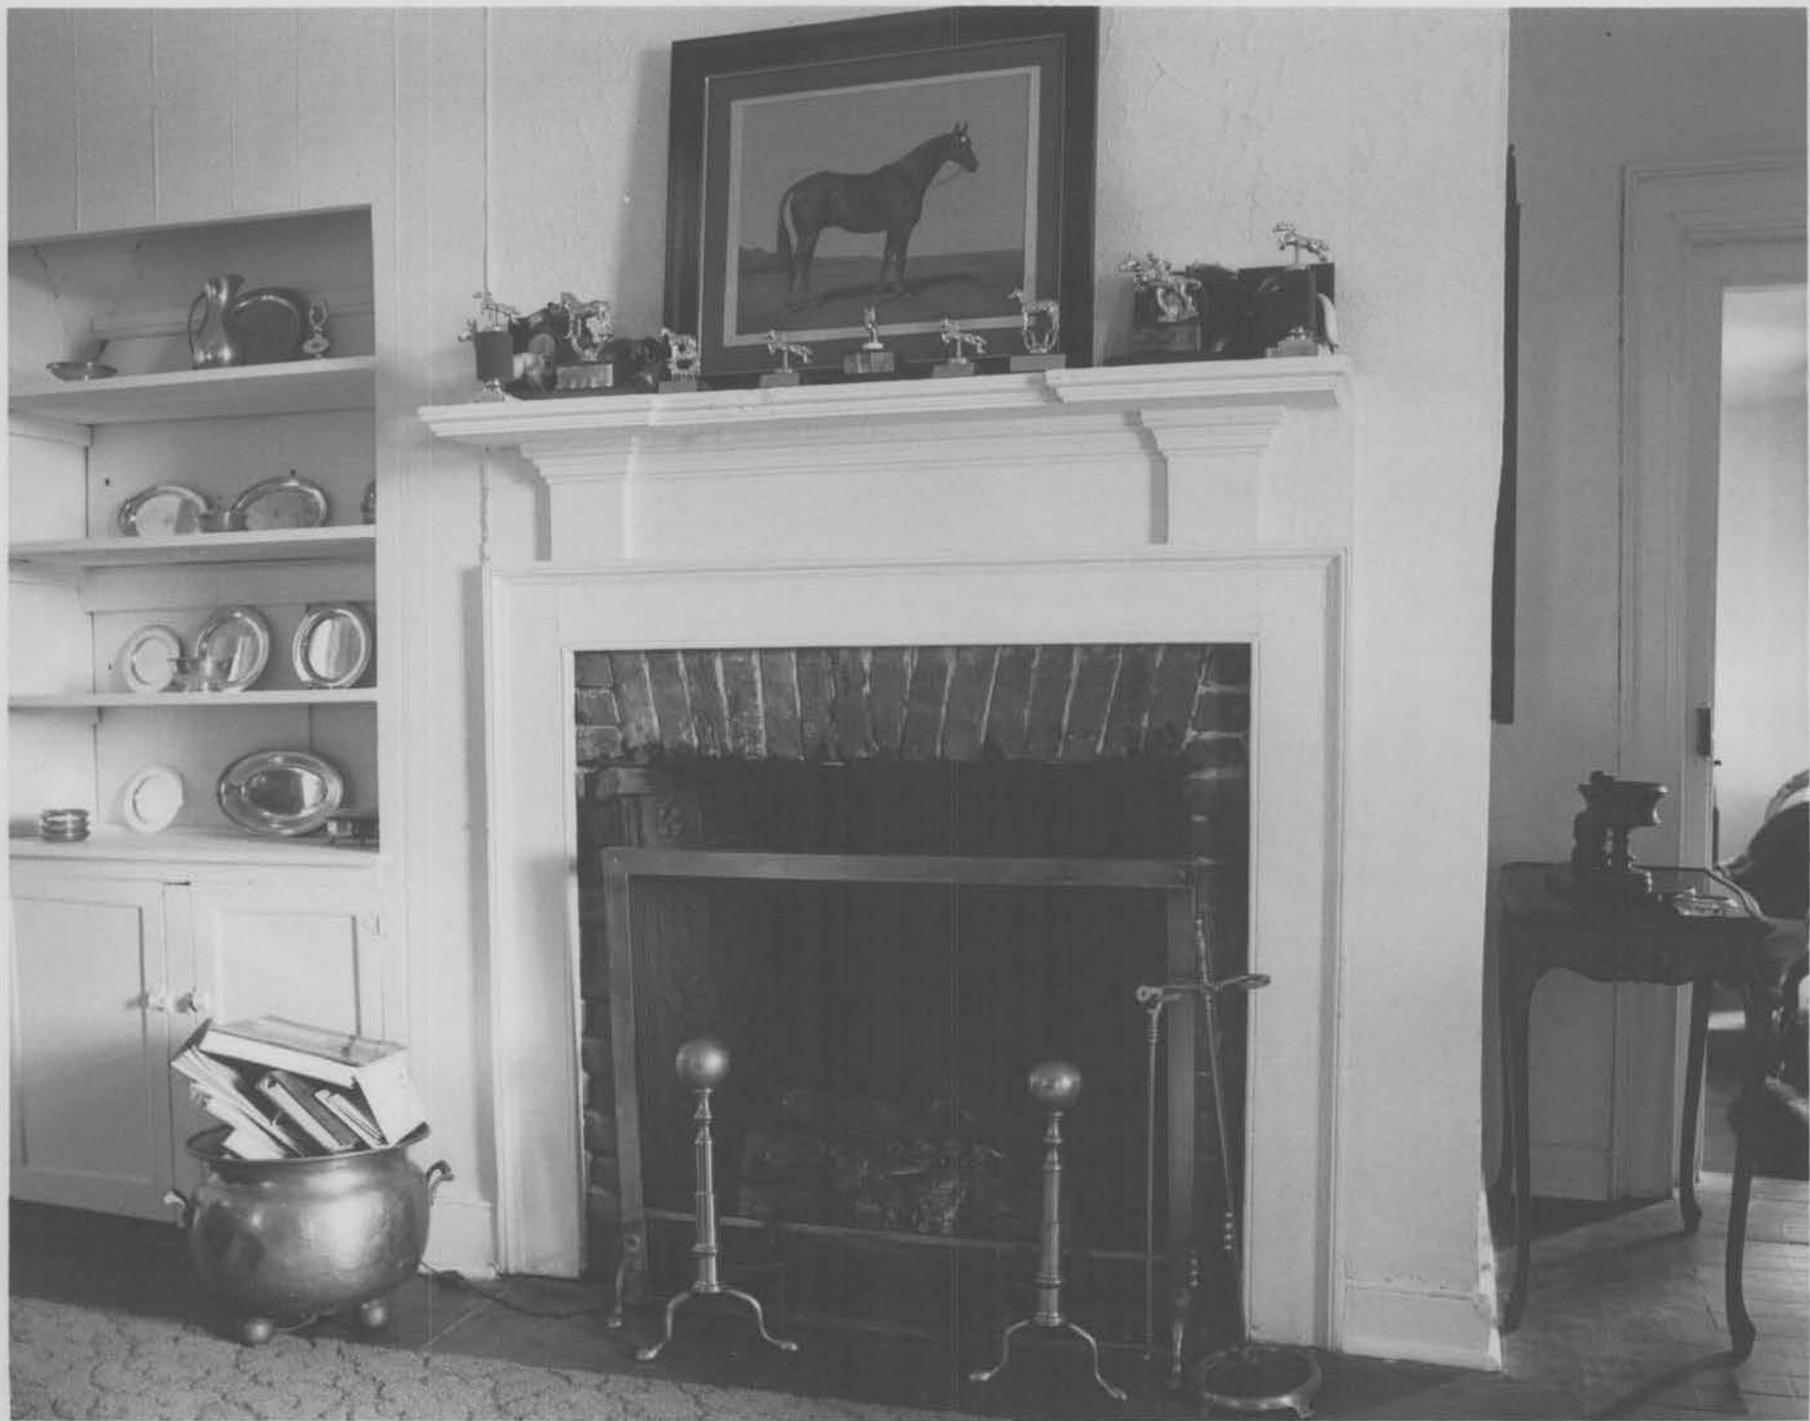
White House Farm K-203

Mantle, parlour 1721 portion

In the old house, first floor, are two mantles each of which are recessed from the enclosed stair walls. Nearly identical, they have rectangular openings with beaded and molded surrounds. and shelves which are broken and rest on plain frieze blocks. Edges of the shelves and the bed moldings are of the delicate, composite type. Stairs are enclosed with wide beaded vertical boards. There are no cornices in the rooms. Window and door trim, beaded with composite backband moldings, is the same throughout the house. All doors have six raised and beveled panels.
