K-238

King's Grant Cottage
West side of Worton Creek
late 18th Century

KING'S GRANT COTTAGE
Chestertown, Maryland
(ca 1800)

INVENTORY FORM FOR STATE HISTORIC SITES SURVEY

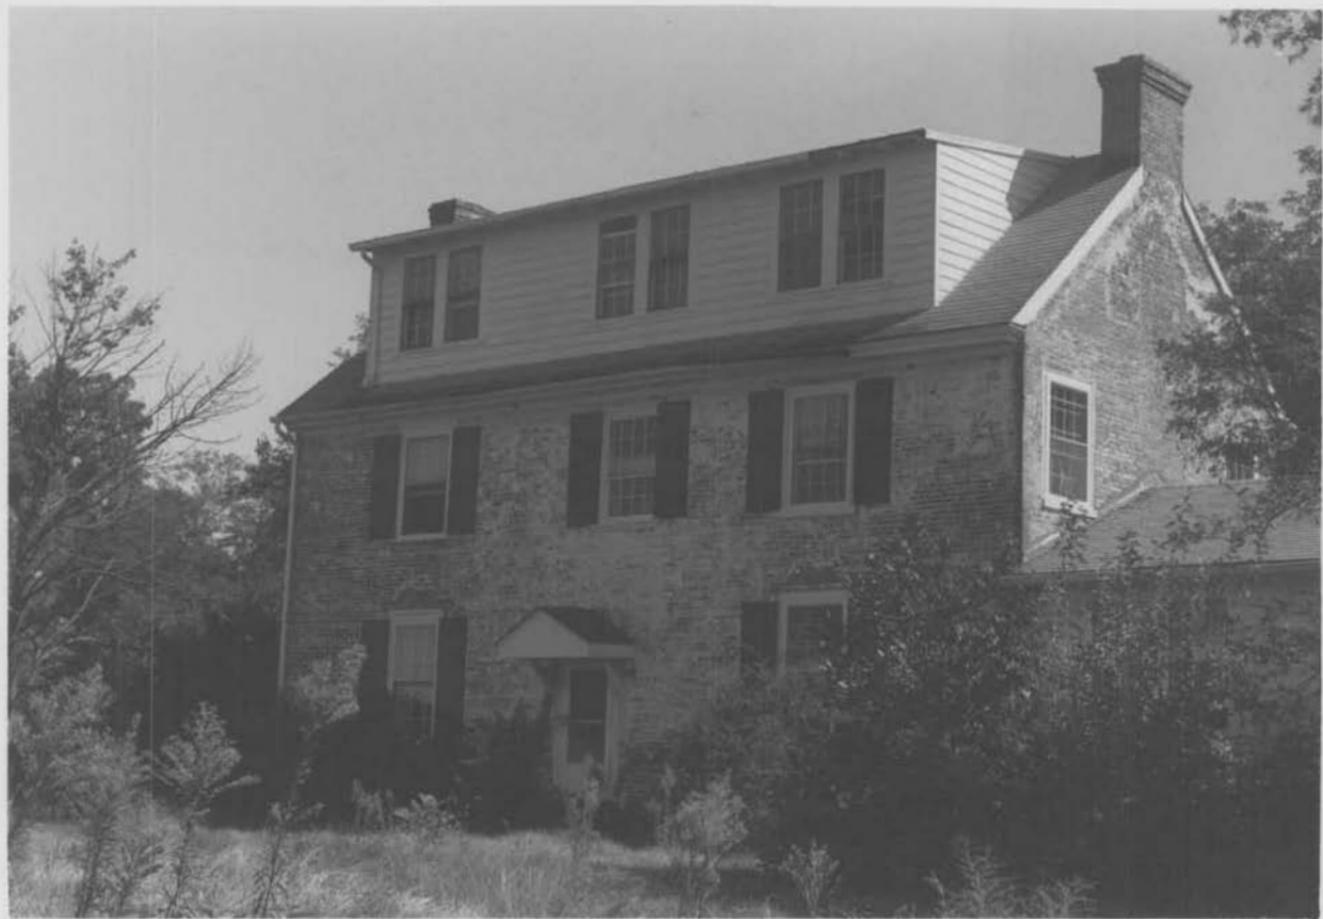
View to East

The building is a 2½ story brick structure which is three bays long and two bays deep. The building, rests on a basement and has a gable roof, now broken by long shed dormers on each slope. On the south gable is a 1½ story, long frame addition of recent date and undistinguished design. The first story of the river front of the house obscured by a one-story, enclosed porch.

The bricks are medium orange in color with random black glazed bricks. The walls are laid in Liverpool bond, except the east facade which is Flemish and has a two-course belt course.

King's Grant Cottage
