## Mowbray Chapel (Walton Chapel)

### **Architectural Survey File**

# Maryland Historical Trust State Historic Sites Inventory Form

Survey No. K-247

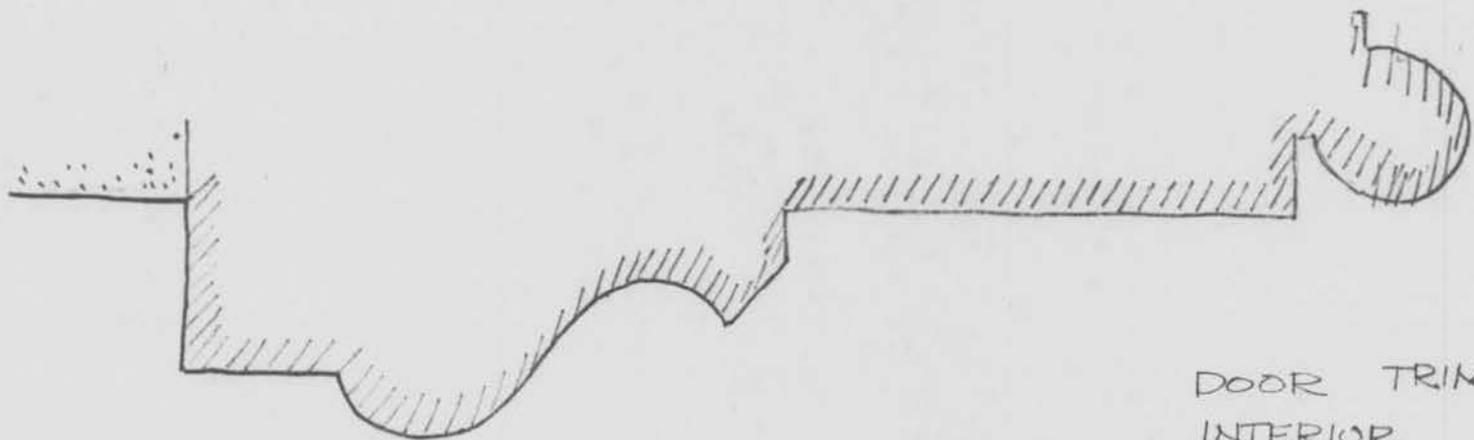
DOOR TRIM

3. Major Mantles - The building was heated with a stove. Chancel Rail: Turned Balusters
4. Major Trim  
Windows/doors - Very bold interior window & door trim. See illustration. Windows have splayed jambs.  
Baseboards - A Greek o.g. & bevel molding at the base of the wainscating  
Cornices - A greek o.g. and bevel about 2½" in height.  
Chair Rails - 1 wainscoting- simple board/ with Greek o.g. molding; vertical beaded boarding.

INTERIOR

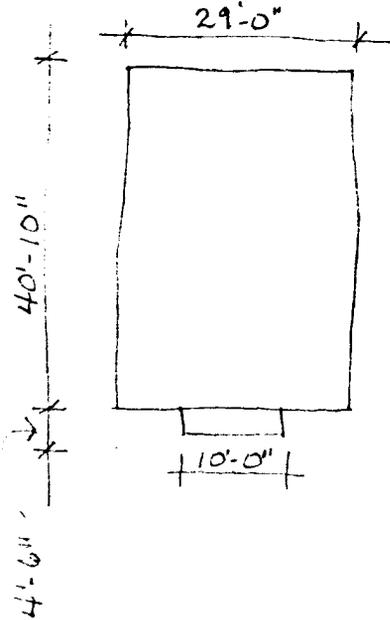
MOWBRAY CHAPEL

1. Size  
Main Section: 1 story, 1 bay wide, 3 bays deep
2. Plan type  
Main Section: Rectangular room (see drawing) with projecting chancel at southern gable.

BRICK WALL THICKNESS - 14"

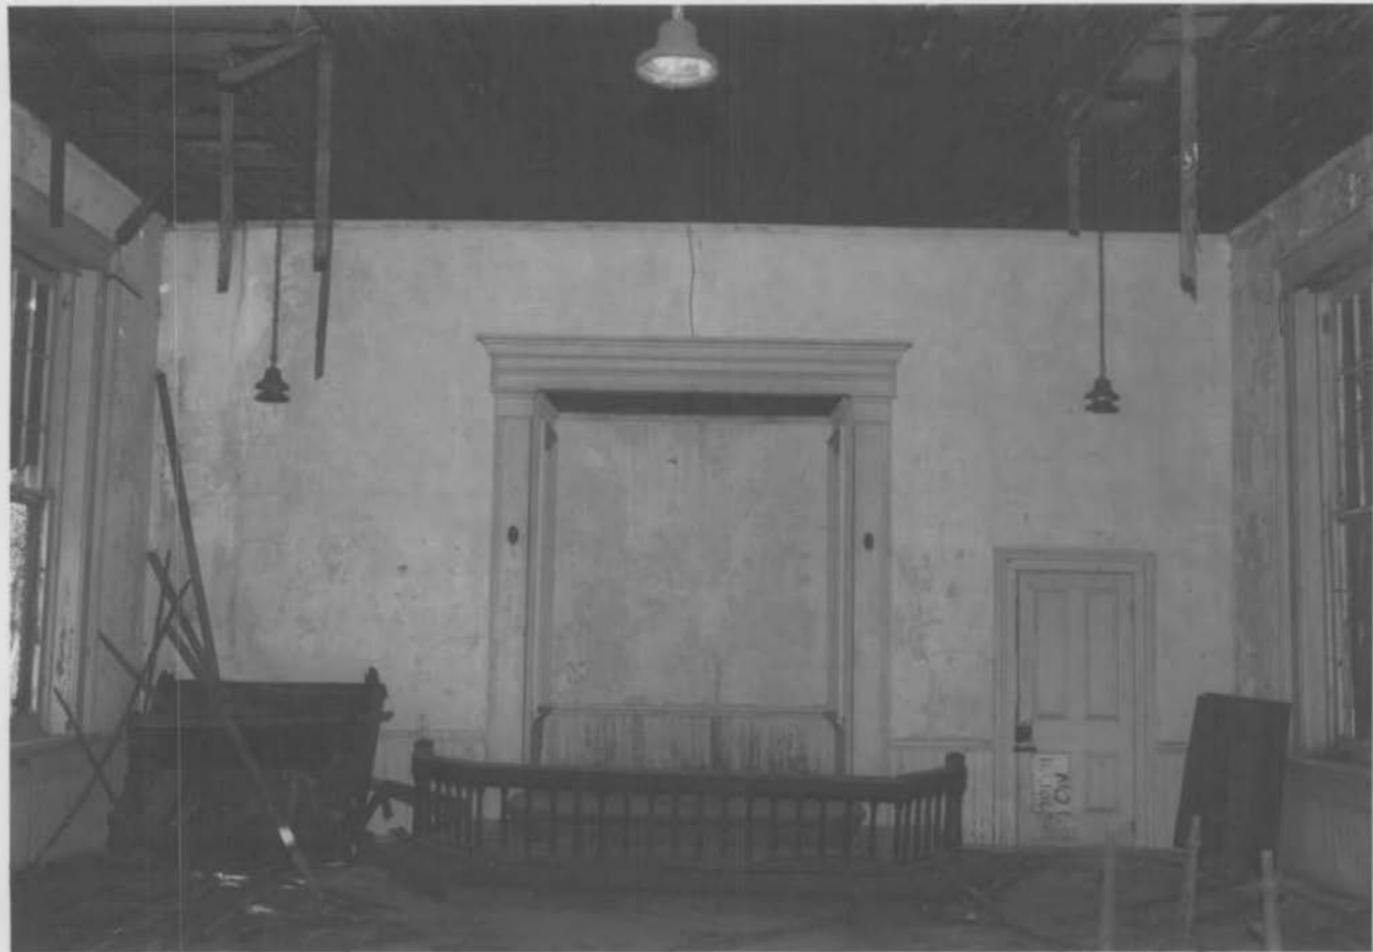
K 247-11

View to east

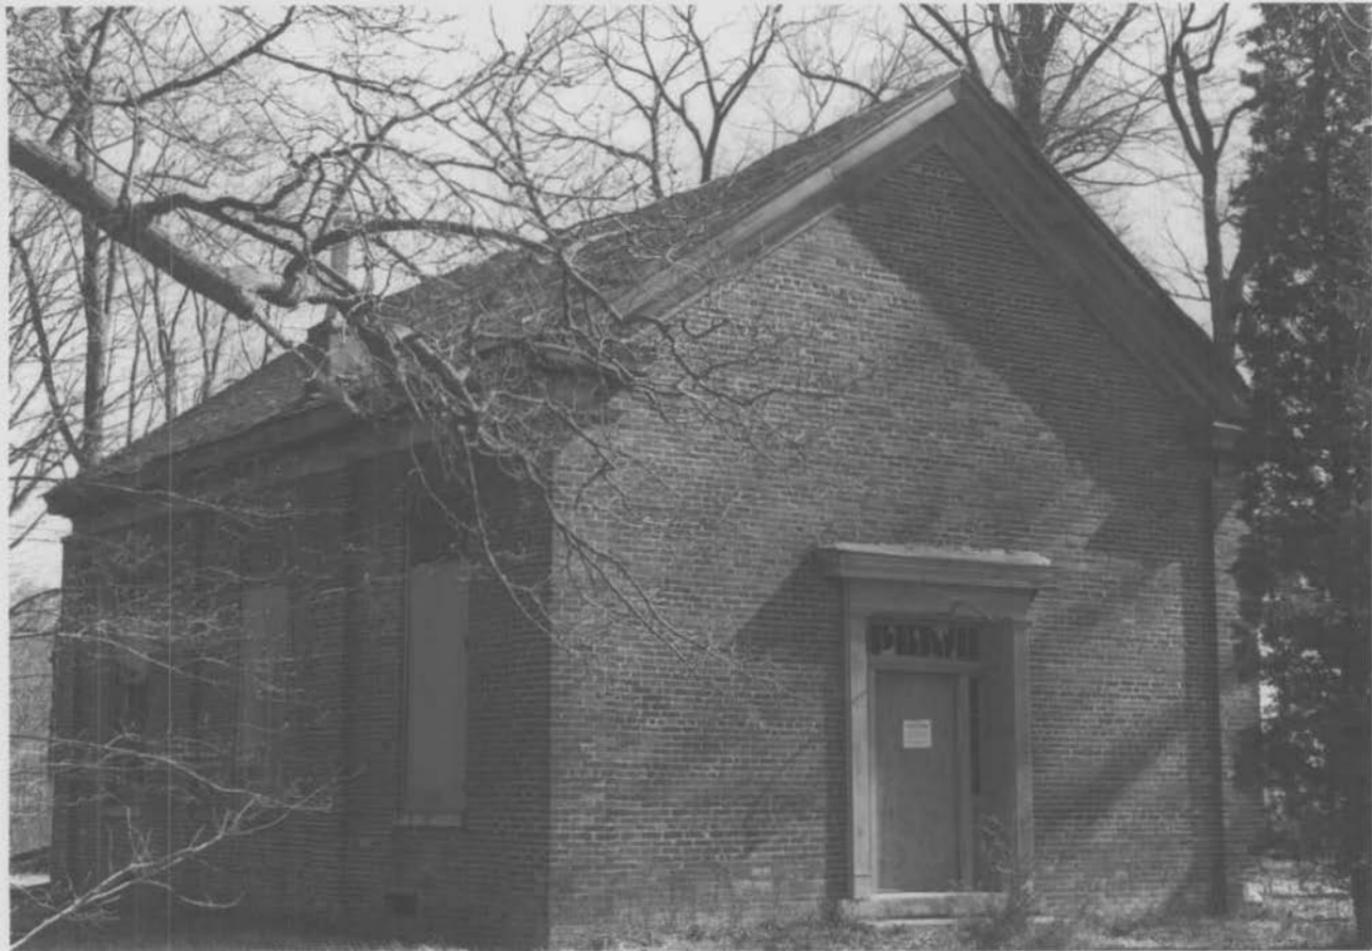
K-247.9

View to southeast
