K-361

Davis House
Near Still Pond
c. 1850's

INVENTORY FORM FOR STATE HISTORIC SITES SURVEY

Davis House

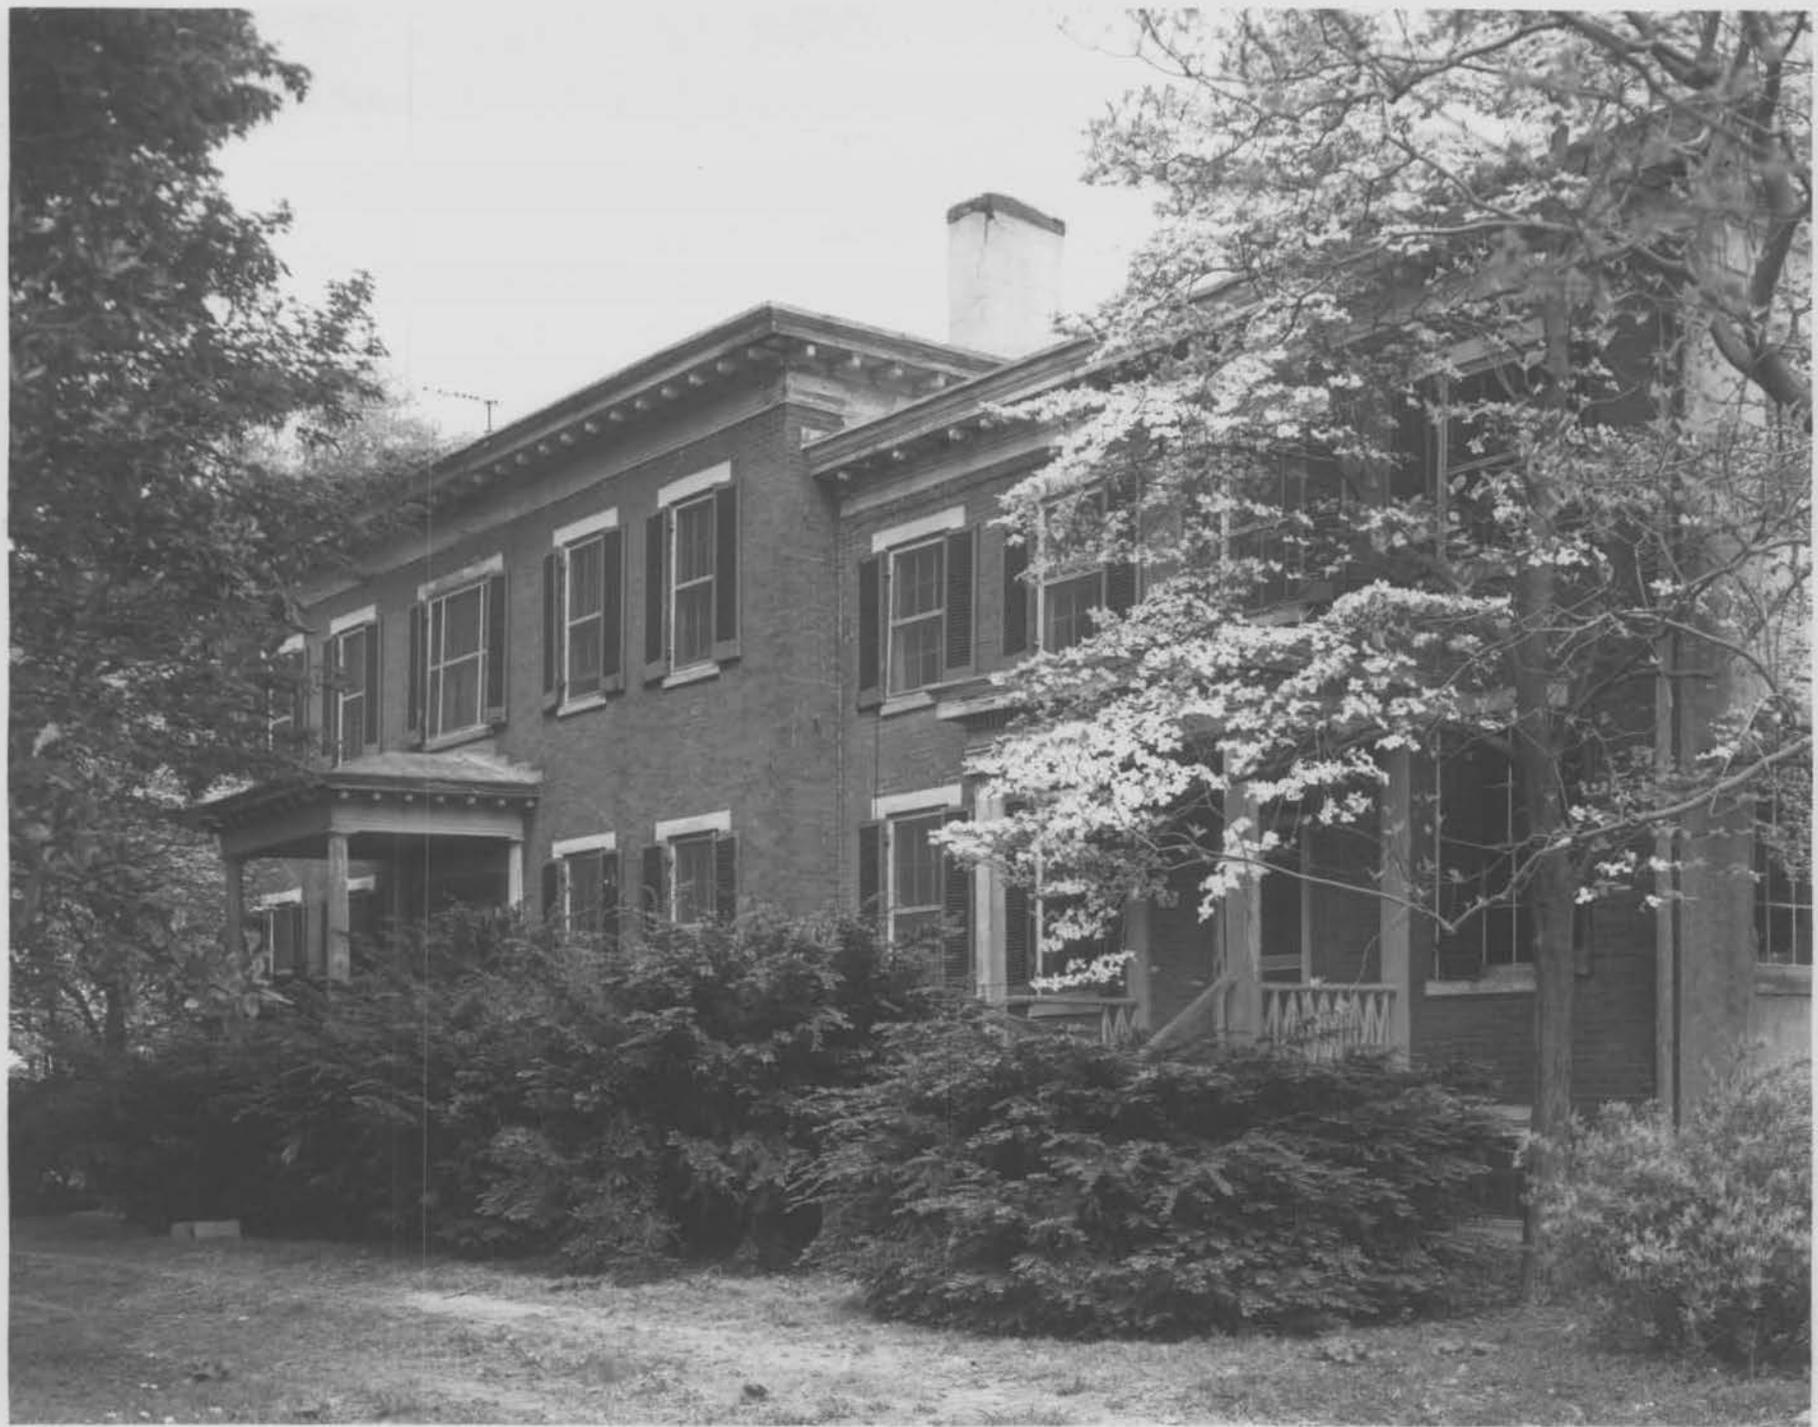
K-361
MHT - ~~K-320~~

FRONT FROM SOUTHEAST

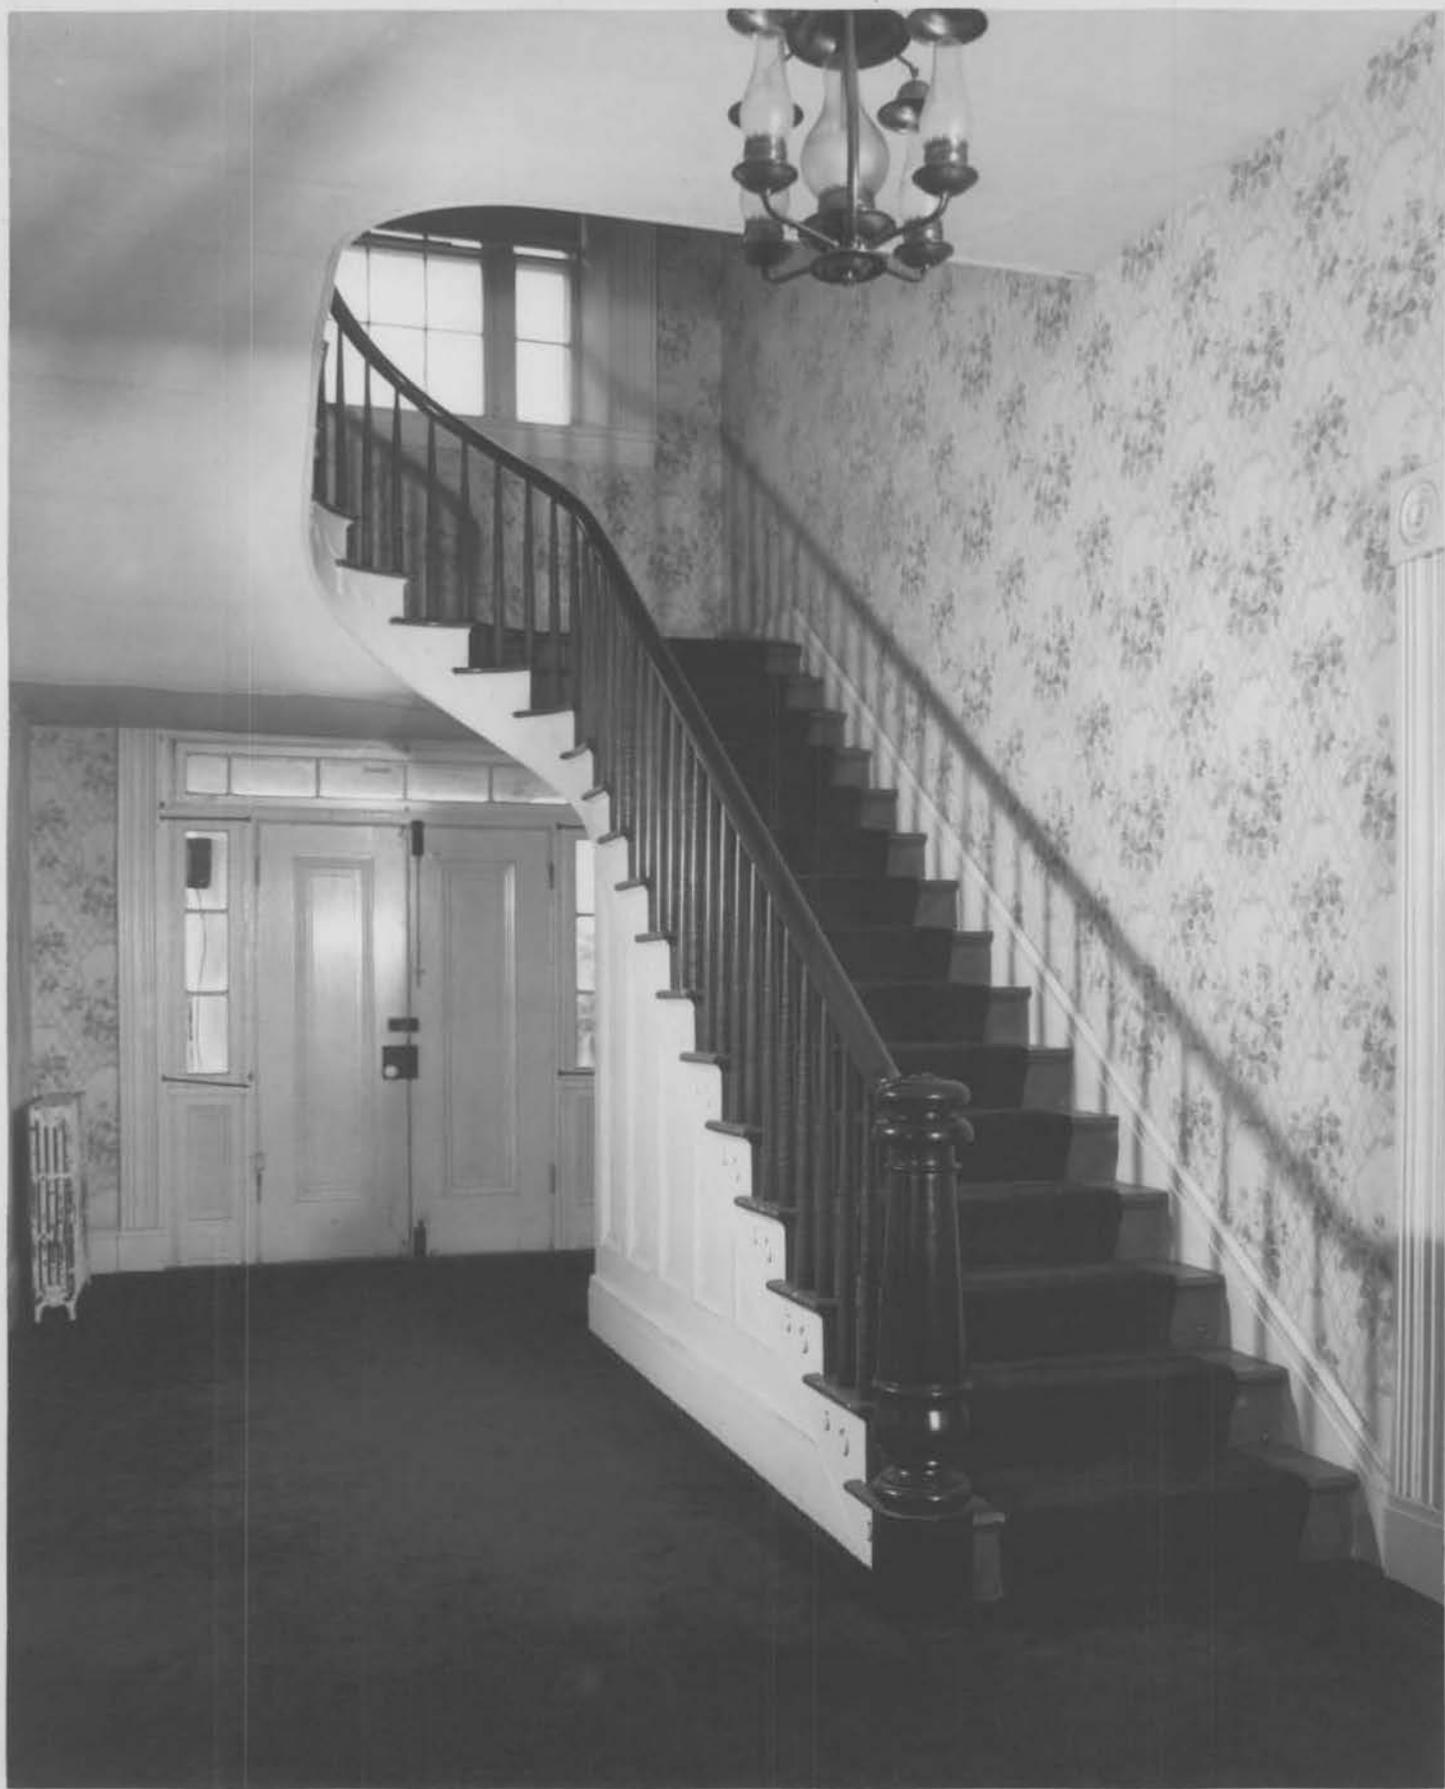
K-361
MHT-K~~320~~

The entrance hall is the most elaborate interior in the house. Newel post and hand rail are mahogany and balusters curly maple. The front vestibule ceiling has molded plaster ornaments in the corners and center. Unusual stair brackets are used on the open string stair.

STAIRWAY - MAIN HOUSE
