PARTNERSHIP FARM
Kennedyville, Maryland
(ca 1875)

INVENTORY FORM FOR STATE HISTORIC SITES SURVEY

Partnership Farm (preferred)

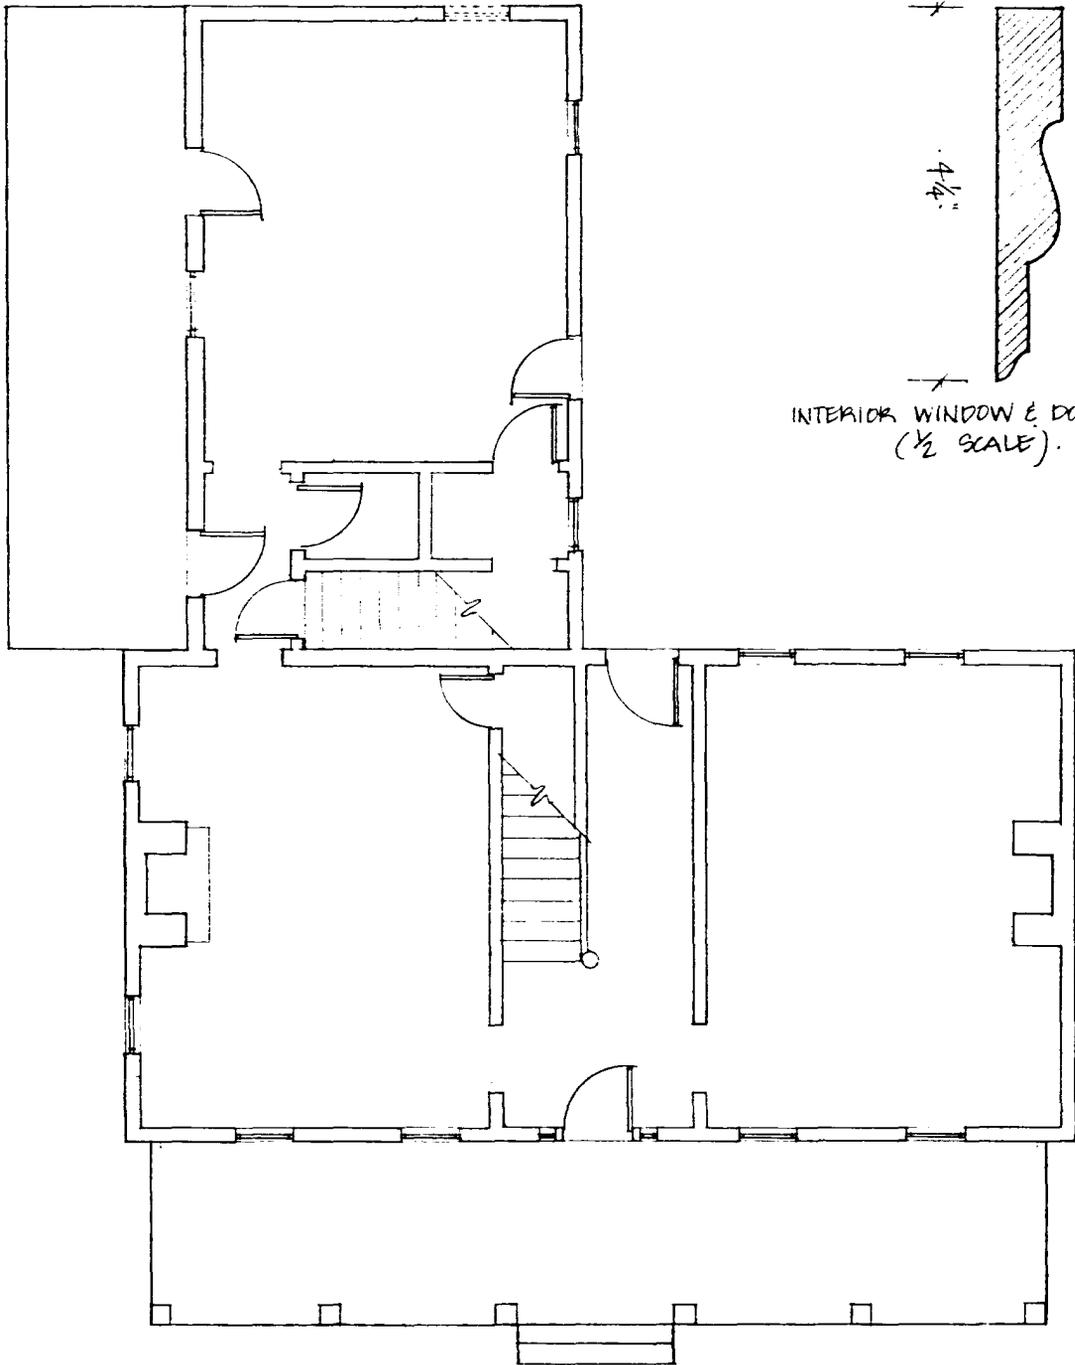
PARTNERSHIP FARM (K-383)

INTERIOR WINDOW & DOOR TRIM
($\frac{1}{2}$ SCALE).

A floor plan of the building is included in this report.

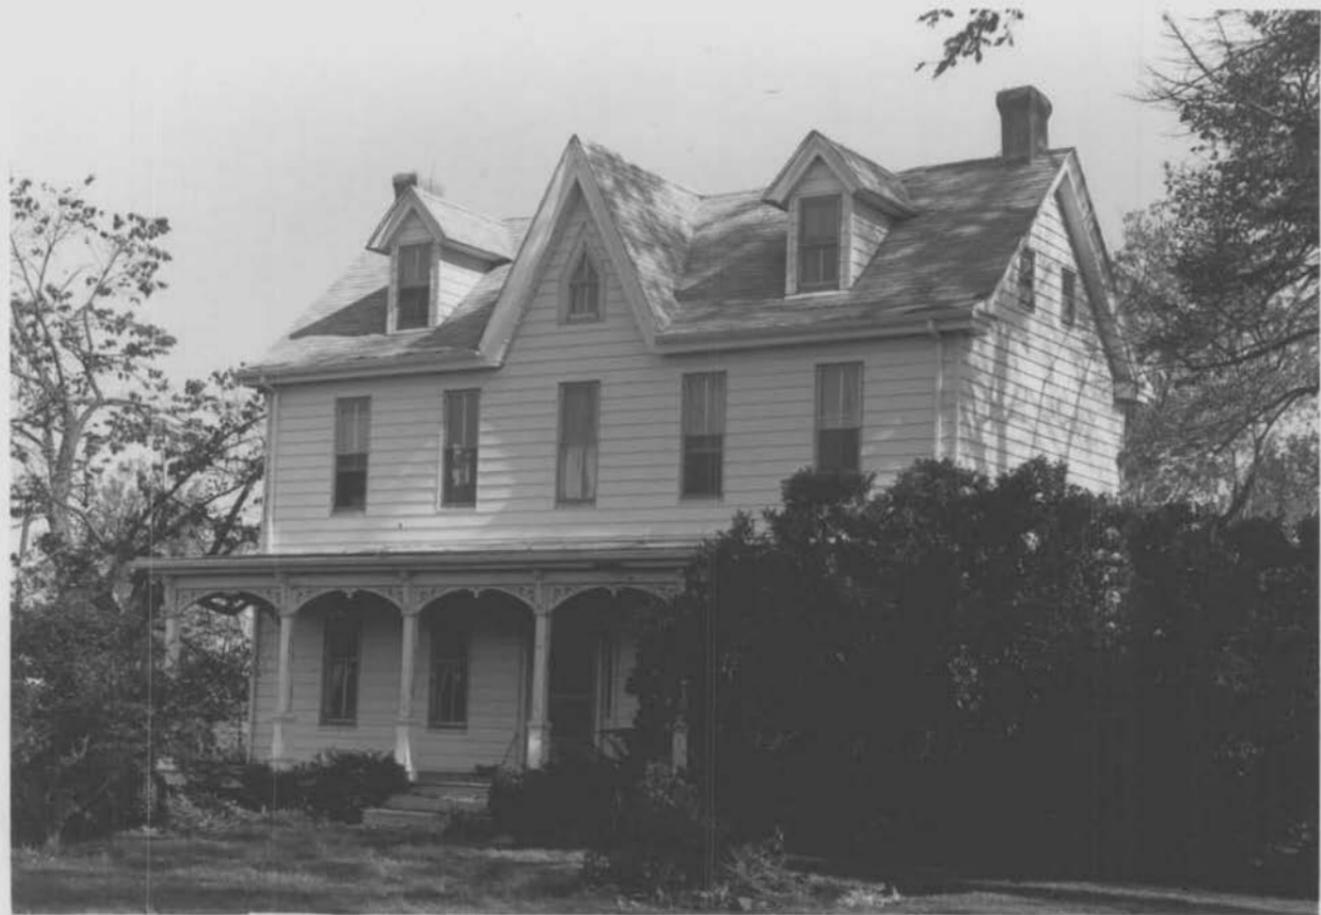
K-383

View to East

The Silcox House is a central gable structure which is five bays wide, two bays deep, and two-and-one-half stories in height. It has a five-bay front porch and a rear ell. Stuccoed brick chimneys are enclosed in each gable and gable dormers project from the main house roof between the two end bays. The central gable is narrow--just over one bay wide--and has a small window with a pointed upper sash. The central entry door has a four-pane transom light and three-pane side light assembly with glass etched in an octagon and flower pattern. The door itself has round upper panels with bolection moldings on all four-panels and a diamond-shaped extra molding applied to the panel fields.

In recent years the structure was covered with white aluminum siding and original decorative detail removed. The only sawn wooden ornament that remains is on the handsome front porch. Its five bays are arched with delicate scroll work and the chamfered columns rest on 18" bases.
