Maryland Historical Trust State Historic Sites Inventory Form

historic The Colonial; Miss Kingsland's Boarding House

and/or common Joseph & Rebecca Downey House

Survey No. K-531

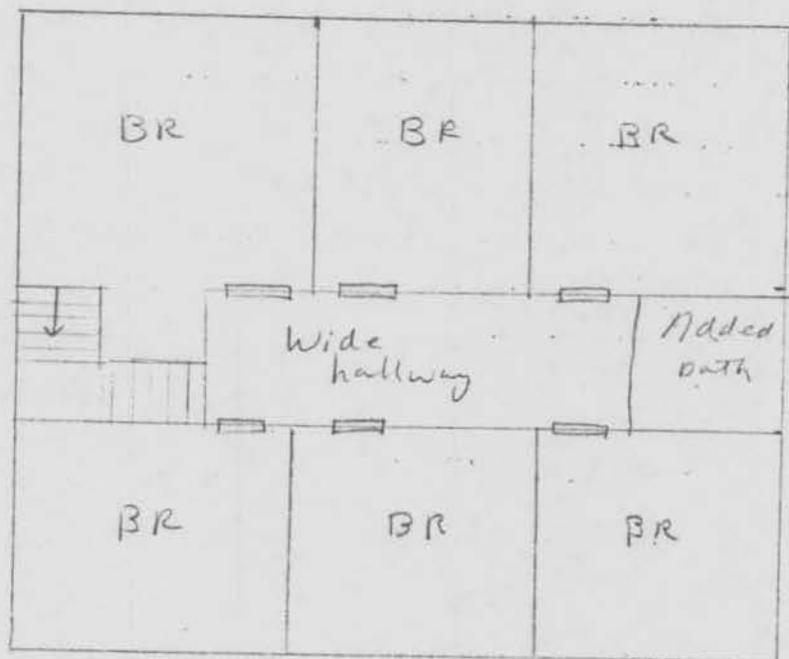
2. Plan type (Main section): four-square on first floor. The original wrap-around porch (most of three sides) has been enclosed for sun porch and kitchen on the south and west. See drawing for second-floor plan (original; now is modified by combination of several small bedrooms).

This building appears to have been built for a boardinghouse; it had six small bedrooms on the second story, each with a small closet (now altered into four bedrooms), a cramped stair (to consume less space and provide the desired number of rooms); the obligatory rocking-chair, large porch; outdoor shower at end of porch in rear for bathers (now gone); a large parlor and a smaller sitting room/stair hall for public rooms.

Approach side

- Stove said to have been here by present owner, but not very near to chimney
