### National Register of Historic Places Registration Form

historic name Johnson-Wolfe Farm (MIHP # M: 12-~~8~~-1)  
other names Comus Inn (preferred)

Johnson-Wolfe Farm (Comus Inn)

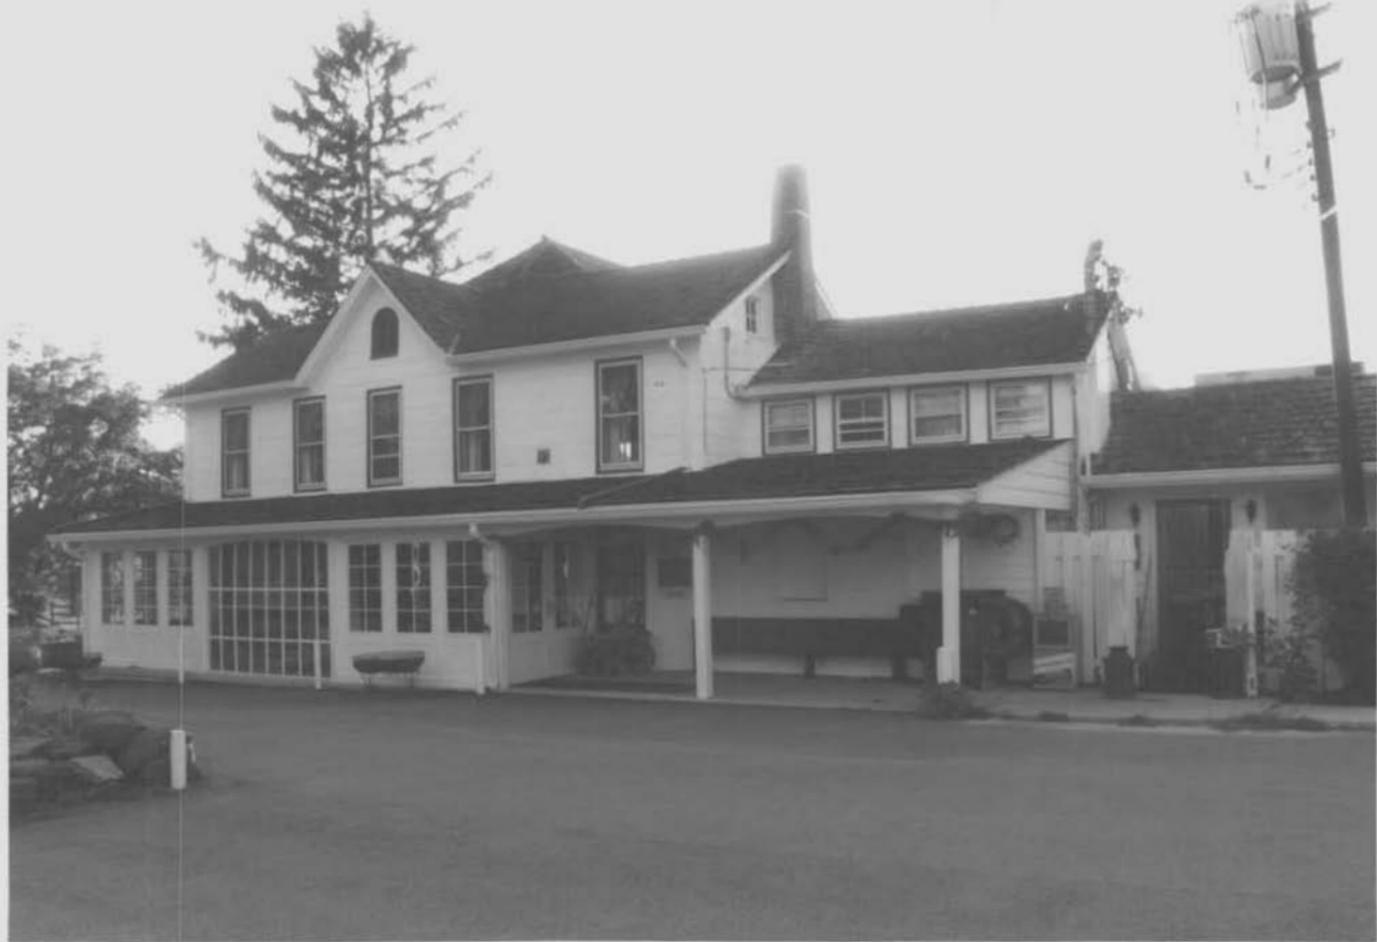
2 of 14

Main house, east facade

The Johnson Wolfe House is a two-story, five-bay, frame building. The exterior walls of the dwelling are currently clad in asbestos shingle siding, which was applied over historic wood siding. The historic wood siding survives intact and in good condition beneath the asbestos cladding. The roof is sheathed with wood shingles. The wood shingles were applied over an existing asphalt roof. The east elevation features a center gable that contains a two-over-two-light, round arched window. The original box cornice of the principal block features gable returns; raking boards further delineate the gable ends of the side elevations (north and south). The south gable of the main block features two original wood-frame, round arched windows containing two-over-two-lights. The windows in the front (east) elevation are two-over-two-light, wood-frame double-hung sash windows that date to ca. 1885. Three windows on the first floor of the east elevation are identical, while a slightly smaller fourth window marks the location of the door into the original log core.

The main entry to the building currently occupies the central bay of the ca. 1885 principal block. This bay houses a contemporary wood panel door with twelve upper panel lights. A brick exterior end chimney rises along the exterior north wall of the center block of the house.

Historic photographs indicate that an open porch with shallow shed roof originally spanned the five-bay facade. The current enclosed porch is a non-original element. Photographic documentation is sufficiently detailed to enable restoration of this element.

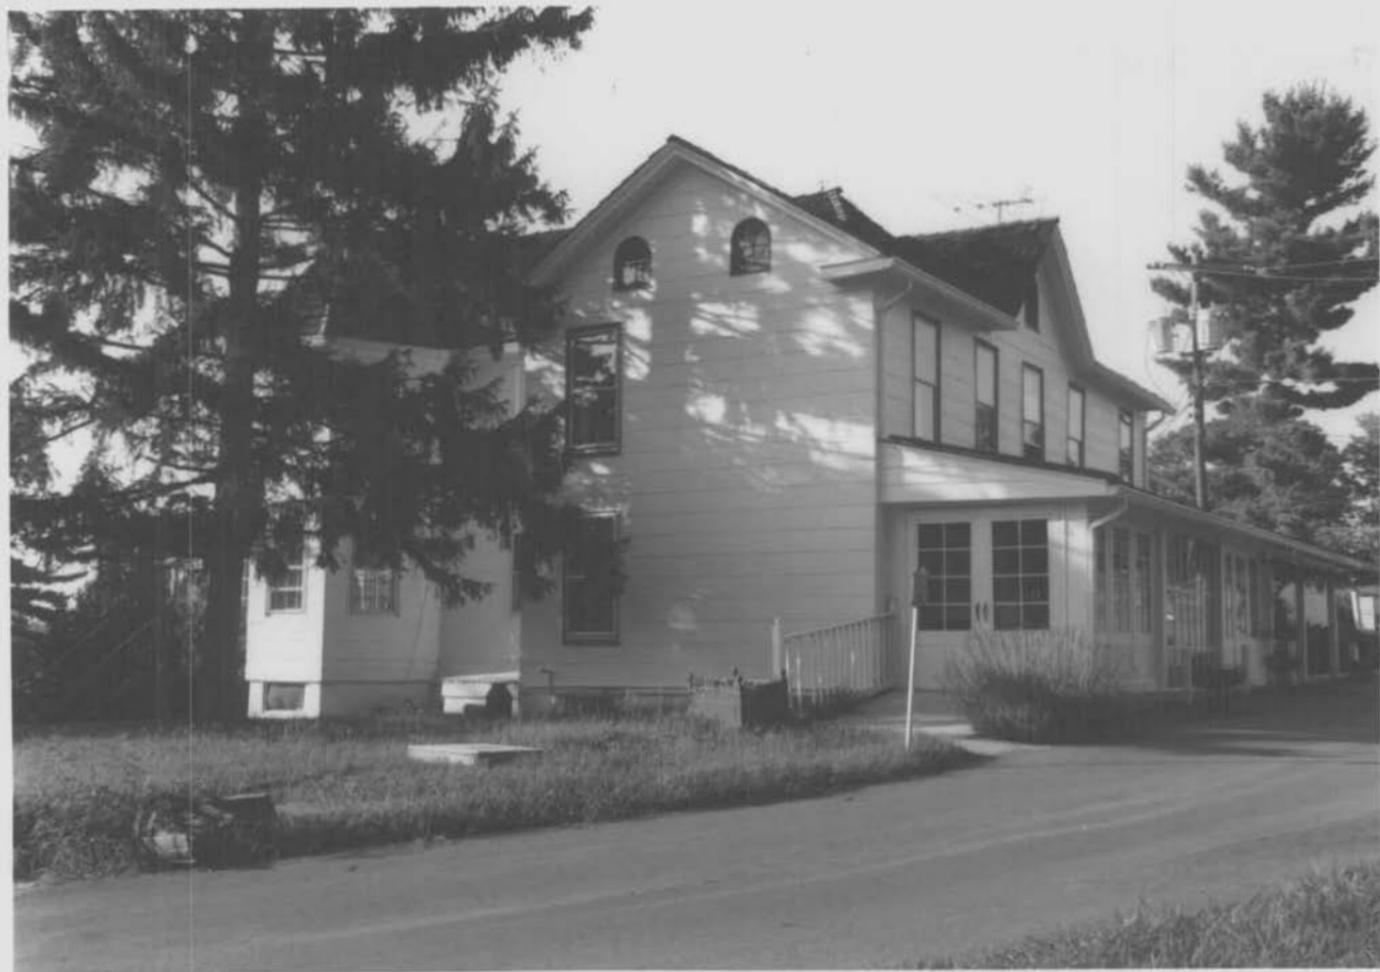
3 of 14

Main house, SE corner

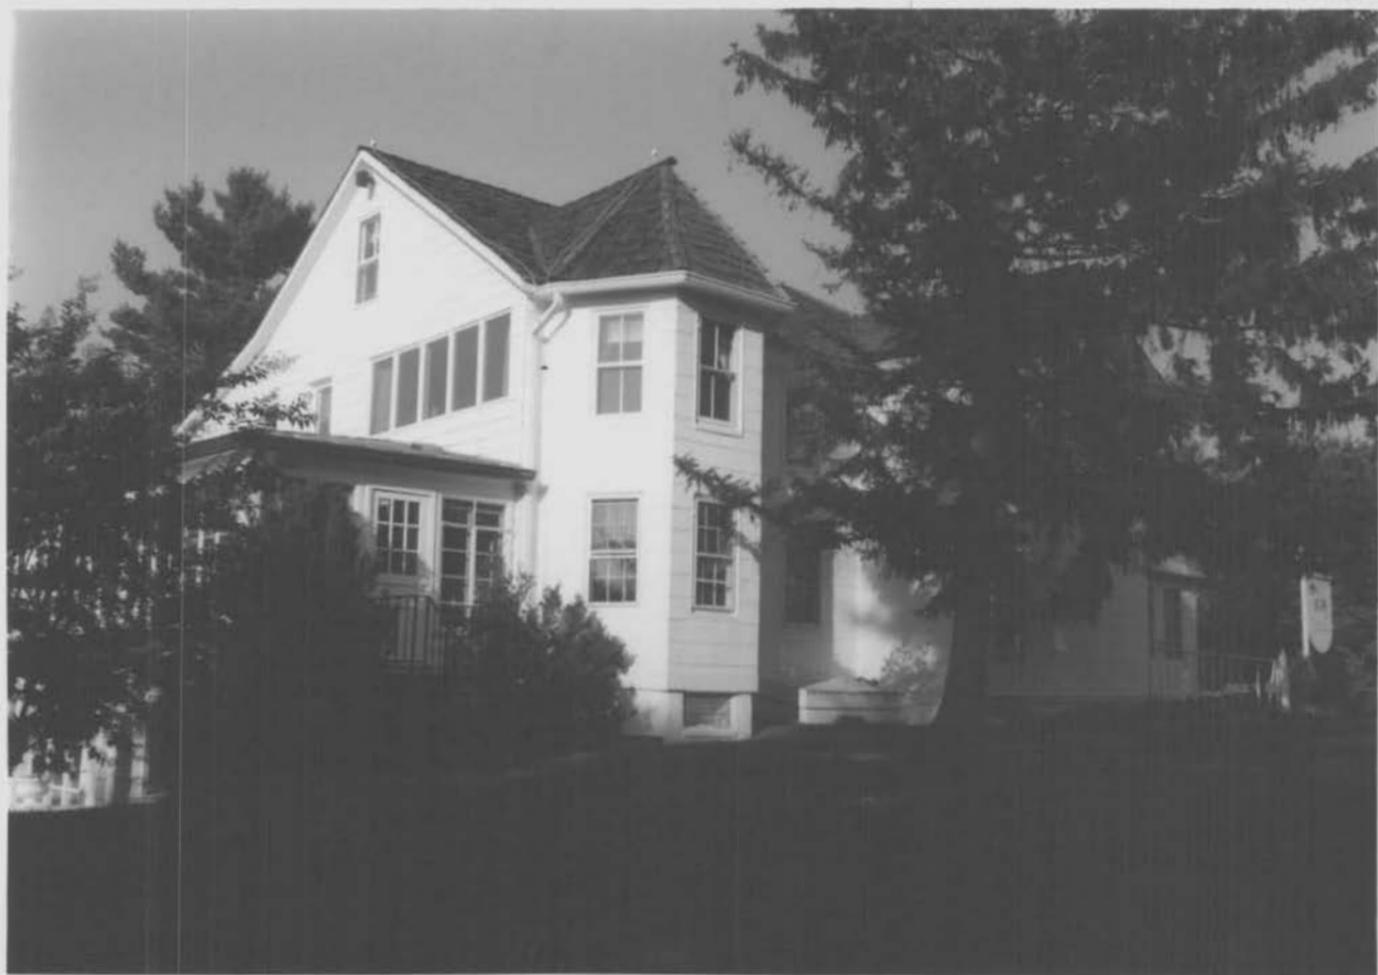
4 of 14

Main house, SW corner

A two-story wood-frame rear addition was appended to the west elevation ca. 1900. This addition features a two-story polygonal bay with a polygonal roof at its southwest corner. This addition rests on a concrete block foundation. This addition is clad with asbestos shingles installed over the original with the exception of the west gable, which retains earlier horizontal wood siding. A wood-frame, two-over-two-light window is located in the attic level of the west gable. The windows in the second floor are contemporary single-light wood casements.

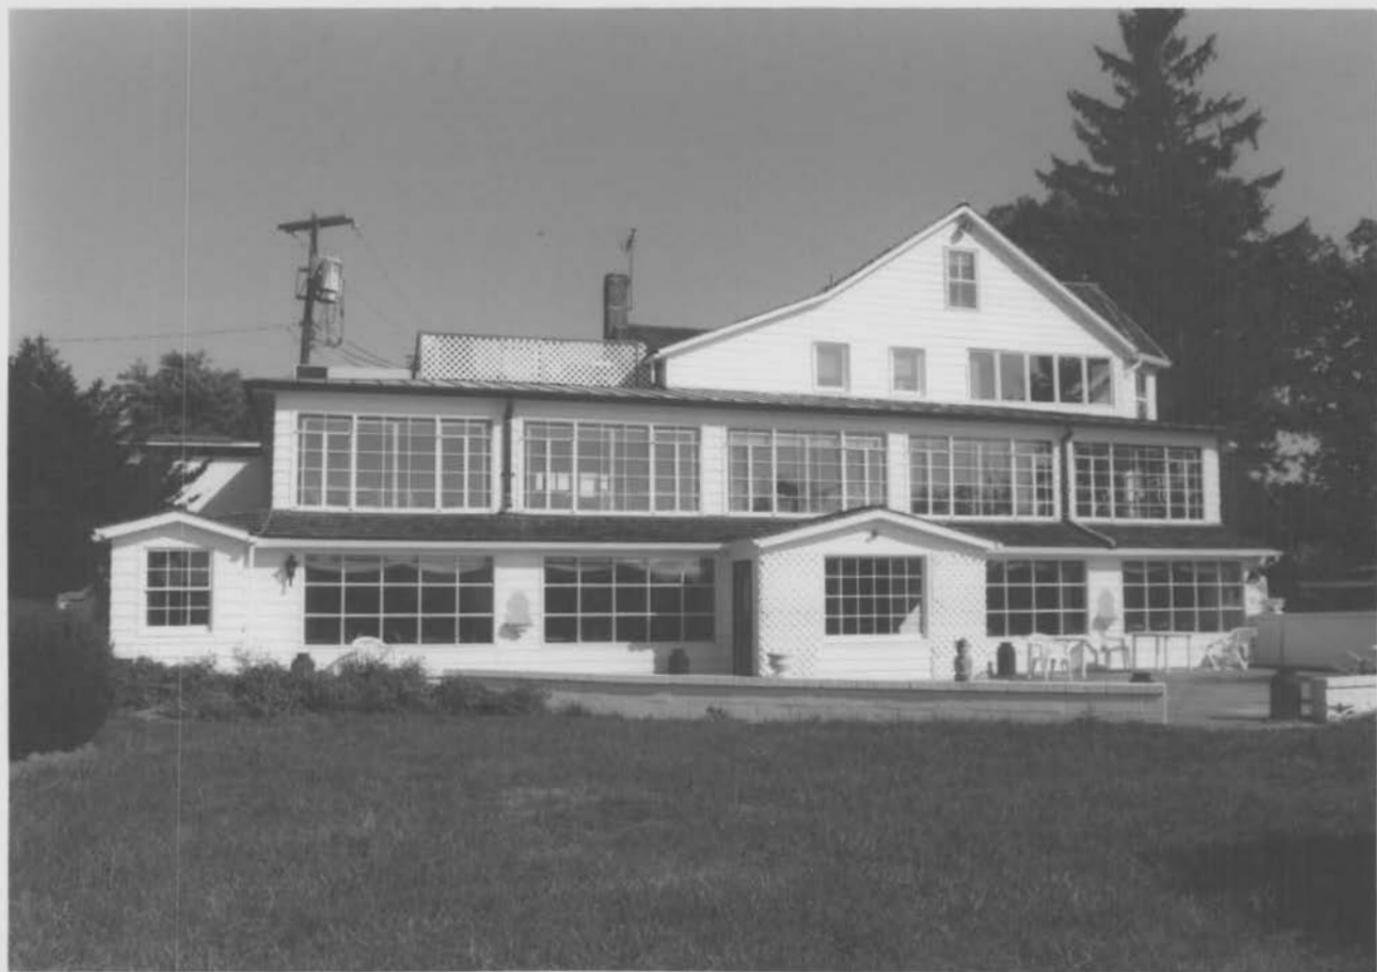
5 of 14

Main house, west facade

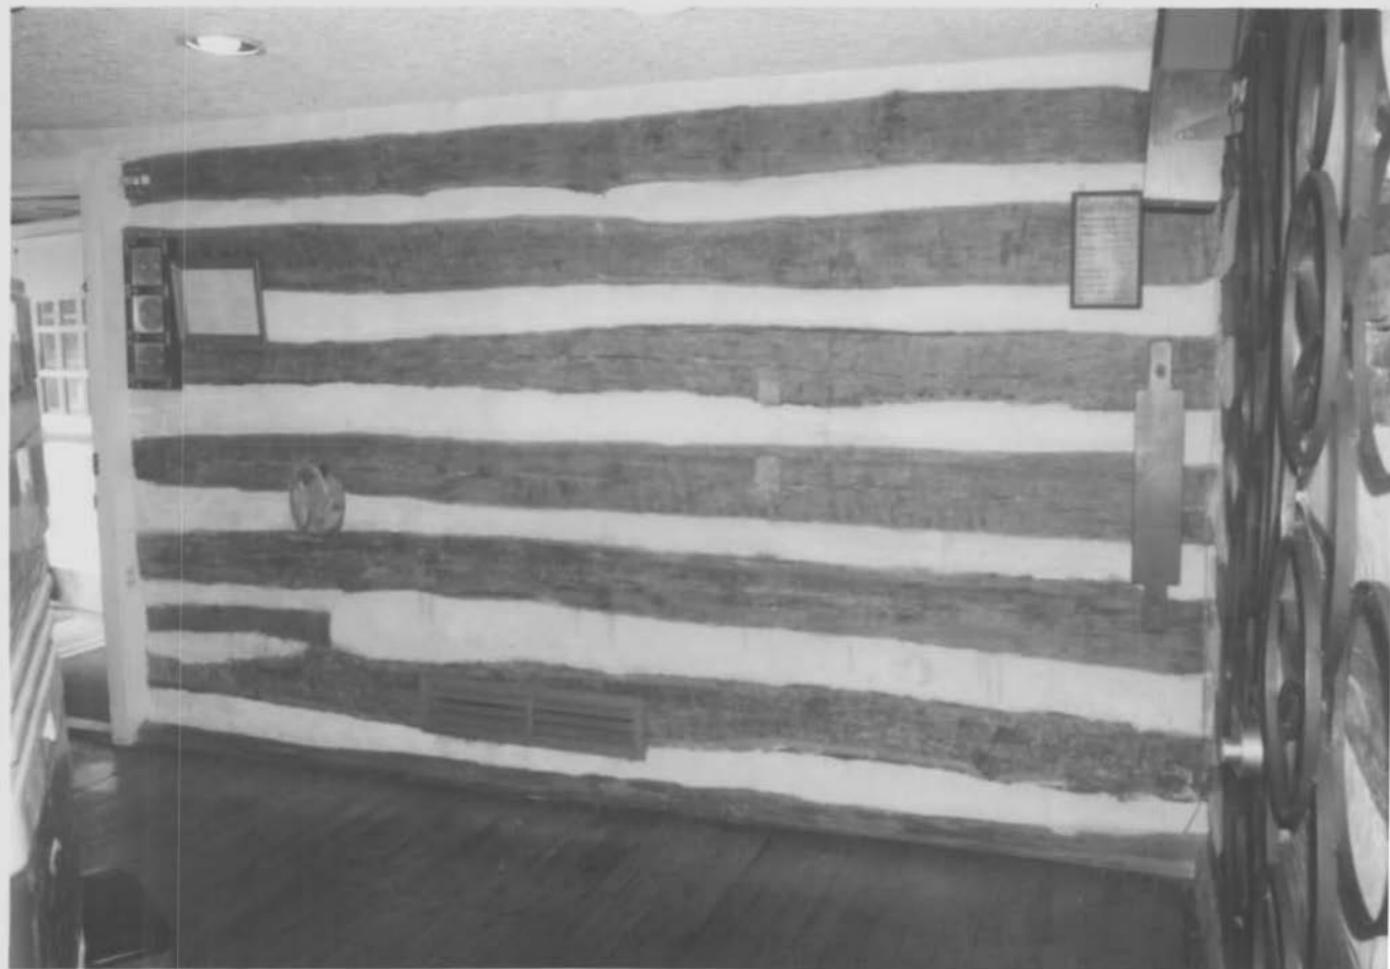
6 of 15

1<sup>st</sup> fl, south wall showing logs

The main house of the Johnson-Wolfe Farm comprises a two-story, five-bay, double pile principal block and rear addition. Examination of the building reveals a complex construction sequence incorporating four periods of major addition and expansion. The original log house constructed ca. 1862 by Robert Johnson was a two-story, two-bay, single pile building. This log dwelling occupies the north end of the principal block. The log core currently is exposed on the interior of the building. The log construction employs squared, hand-hewn logs keyed with steeple corner notches. The wide width between the log courses and their good state of preservation suggests that the log walls of the original dwelling were not exposed to the weather. The pattern of nail holes on the interior face of the logs suggests that the interior walls likely were sheathed in lath and plaster.

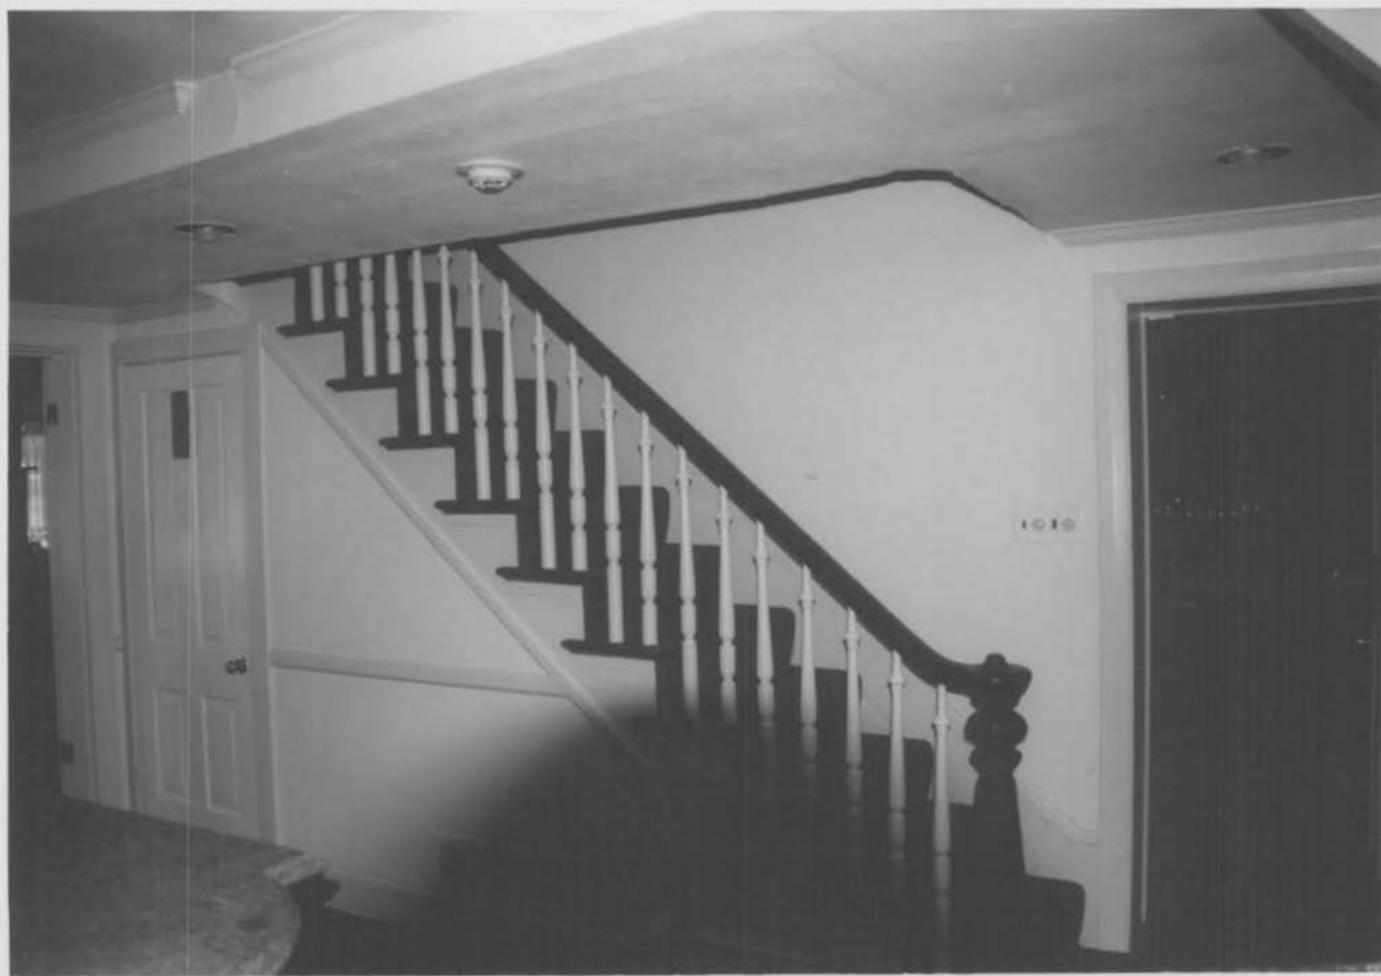
7 of 14

1st floor stair, view looking NW

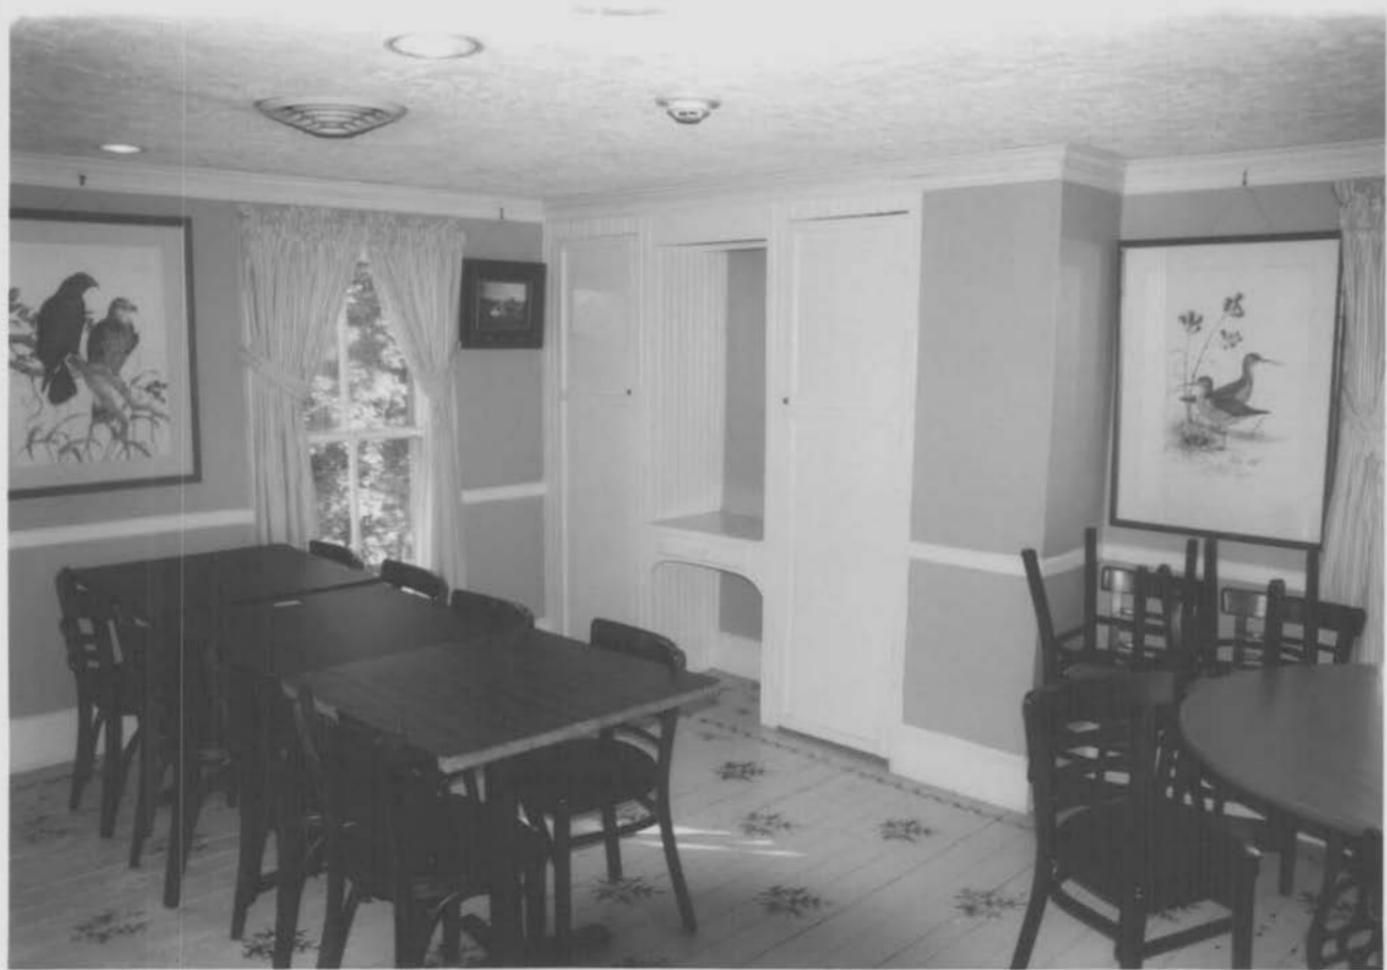
8 of 14

2nd floor, SE corner

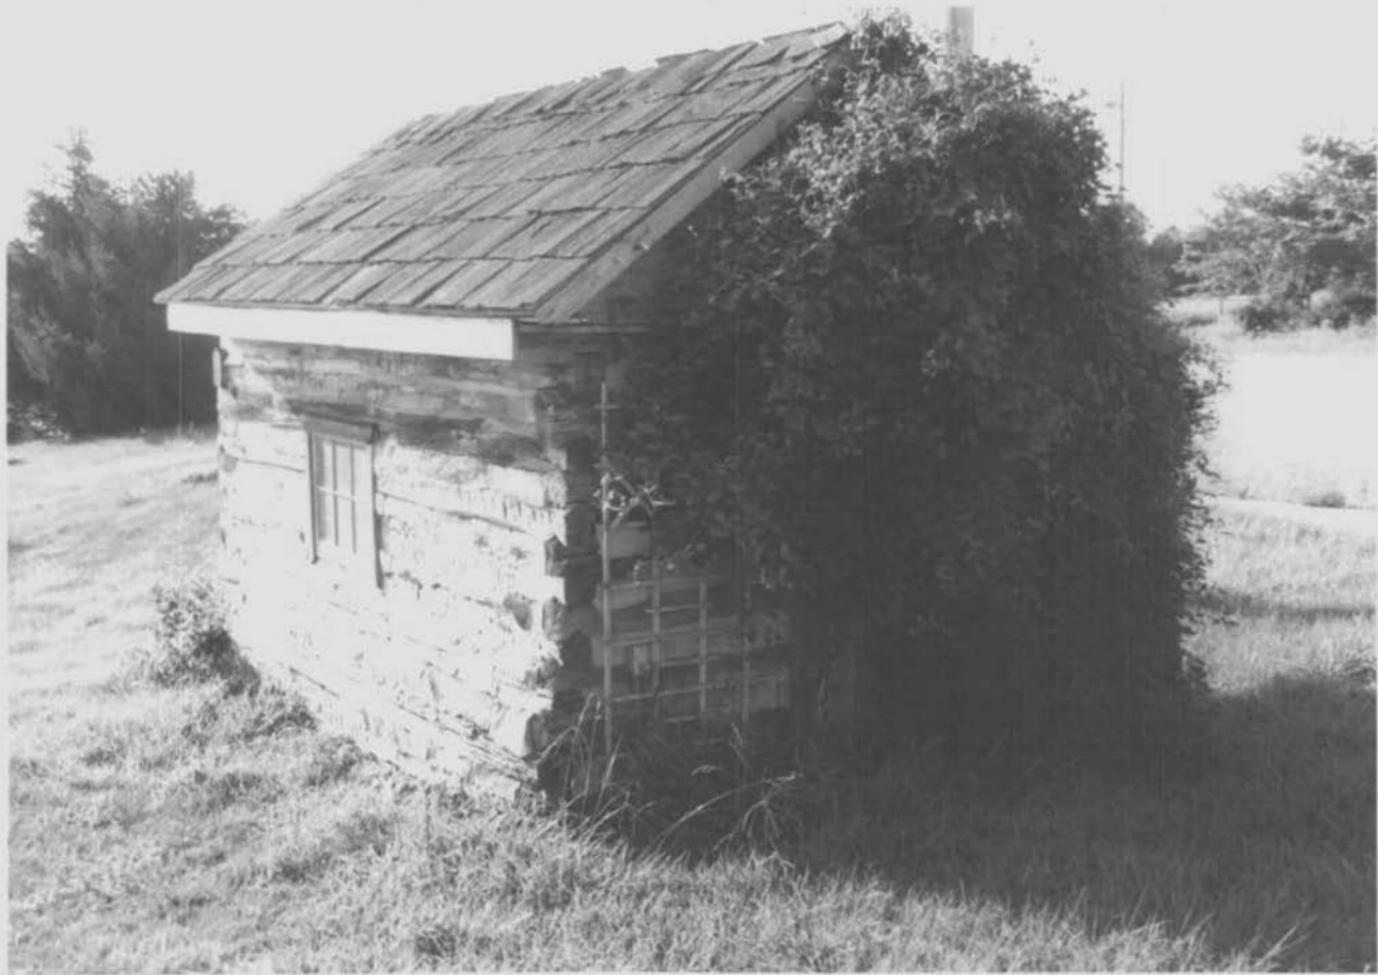
9 of 14

smokehouse, east and south elevations

The property contains a smokehouse, a barn, and a large chicken coop. The smokehouse is contemporary with the original log dwelling and exhibits similar construction techniques. The smokehouse is a one-story, rectangular log building located north of the house. The ca. 1862 log smokehouse has steeple-notched chinked logs. The gable roof is sheathed with wood shingles. A fixed six-light window is located in one side.

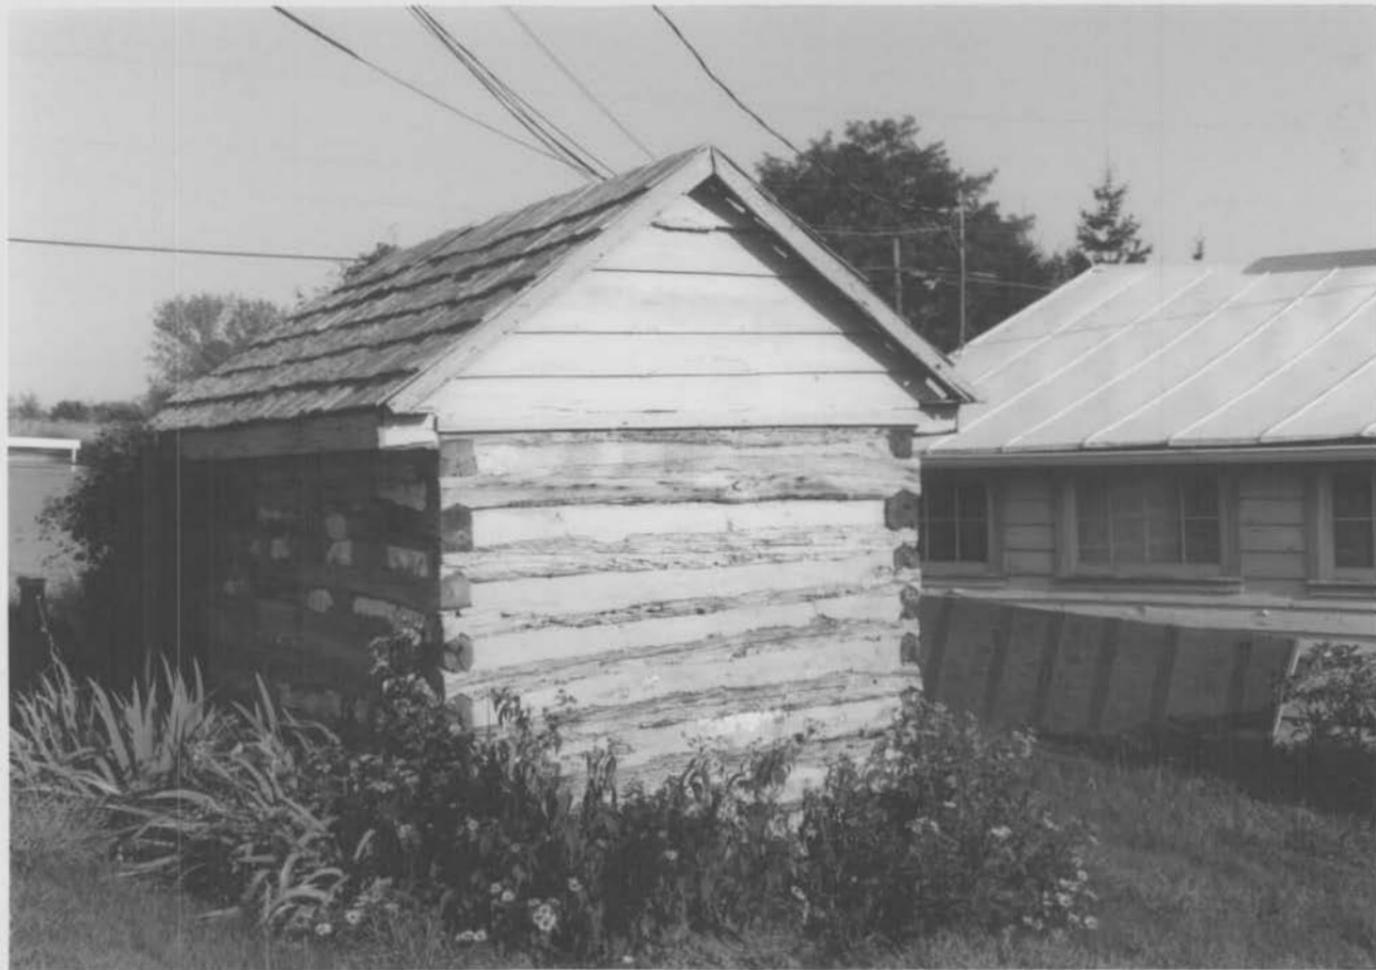
10 of 14

smokehouse, west and north elevations

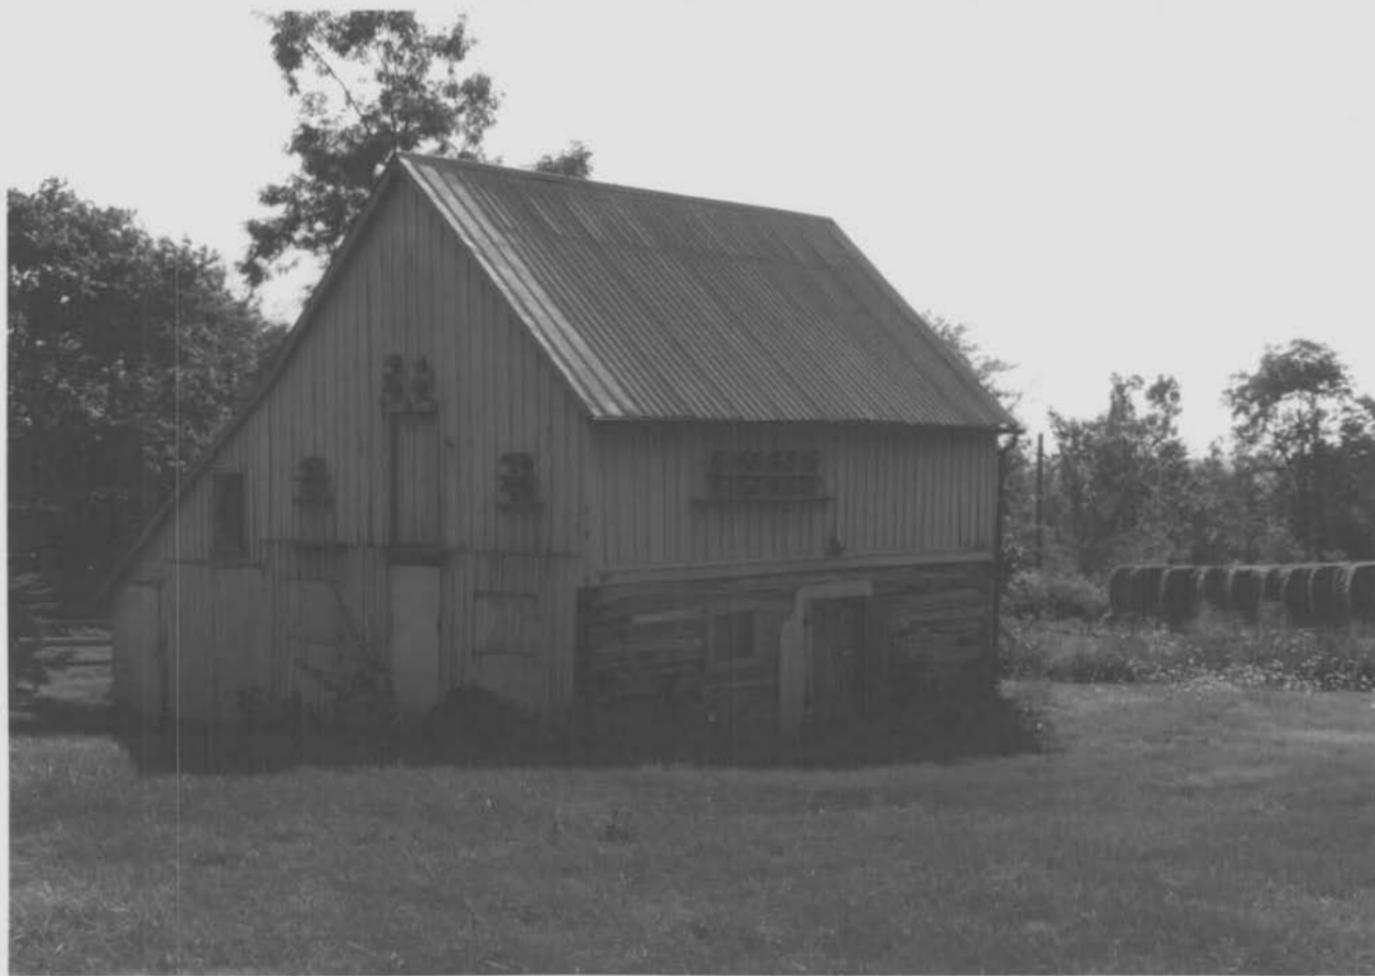
11 of 14

Barn, north and east elevations

The barn was constructed in two stages. The original log core was built ca. 1862 during the establishment of the farmstead. This small, two-story barn is located west of the main house. The foundation of the barn is rubble stone and may be the remnants of an older building (Cuttler, personal communication 9/17/2002). The first floor of the building was constructed ca. 1862 of hand-hewn steeple-notched logs, which are exposed on the north elevation. The upper portion of the barn and the shed addition along the south elevation appear to be frame and were added by Joel Hamilton Wolfe ca. 1885 (Cuttler, personal communication 9/17/2002). These portions of the barn are clad with vertical board and batten siding, which also dates from this period. The entire building is unified under a gable roof that is sheathed with standing seam metal. Paired and single hinged doors are evident on the east and north elevation. The east elevation of the barn was modified to accommodate double lead doors for automobile storage, ca. 1936. The upper story has been modified with many bird holes to accommodate pigeons. A photograph located in the Comus Inn depicted the building without the bird holes.

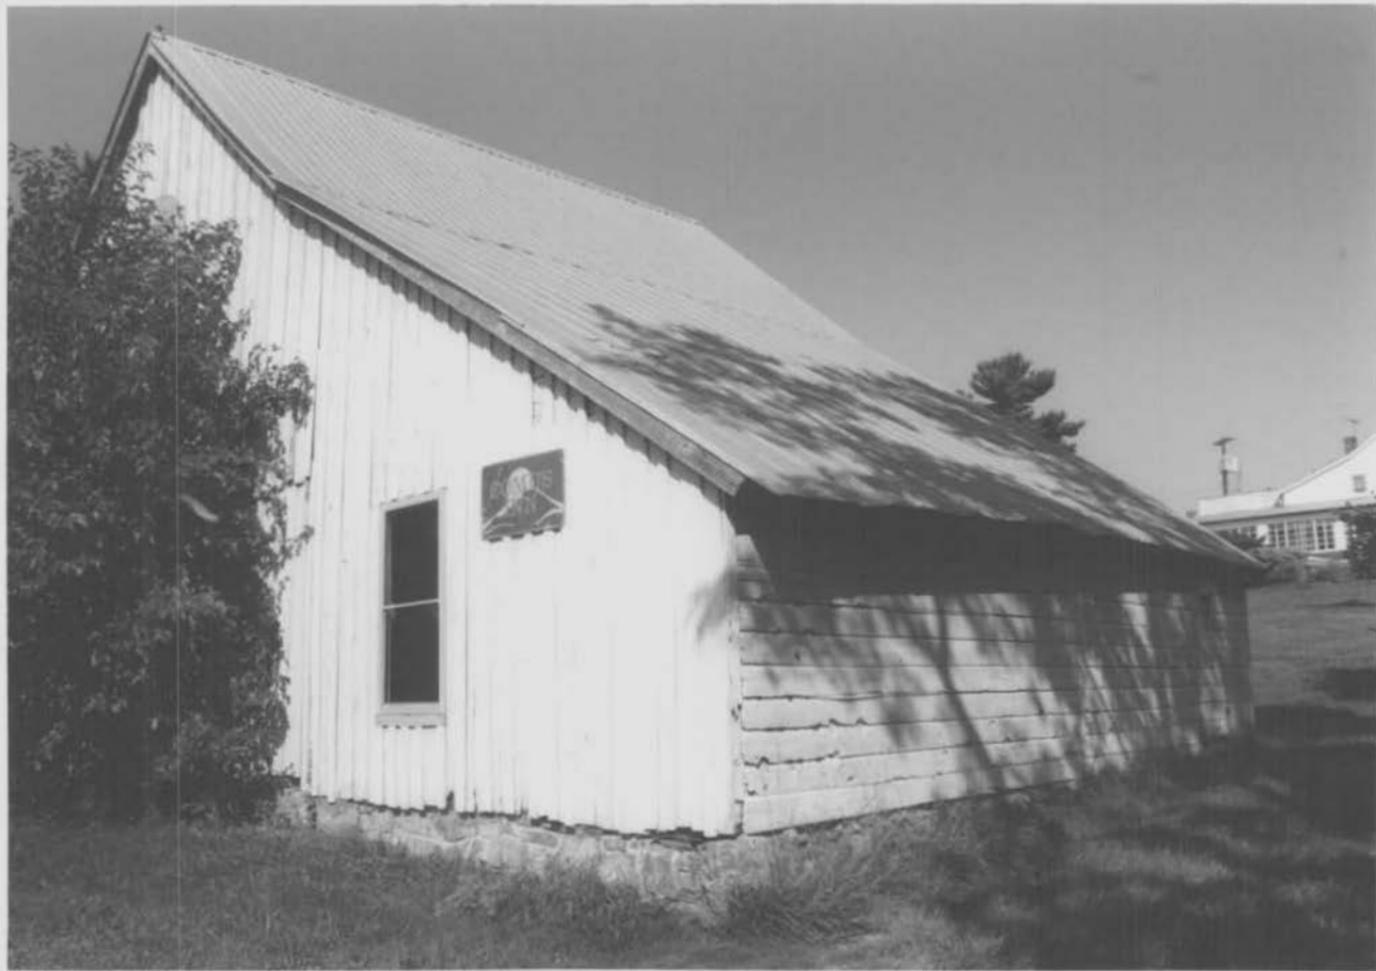
12 of 14

Barn, south and west elevations
