# Maryland Historical Trust

## State Historic Sites Inventory Form

and/or common George Butler Farm

Survey No. M: 16-28

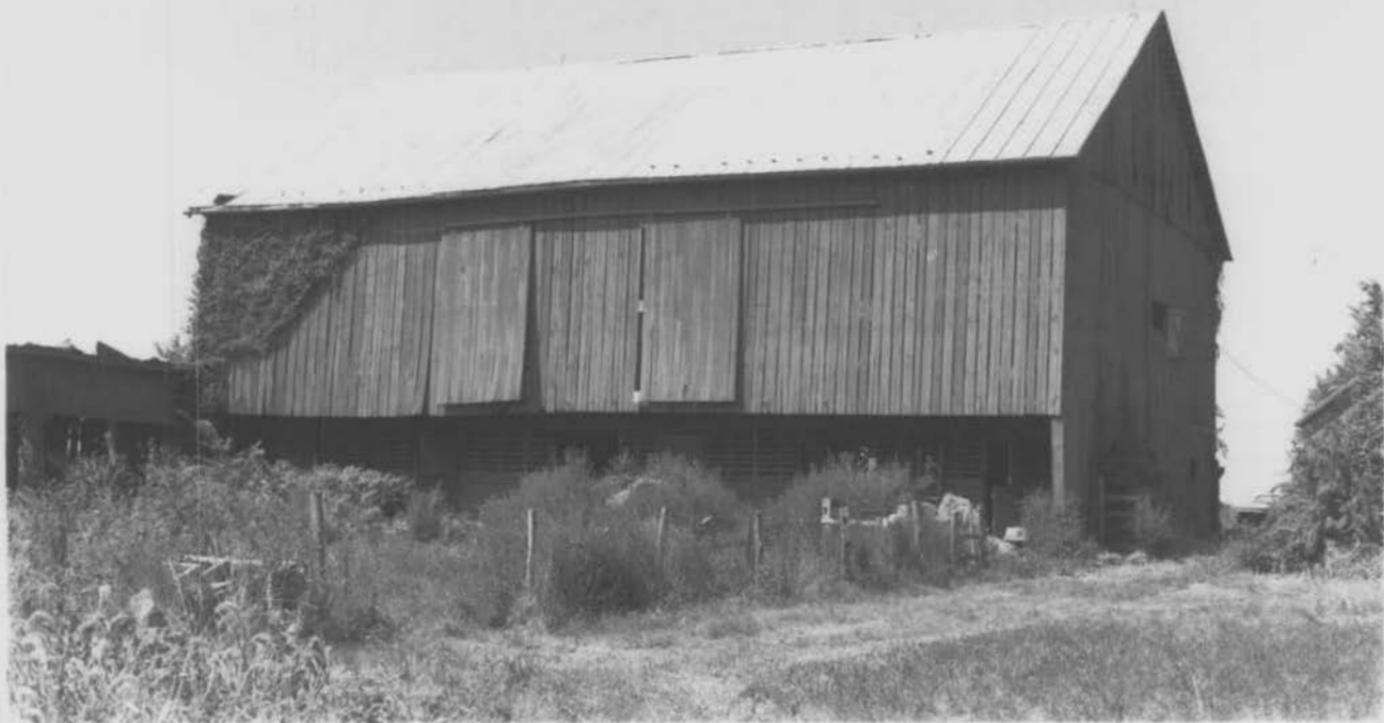
M:16-28

The stabling area on the ground level opens onto the southwest elevation of the barn. This elevation has the overhang typical of general purpose bank barns. The recessed wall of the ground floor has several dutch doors, between which the wall consists of horizontally applied boards on the lower half and widely spaced horizontal boards above. Three small windows in the southeast wall provide additional light to the stabling area, which is divided into two areas for free-ranging cattle, with a manger between. There are several small pens in the northwest end of the stabling area.

The exterior wall above the stabling area is simple vertical boards, with two doors suspended from tracks covering two separate doorways in the middle of the southwest elevation. In the center of the southeast elevation at the hayloft level is a small opening with a hinged door.

Southwest elevation
