National Register of Historic Places
Continuation Sheet

historic name Dowden's Luck
other names/site number Ellerslie or Wallace Poole Farm M: 17-20

street & number 18511 Beallsville Road not for publication
city, town Poolesville vicinity
state Maryland code MD county Montgomery code 031 zip code 20837

United States Department of the Interior
National Park ServiceNational Register of Historic Places
Continuation SheetDowden's Luck M: 17-20
Montgomery County
MarylandSection number 7 Page 1GENERAL DESCRIPTION:

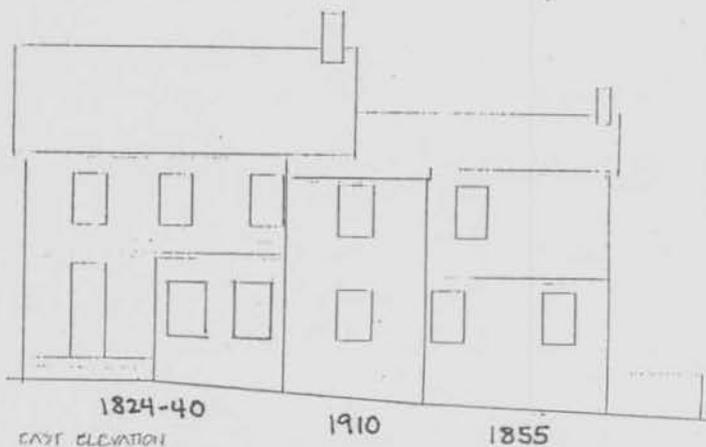
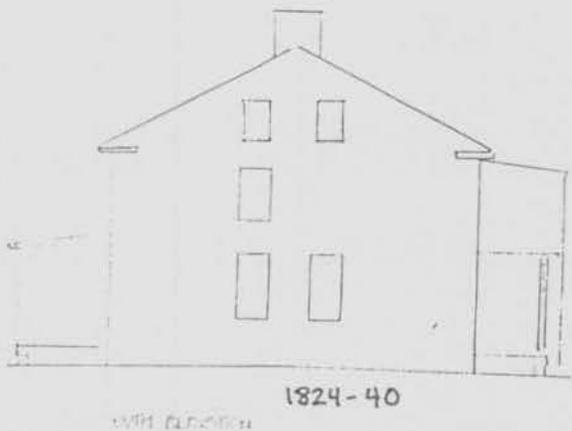
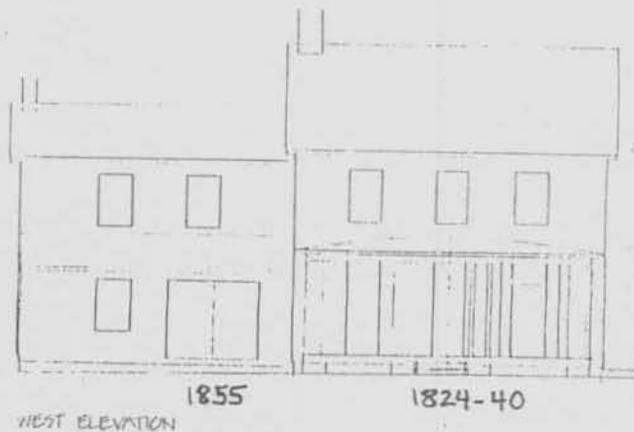
"DOWDEN'S LUCK"
Montgomery County, MD
South, East, West Elevations
Main Dwelling

The main block of the residence, 30 feet by 32 feet, built between 1824 and 1840 is constructed in the late Federal style of the Early Republic Period. It is three bays wide, two and a half stories high with low pitched gable roof, and interior end wall chimney. Across the front there is a hipped roofed veranda-type porch with posts trimmed in gingerbread, Gothic Revival Style and bracketed cornices in an Italianate Style. This is an 1855 addition to the main block. The windows of the main block are six over six pane with large lights and thin muntins. On the front, two windows have molded and paneled moveable aprons which open inward. The large 6-panel front door is surrounded by vertical wooden panels on each side, sidelights and transom lights. Extending across the East facade of the main block there is a wooden porch with a slightly slanted roof supported by 3 chamfered 4" x 4" wooden posts. The bay window of the back parlor projects on to this porch. Two Seneca sandstone steps lead from the porch to the garden.

The walls of the house are constructed of timber framing filled with brick nogging and covered with 6 to 8 inch wide weatherboarding. The exterior was covered in the 1950's with asbestos shingles. The weatherboarding and their corner boards are visible in some places where the shingles have been removed. The wood shingle roof is covered with asbestos shingles.

Alterations to the main block are: the addition of a wing to the north, built in 1855, east windows of the back parlor revised into a projecting bay, doors added to the north wall of the first and second floors to give access to the newly constructed (1855) wing and, on the exterior, pendant brackets added along the roof cornice. The 1855 porch addition is described above.

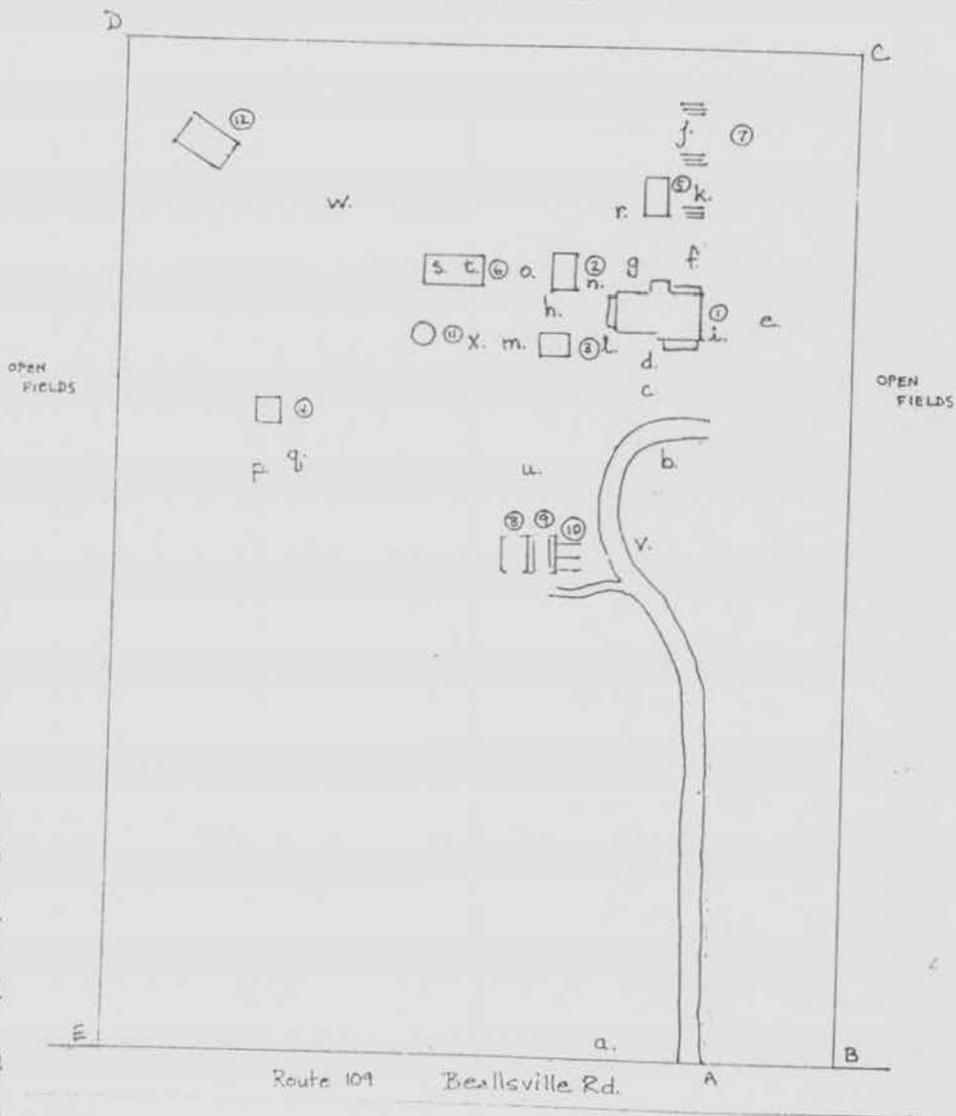
PHOTOGRAPH MAP

s	39	Foundation of 'Switzer barn' 1824-40, from interior, w/s walls.
t	40	Foundation of Switzer barn, s. wall, built in shales & timbers.
u	41	Two agricultural equipment storage buildings, n. elevation.
v	42	Two car garage, s. elevation.
w	43	Dairy barn, southwest elevation.
x	44	Silo, s. elevation.

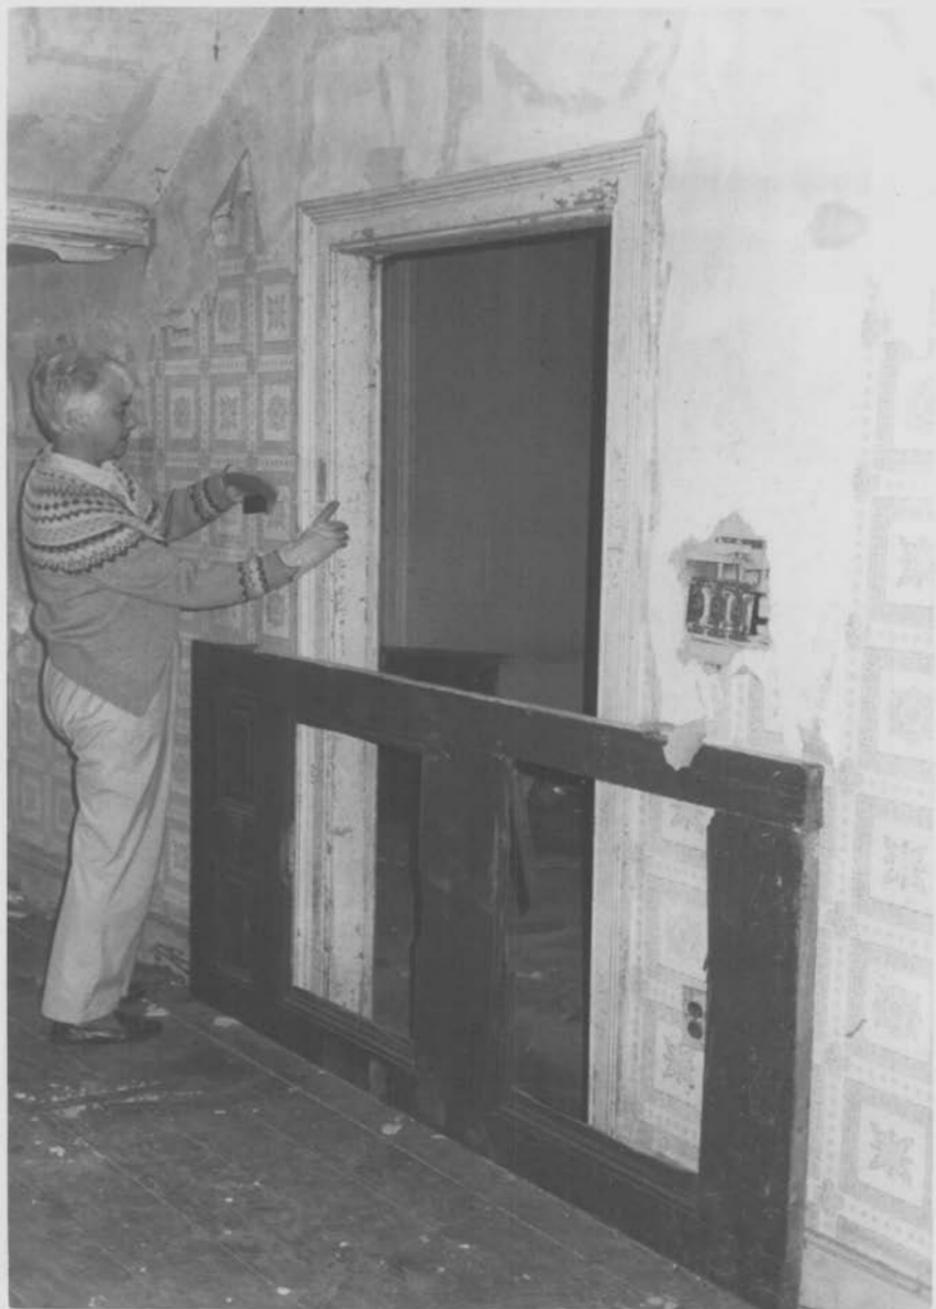
12A ^{cf} slides 14 of 39

One of two doorways in this wall.

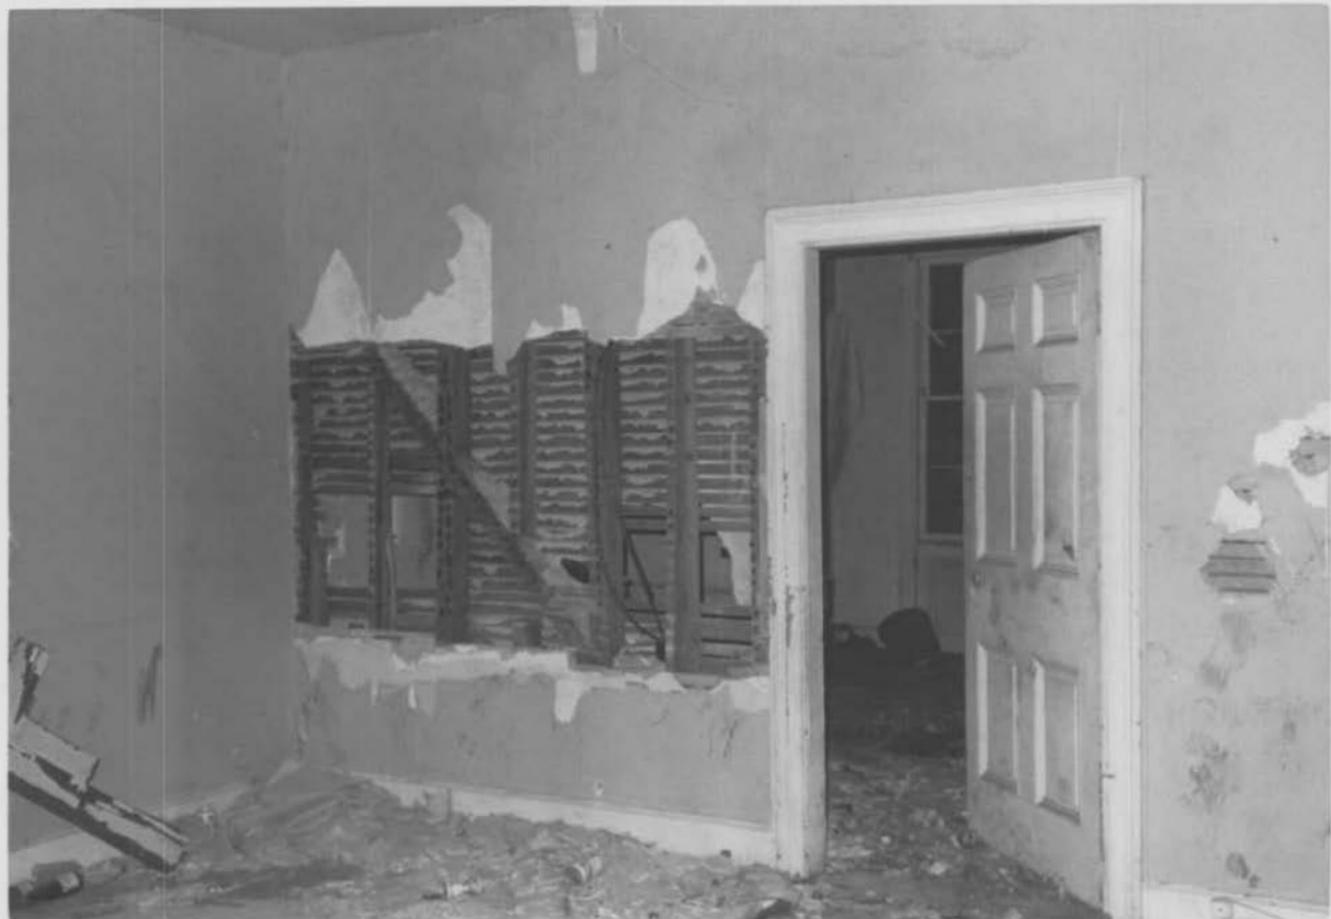
15A SLIDE 19 of 39

West wall of back parlor showing woodwork
and six-panel door.

Opening from the left side of the entrance hall there are two parlors, front and back, each with fireplaces, whose mantels have been removed. The wooden trim of the architraves are cyma reversa combined with flush bead molding and two fascias in a 4 1/2" band. The doors are molded six panel doors. Ceilings are 9 ft. Floorboards are 6 1/2 to 8 inches wide. The front parlor has the apron windows mentioned earlier. The back parlor has a late addition of a bay window consisting of four fifteen-pane windows facing the back, (East). In this parlor there is an original cupboard built into the chimney and two doorways to the North wing of the house.

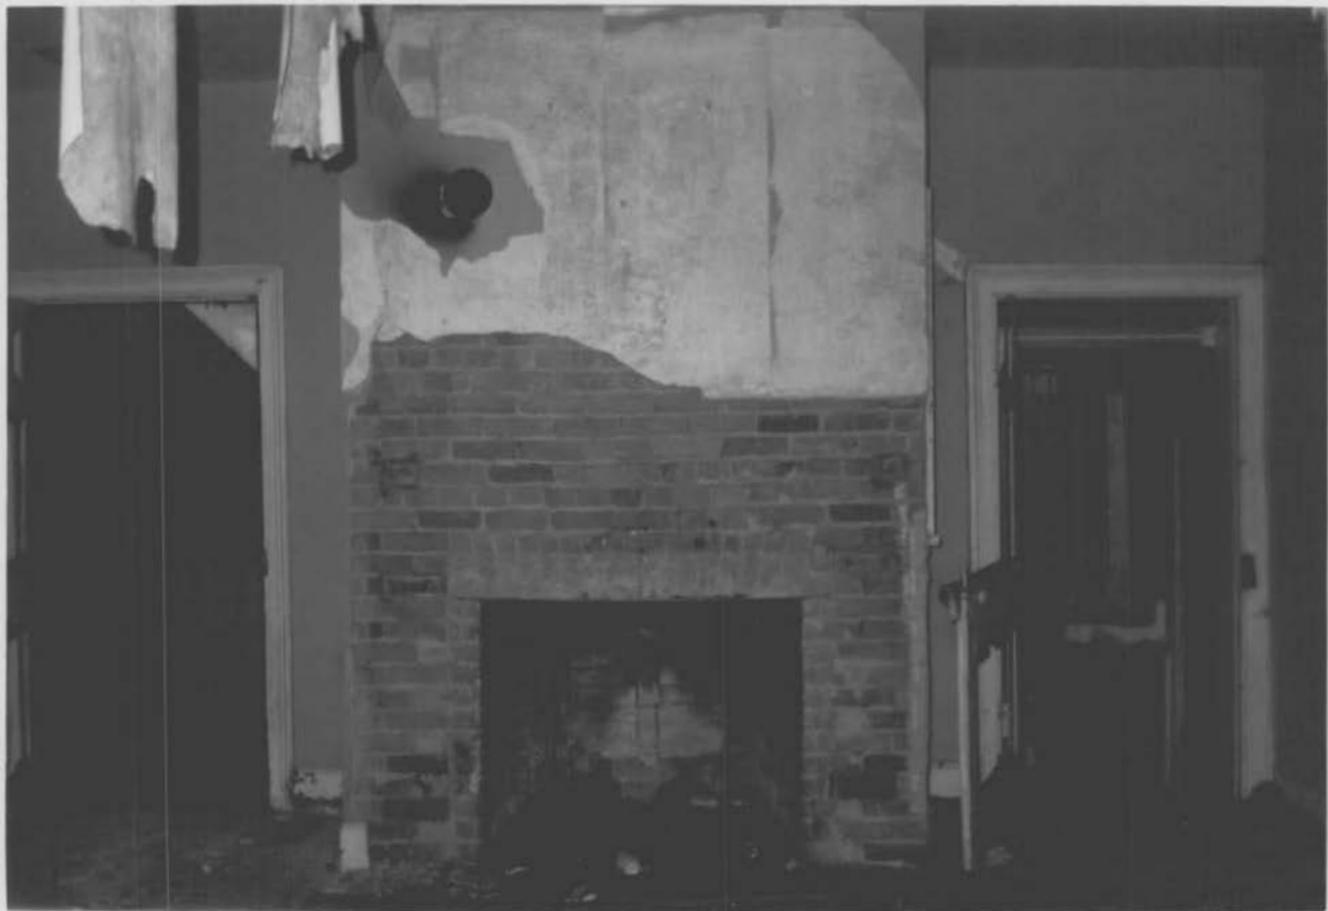
15B SLIDE 20739

Back parlor, North wall, fireplace mantle
missing, closet in back of mantle, damaged
six panel doors

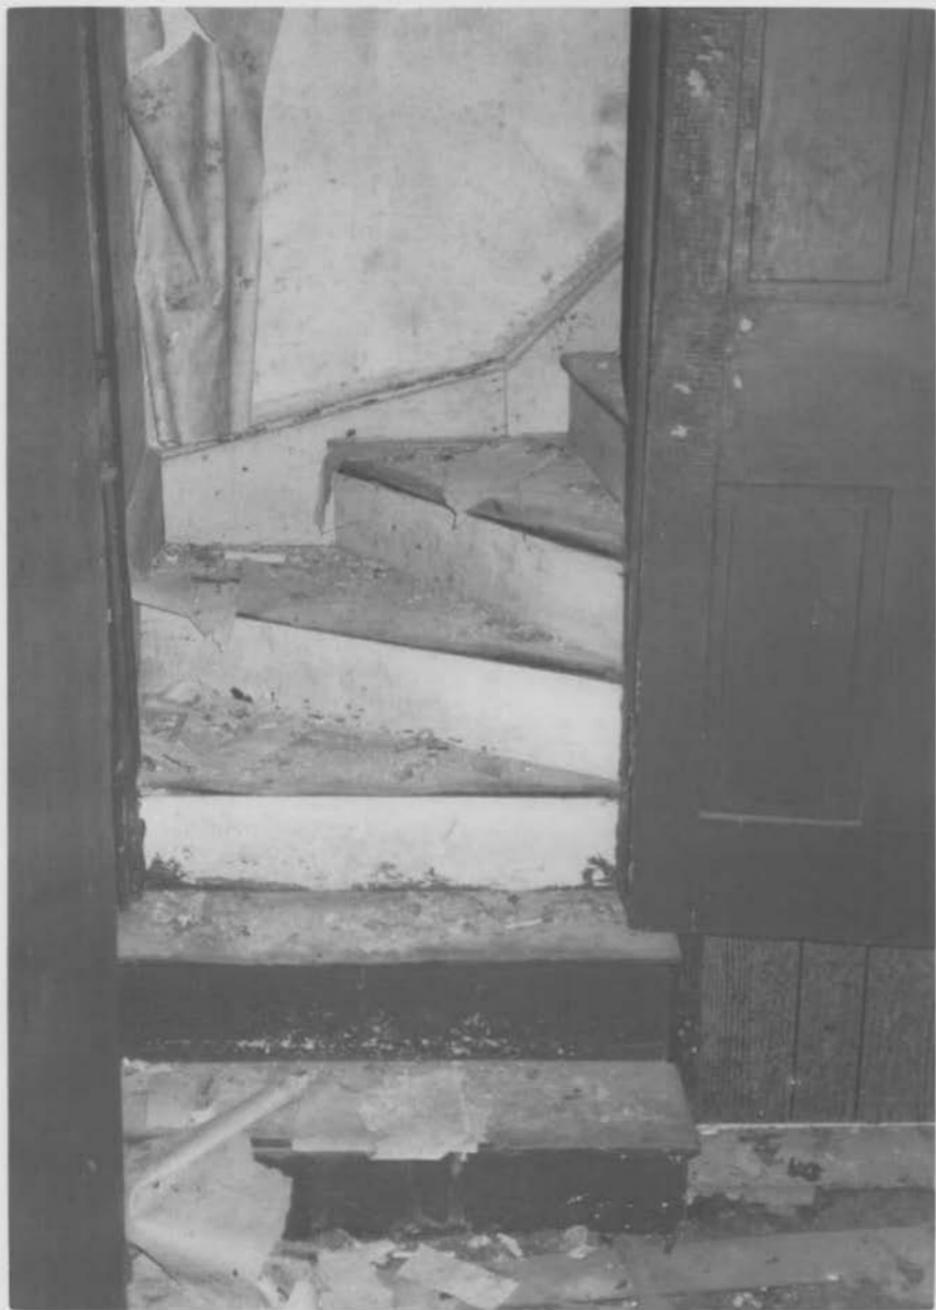
17 ~~SE~~IDE 220739'

Closed staircase on South wall of 1855
addition leading to bedroom directly above
dining room.

In the dining room a fireplace is built into the back of the chimney of the main block and surrounded with a simple wooden mantel with a Tudor arch and narrow shelf. An enclosed quarter-turn stairway with winders, rising to the bedroom above, is built into the southeast corner of the dining room. Woodwork in this wing is

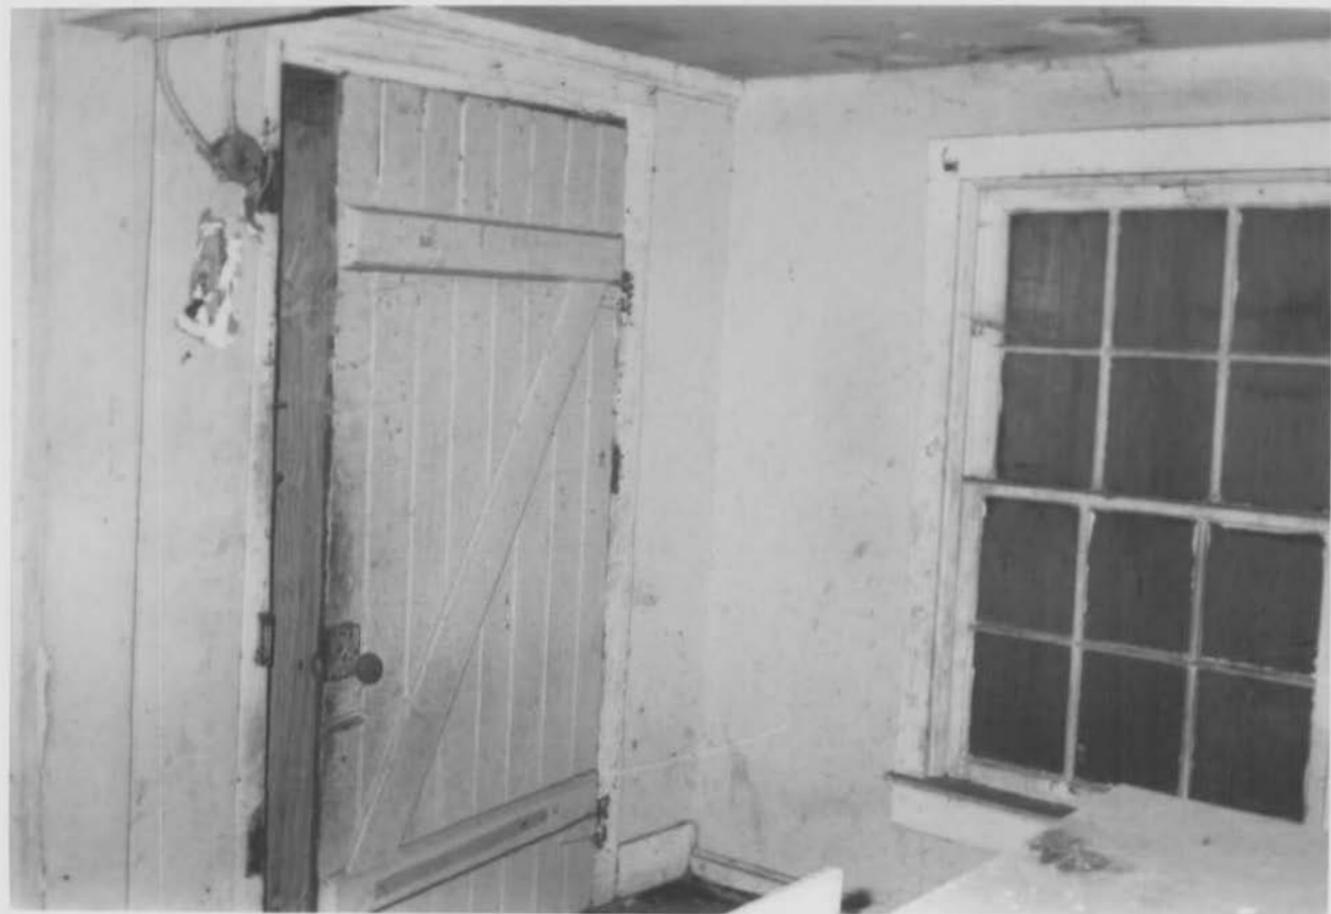
18 SLIDE 24939

Kitchen interior, Northeast corner

The first floor of the addition contains a dining room, kitchen, pantry and small back hall.

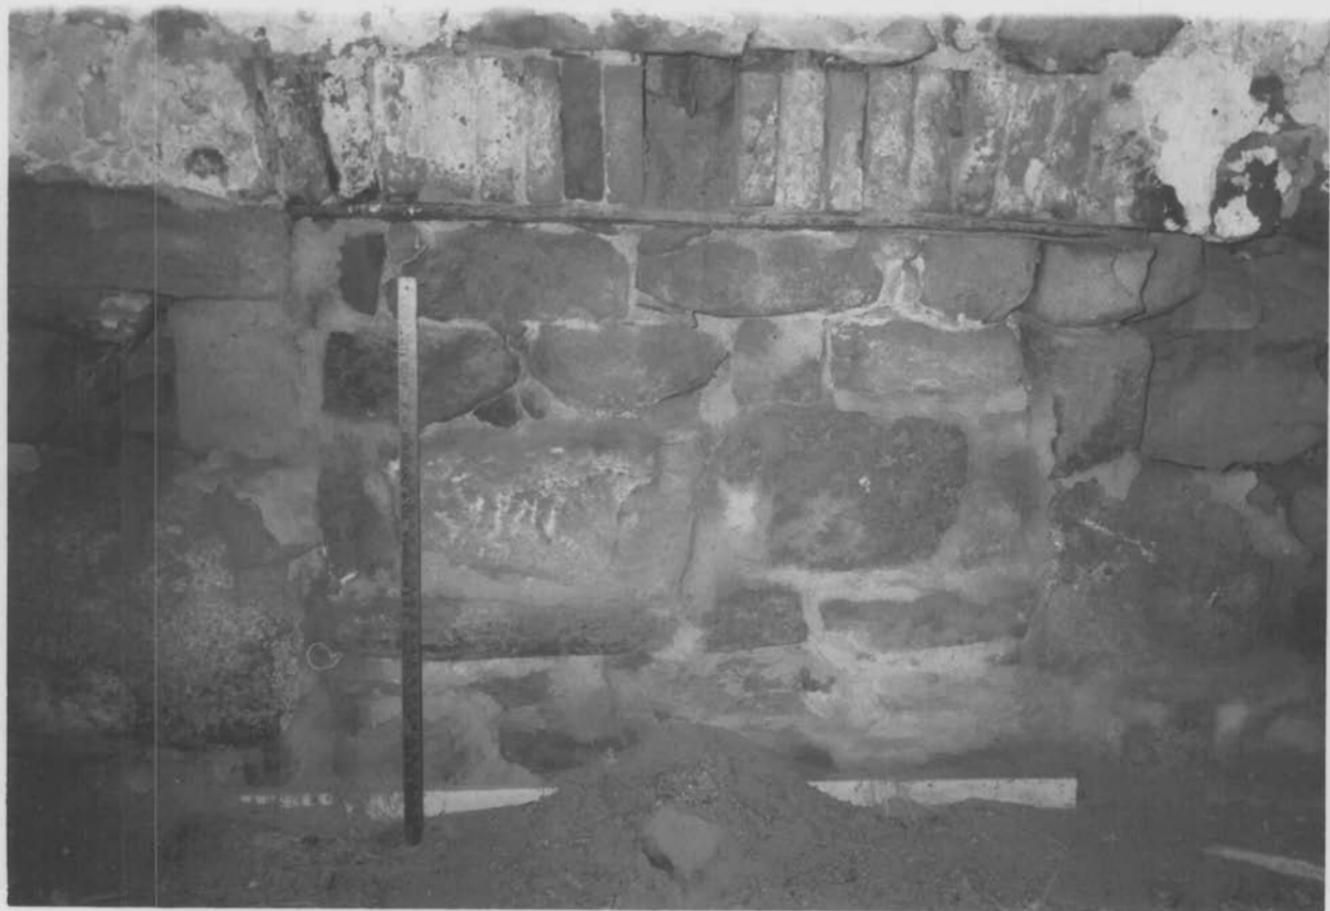
32 SLIDE 34 739

Slave quarter, interior, West wall,
fireplace filled with rubble stone

On the interior, two rooms are divided by a vertical-board wall containing one door. The walls are plastered, the three windows deeply recessed. A stone fireplace in the west end of one room has a brick lintel and no mantelpiece. The opening is filled with rubble stone. There is no ornamentation on windows or doors. Architraves are made of flat boards. The two steps leading from the entrance on the exterior are two large flat stones.
