Maryland Historical Trust State Historic Sites Inventory Form

and/or common Wesley Hargett Farm

street & number 13931 Schaeffer Road not for publicationcity, town Germantown vicinity of congressional district

Survey No. M: 19-35

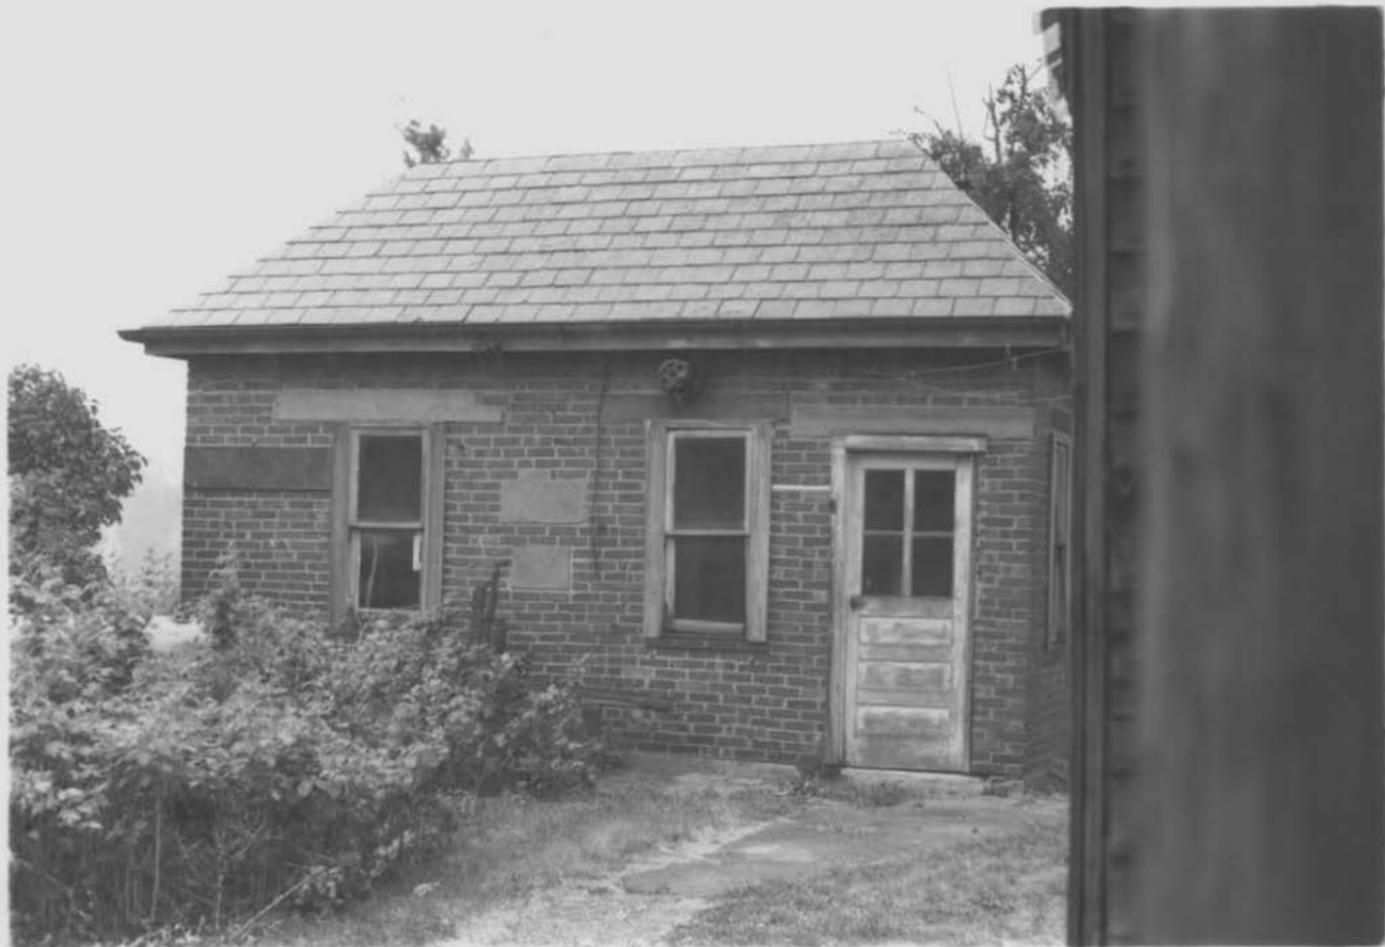
M: 19-35

The dairy to the southeast of the barn was built c. 1930, and is a small, three bay by one bay brick structure with a slate covered hip roof. Over the door and windows are large stone lintels. Three other pieces of stone are inserted in the southeast (front) elevation. The windows have one-over-one wood sash. The upper half of the wood door contains four lights, the lower half contains three horizontal, raised panels.

Dairy, southeast elevation

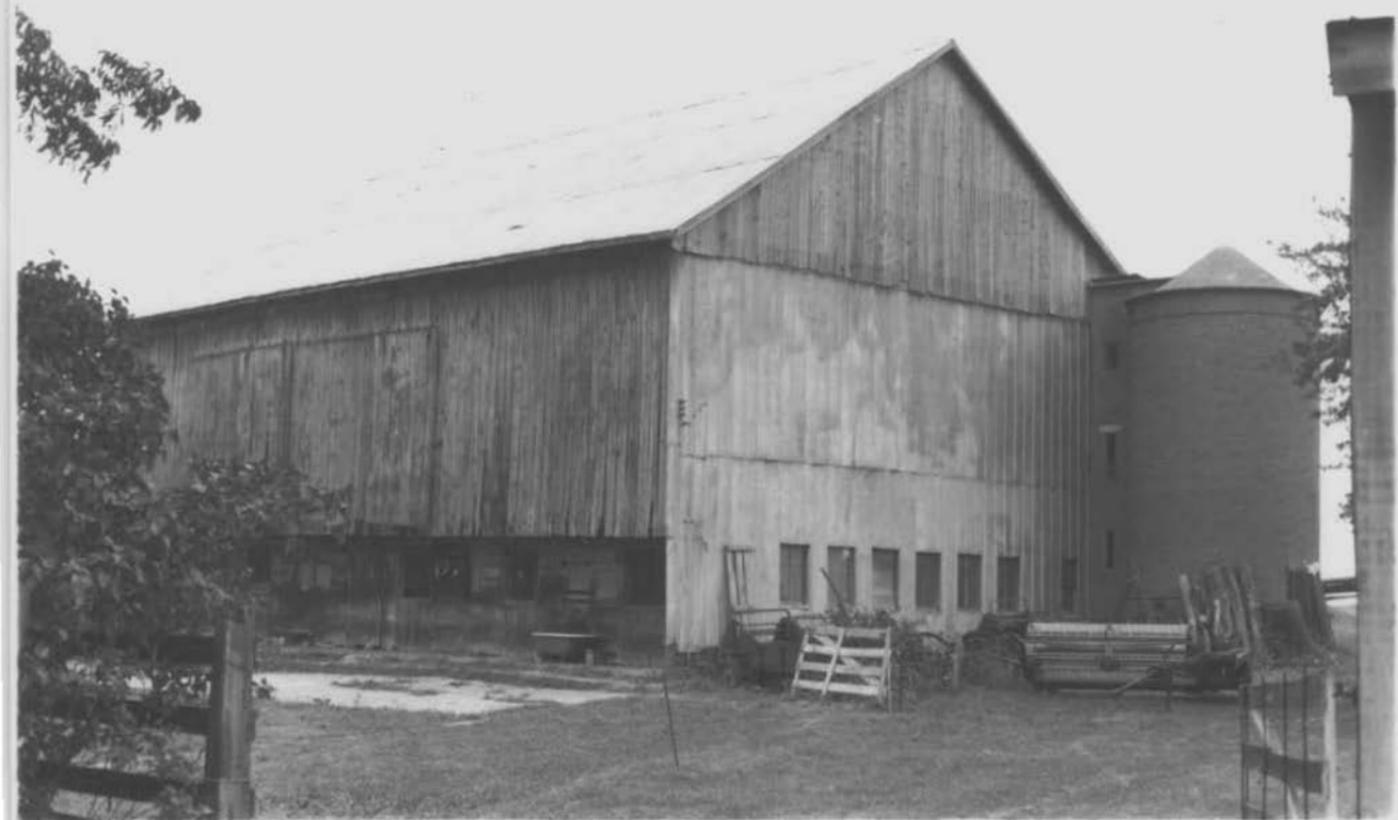
M: 19-35

The Wesley Hargett barn is a large, wood frame, gable roof bank barn with a brick silo. The barn is sheathed in vertical boards (installed while still green, according to Mr. Hargett, who claims this is why so many of the boards are warped and won't hold paint¹). Portions of the siding have been covered with large sections of sheet metal. The barn was built in 1906, and originally its roof was covered with wood shingles. The metal roof was installed in 1940. The brick silo with conical cement roof was built in 1919.²

The brick silo is attached to the north corner of the barn by a narrow, three-story connector, also of brick, containing three narrow windows. The silo is banded near the top, approximately six courses below the overhang of the conical roof.

Wesley Hargett Farm
13931 Schaeffer Road
Germantown, MD
Andrea Rebeck
Looking west
