**MARYLAND HISTORICAL TRUST  
DETERMINATION OF ELIGIBILITY FORM**

Property Name: National Capital Gun Club Inventory Number: M : 20-48  
 Address: 16700 Riffle Ford Road City: Gaithersburg vicinity \_\_\_\_\_ Zip Code: 20879  
 County: Montgomery USGS Topographic Map: Germantown 1:24000 USGS Quad \_\_\_\_\_  
 Owner: State of Maryland's Department of Natural Resources Is the property being evaluated a district? \_\_\_yes  
 Tax Parcel Number: P2 Tax Map Number: DT51 Tax Account ID Number: 00397868  
 Project: DNR Documentation of Razings Agency: Md's Department of Natural Resources  
 Site visit by MHT Staff: \_\_\_no \_\_\_yes Name: \_\_\_\_\_ Date: \_\_\_\_\_  
 Is the property located within a historic district? \_\_\_yes Xno

CAPSULE SUMMARY  
National Capital Gun Club  
Riffle Ford Road  
Gaithersburg vicinity, Montgomery County  
Begun c. 1895, alterations to site through c.1979-82  
Public- within Seneca Creek State Park

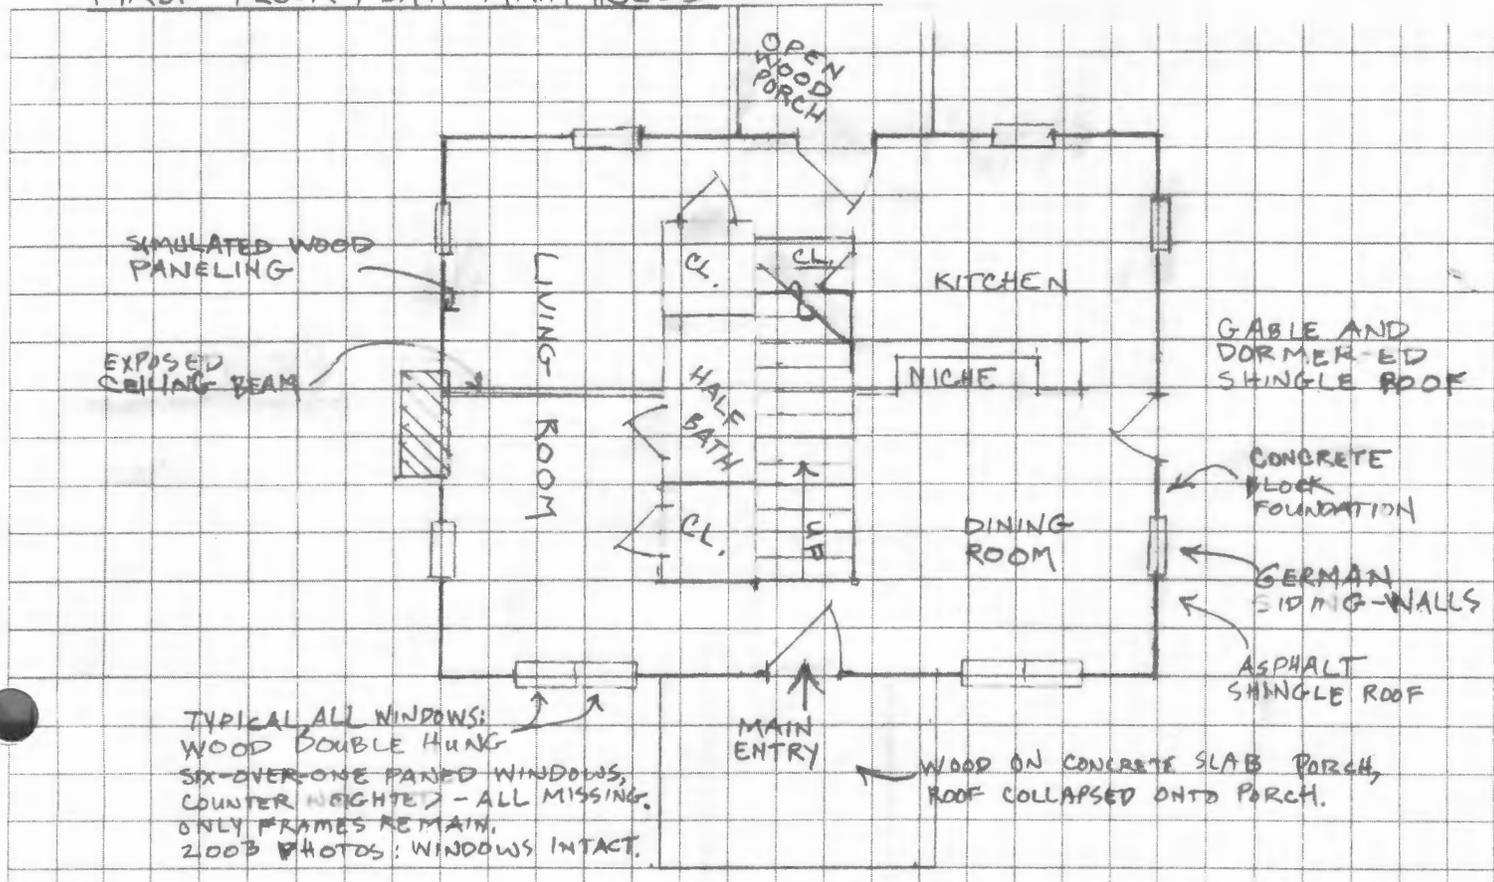
FIRST FLOOR PLAN - MAIN HOUSE

The one and half story, three bay, gable roofed Cape Cod styled **primary residence** built c. 1932-49, facing the entry driveway, is built on concrete block foundation, with walls of German styled siding. A shed roofed porch roof sits collapsed onto the front porch over the main entrance. Remnants of a wooden porch floor rest on a concrete slab at the front porch. Supporting posts and balustrade are missing. The main entrance door, now placed inside, has a configuration of 6 panels plus upper fanlight of glass, with all glass missing. A rear wooden porch is in collapsing condition. A rear wood entrance door of three horizontal panels in the lower half, had a single pane of glass in the upper half; glass is now nonexistent. All windows have plain frames; sash is all missing, but originally sashes were wood with six-over-one paned configurations.

The interior of the house is accessed via the main entry door in the center bay on the front (south) façade. Inside, one is standing at the bottom of the staircase to the second floor. Missing a complete balustrade, the straight run stair consists of only wooden steps. East of the front entrance door is the dining room with a wall niche to accommodate a server or sideboard. West of the front entrance door is the living room. A thin veneer of brick surrounds the fireplace and a thin artificial wood veneer paneling covers parts of the living room walls. On the east living room wall are two doorways, in which each door has two rectangular panels. One accesses a half bath which is now damaged and partially missing, and one accesses a closet.

A kitchen is located south of the dining room, but like the rest of the house, lacks window sash, as well as kitchen cabinetry and plumbing fixtures.

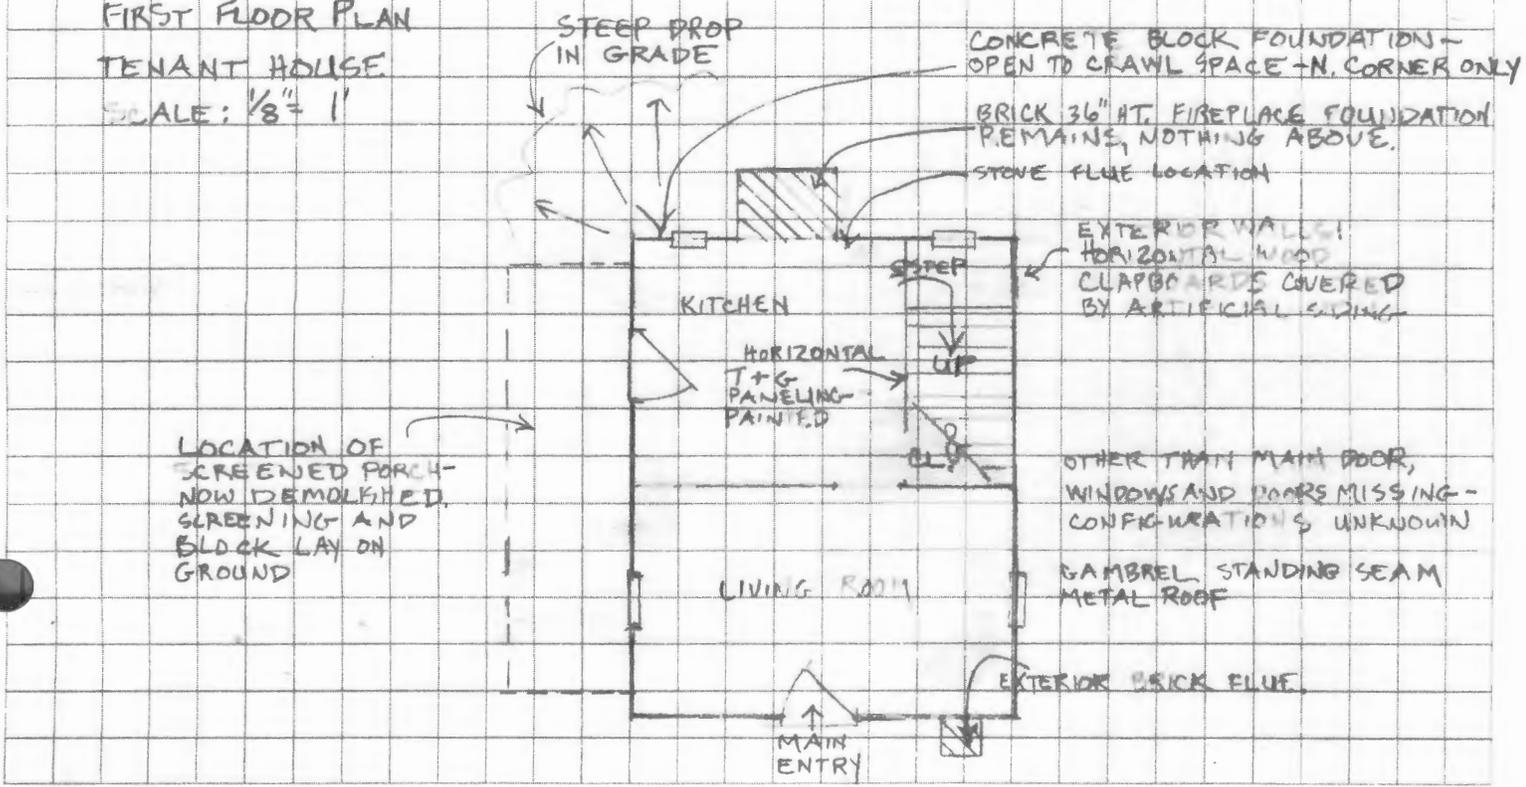
FIRST FLOOR PLAN  
 TENANT HOUSE  
 SCALE:  $\frac{1}{8}'' = 1'$

3. a totally collapsed 6' x 8' dog kennel, built c. 1954, which is constructed of 5' height tree trunks, with a shed roof of corrugated sheet metal;
4. A two story, gambrel roofed, two bay **tenant house**, built c.1895-1911. The standing seam metal roof of the tenant house has partially collapsed, window sashes are all missing, one exterior door remains, exterior walls are not plumb, and 3' x 3' holes exist in first and second floor and stair. Exterior walls are covered in horizontal wood clapboards, followed by artificial siding. On the south façade is a single entry with door containing glass in the upper half and three horizontal panels in the lower half. An exterior brick flue is attached to the south facade, east of the door. The two second floor windows on the south facade have been altered into one large rectangular window opening in the center of the second floor. On the side (east) façade is a single first floor window opening. The grade descends steeply to the north and a concrete block foundation with basement entry is evident at the northwest corner. A brick foundation is all that remains of a full height brick fireplace flue, attached to the exterior of the north facade. A small first floor window opening flanks each side of the fireplace foundation. A single large rectangular window opening in the center of the second floor mirrors the window on the south façade. On the side (west) façade are two openings- a doorway into the rear first floor kitchen and a window in the first floor front living room. A narrow screened one story porch existed at one time, attached to the west façade, nearly the full length of the west wall. The porch was built upon a concrete block foundation and accessed the house via the kitchen door. Both screening and block are now broken and strewn in the area west and north of the tenant house. On the interior, a narrow enclosed stair is located on the east wall of the kitchen, ascending to the second floor. Plumbing fixtures, interior doors and window sashes are missing. Two rooms exist on the first floor and one on the second.

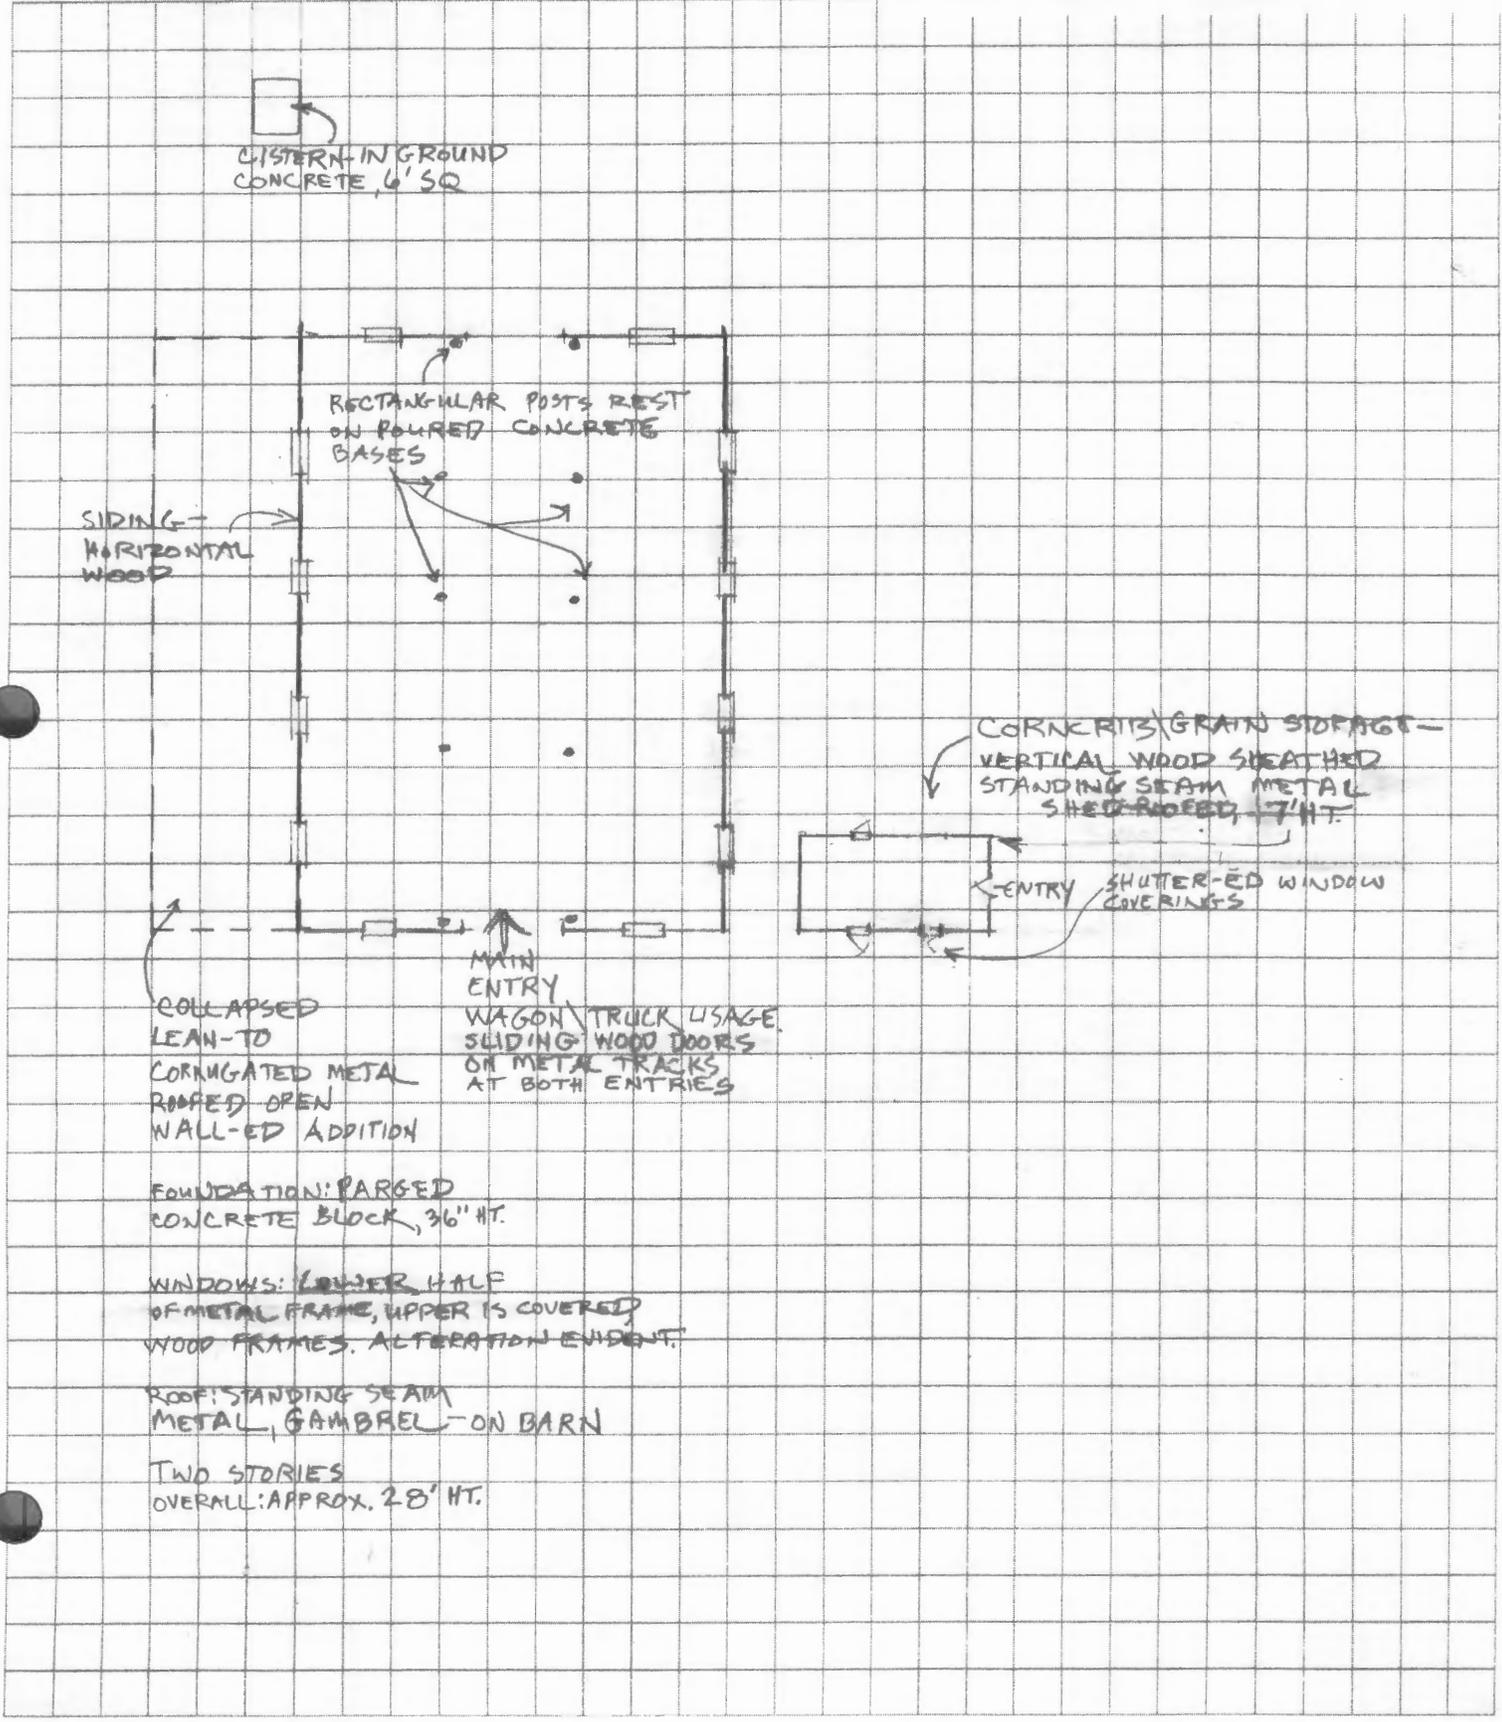
Project NATIONAL CAPITAL GUN CLUB  
SENECA CREEK STATE PARK  
Project # M:20-48 Date 1/15 Page  
RIFFLE FORD ROAD GAITHERSBURG VIC.  
MONTGOMERY COUNTY  
SCALE:  $\frac{1}{8}'' = 1'$  NOV. 2014  
PLAN OF BARN AND CORNCKIB

Beginning approximately 60' south and uphill of the entrance lane and south of the primary residence is located a two story, gambrel roofed 34.5' x 48' frame barn (c.1895-1911) and an adjacent one story shed roofed 16' x 8' frame corncrib. The barn, approximately 28' in height, has horizontal wood siding and is accessible via an 8' wide doorway in the north façade. Sliding wooden doors originally were located on the exterior of the north and south facades and were located in metal tracks still visible above each central door opening. Parts of broken doors lay on the floor beneath grain and dirt. A window opening flanks each of the central doorways on the north and south facades. All twelve of the window openings appear altered. Original configuration is unknown because metal window frames appear in the lower half, while upper window sash is missing and replaced by wood board. Both the east and west facades of the barn have windows- four on each side. Louvered wood window openings are located at second floor level. A gable jerkinhead- like roof over the uppermost door opening on the south facade with hook would have allowed access via a pulley system for hay bales to and from wagons. A 12' wide, shed roofed, open walled addition to the east was added later, providing partial protection for animals in the barnyard. The corrugated metal roofed structure constructed with rough hewn tree trunks is now totally collapsed into the barnyard. The barn's foundation, visible on the north façade of the barn, appears to be stone with a concrete -like parging covering the stone. Elsewhere, concrete appears at foundation level supporting first floor joists and framing members, and stone is not evident. While not hand hewn, the machine cut members are assembled with some timber framing techniques such as upbraces located in corners, with half lap joints, mortise and tenon joints at roofline. Lining both sides of the central wagon "driveway" on the first floor interior of the barn are wooden unchamfered posts, located in two lines, north to south, and spaced approximately 5' apart. These columnar vertical posts rest on poured concrete bases. There are no enclosed bays or boxed stalls on the interior, nor stair to the second floor. A second floor exists with random width flooring. Water infiltration has weakened the second floor, hay protrudes from large gaping holes in the flooring. An access stair had most likely existed in the northwest corner of the barn where a rectangular shaped hole exists in the second floor, and the north wall has been damaged by its removal. Most of the north wall of the barn has slipped off its foundation, and is collapsing within it. All window openings lack covering of any sort in the lower half; therefore, causing interior water damage.

Approximately 8' to the west of the barn is located the corncrib (c.1895- 1911). The one story shed roofed 16' x 8' corncrib is in poor condition, but the best preserved of all the structures on the property. A standing seam metal roof slopes from the north to the south, and the overall height at the lowest point is 7'. Entry is via the narrow door on the west façade. Narrow wood vertical slats clad the exterior walls, flooring is random width wood, a partially intact compartment is evident in the northwest corner of the structure. The windows, of which there are three, were originally covered by a narrow vertically slatted hinged shutter. One window on the north façade has that shutter configuration intact. Two windows are located on the north façade and one on the south façade. Trees and vines now grow close to the foundation and up the walls of both the barn and the corncrib and inside the east barnyard.

CISTERN IN GROUND  
CONCRETE 6' SQ

SIDING -  
HORIZONTAL  
WOOD

RECTANGULAR POSTS REST  
ON POURED CONCRETE  
BASES

CORNER RISER GRAIN STORAGE -  
VERTICAL WOOD SHEATHED  
STANDING SEAM METAL  
SHEATHING, 7' HT.

ENTRY SHUTTERED WINDOW  
COVERINGS

COLLAPSED  
LEAN-TO  
CORRUGATED METAL  
ROOFED OPEN  
WALLED ADDITION

MAIN  
ENTRY  
WAGON / TRUCK USAGE.  
SLIDING WOOD DOORS  
ON METAL TRACKS  
AT BOTH ENTRIES

FOUNDATION: PAVED  
CONCRETE BLOCK, 36" HT.

WINDOWS: LOWER HALF  
OF METAL FRAME, UPPER IS COVERED  
WOOD FRAMES. ALTERATION EVIDENT.

ROOF: STANDING SEAM  
METAL, GAMBREL - ON BARN

TWO STORIES  
OVERALL: APPROX. 28' HT.

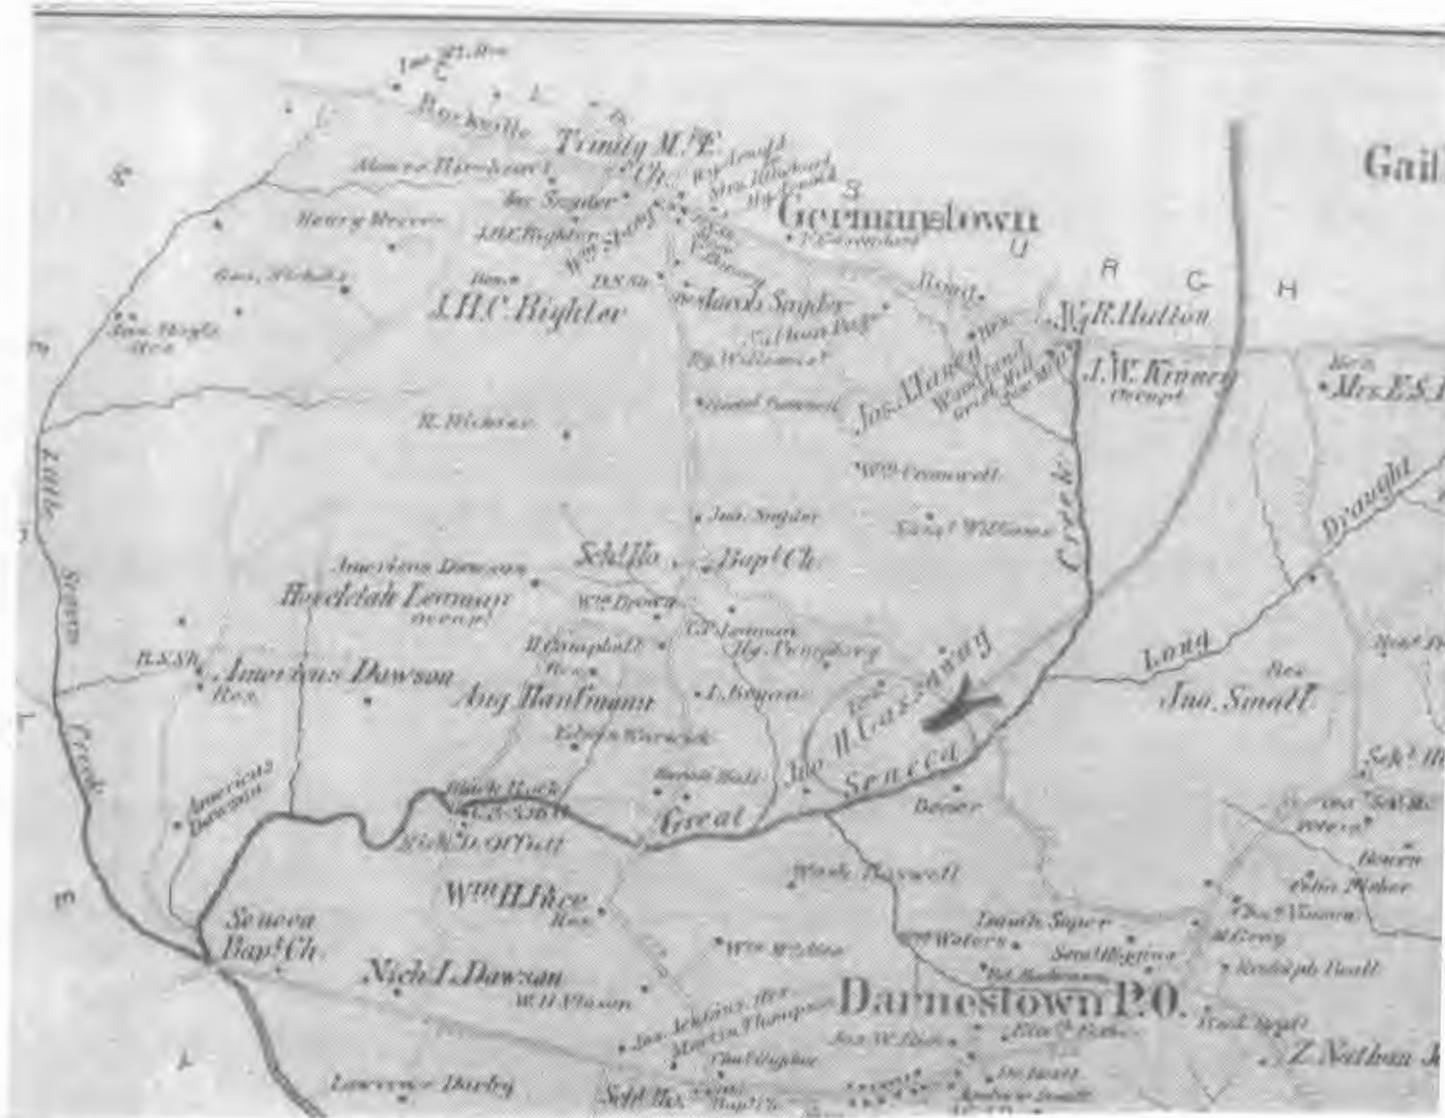
PHOTOGRAPH OF GEORGE M. HOPKINS'S ATLAS OF 15 MILES AROUND WASHINGTON, DC, DARNESTOWN DISTRICT NO. 6 MAP, 1878. GUN CLUB PROPERTY IS SHOWN AS OWNED BY "JNO H GASSAWAY" AND RESIDENCE IS IDENTIFIED ON MAP.

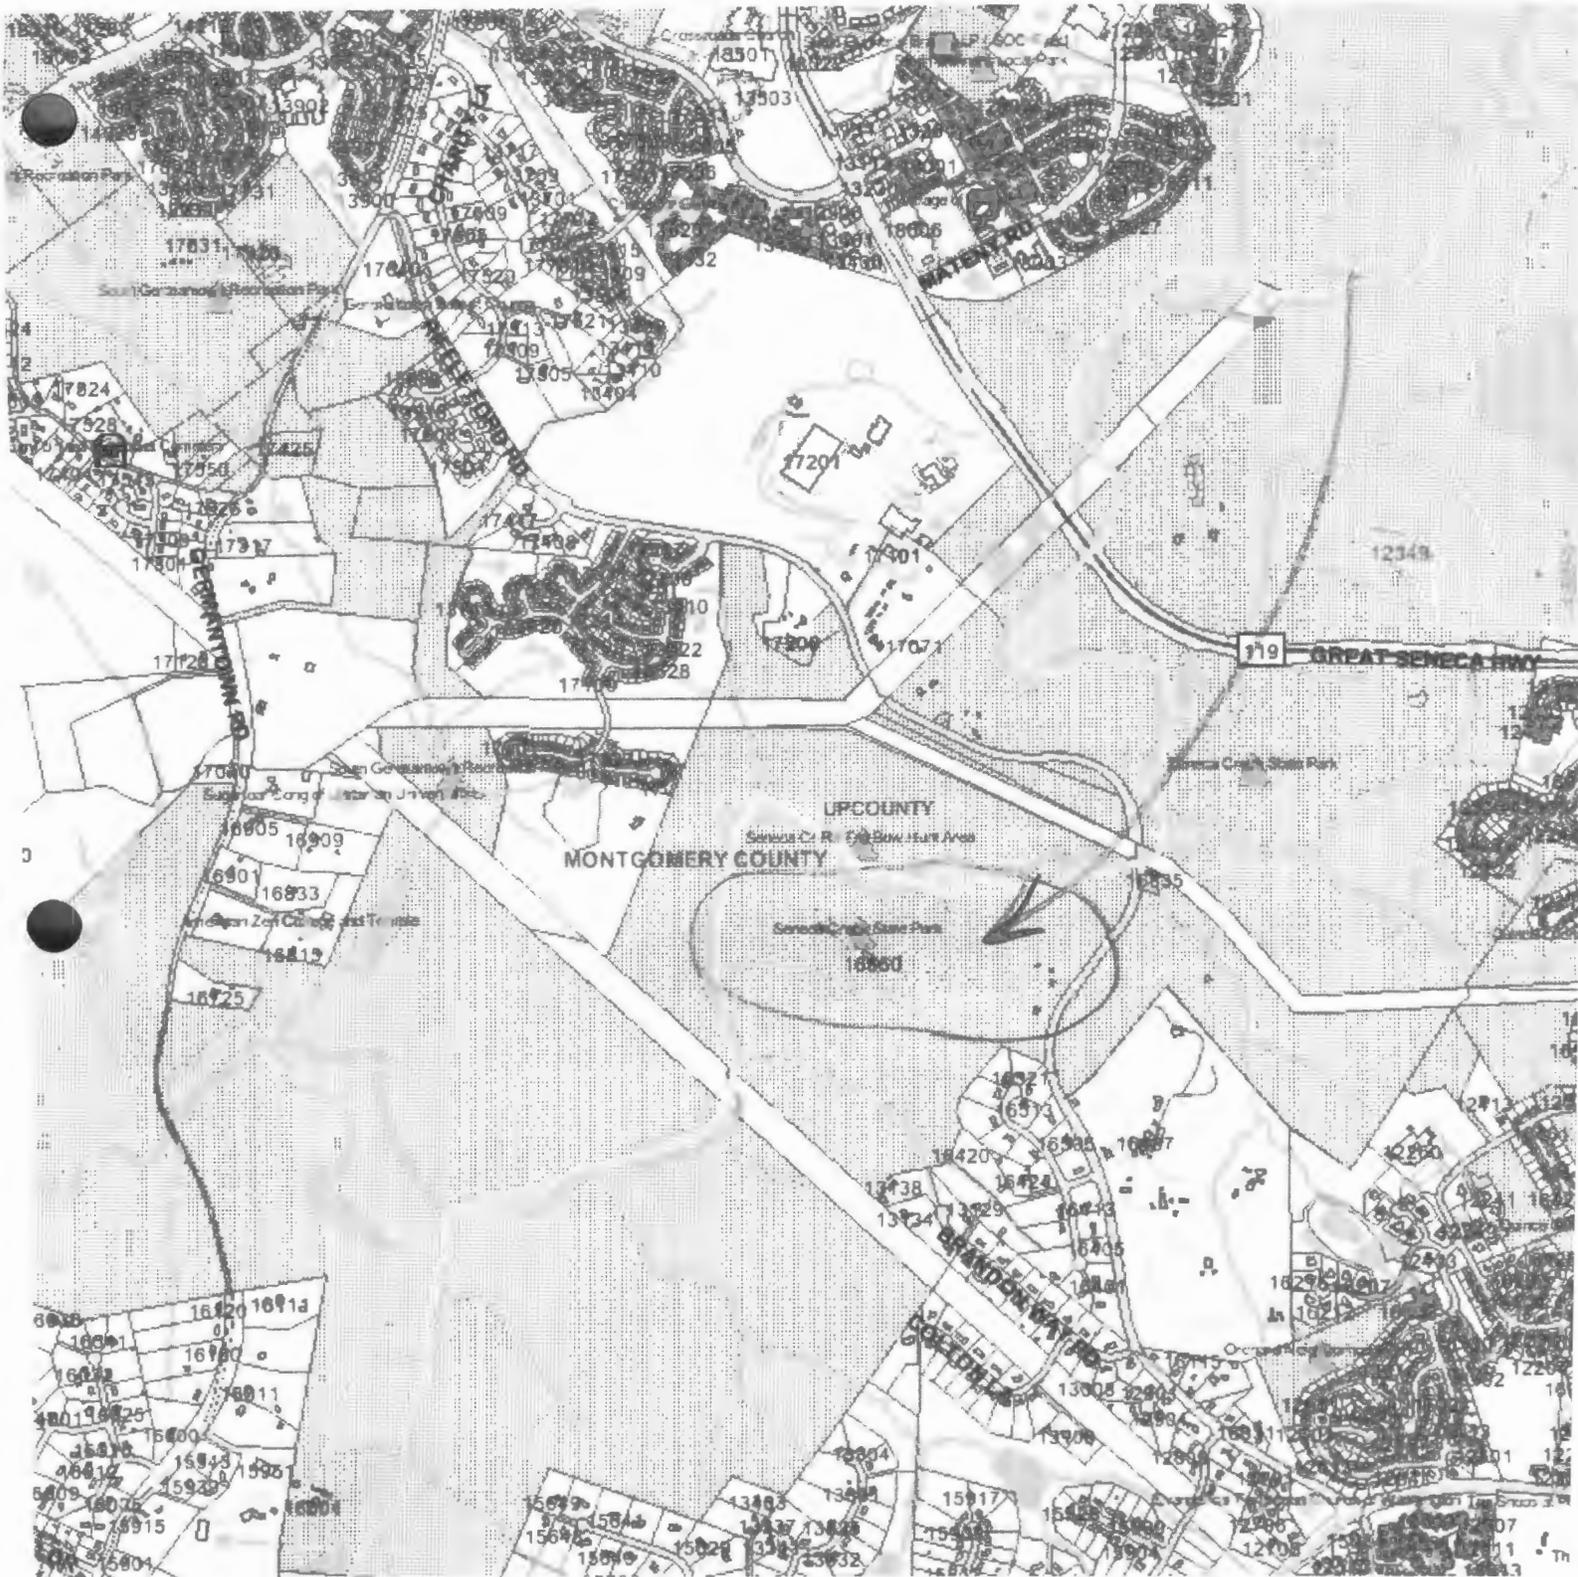
PHOTOGRAPH OF MARYLAND'S CURRENT STATE SHEET MAPS & STATE MAPS SERIES, ACCESSED VIA JOHNS HOPKINS UNIVERSITY WEBSITE. SITE CIRCLED; RED DOTS INDICATE STRUCTURES ON SITE.

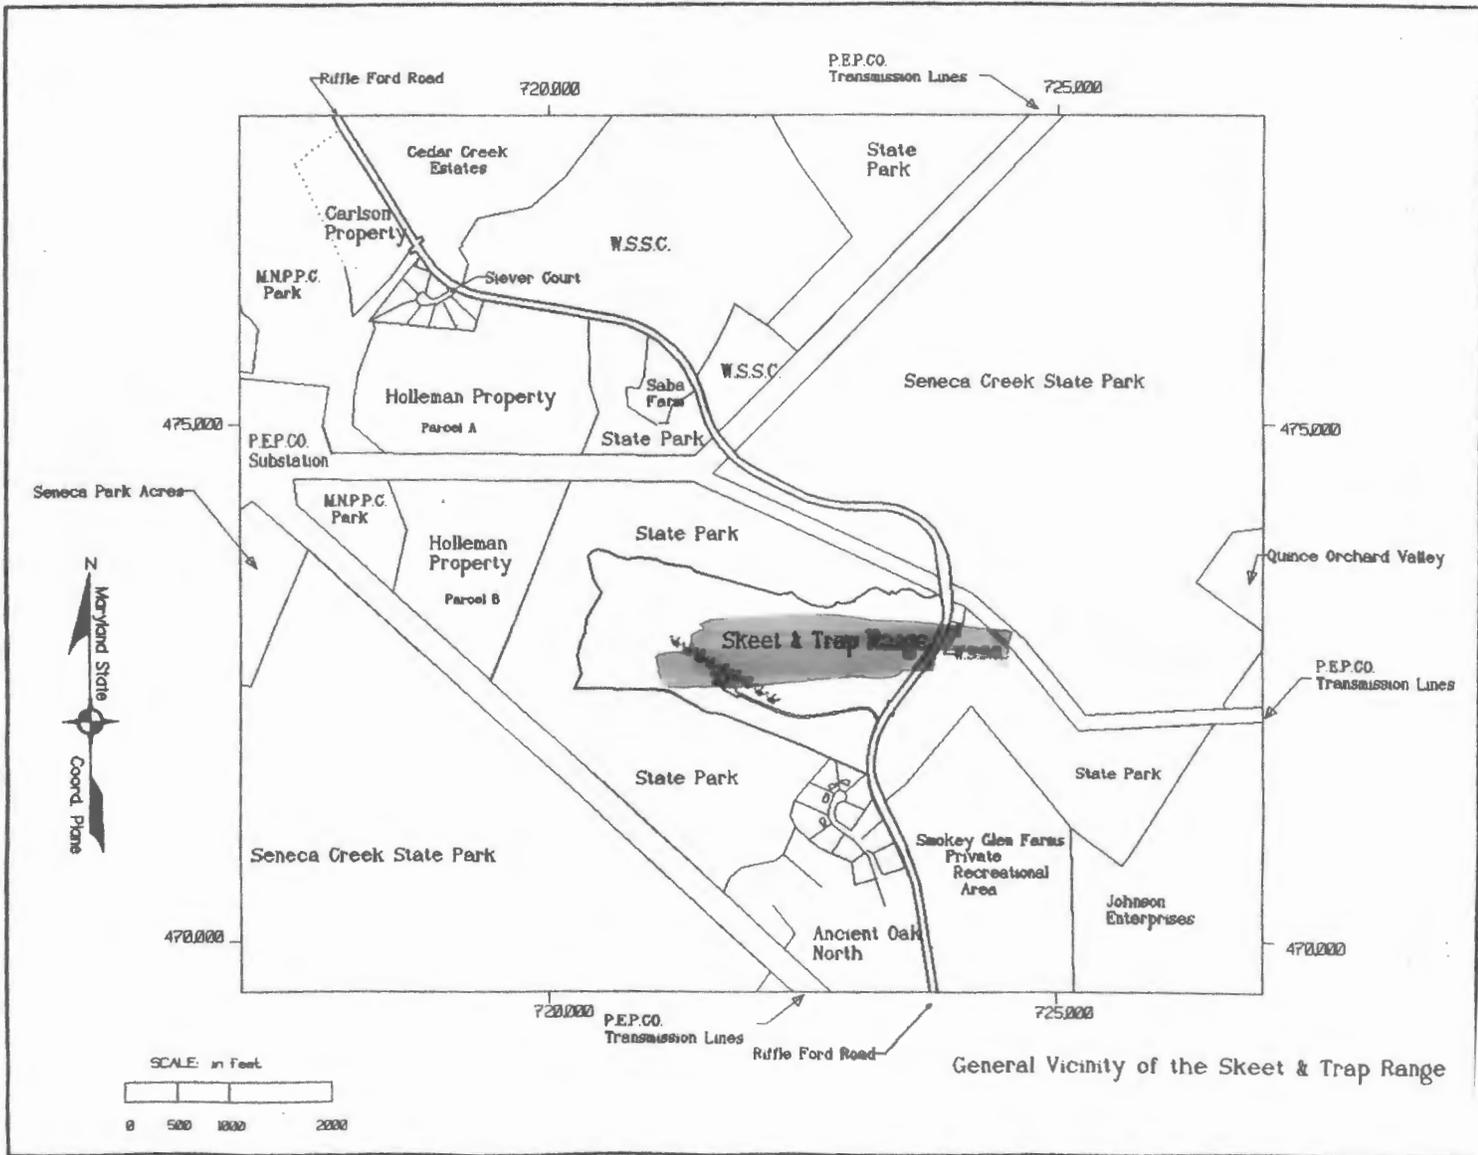
**PHOTOGRAPH OF CURRENT PARKLANDS' BOUNDARY RELATIVE TO GUN CLUB PROPERTY, C. 2000, COURTESY OF PARK OFFICE, SENECA CREEK STATE PARK.**

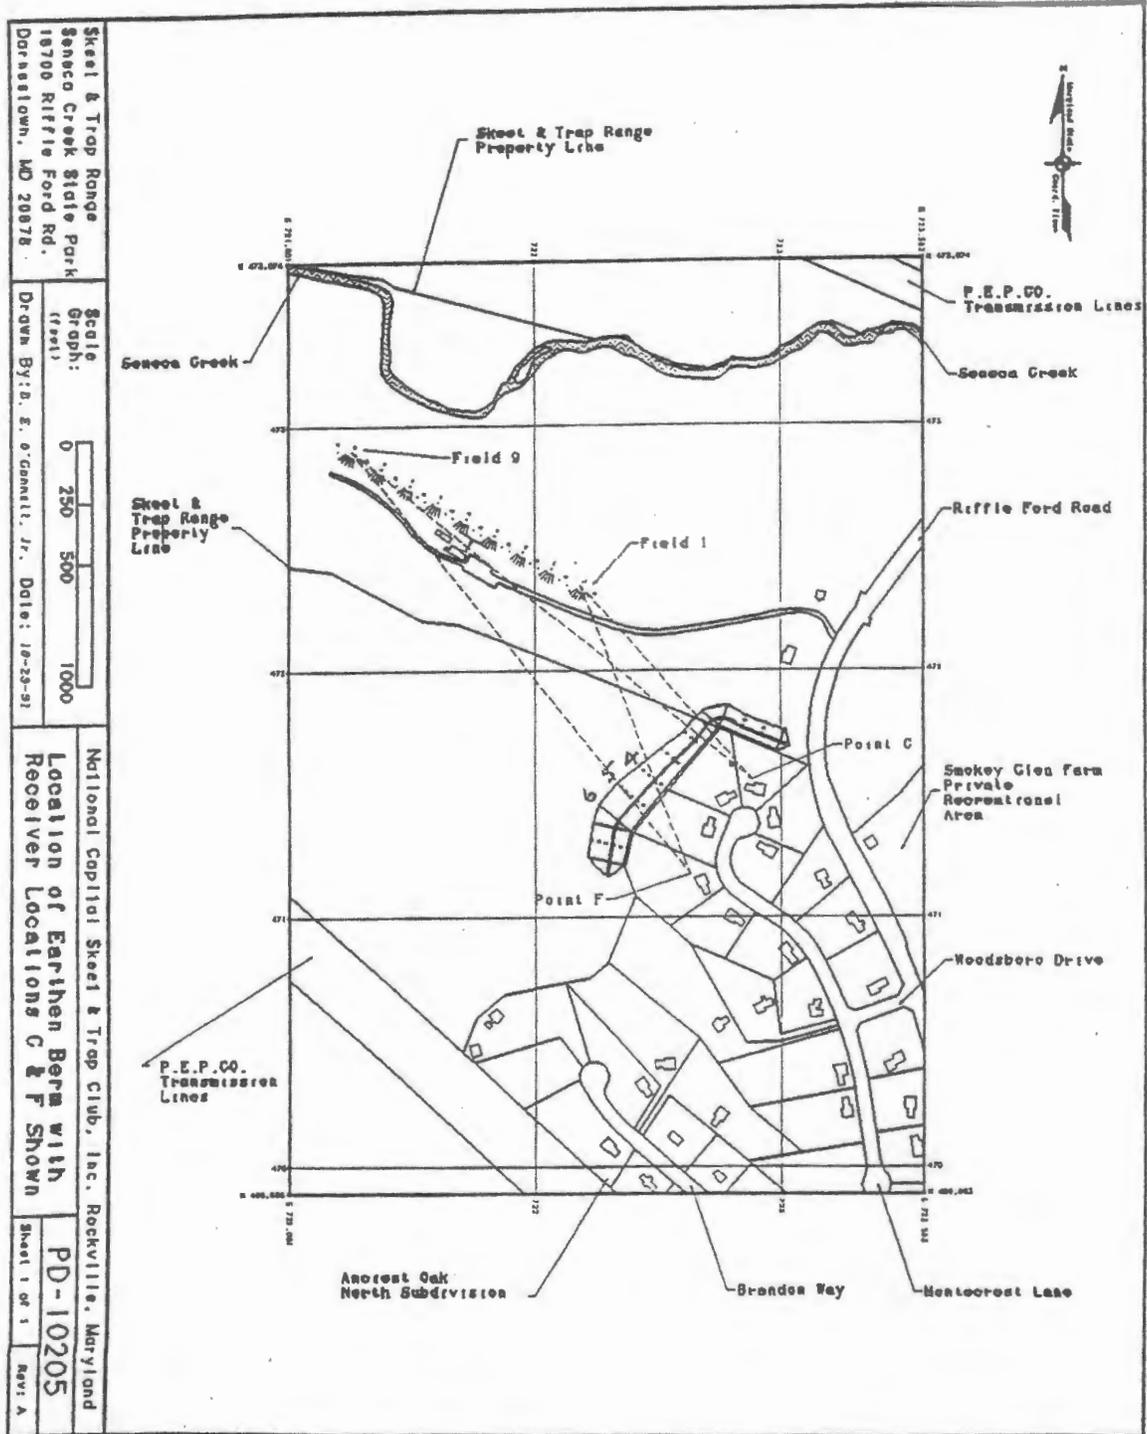
PHOTOCOPY OF DRAWING SHOWING EARTHEN BERM LOCATION,  
 CONSTRUCTED BY GUN CLUB, DRAWING DATED 10-29-1991.

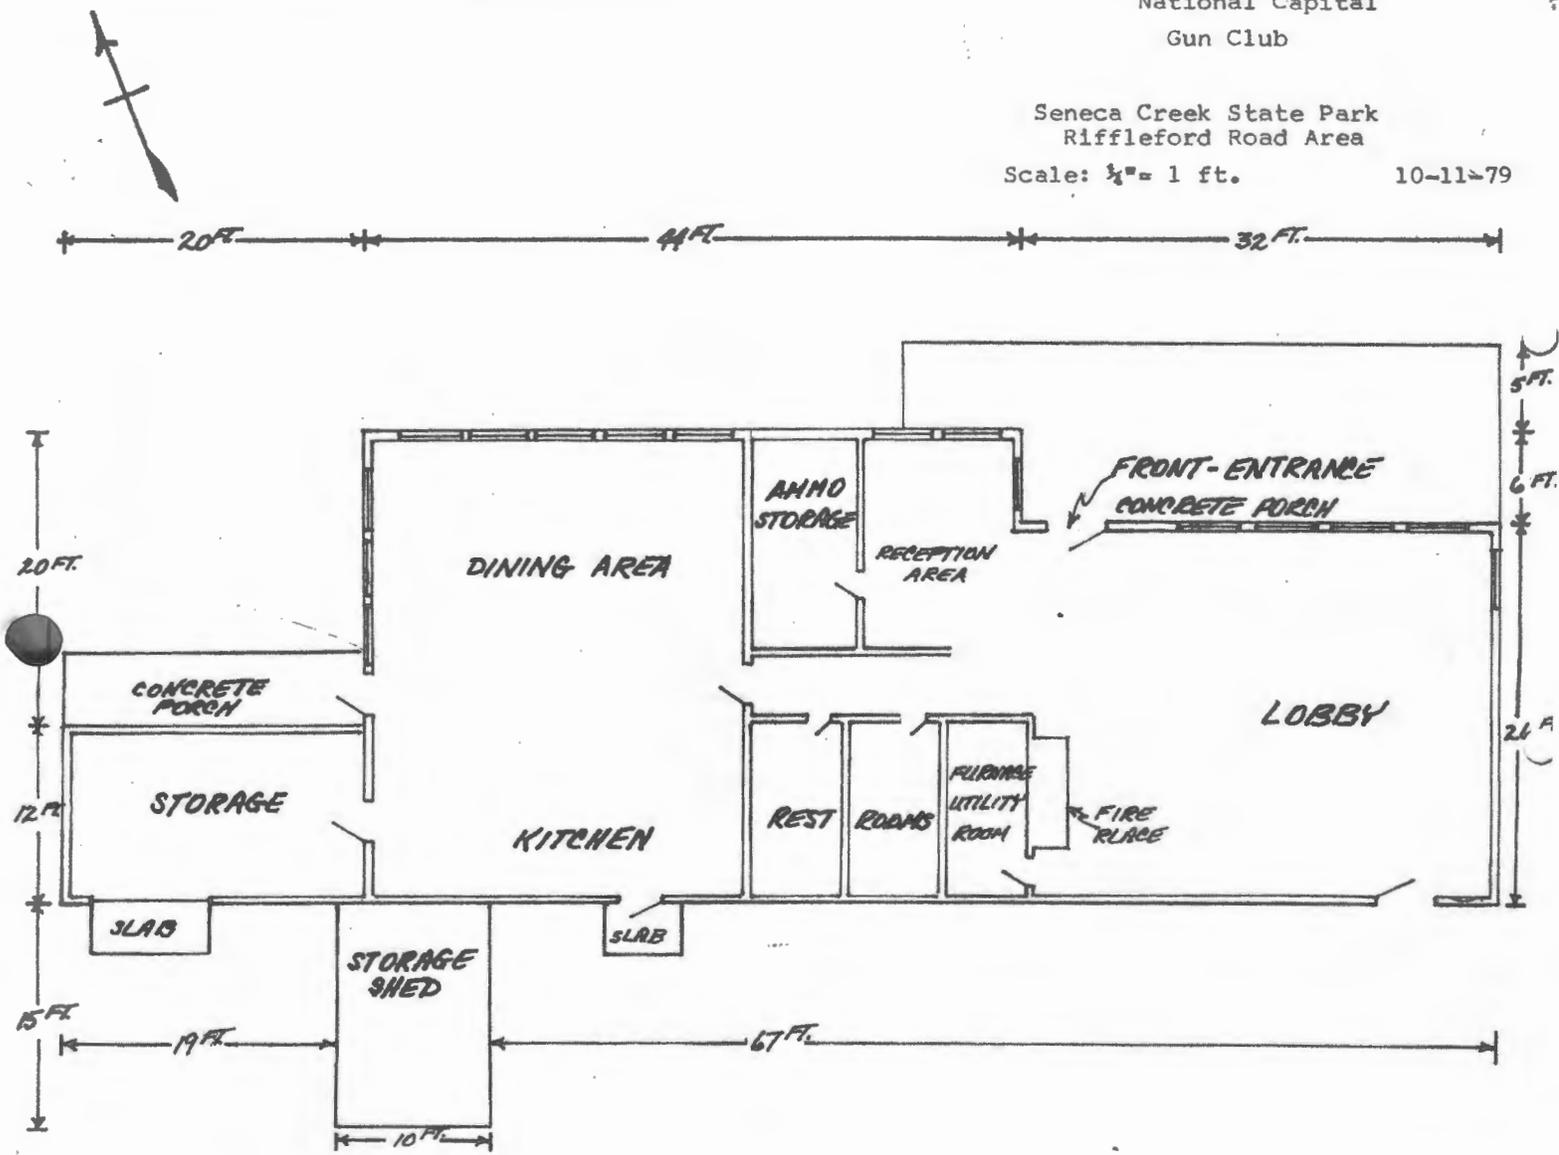
PHOTOCOPY OF GUN CLUBHOUSE, DRAWING DATED 10-11-1979.

The gun club's clubhouse had been located at the end of the driveway and approximately 1,400' from the entrance to the property. The one story brick and concrete block clubhouse stood from April 1954 until it burnt February 2011 in an electrical fire. Remaining today are: the concrete slab, broken brick and concrete block

jagged walls of approximately 3' height, fireplace and flue which had been located in the "Lobby" of the building, and approximately four metal exterior columns. Because of its location on a knoll above the shooting range, there was a clear view of play.

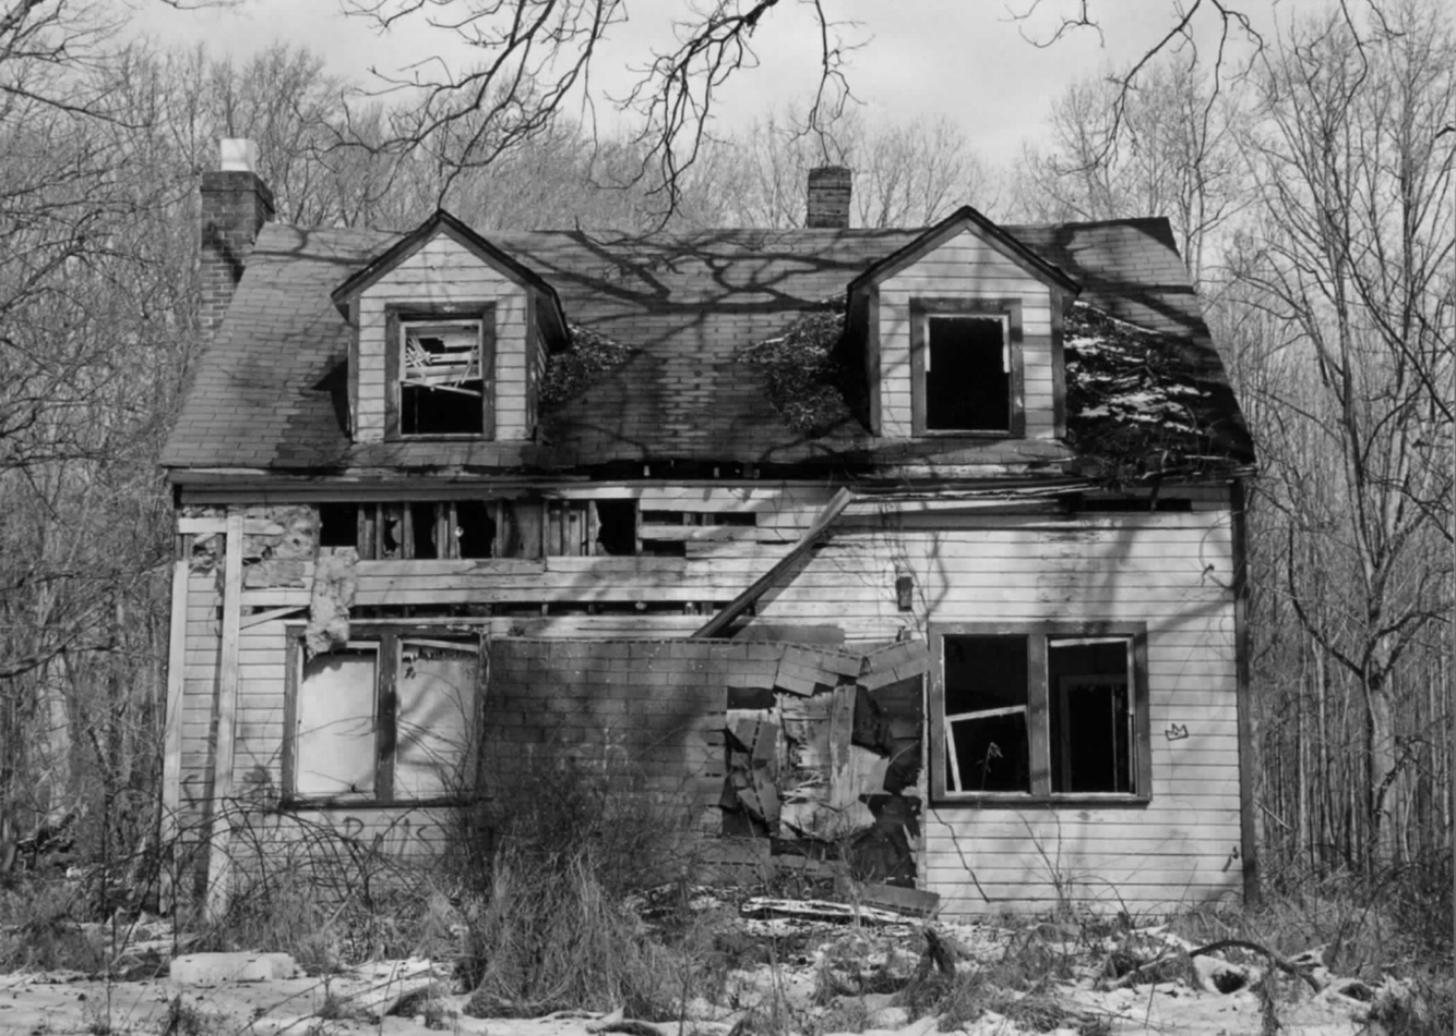
PRIMARY RESIDENCE  
SOUTH (FRONT) FACADE  
1 OF 12

On the front (south) façade, first floor, there are paired double -hung sash windows on either side of a main entrance door. Centered above each of the end bays of the second story is a dormer containing a single double -hung sash window. Asphalt shingle covers the dormers and roof. Guttering is nonexistent.

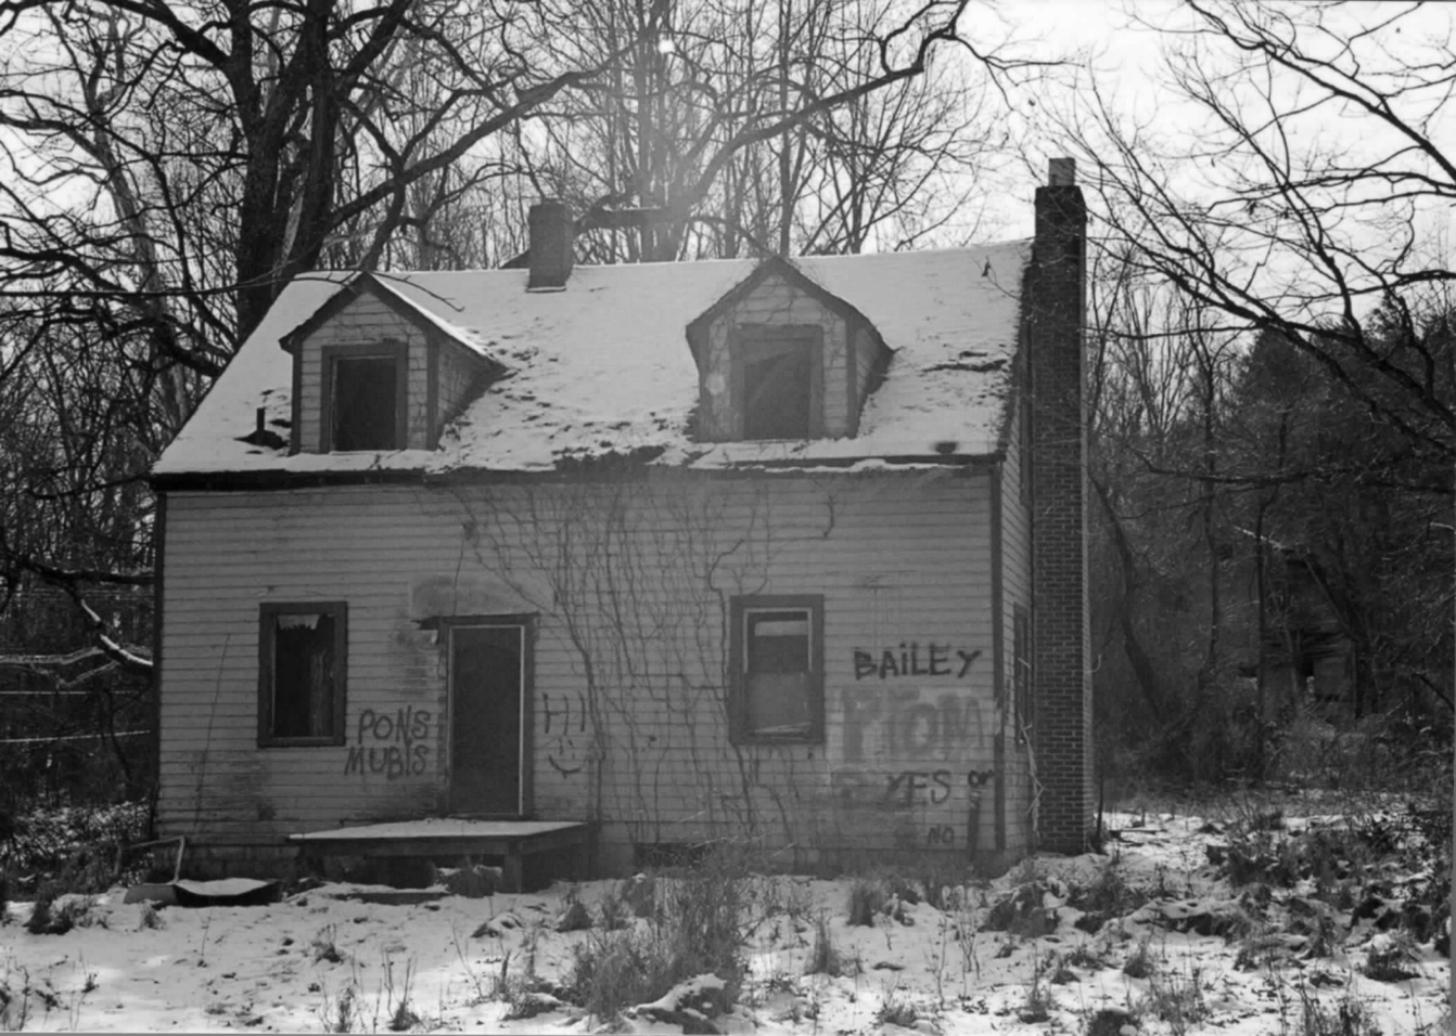
MIHP #M: 20-48  
NATIONAL CAPITAL GUN CLUB  
RIFLE FORD RD  
CA MASEK  
1/15  
MDSHPD  
PRIMARY RESIDENCE  
~~X~~ NORTH (REAR) FACADE  
2 OF 12

On the rear (north) façade is a single door, off center, flanked by a single double -hung sash window. A dormer window on the second floor is located in each end bay, mirroring those on the front (south) façade.

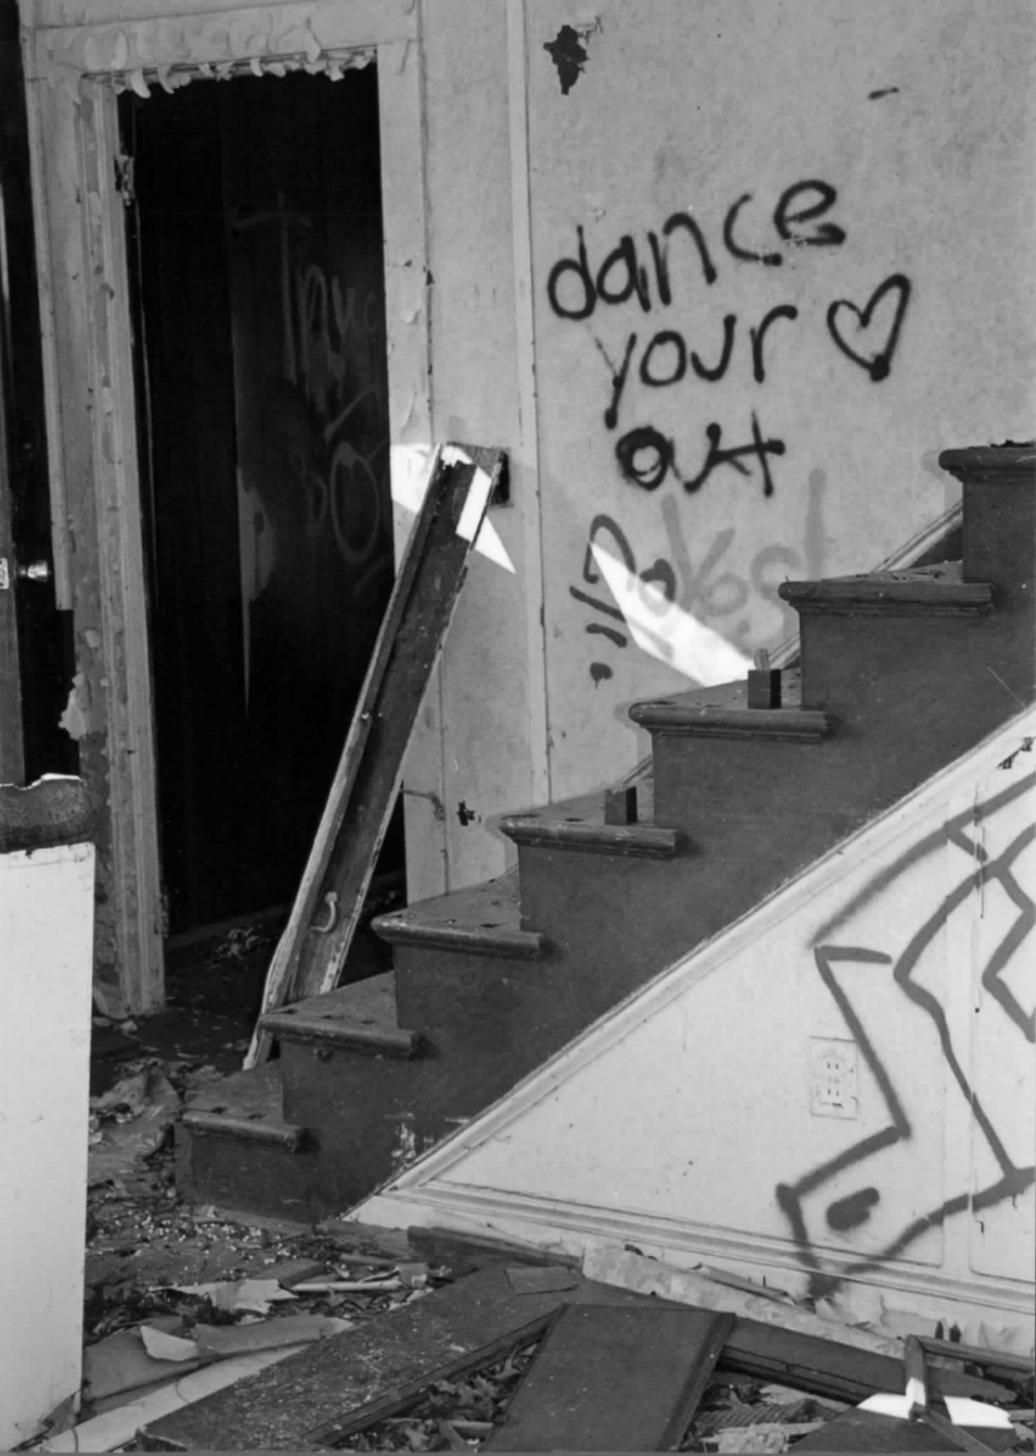
3 OF 12

PRIMARY RESIDENCE

INTERIOR 1ST FL. HALL

WEST WALL
