**MARYLAND HISTORICAL TRUST  
DETERMINATION OF ELIGIBILITY FORM**

Property Name: National Capital Gun Club Inventory Number: M : 20-48  
 Address: 16700 Riffle Ford Road City: Gaithersburg vicinity \_\_\_\_\_ Zip Code: 20879  
 County: Montgomery USGS Topographic Map: Germantown 1:24000 USGS Quad \_\_\_\_\_  
 Owner: State of Maryland's Department of Natural Resources Is the property being evaluated a district? \_\_\_yes  
 Tax Parcel Number: P2 Tax Map Number: DT51 Tax Account ID Number: 00397868  
 Project: DNR Documentation of Razings Agency: Md's Department of Natural Resources  
 Site visit by MHT Staff: \_\_\_no \_\_\_yes Name: \_\_\_\_\_ Date: \_\_\_\_\_  
 Is the property located within a historic district? \_\_\_yes Xno

CAPSULE SUMMARY  
National Capital Gun Club  
Riffle Ford Road  
Gaithersburg vicinity, Montgomery County  
Begun c. 1895, alterations to site through c.1979-82  
Public- within Seneca Creek State Park

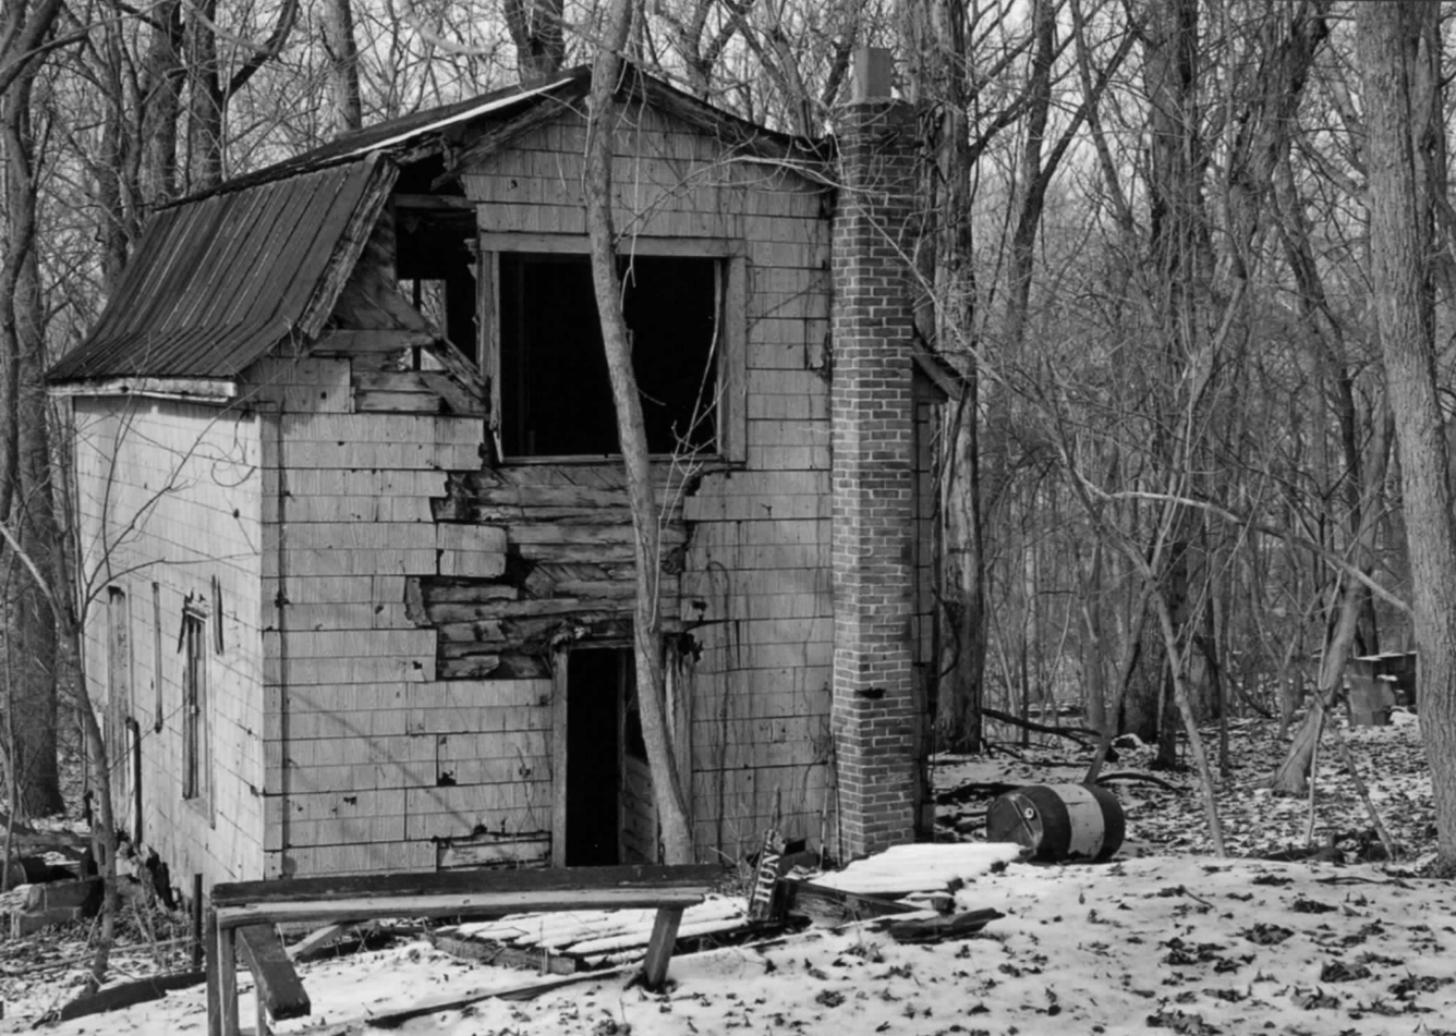
4 OF 12

3. a totally collapsed 6' x 8' dog kennel, built c. 1954, which is constructed of 5' height tree trunks, with a shed roof of corrugated sheet metal;
4. A two story, gambrel roofed, two bay **tenant house**, built c.1895-1911. The standing seam metal roof of the tenant house has partially collapsed, window sashes are all missing, one exterior door remains, exterior walls are not plumb, and 3' x 3' holes exist in first and second floor and stair. Exterior walls are covered in horizontal wood clapboards, followed by artificial siding. On the south façade is a single entry with door containing glass in the upper half and three horizontal panels in the lower half. An exterior brick flue is attached to the south facade, east of the door. The two second floor windows on the south facade have been altered into one large rectangular window opening in the center of the second floor. On the side (east) façade is a single first floor window opening. The grade descends steeply to the north and a concrete block foundation with basement entry is evident at the northwest corner. A brick foundation is all that remains of a full height brick fireplace flue, attached to the exterior of the north facade. A small first floor window opening flanks each side of the fireplace foundation. A single large rectangular window opening in the center of the second floor mirrors the window on the south façade. On the side (west) façade are two openings- a doorway into the rear first floor kitchen and a window in the first floor front living room. A narrow screened one story porch existed at one time, attached to the west façade, nearly the full length of the west wall. The porch was built upon a concrete block foundation and accessed the house via the kitchen door. Both screening and block are now broken and strewn in the area west and north of the tenant house. On the interior, a narrow enclosed stair is located on the east wall of the kitchen, ascending to the second floor. Plumbing fixtures, interior doors and window sashes are missing. Two rooms exist on the first floor and one on the second.

TENANT HOUSE

FRONT (SOUTH) - SIDE (WEST) FACADES

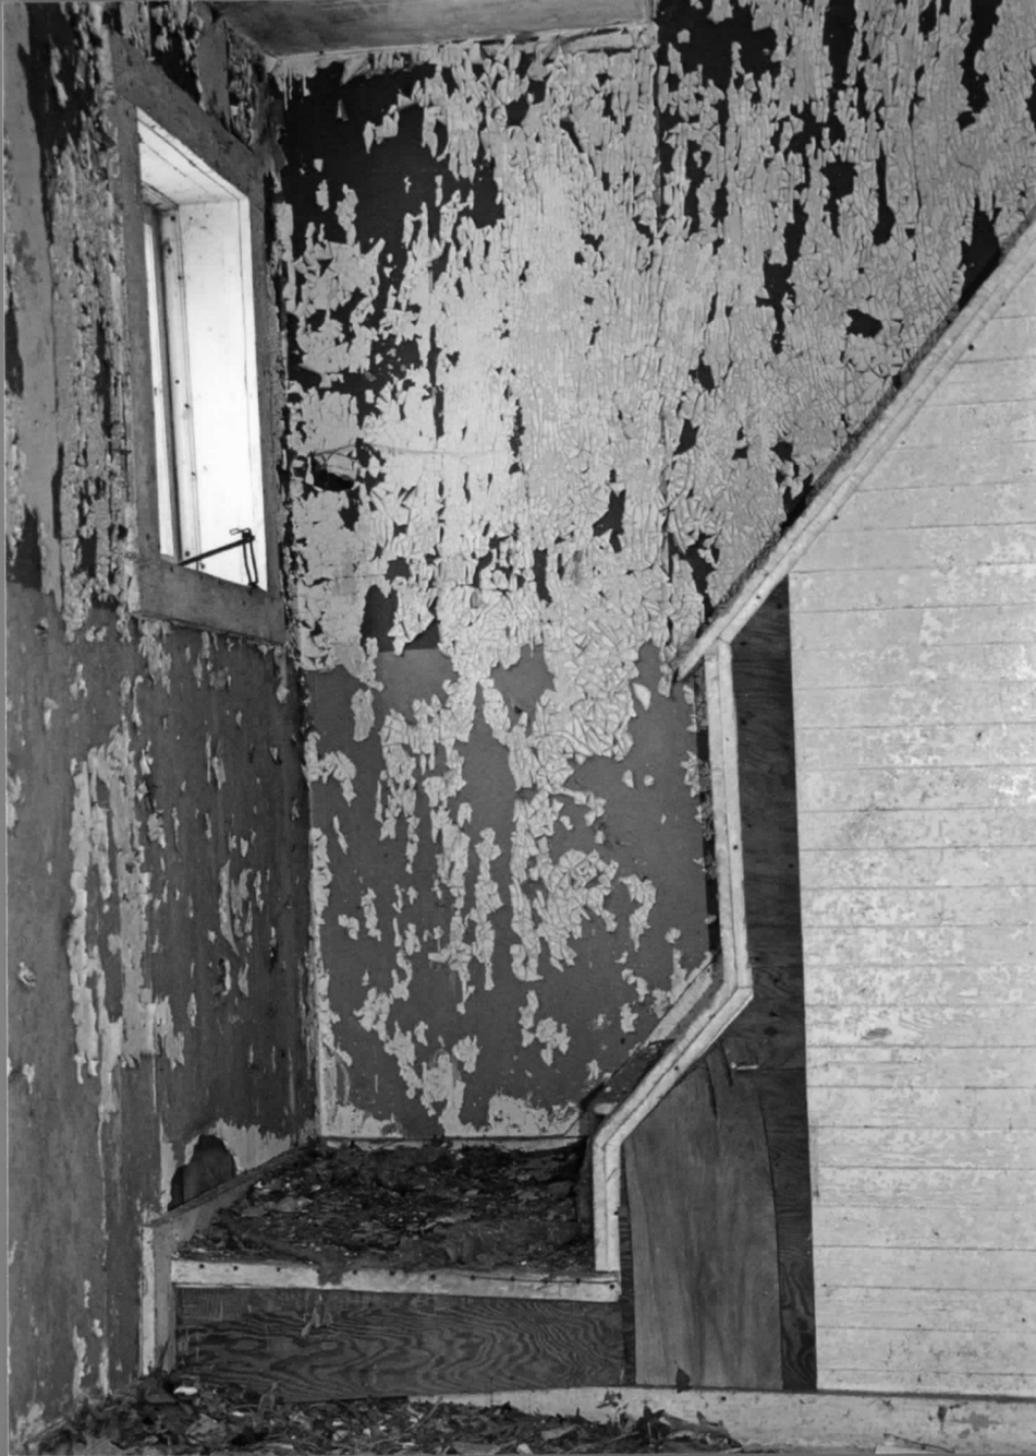
6 OF 12

TENANT HOUSE

INTERIOR 1ST FLOOR

KITCHEN EAST WALL

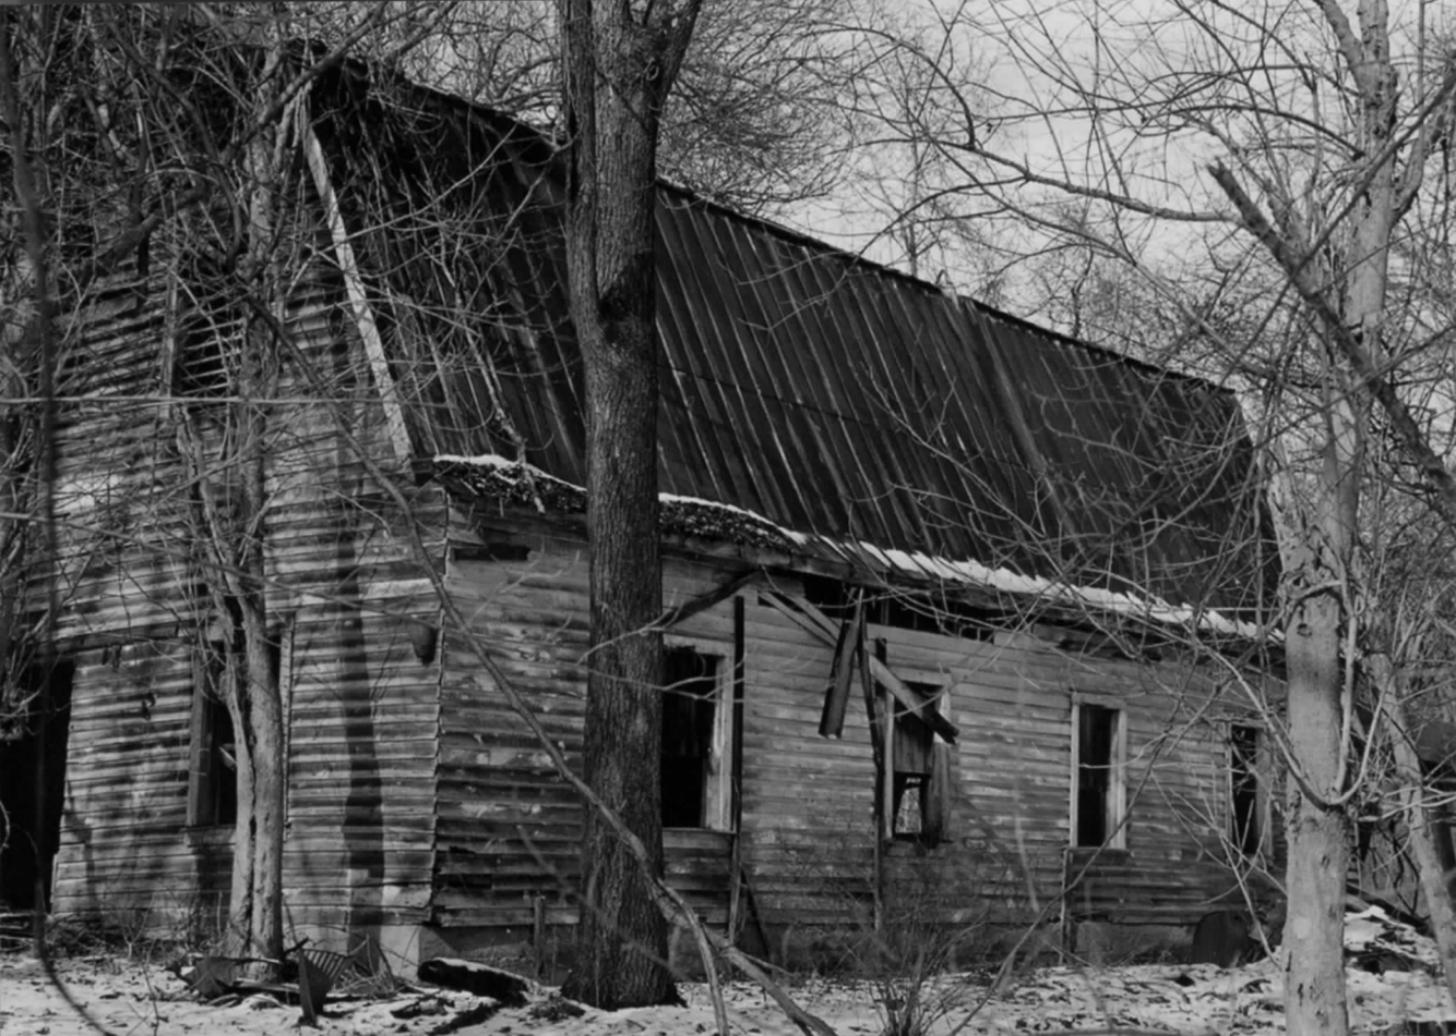
MIHP # M:20-48  
NATIONAL CAPITAL GUN CLUB  
RIFLE FORD RD  
CA MASEK  
V15  
MD SH PO  
BARN  
SIDE (EAST) FACADE  
8 OF 12

Beginning approximately 60' south and uphill of the entrance lane and south of the primary residence is located a two story, gambrel roofed 34.5' x 48' frame barn (c.1895-1911) and an adjacent one story shed roofed 16' x 8' frame corncrib. The barn, approximately 28' in height, has horizontal wood siding and is accessible via an 8' wide doorway in the north façade. Sliding wooden doors originally were located on the exterior of the north and south facades and were located in metal tracks still visible above each central door opening. Parts of broken doors lay on the floor beneath grain and dirt. A window opening flanks each of the central doorways on the north and south facades. All twelve of the window openings appear altered. Original configuration is unknown because metal window frames appear in the lower half, while upper window sash is missing and replaced by wood board. Both the east and west facades of the barn have windows- four on each side. Louvered wood window openings are located at second floor level. A gable jerkinhead- like roof over the uppermost door opening on the south facade with hook would have allowed access via a pulley system for hay bales to and from wagons. A 12' wide, shed roofed, open walled addition to the east was added later, providing partial protection for animals in the barnyard. The corrugated metal roofed structure constructed with rough hewn tree trunks is now totally collapsed into the barnyard. The barn's foundation, visible on the north façade of the barn, appears to be stone with a concrete -like parging covering the stone. Elsewhere, concrete appears at foundation level supporting first floor joists and framing members, and stone is not evident. While not hand hewn, the machine cut members are assembled with some timber framing techniques such as upbraces located in corners, with half lap joints, mortise and tenon joints at roofline. Lining both sides of the central wagon "driveway" on the first floor interior of the barn are wooden unchamfered posts, located in two lines, north to south, and spaced approximately 5' apart. These columnar vertical posts rest on poured concrete bases. There are no enclosed bays or boxed stalls on the interior, nor stair to the second floor. A second floor exists with random width flooring. Water infiltration has weakened the second floor, hay protrudes from large gaping holes in the flooring. An access stair had most likely existed in the northwest corner of the barn where a rectangular shaped hole exists in the second floor, and the north wall has been damaged by its removal. Most of the north wall of the barn has slipped off its foundation, and is collapsing within it. All window openings lack covering of any sort in the lower half; therefore, causing interior water damage.

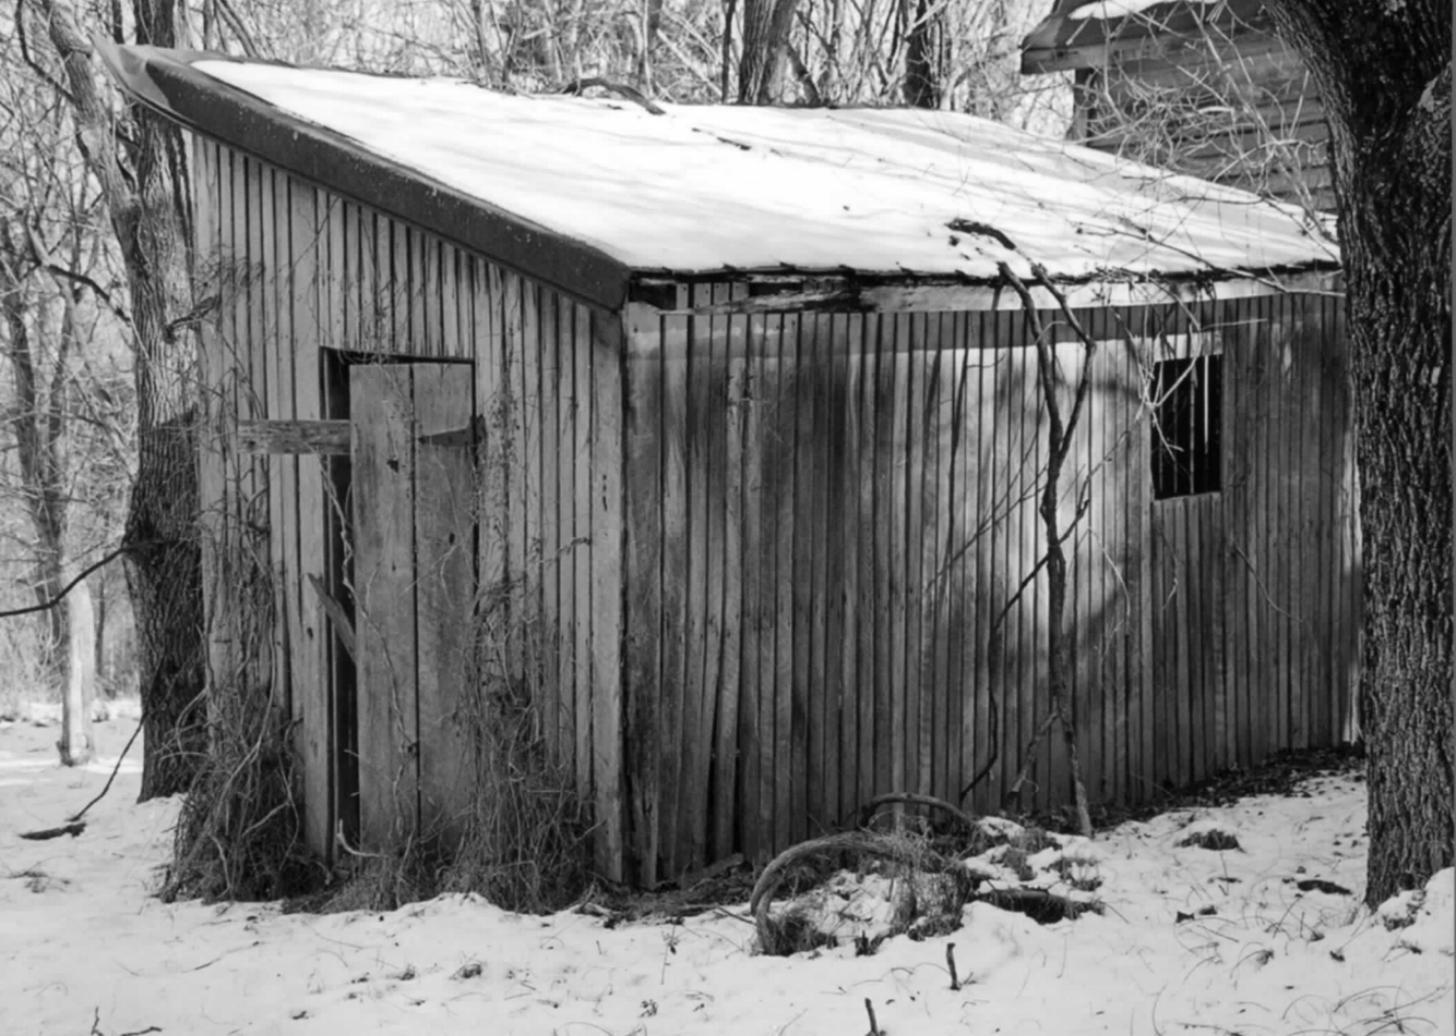
10 OF 12

Approximately 8' to the west of the barn is located the corncrib (c.1895- 1911). The one story shed roofed 16' x 8' corncrib is in poor condition, but the best preserved of all the structures on the property. A standing seam metal roof slopes from the north to the south, and the overall height at the lowest point is 7'. Entry is via the narrow door on the west façade. Narrow wood vertical slats clad the exterior walls, flooring is random width wood, a partially intact compartment is evident in the northwest corner of the structure. The windows, of which there are three, were originally covered by a narrow vertically slatted hinged shutter. One window on the north façade has that shutter configuration intact. Two windows are located on the north façade and one on the south façade. Trees and vines now grow close to the foundation and up the walls of both the barn and the corncrib and inside the east barnyard.

SOUTH (REAR) & WEST FACADES

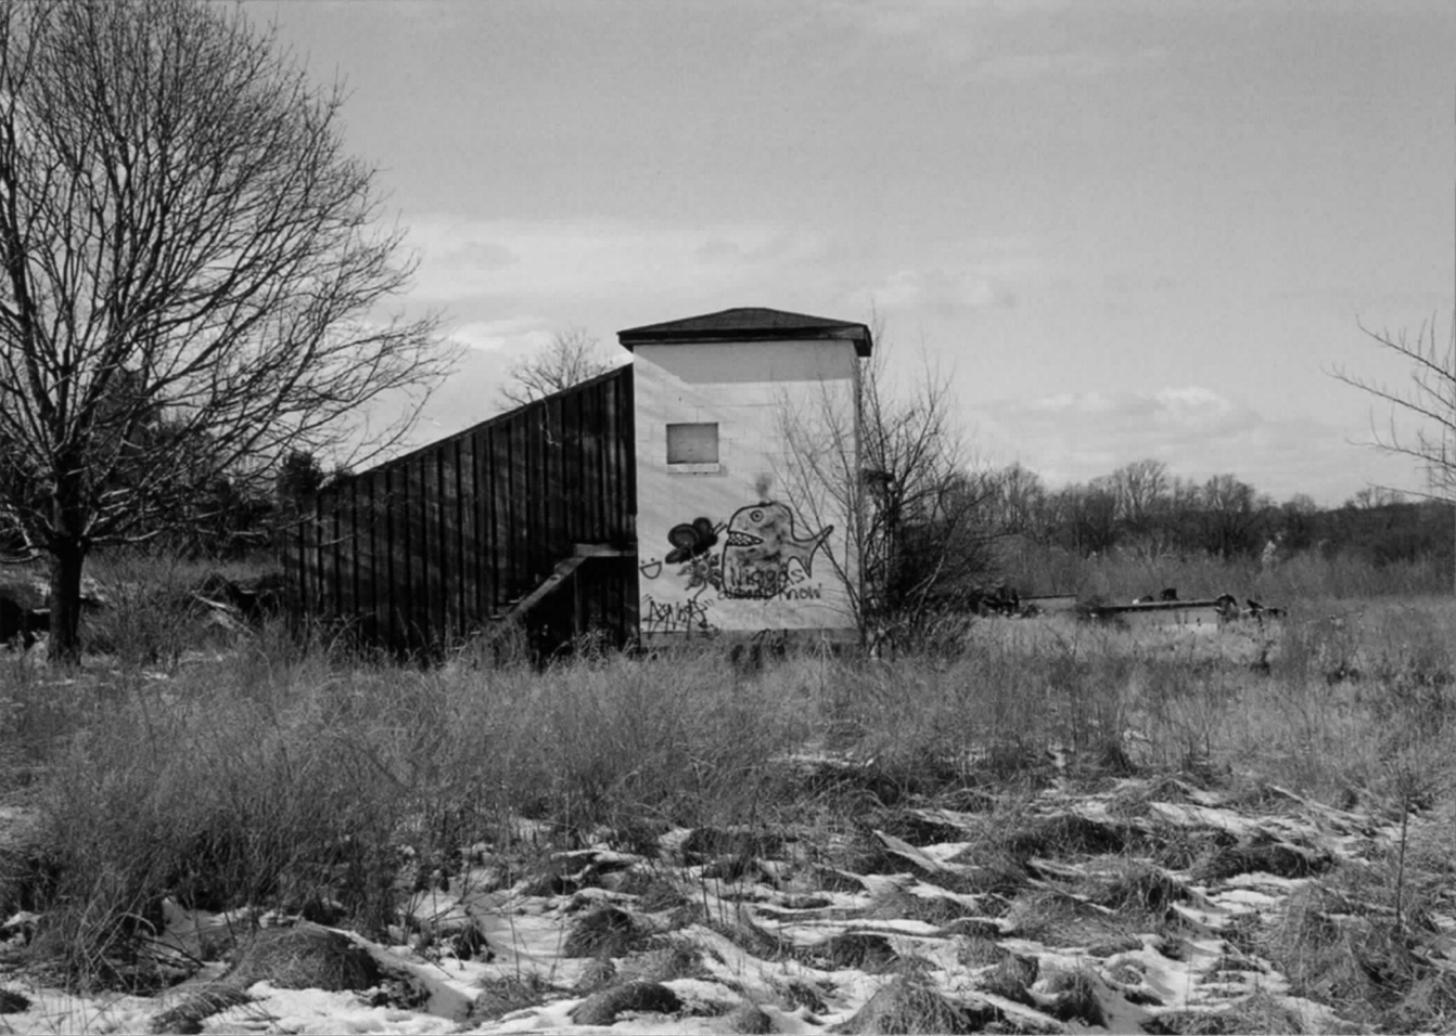
11 OF 12

The gun club's clubhouse had been located at the end of the driveway and approximately 1,400' from the entrance to the property. The one story brick and concrete block clubhouse stood from April 1954 until it burnt February 2011 in an electrical fire. Remaining today are: the concrete slab, broken brick and concrete block

jagged walls of approximately 3' height, fireplace and flue which had been located in the "Lobby" of the building, and approximately four metal exterior columns. Because of its location on a knoll above the shooting range, there was a clear view of play.

VIEW WEST
