CAPSULE SUMMARY

HIGGINS-KING HOUSE

14700 BERRYVILLE ROAD, DARNESTOWN

Montgomery County Survey Prefix & Site Number: M-24/23

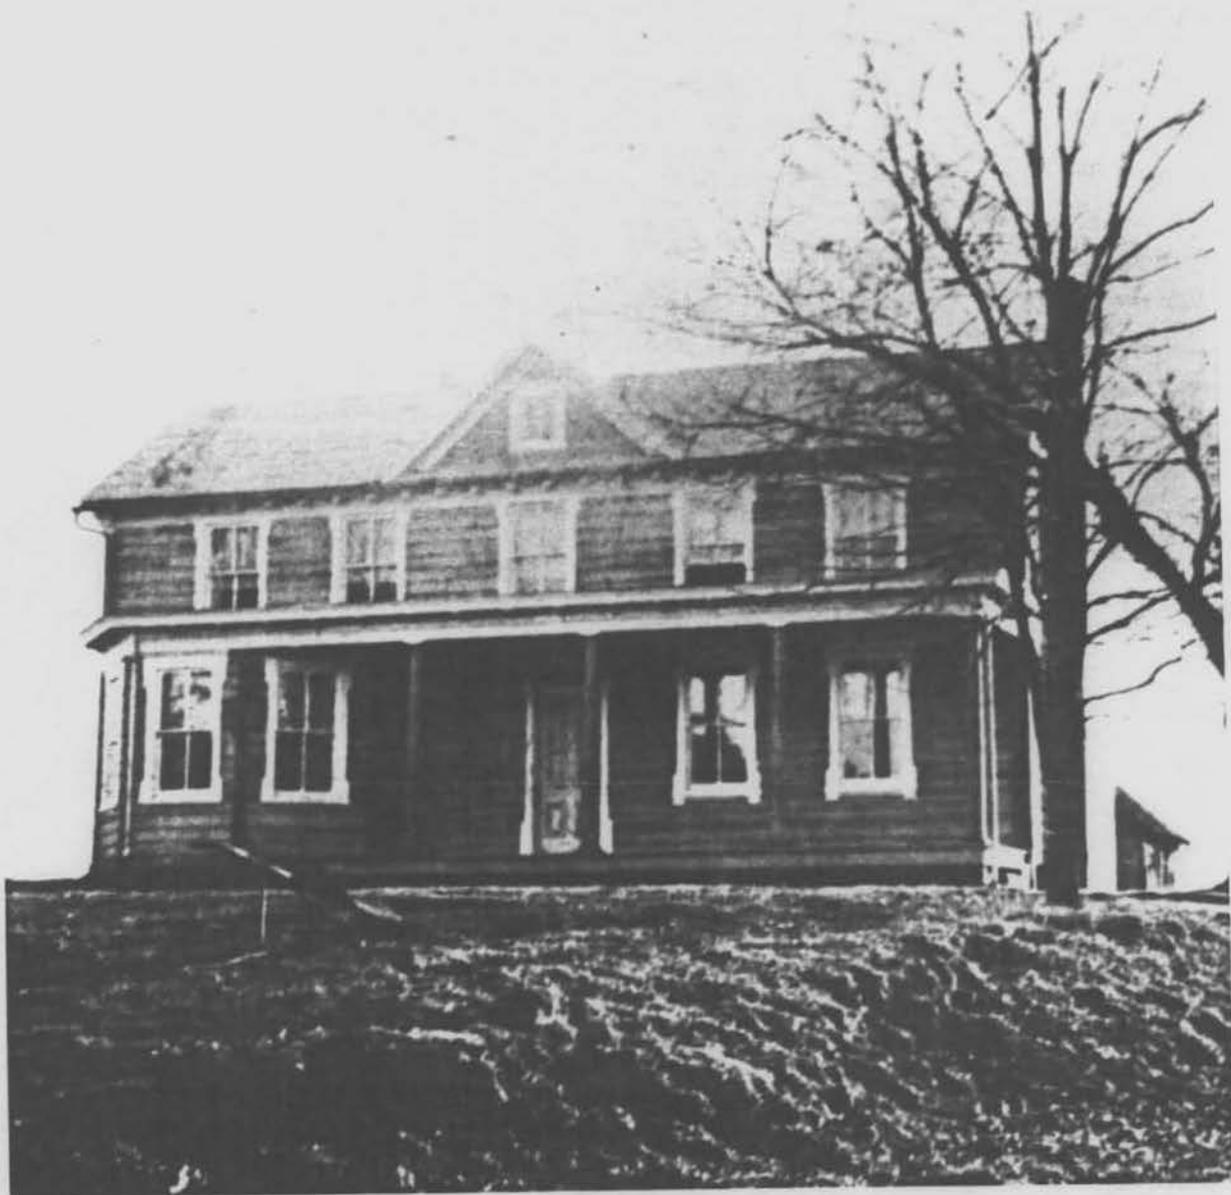
1938 View of Higgins-King Farmhouse
Source: Nancy Houston private collection

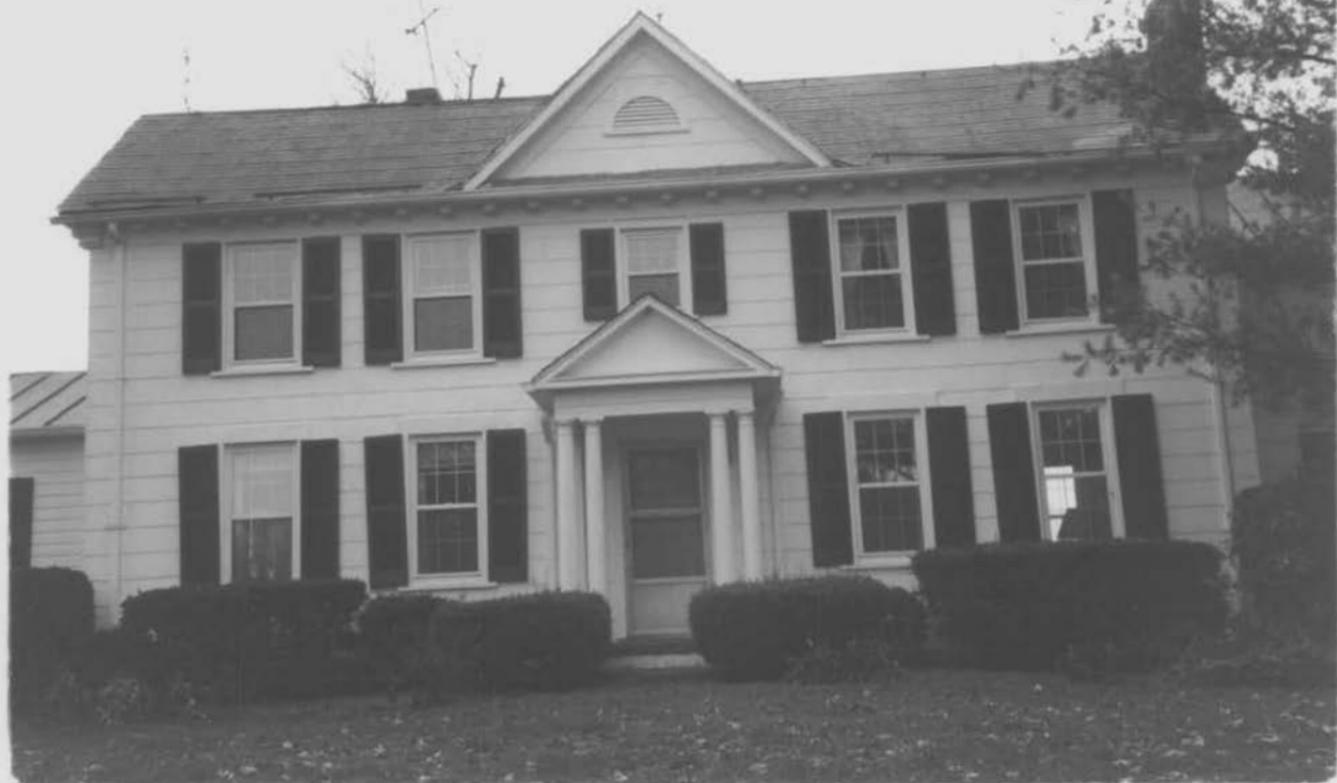
9 of 12

North (MAIN)

The main block, which faces north, is two stories tall and five bays wide with a side gable roof and center cross gable. The roof, covered with scalloped asphalt shingles, has return cornices at both gable ends and an internal chimney at the west gable end. A wide cornice is embellished with modillions and anchored on each end by scroll brackets. Asbestos shingles cover the original wood siding. Most windows are double glazed sash with six over six sandwich muntins, plain surrounds, and louvered shutters. A single, six light casement window is found at the east gable end. The foundation is Seneca sandstone.

The symmetrical north facade has a center entrance with a one story, one bay, front gable, pedimented portico supported by paired Doric columns. On the second level above the entrance is an under-sized replacement window with sandwich muntins. The standard replacement windows are located in the remaining four bays on the first and second level. The center gable features a louvered semi-circular window.

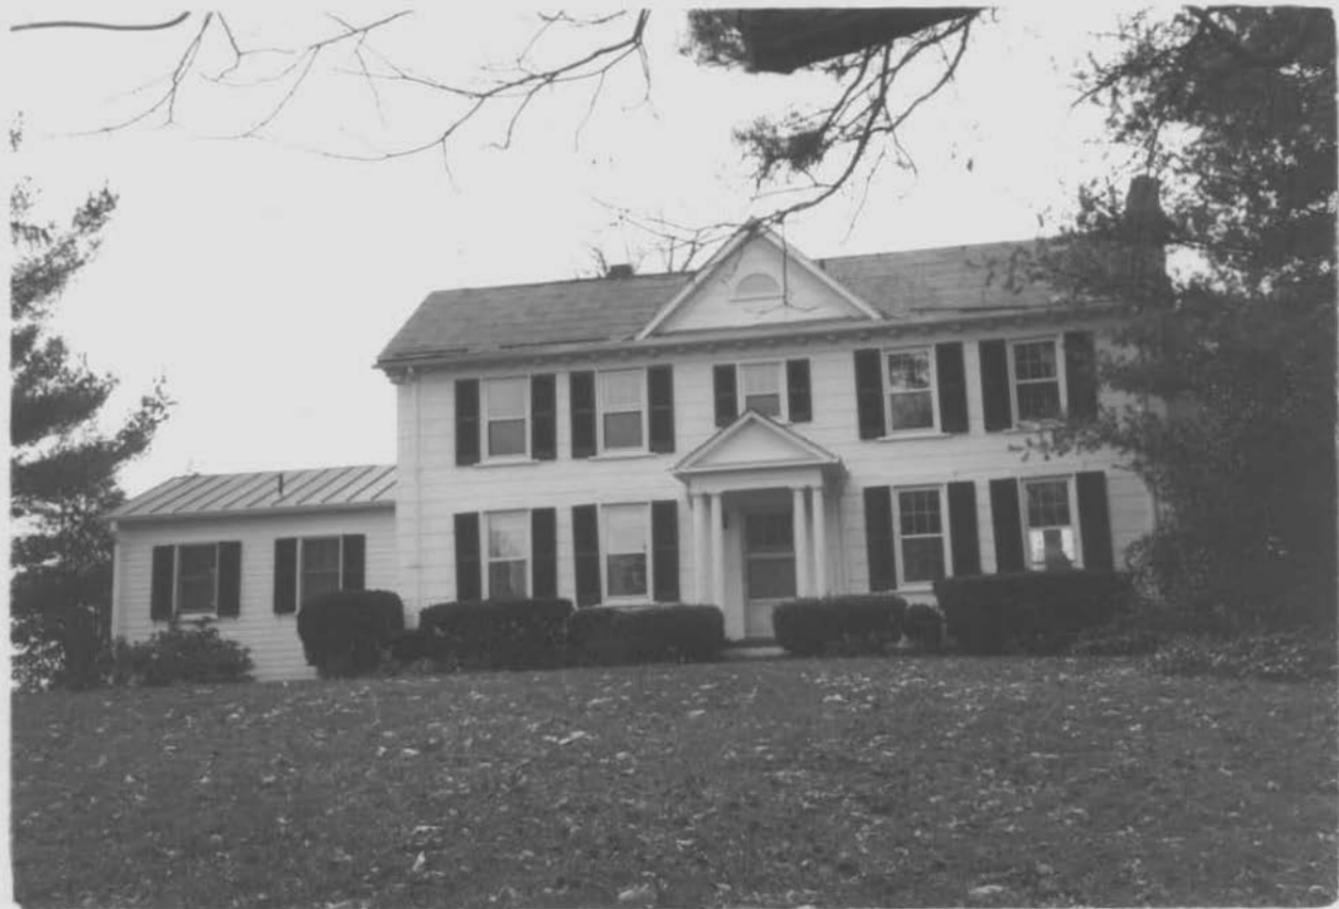
10 of 12

NORTH (MAIN)

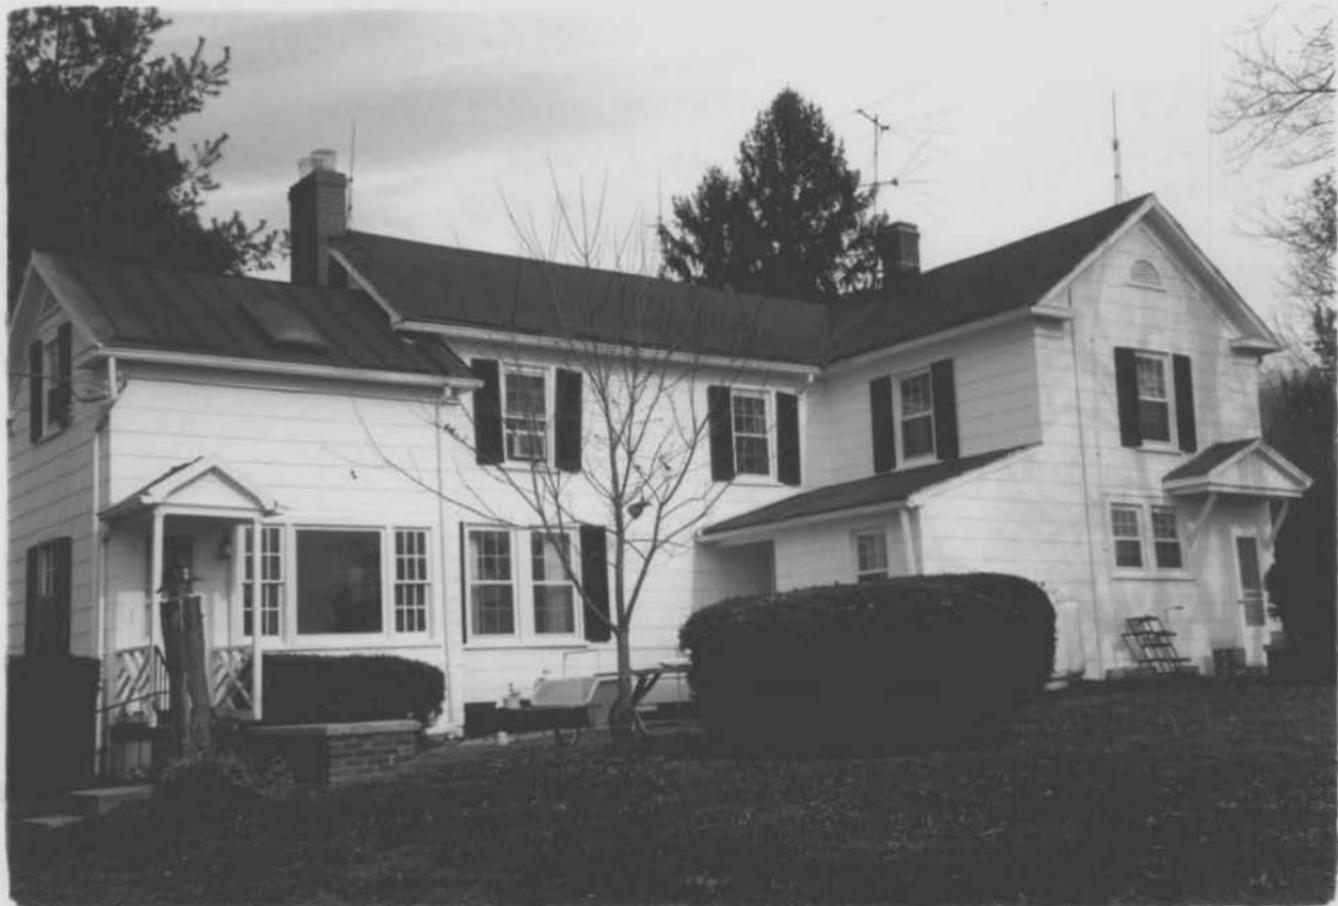
11 of 12

SOUTH (REAR)

the east-most bay, is an entrance with a small, bracketed, front pedimented portico. At the northwest corner of the ell, where it joins the main block, there is a one story, shed roof addition with a recessed entrance to the kitchen in the northmost bay.

At the rear of the west wing is a one story, one bay entrance porch covered with a front gable, pedimented portico supported by narrow, square posts. The porch has a Chippendale-style railing, is reached by a short flight of steps, and faces a stone patio.

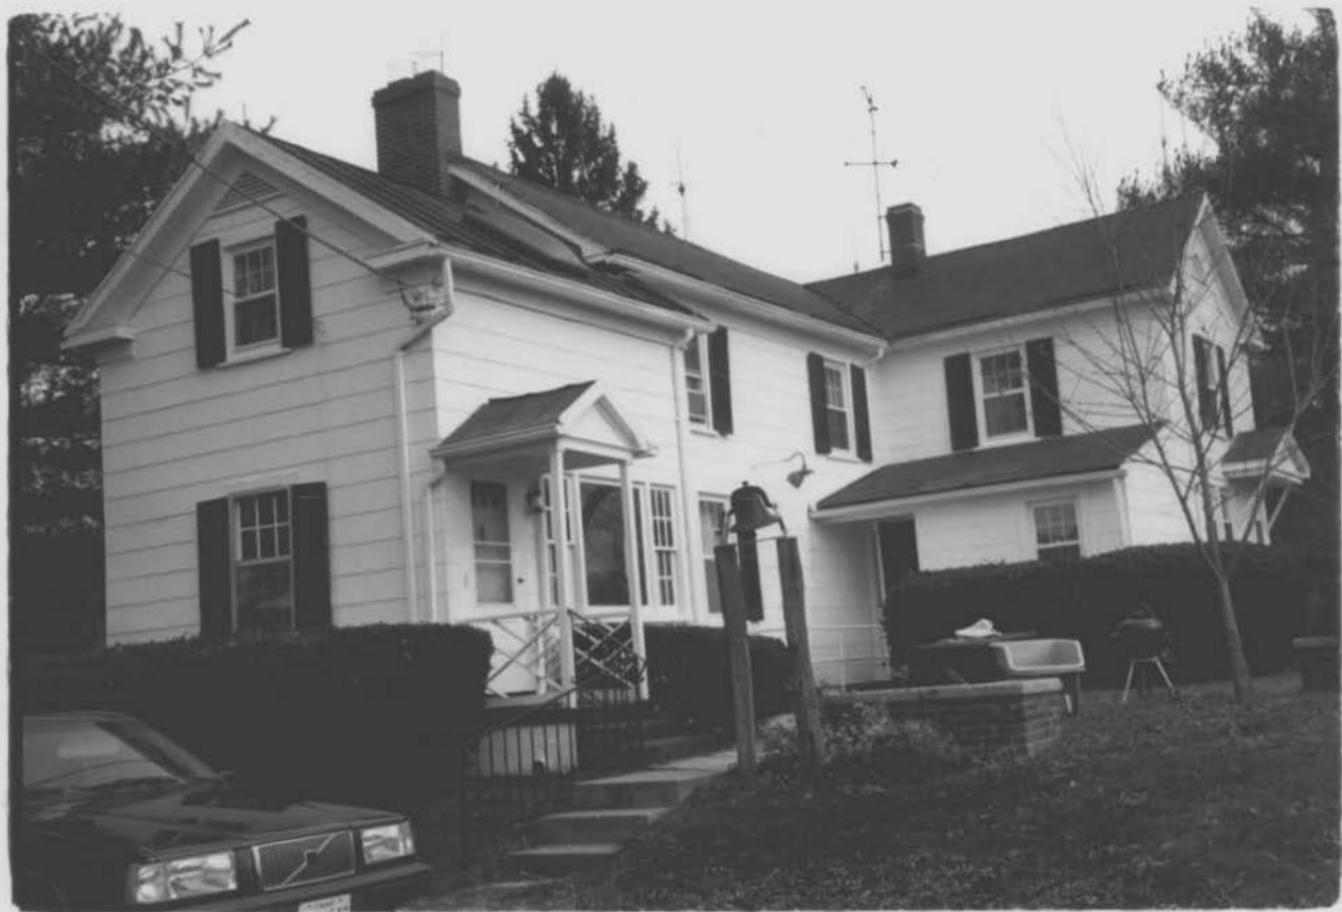
No 12

West (Left) & South (Right)

At the west end of the main block is a lower two-story, one-bay wing which is obscured from the front by a large tree. Windows are six over six and shuttered, the cornice is returned, and the roof is raised-seam metal.

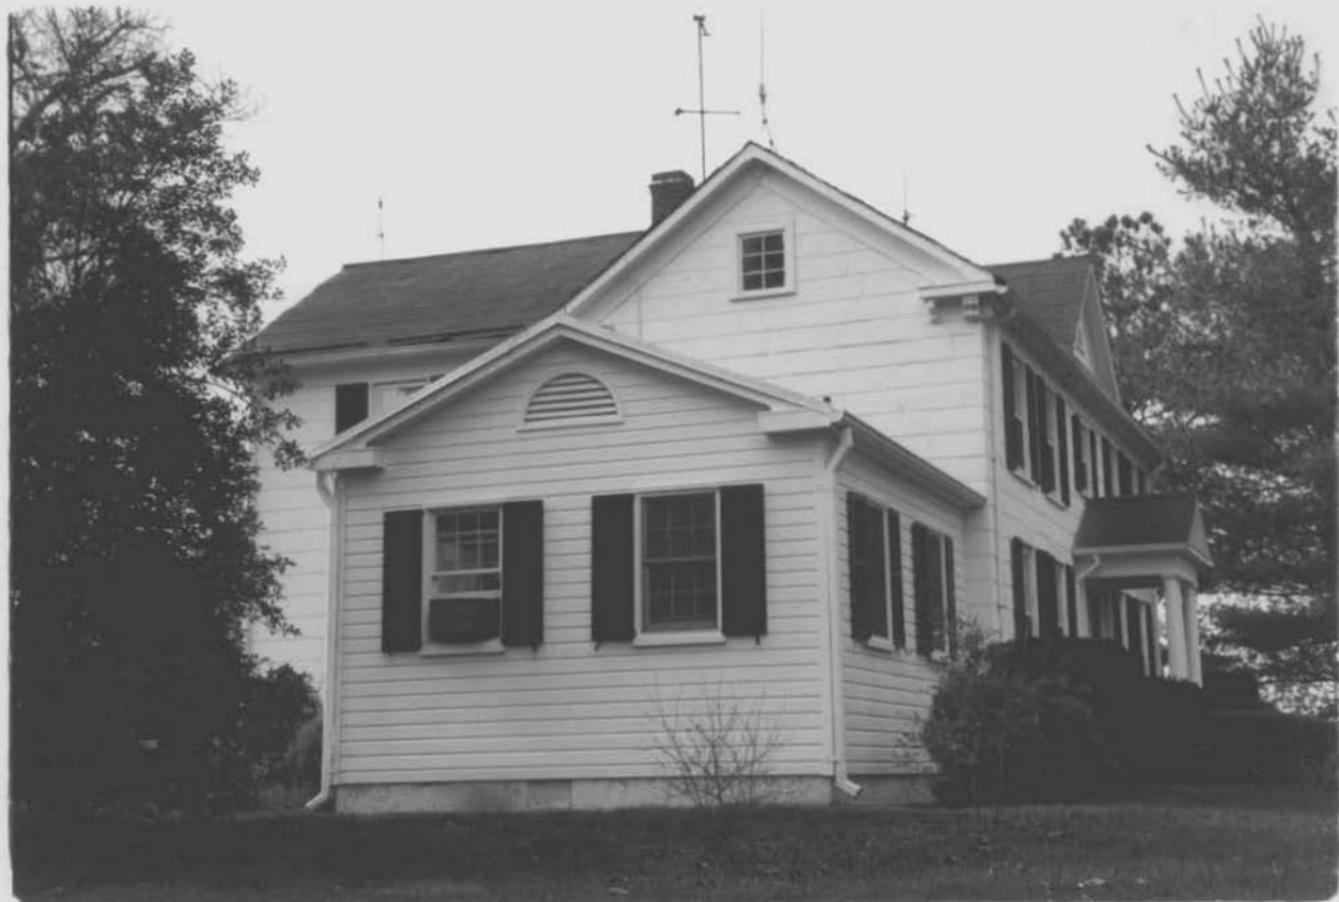
5 of 12

East (Left) + North (Right)

Attached to the east end of the main block is a one story, two bay, side gable wing with a return cornice and a louvered semicircular window at the east gable end. Windows are six over six sash and shuttered, siding is clapboard, the roof is raised-seam metal, and the foundation is concrete-block. The wing was constructed by the current owner in the 1980s to replace a glassed-in porch.

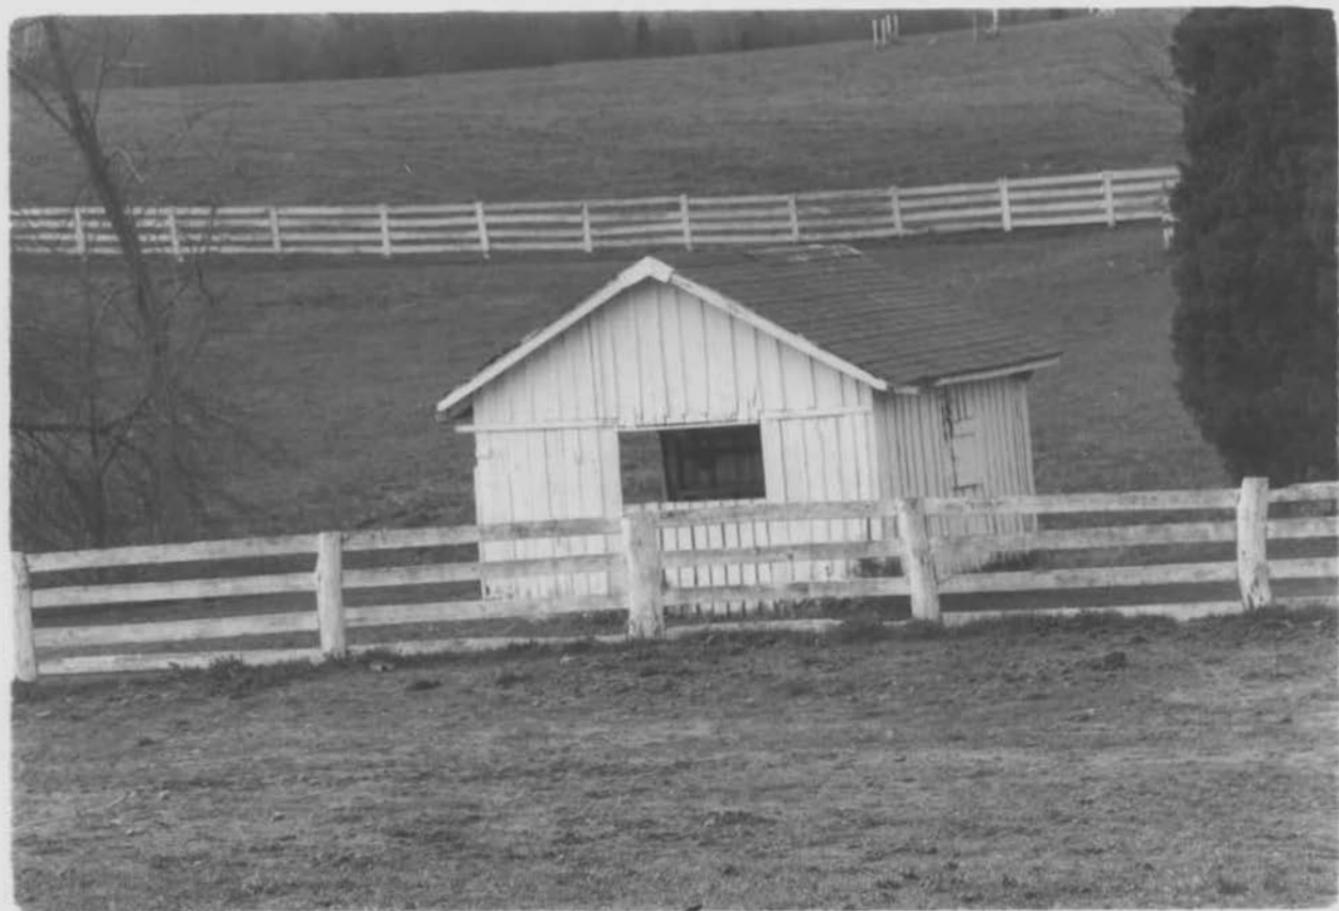
20f12

Higgins / King FARM (Outbuilding) (#3)

To the west of the barn is a small, one bay, front gable shed with a patterned tin roof and board-and-batten siding (Bldg.#3). To the west of the shed is a north-facing cow barn, now used for horses. The three bay, front gable barn has board-and-batten siding and a large overhead door and vented windows in the north elevation. A former opening in the gable end is boarded over. There is a one story, shed roof addition on the east elevation. The roof is raised-seam metal and the foundation is Seneca sandstone. Attached to the rear (south) end is a row of open, shed-roof stalls (Bldg.#4).

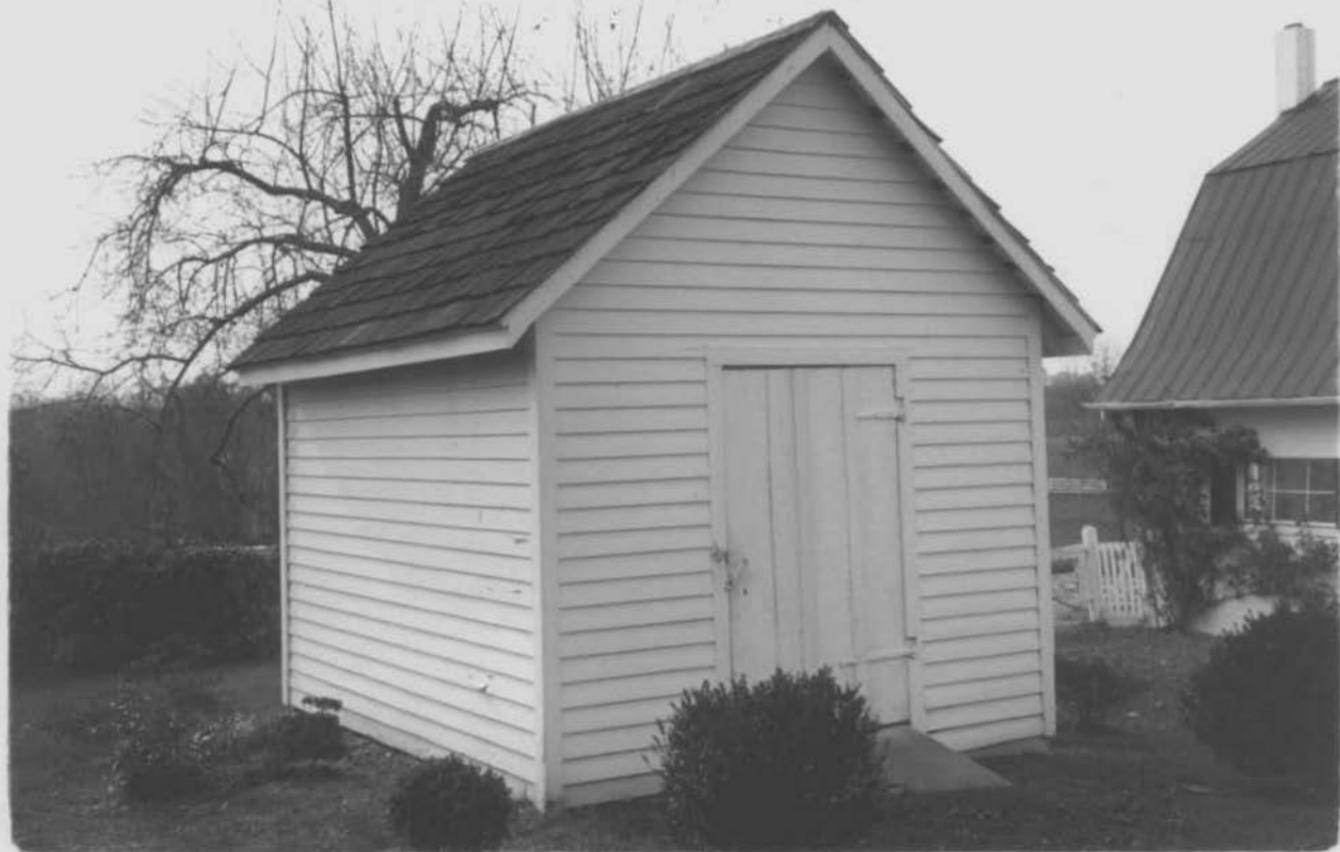
3 of 12

Higgins / King FARM (Outbuilding) (Amshelone)
(#1)

(south) of the house is a front gable, one bay log smokehouse (Bldg. #1) with a cedar shingle roof and clapboard siding. A board and batten door with metal strap hinges is centered in the north elevation. At the rear is a single window with six over six sash.

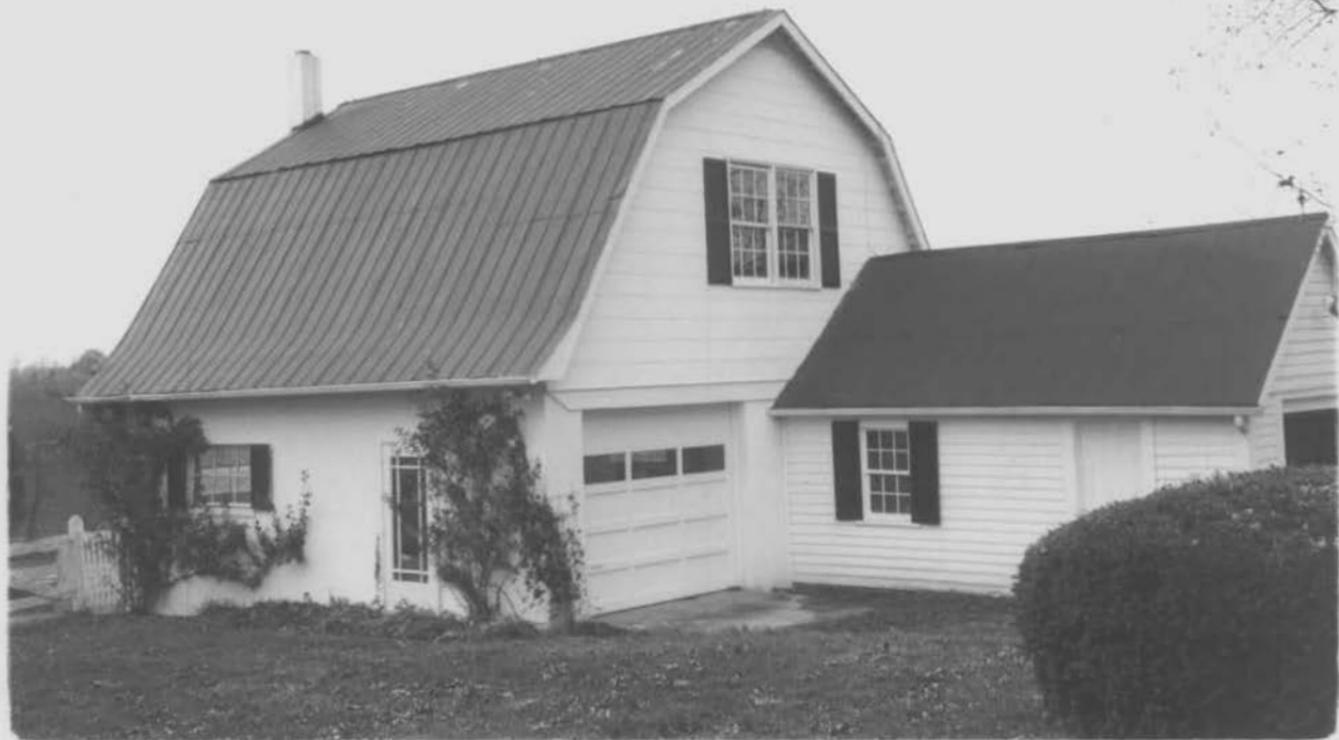
40f12

Higgins/King FARM (Outbuildings) (Barn/Garage)
(#2)

To the west of the smokehouse is a two bay, gambrel roof dairy barn (Bldg. #2) which has been converted for use as a garage. The roof is raised seam metal, the north gable end is covered in asphalt shingles, and the lower third of the barn is concrete-block. There are two six over six sash windows at the north gable end, with shutters. Entrance is from a large overhead garage door at the north elevation and a smaller entrance in the north-most bay of the east elevation. Attached at the northwest corner of the dairy barn and extending to the north is a newer one story, two bay, front gable garage with entrances from both the north and west elevations. The roof is composition material, the siding is clapboard.

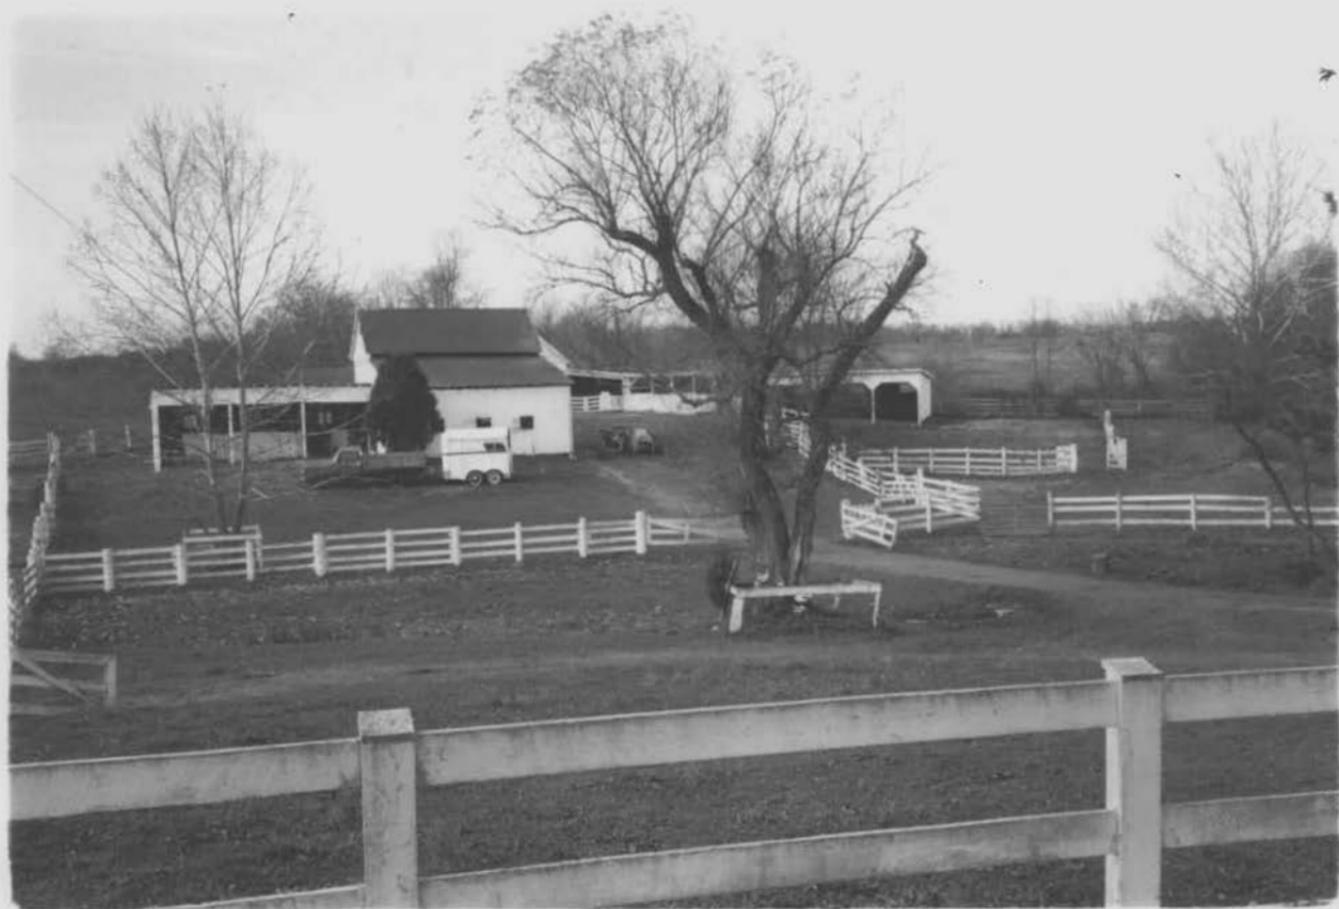
M-24/23 (Overview - #465)

To the west of this barn is a three bay, front gable corn crib with a small one bay, shed roof addition at the southeast corner. The roof is corrugated metal and the siding is vertical plank. The doors on either side of the gated center opening and in the addition have metal strap hinges and the foundation is Seneca sandstone. There is also a small door at the gable end, with metal strap hinges. Attached to the north end of the corn-crib is a row of shed-roof stalls and storage sheds (Bldg.#5).

Higgins / King FARM (Out buildings)

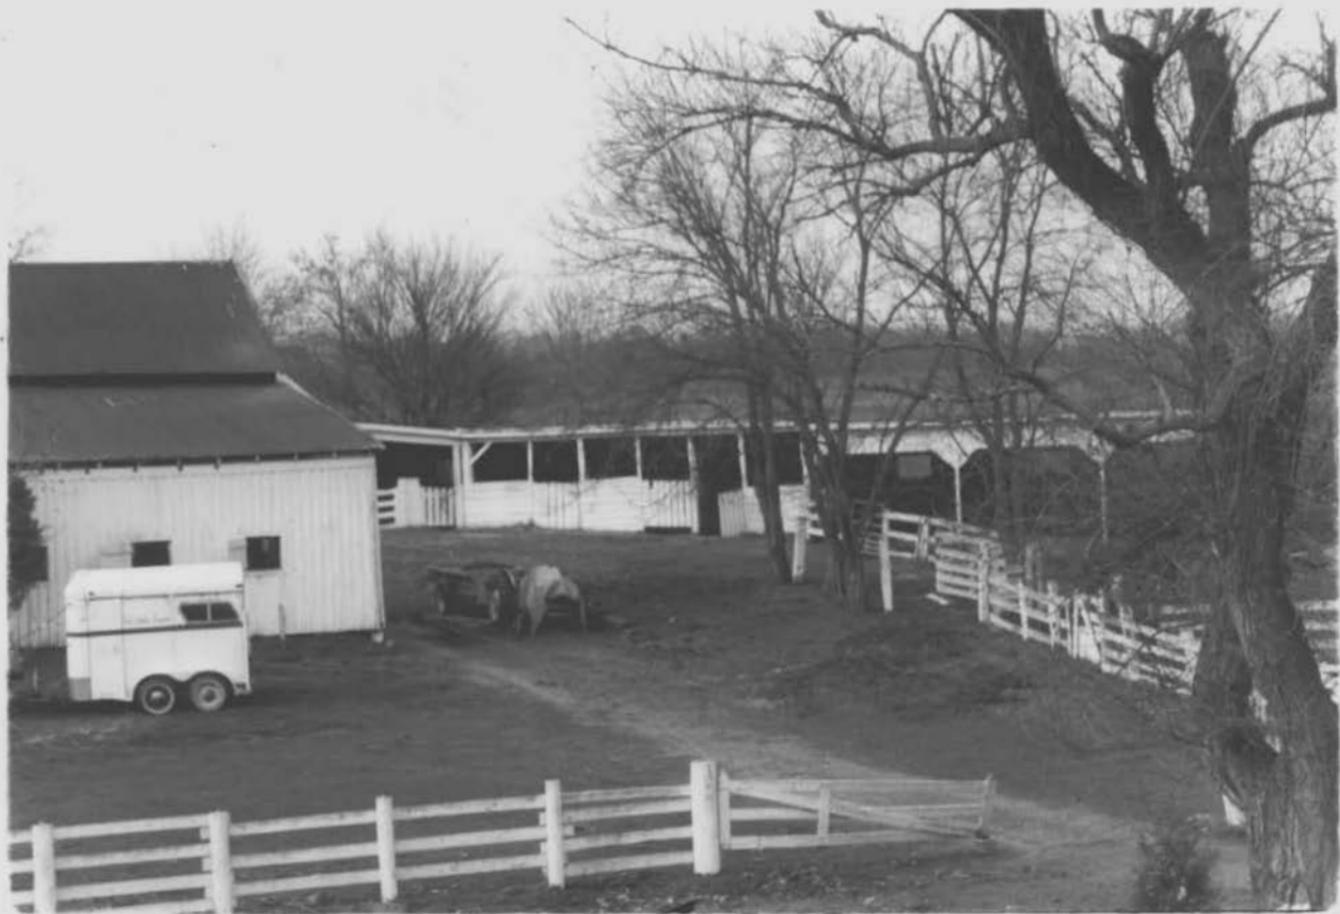
04/12

Higgins/King FARM

(Right - #5)

(Left - #4)

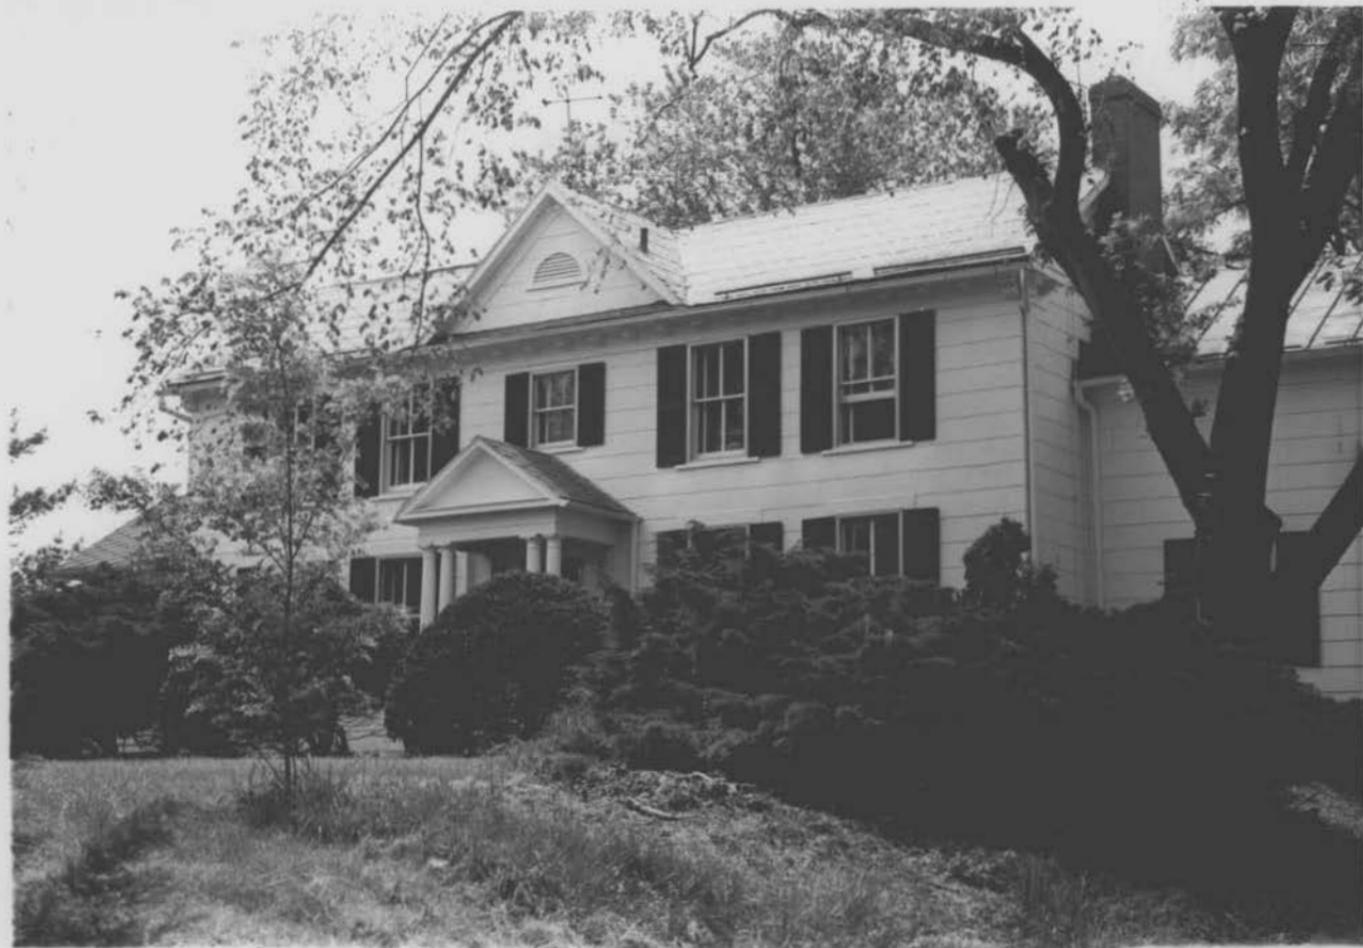
#24-23

FACADE N
