Wagner House

201 West Montgomery Avenue

Maryland Historical Trust State Historic Sites Inventory Form

Survey No M.26/10/41

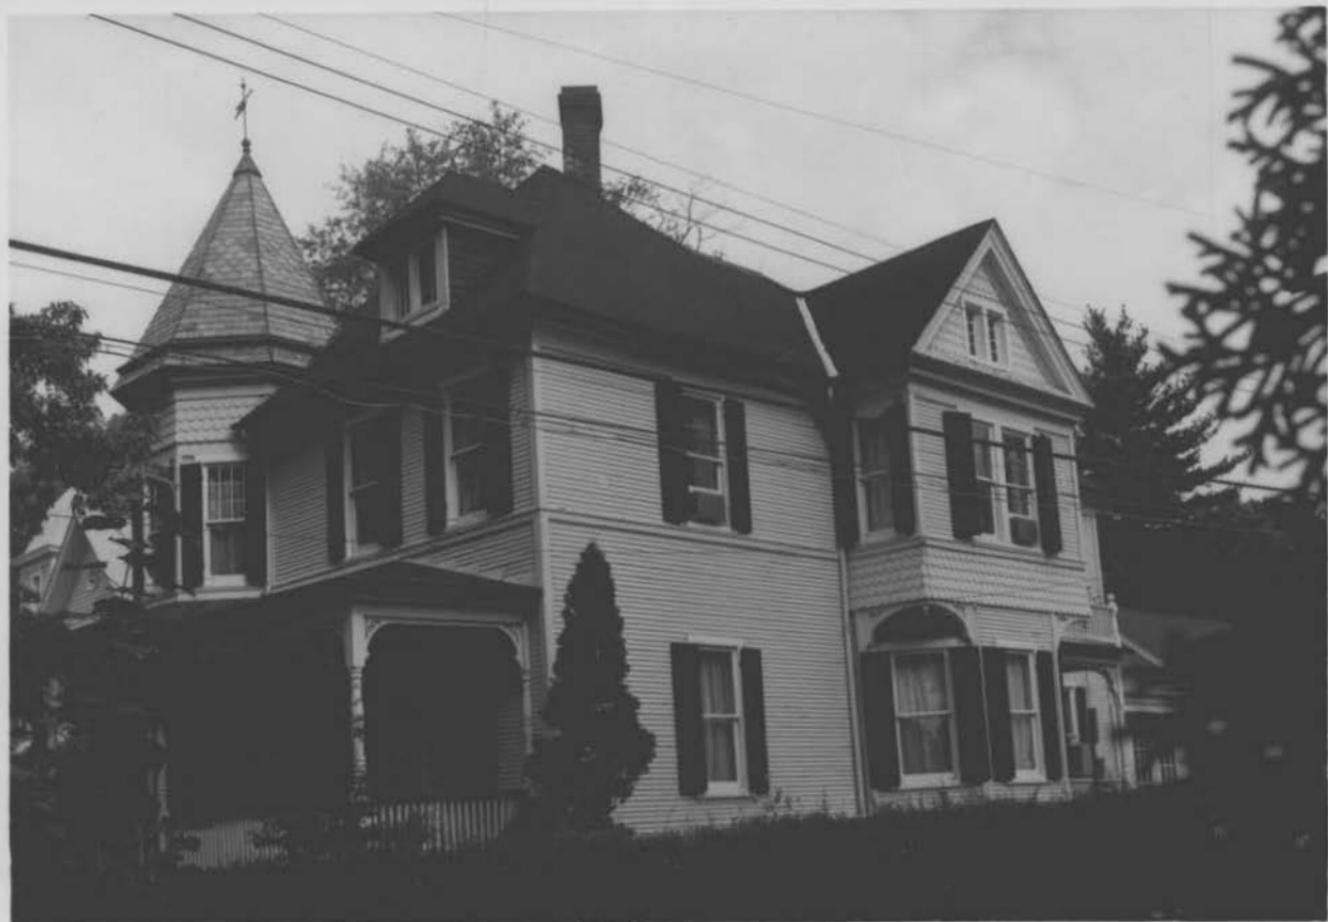
0885-16-4

M: 26/10/41
Wagner House
201 W. Montgomery Ave.
Rockville
8-85 SE facade

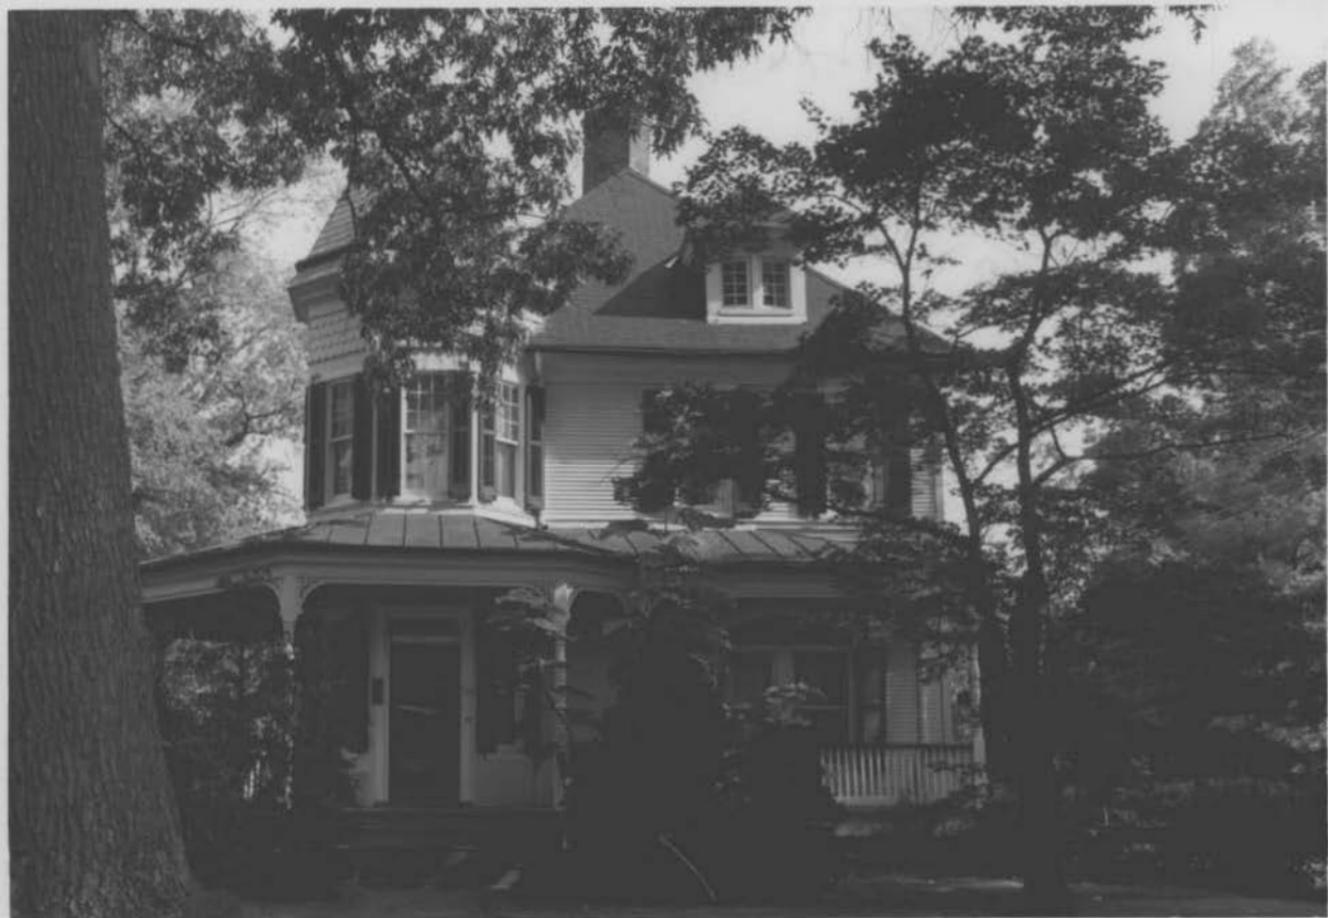
0885-16-1

Typical of the Queen Anne style residence, the principal facade is asymmetrically arranged. A one-story, full-width, wrap-around porch visually connects the many stylistic features on the facade. This porch has turned columns with jig-sawn brackets. A plain balustrade connects the columns and extends down the wide front steps, near the center of the facade, ending in turned newel posts.

The polygonal tower at the southwest corner of the house appears to rise through the porch to dominate the facade. Four six-over-one windows highlight the tower's first floor. An exterior door with one large pane of glass in a beaded molding with glass transom separates the third and fourth windows; this serves as the main entryway to the house. The second story of the tower has five six-over-one windows. A conical roof covered with patterned slate tops the tower and is accented by a copper weathervane. A wide band of fish-scale shingles separates the second story windows and the roof. Single one-over-one windows are in each of the other two bays on the second story.

M: 26/10/41
Wagner House
201 W. Montgomery Ave.
Rockville
8-85 S. Facade
