Site: M:26/10/90

The Wilson-Bullard House

209 Harrison Street

Maryland Historical Trust State Historic Sites Inventory Form

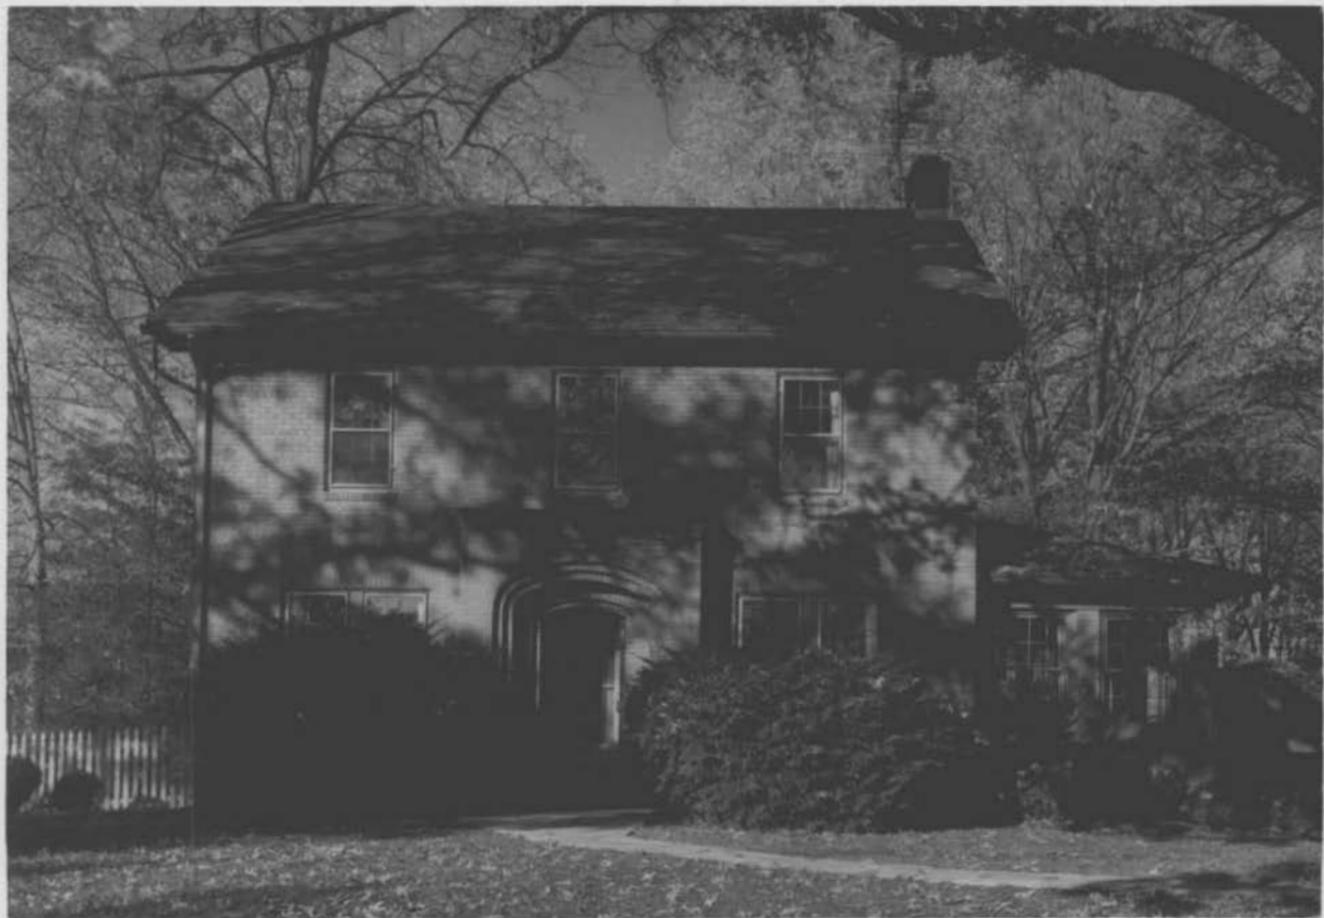
M:26/10/90
Wilson-Bullard House
209 Harrison Street
Rockville, Md. 20850
Richard Andrews
date:6/1987 elevation: S

The three-bay south (front) facade has a single 6/6 double sash window in each bay, second story. A pair of windows occupies the east and west bays of the first story. The brick flat-roofed portico occupies the center bay, projecting about three feet and accessed from the walk by two steps. Its corbelled cornice creates a strong horizontal shadow above the slightly flattened arch with succeeding layers of reveal leading to the six-panel recessed wood door. The interior, lit by a pendant electric light fixture, can be secured by wrought iron openwork doors mounted in the portico opening. Small exterior carriage light fixtures flank the archway.
