Site: M:26/11/12

Dawson Store/Burbanks

18,20 West Montgomery Avenue

## Late Historic Sites Inventory Form

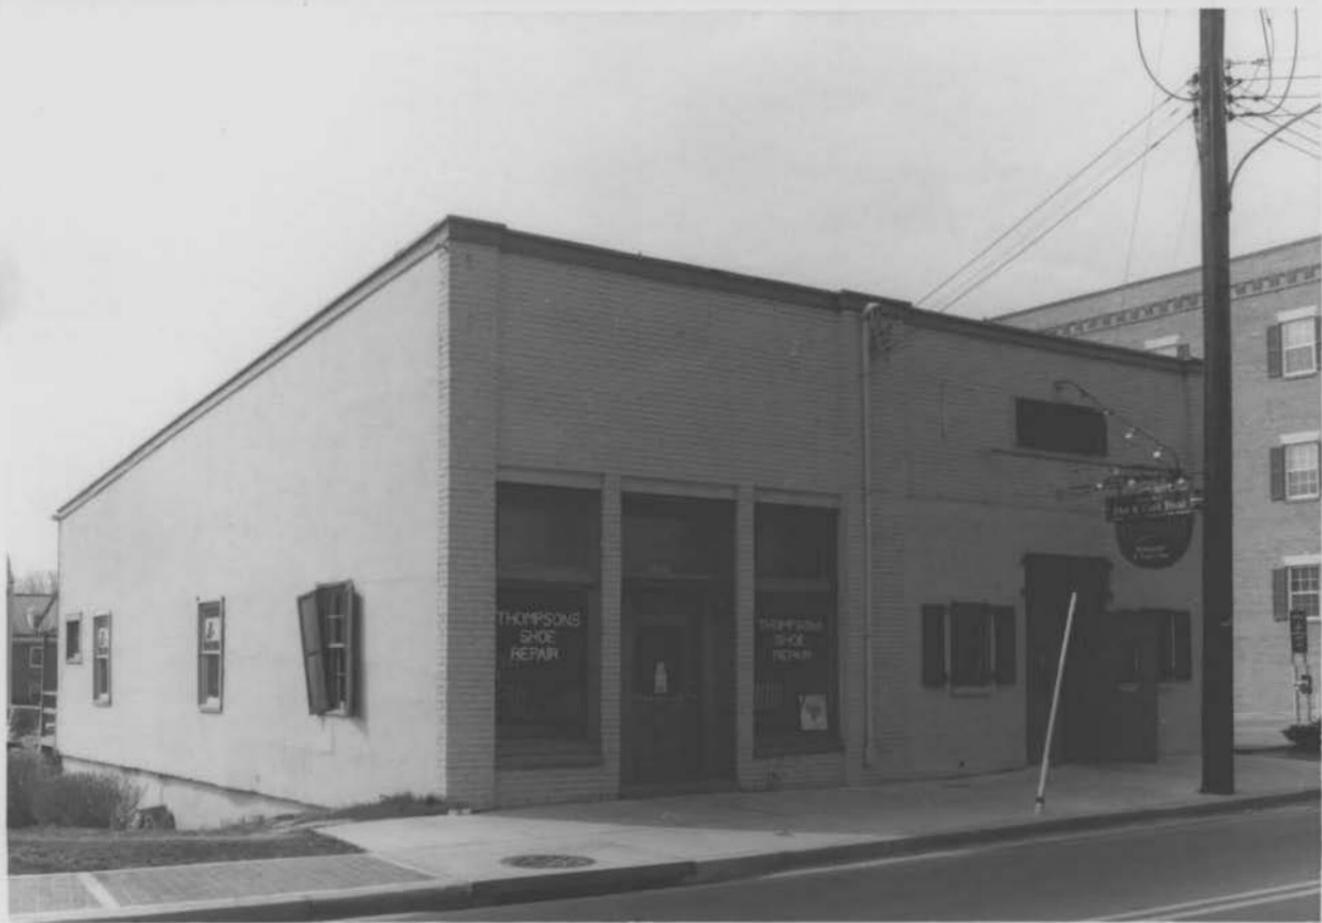
M: 26/11/12  
Dawson Store/ Burbank  
18-20 W. Montgomery Ave.  
Rockville - SE facade  
5-86

The four-bay east facade is covered in a smooth stucco while the foundation is parged with cement. A small casement window in a wooden frame has two four-light windows. The second and third bays are recent replacements with one-over-one windows. The fourth bay retains an original six-over-six window.

The south or rear facade includes a shed roof on the western half, once a porch, that is enclosed and covered with vinyl siding. It is supported on brick piers enclosed with bricks and parged with cement. Two windows are on the far western side and covered with security bars. The recessed eastern portion has two two-over-two windows, protected with security bars, on the west. An open frame porch with shed roof covered in asphalt shingles extends over single wooden exterior and screen doors on the east. Cinder blocks support the porch; wooden steps lead down to the west.

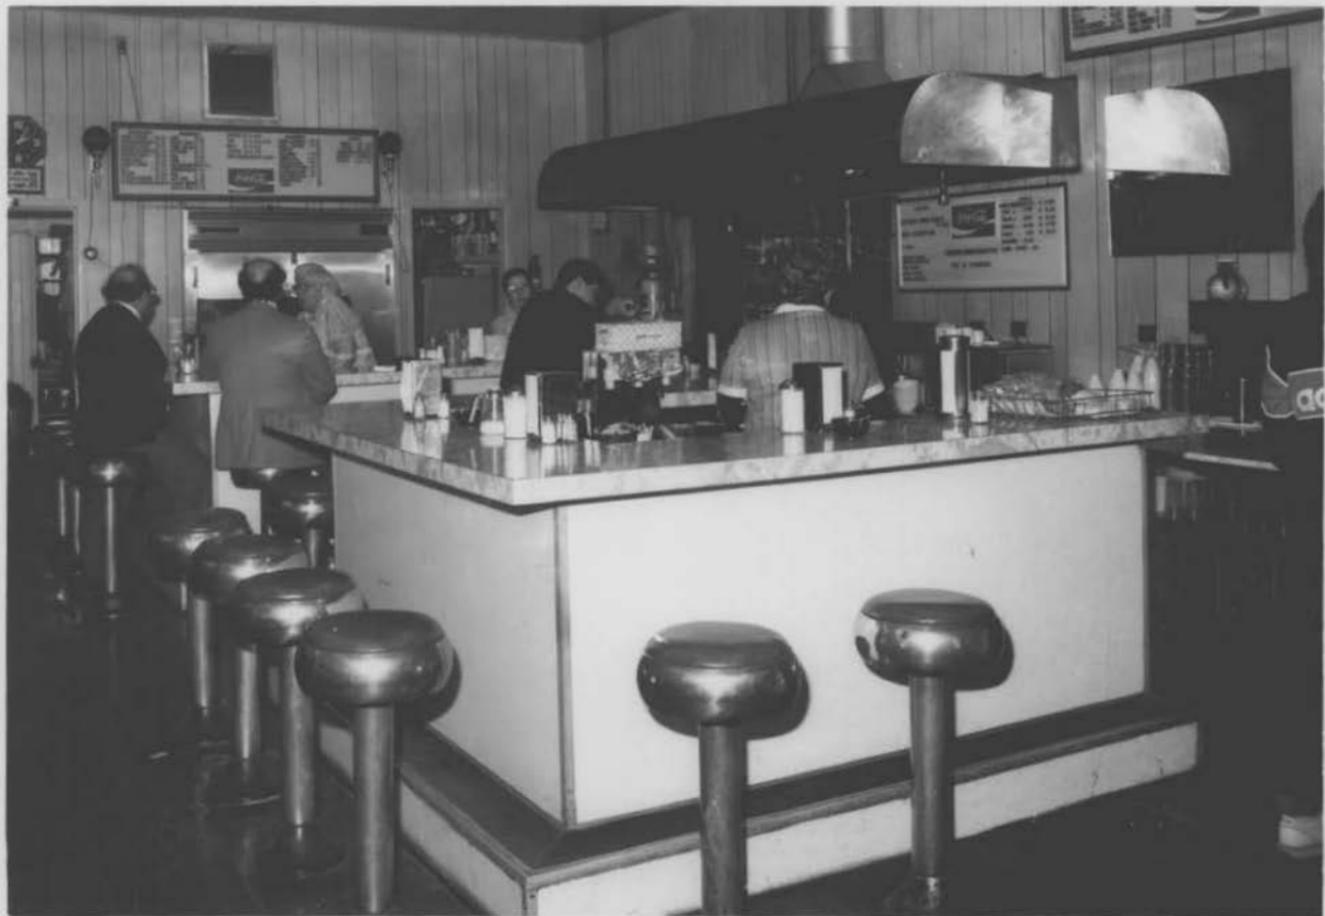
M: 26/11/12

The interiors of both stores have been altered with paneling and updated materials. The western side or "Burbanks," however, still contains its early luncheonette counter and stools.

interior
