MARYLAND HISTORICAL TRUST ADDENDUM SHEET
INTERCOUNTY CONNECTOR PROJECT

Property Name: Layhill Community Free Methodist
Church Property
Survey No.: M:27-16 (PACS C3.6)

Layhill Community Free Methodist Church

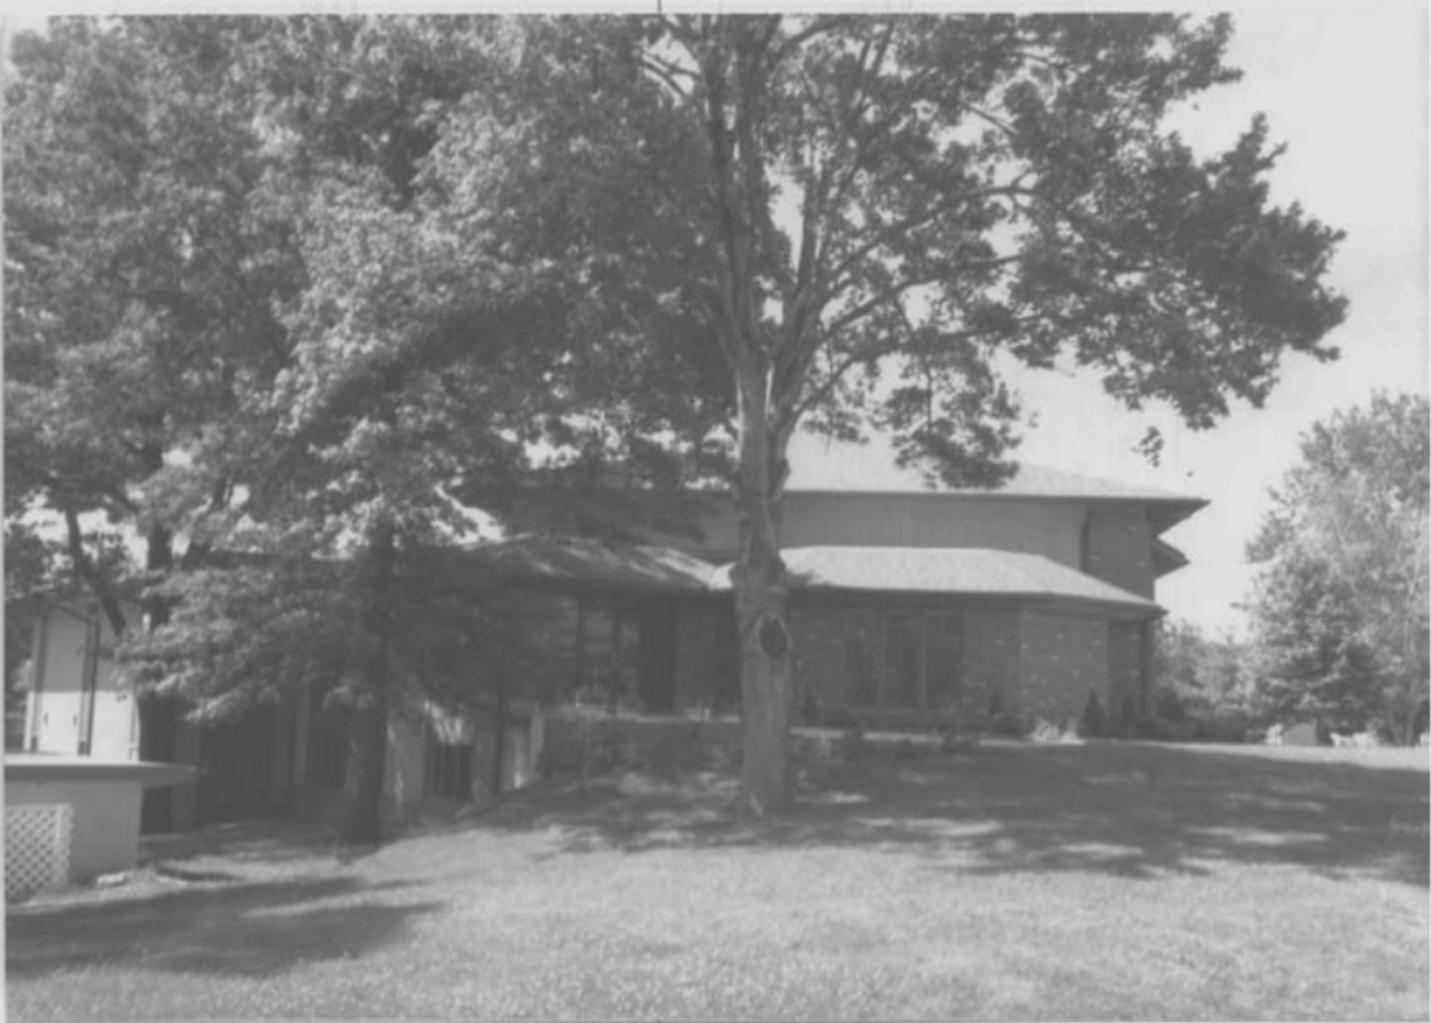
1 M:27-16

7 1900 Bonifant Rd., modern church

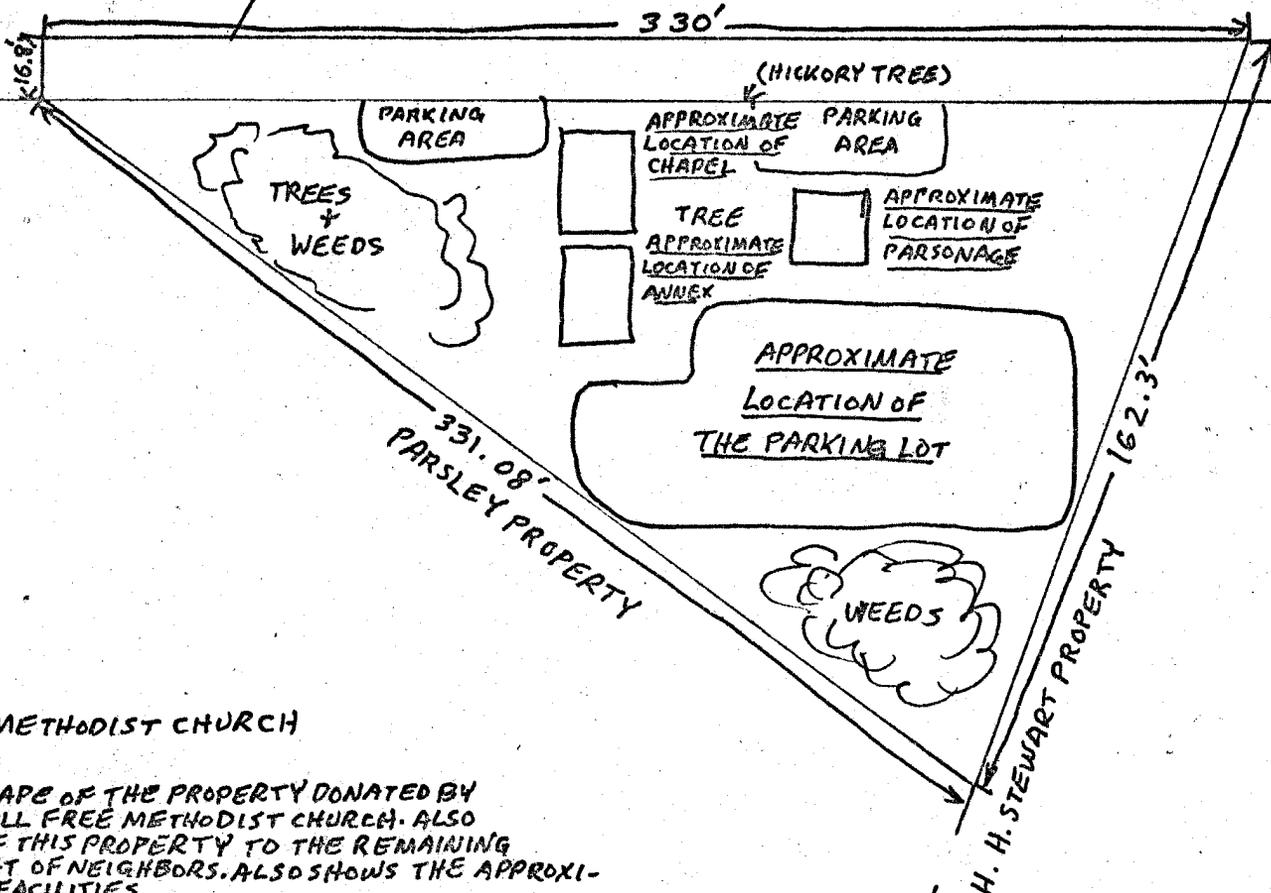
MAP # 3: DIMENSIONS + SHAPE OF THE PROPERTY DONATED BY
CHRISTINA PARSELY TO LAYHILL FREE METHODIST CHURCH. ALSO
SHOWS THE JUNCTADPOSITION OF THIS PROPERTY TO THE REMAINING
PARSELY PROPERTY + TO THAT OF NEIGHBORS. ALSO SHOWS THE APPROXI-
MATE LOCATION OF CURRENT FACILITIES.

SURFACE FALLS TOWARD THE EAST AND SOUTH AT AN APPROXIMATE
AVERAGE OF 1 VERTICAL FOOT FOR EVERY 30 HORIZONTAL FEET.

NOT DRAWN TO SCALE

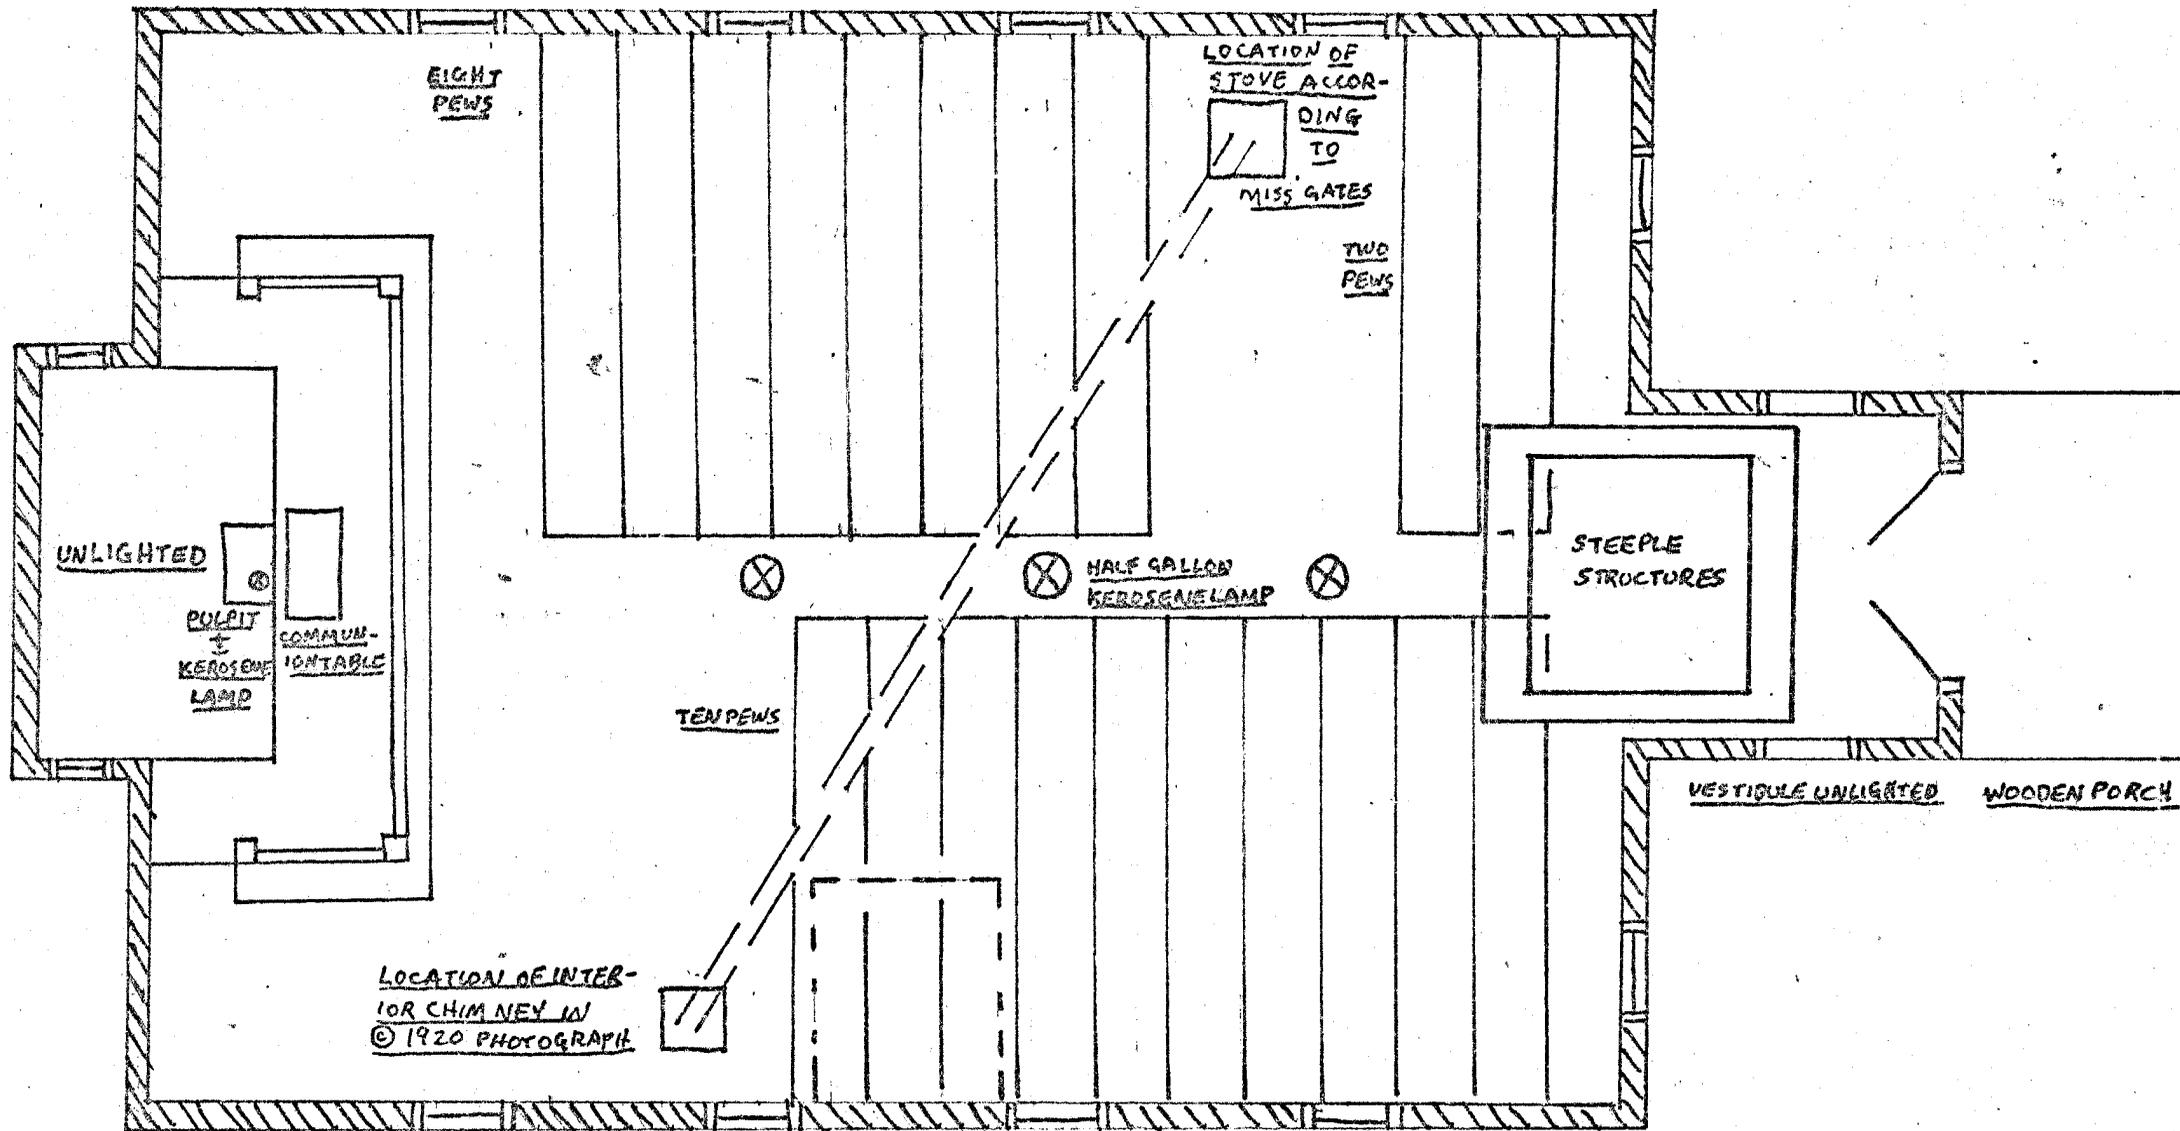
PLAN #2: THE CHURCH AND ITS ACCESSORIES AS THEY APPEARED ABOUT 1920; AND THE
LOCATION OF THE STEEPLE STRUCTURE

--- = PRESENT LOCATION OF THE FURNACE (BASEMENT)

--- = STOVE PIPE THAT MISS GATES SAYS CONNECTED STOVE TO CHIMNEY

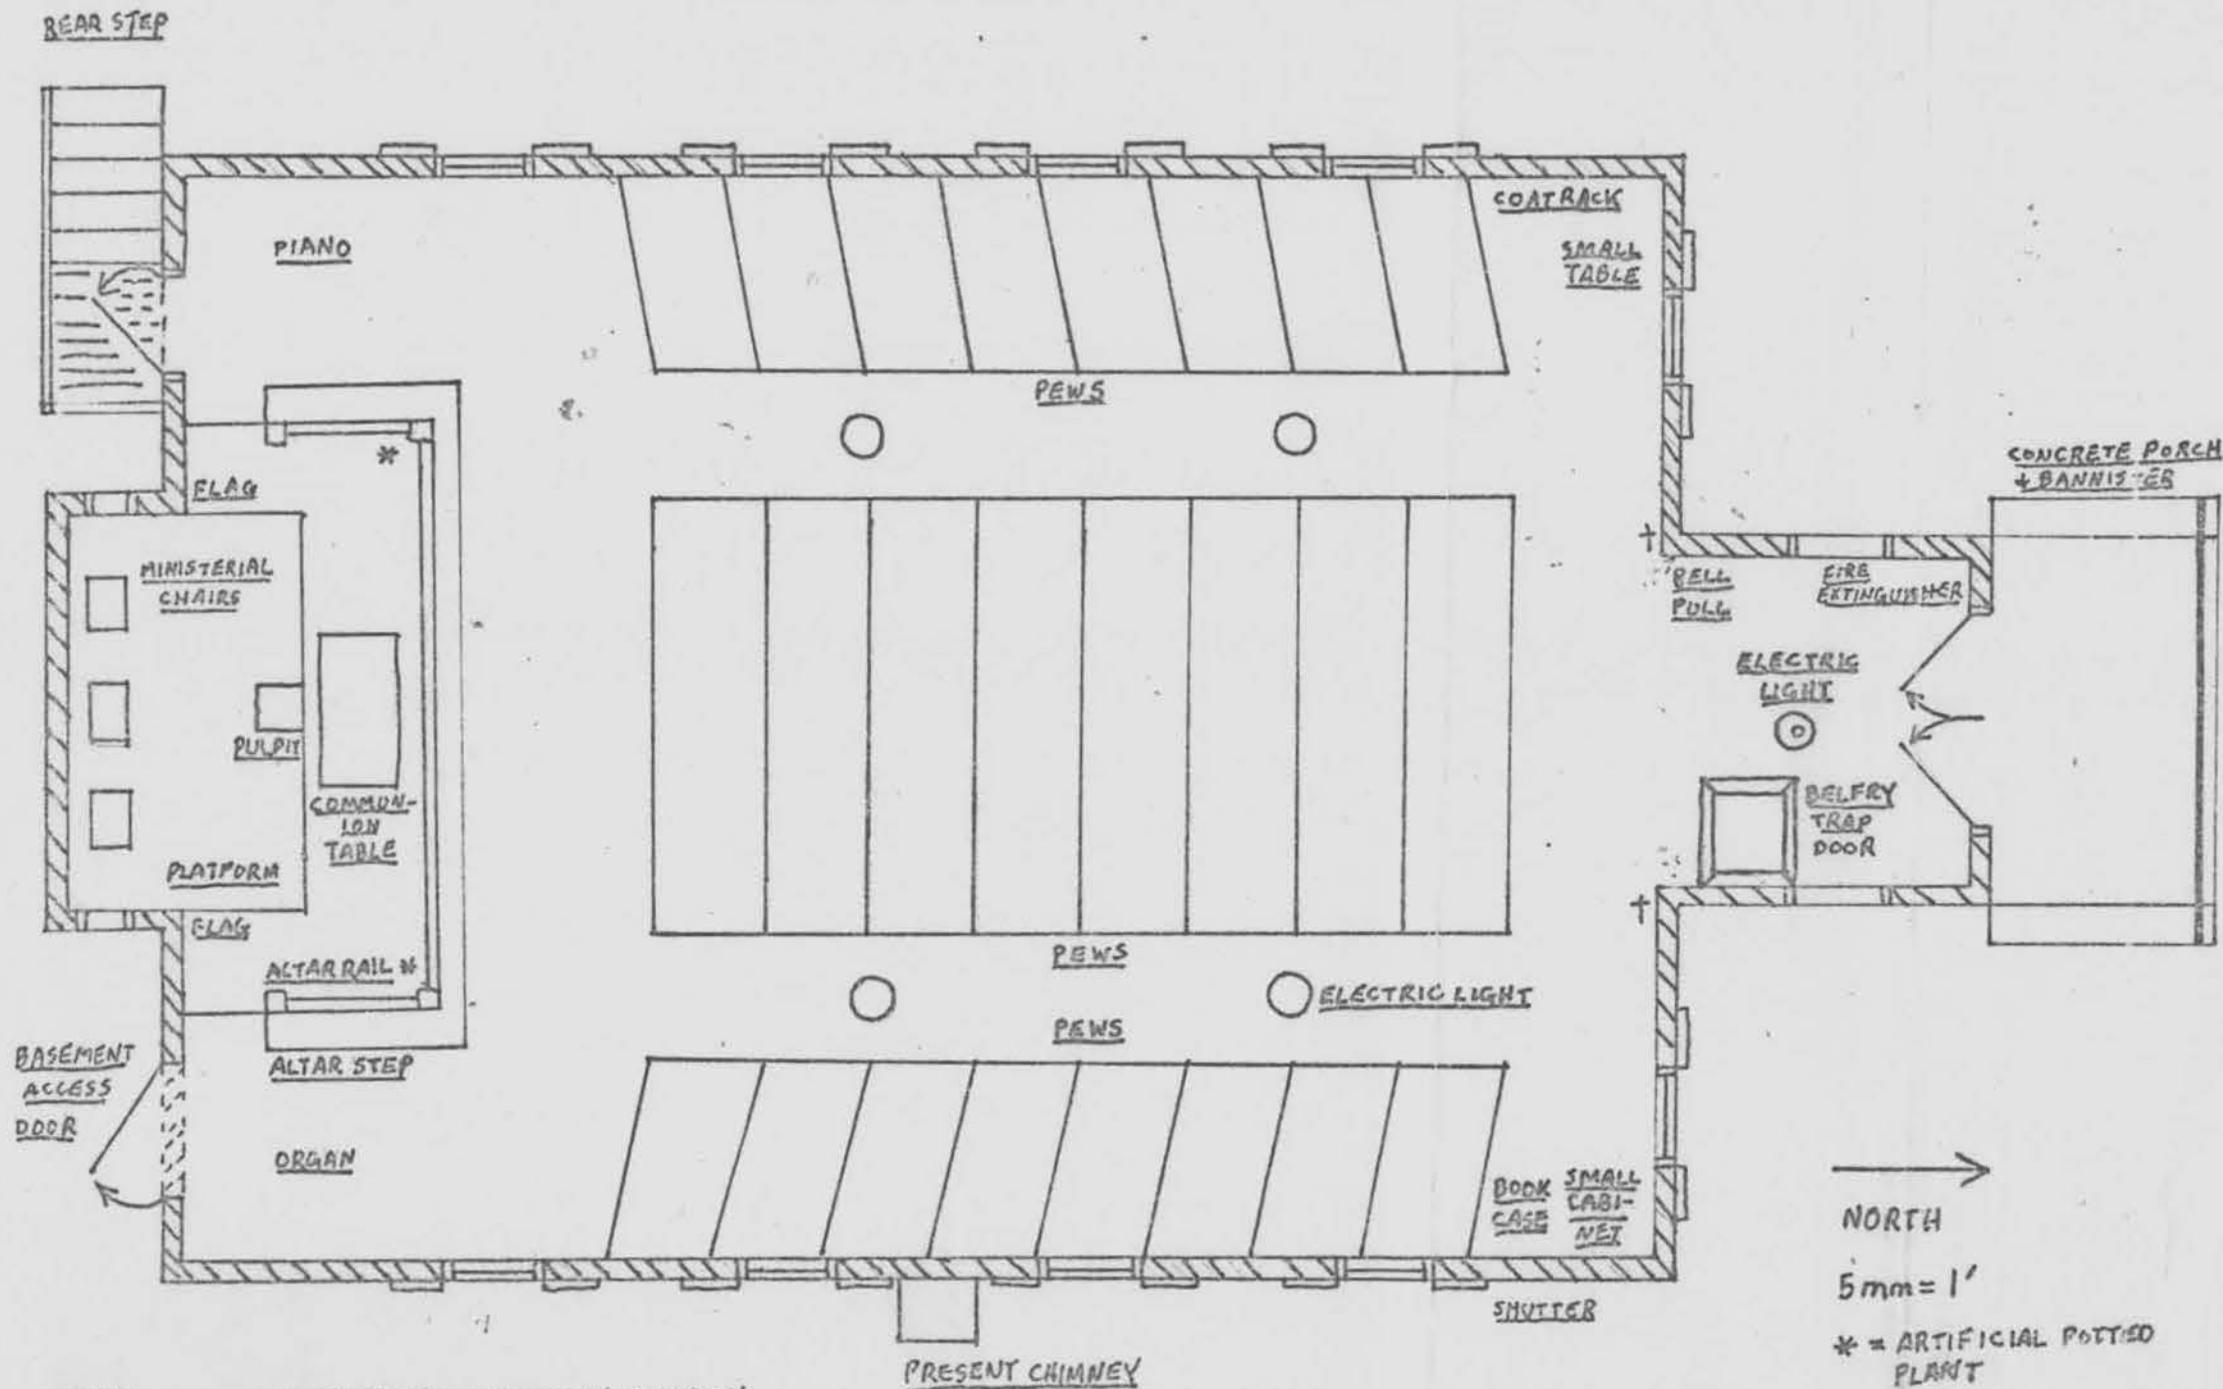
LAYHILL COMMUNITY FREE METHODIST CHURCH
 SILVER SPRING, MD (1916)
 PLAN #1: PRESENT SANCTUARY LAYOUT
 LAWRENCE E. HIBBSMAN APR 10, 1978

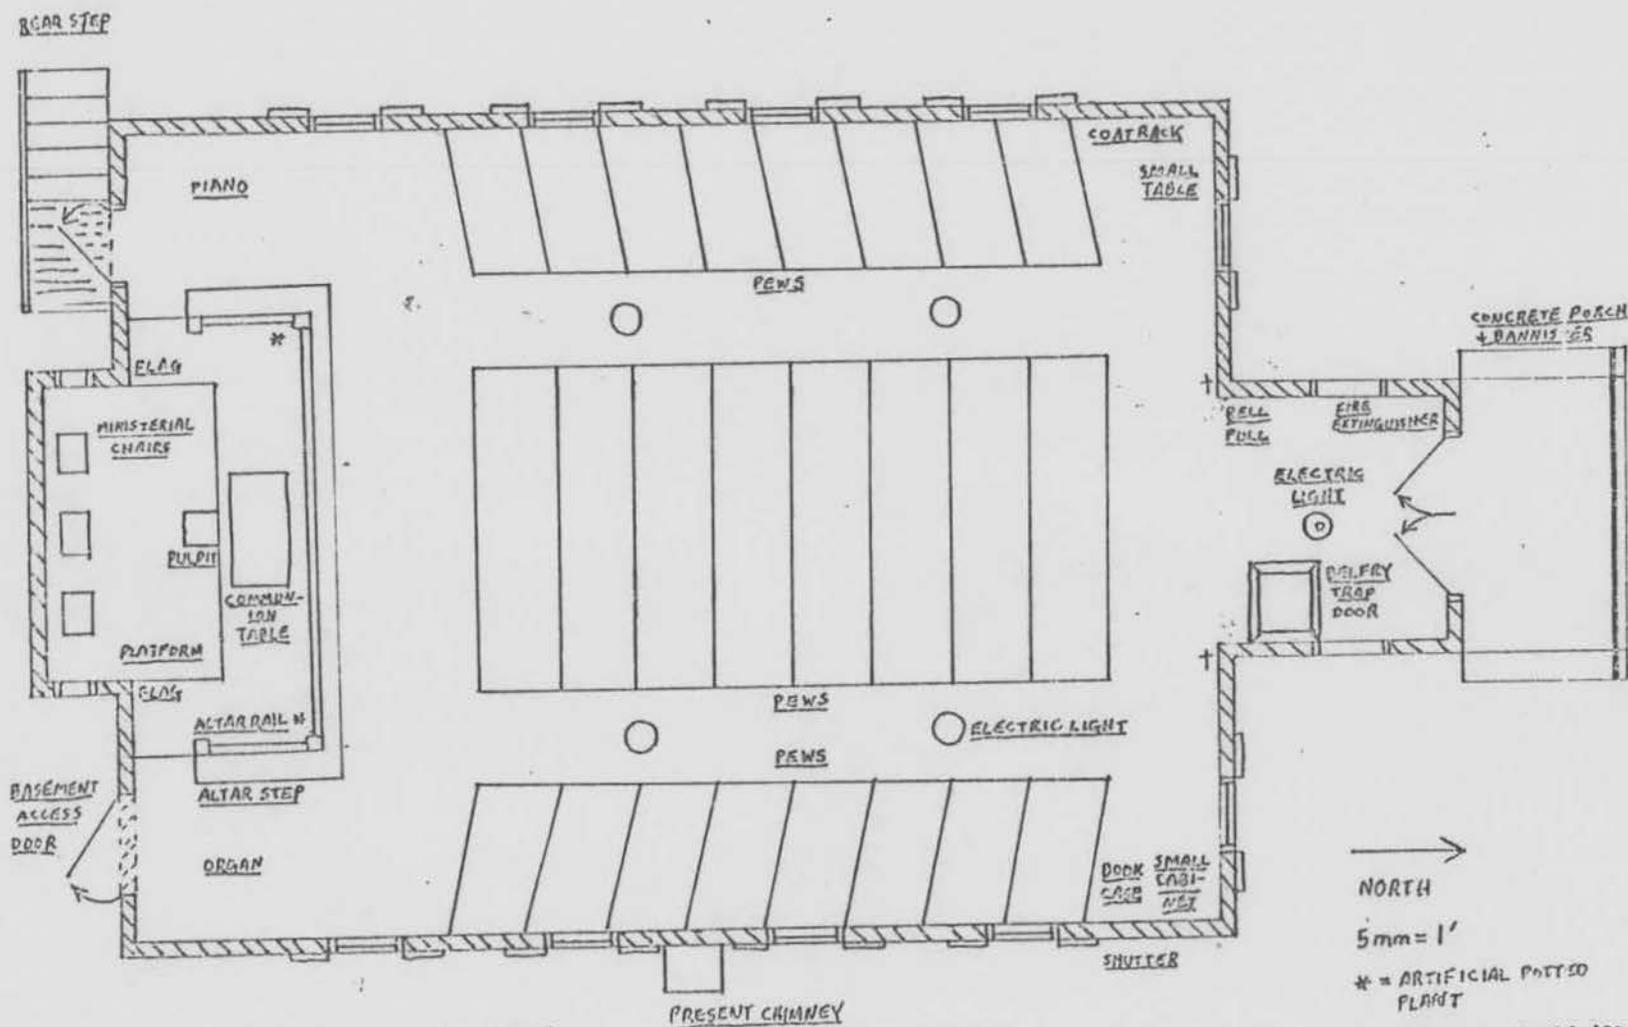
LAYHILL COMMUNITY FREE METHODIST CHURCH
 SILVER SPRING, MD (1916)
 PLAN #1: PRESENT SANCTUARY LAYOUT
 SANITARY SURVEILLANCE APR 10, 1978

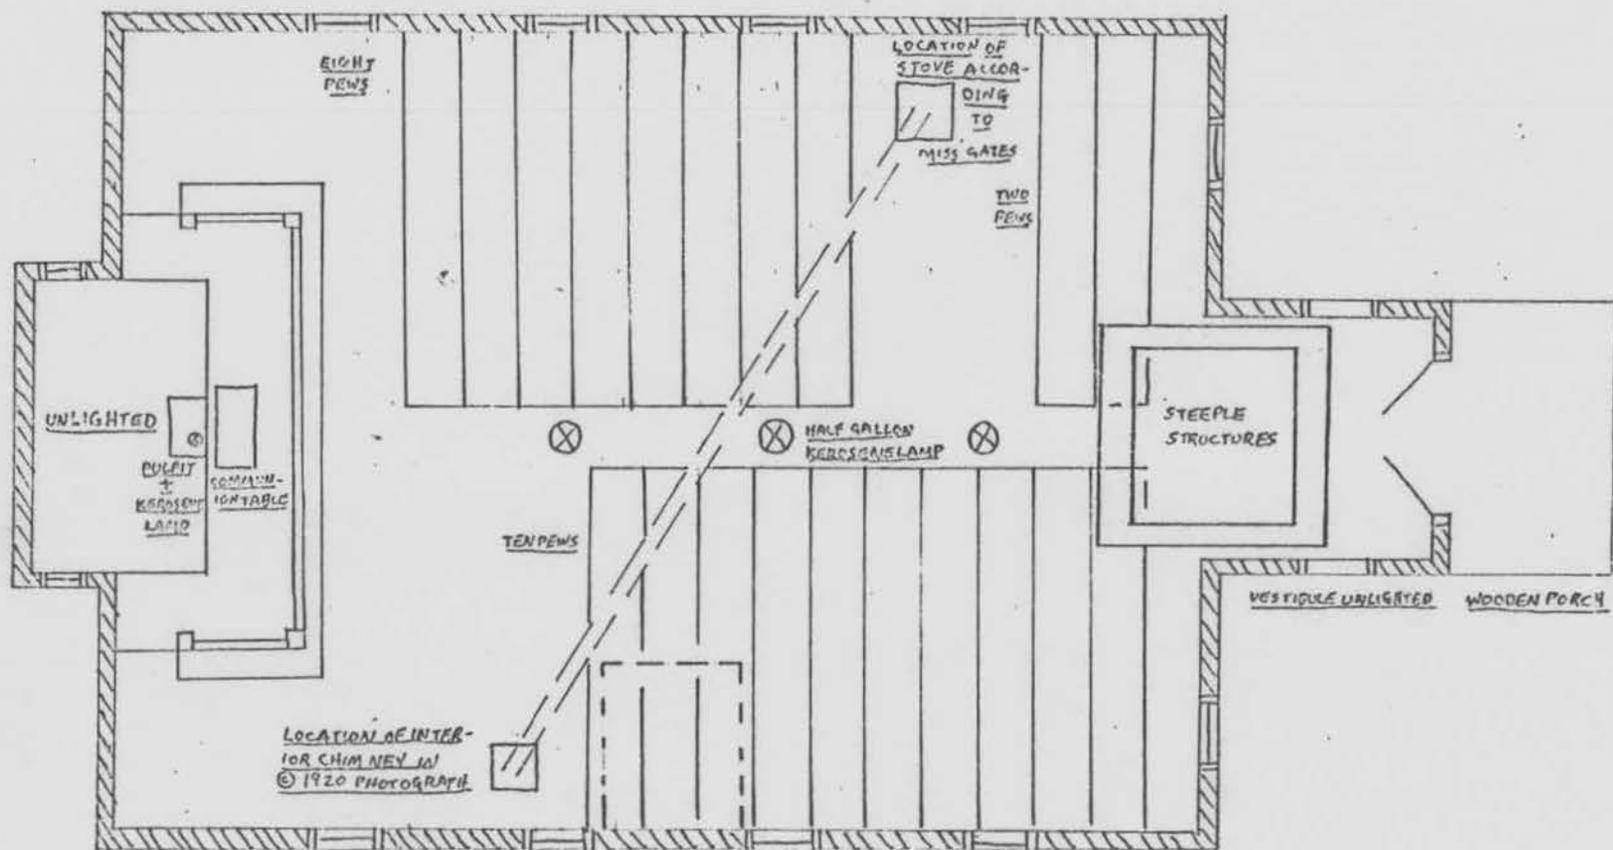
LAYHILL COMMUNITY FREE METHODIST CHURCH
 SILVER SPRING, MD
 PLAN # 2: THE CHURCH AND ITS ACCESSORIES AS THEY APPEARED ABOUT 1920; AND THE
 LOCATION OF THE STEEPLE STRUCTURE
 LAWRENCE E. HIBPSHMAN APR 10, 1978.

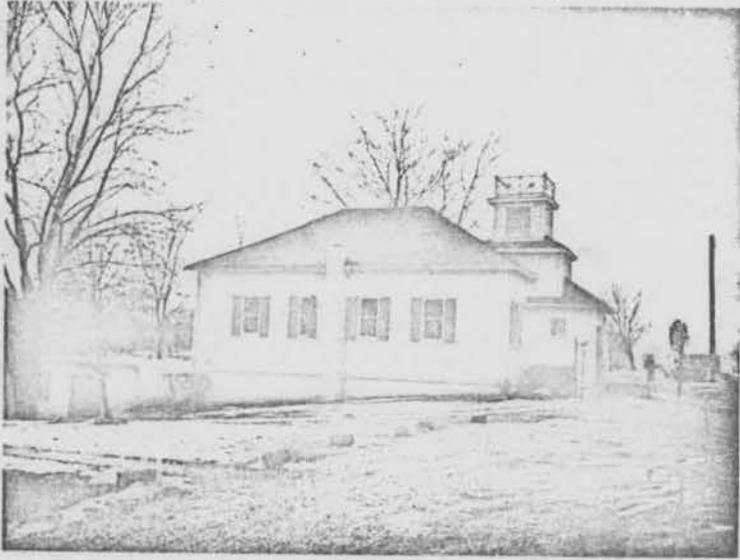
Picture 1. Sanctuary building; east elevation. This picture illustrates the siting of the building, and the rapid fall of the land surface.

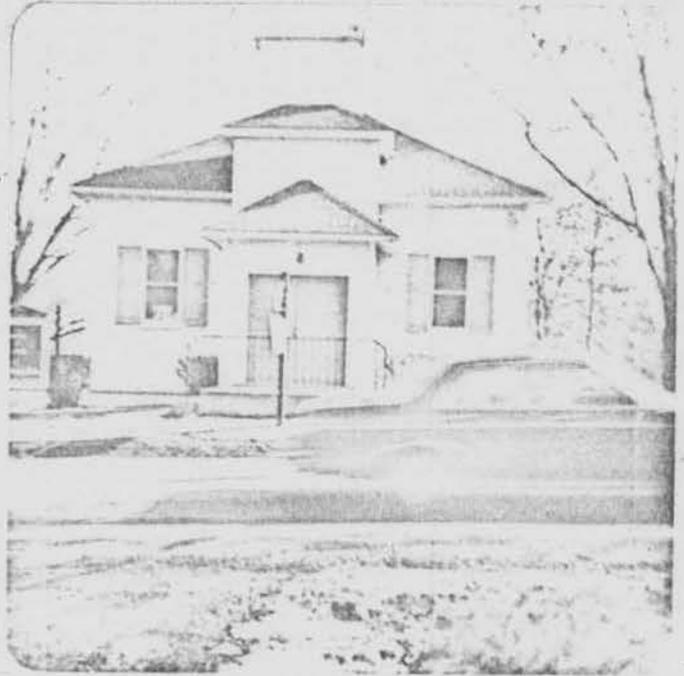
Picture 2. North elevation. This picture shows how close the building is to the right of way of Bonifont Road, and the front elevation of the lobby and steeple structure.

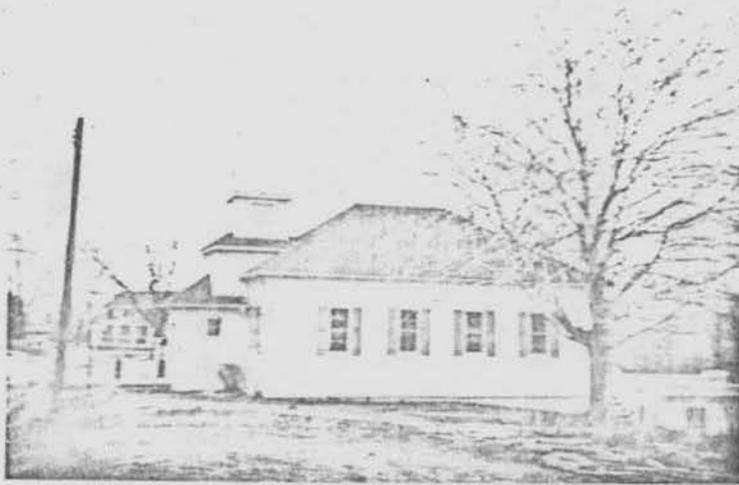
Picture 3. West elevation. The nearness to the road is again clearly visible.

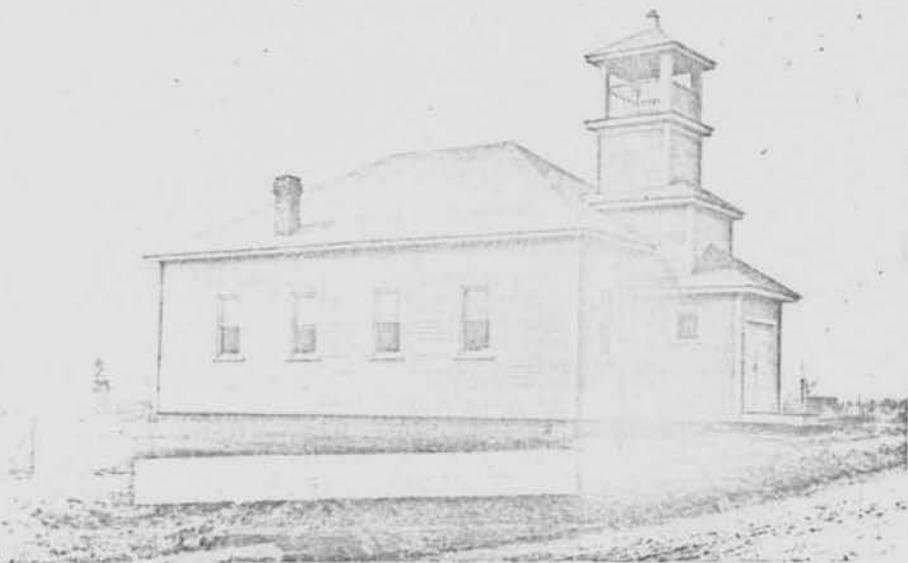
Picture 4. Sanctuary building, east elevation, about 1920.
Photograph courtesy of Wayne D. Lawton.

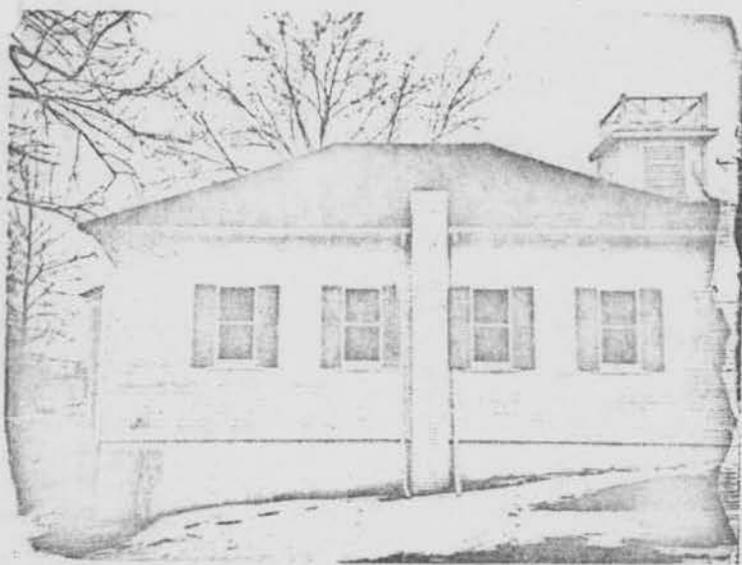
Picture 5. Detail; east elevation, showing roof,
chimney and drainage spouts.

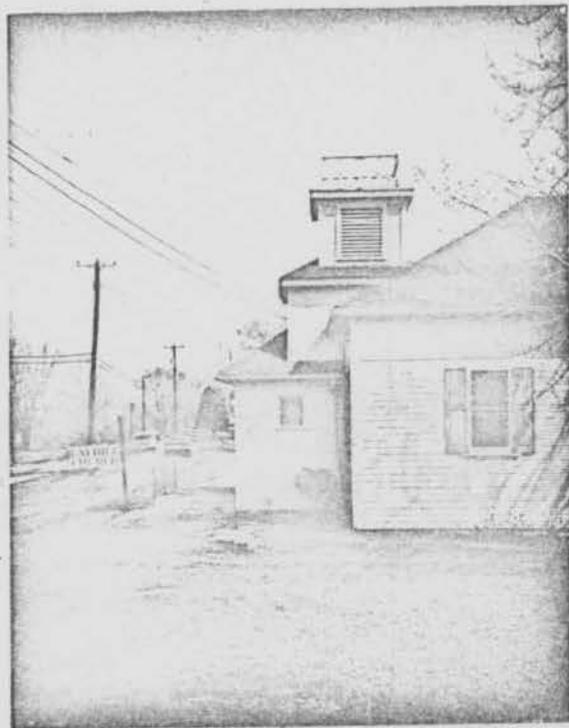
Picture 6. Detail; west elevation. The
side of the steeple structure.

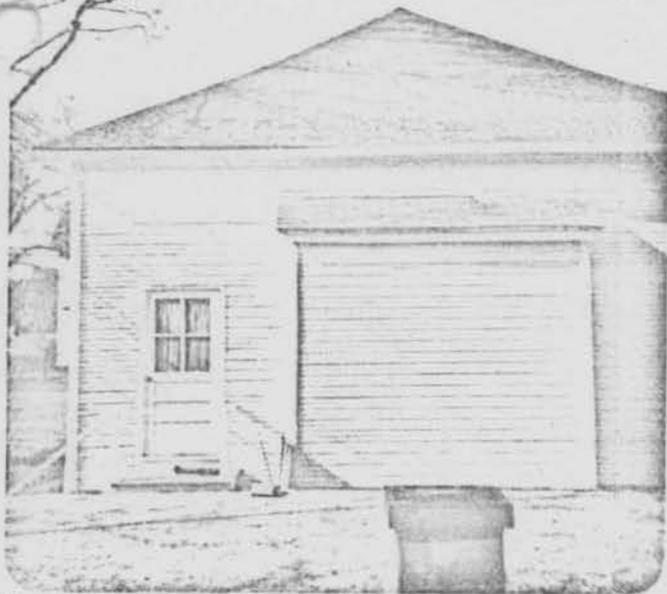
Picture 7. Detail; south facade. This picture shows the rear door and the back wall of the leanto.

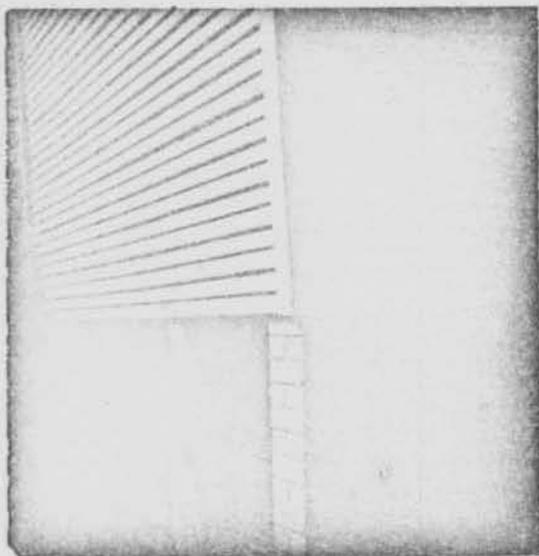
Picture 8. Detail of the southeast corner of the leanto. This picture shows the clapboarding, the vertical corner mullion, and the brick pillar that supports the leanto.

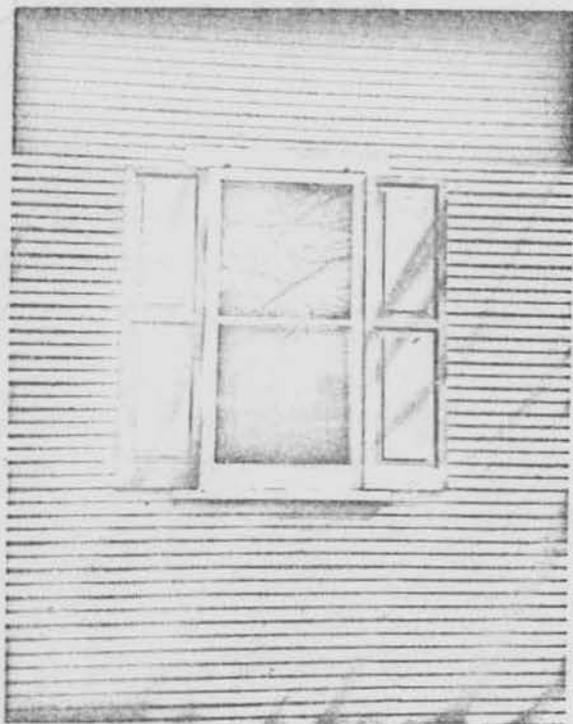
Picture 9. Detail of the north window in the west wall. All windows in the longitudinal walls, and those in the main wall of the front elevation are identical to this one.

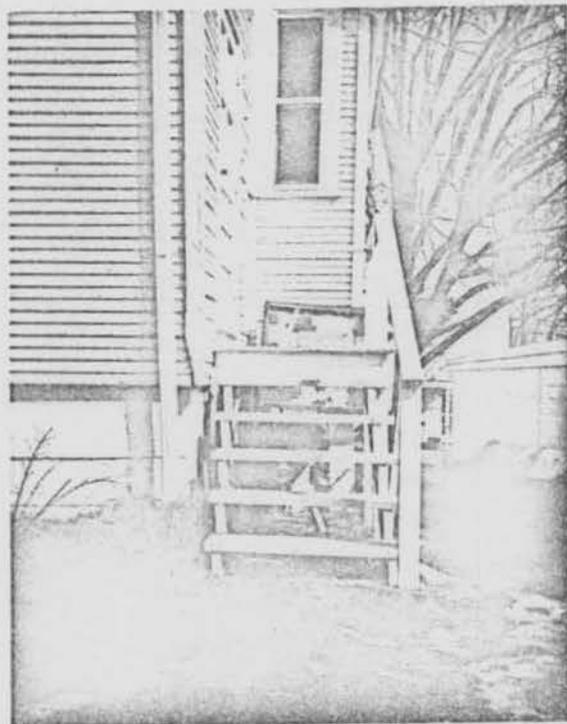
Picture 10. Detail of the back step. This picture also shows one of the narrow leanto windows. The hinges of the storm window are visible at the extreme upper margin.

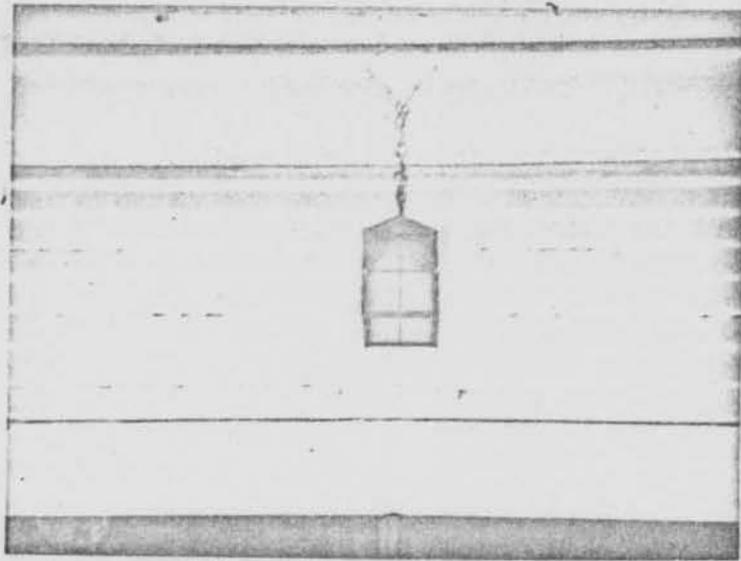
Picture 11. Detail of the decorative light fixture over the front door.

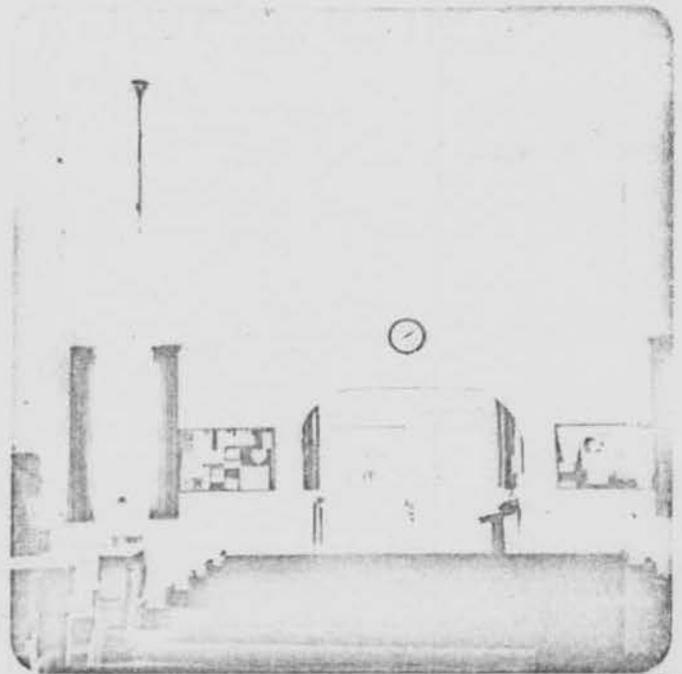
Picture 13. Detail of the north wall of the auditorium and the vestibule. This picture shows the form of the light fixture.

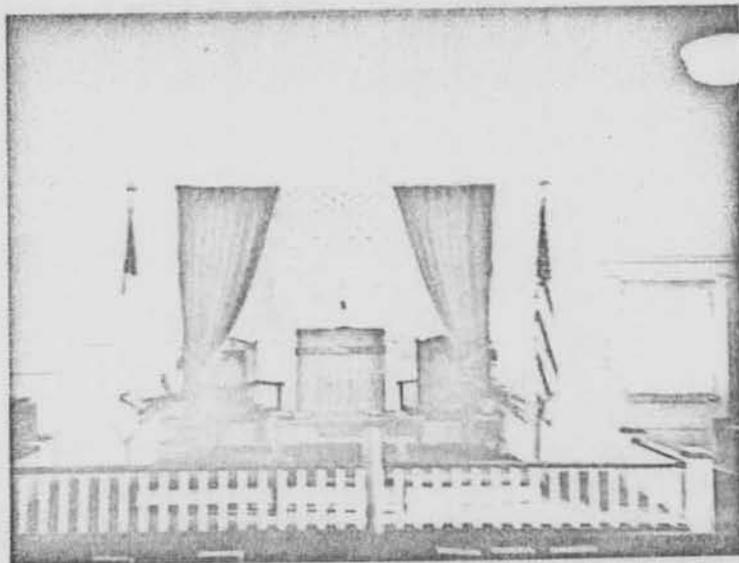
Picture 14. Detail of the leanto, platform and altar railing. The fluer-de-lis design of the wallpaper can be seen.

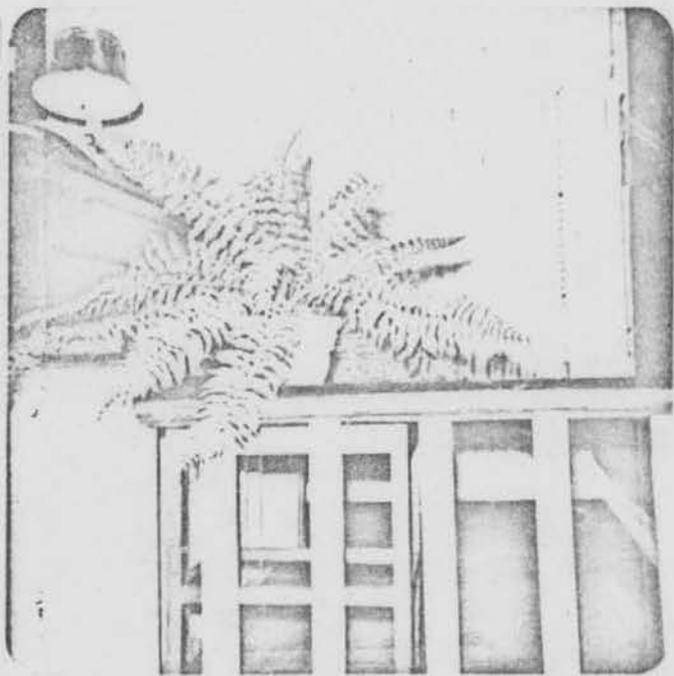
Picture 15. Detail of the east corner of the altar rail, with one of the potted plants used to decorate it. The wainscoting can be seen, illustrating how its upper margin rises next to the leanto.

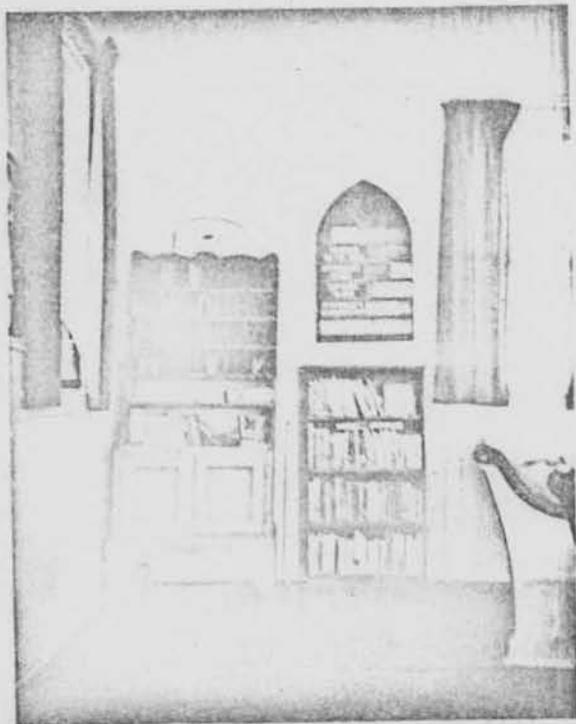
Picture 19. Detail of the northwest corner of the auditorium and typical auxiliary furnishings.
