Survey No.: M: 28-51 Construction Date: circa 1885, 1941-1947

Name: Round Oak Missionary Baptist Church

Location: 15812 Good Hope Road, Silver Spring vicinity (Cloverly), Montgomery County

Maryland Historical Trust
Maryland Inventory of Historic Properties Form
Intercounty Connector Project

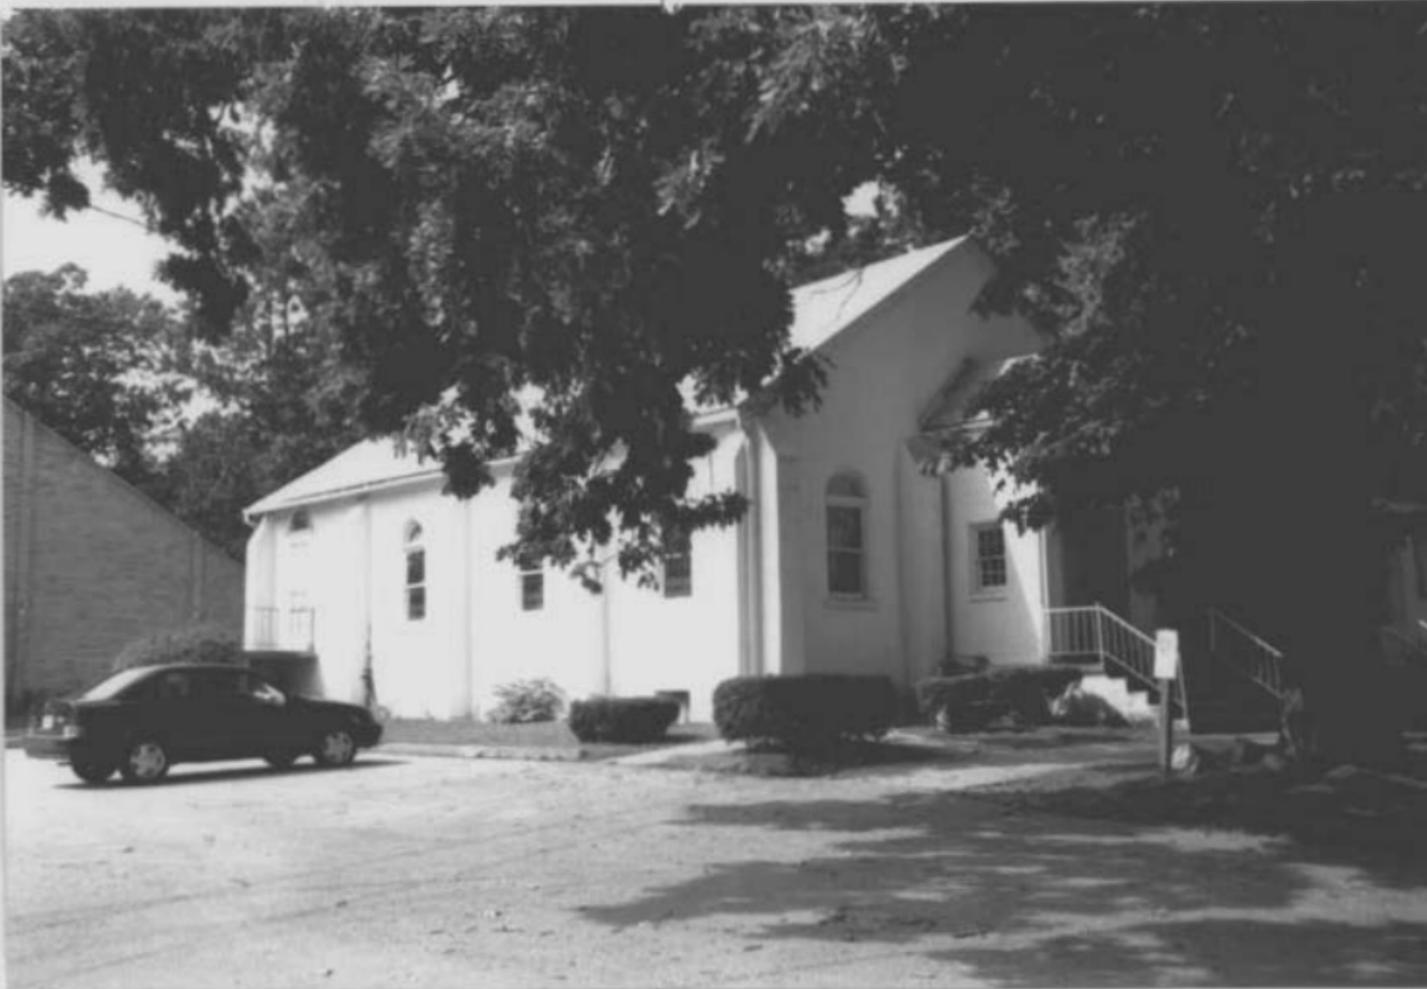
1. M: 28-51
2. Round Oak Missionary Baptist Church
3. Montgomery Co., MD
4. PAC Sporo & Co.
5. 8/97
6. MD SHPO
7. Church, south & east elevations
8. 1 of 15

The east, or front elevation has a projecting gable entry with a wood double door with raised panels, accessed from grade by concrete steps. The first bay has a round arch, leaded stained glass window between two buttresses. Most of the third bay has been concealed by the north addition.

The south elevation has five buttresses that extend to the roof overhang. Between the buttresses are three round arch, leaded stained glass windows and one wood door. The door, which has decorative raised panels and concrete steps to grade, has a round arch leaded stained glass transom.

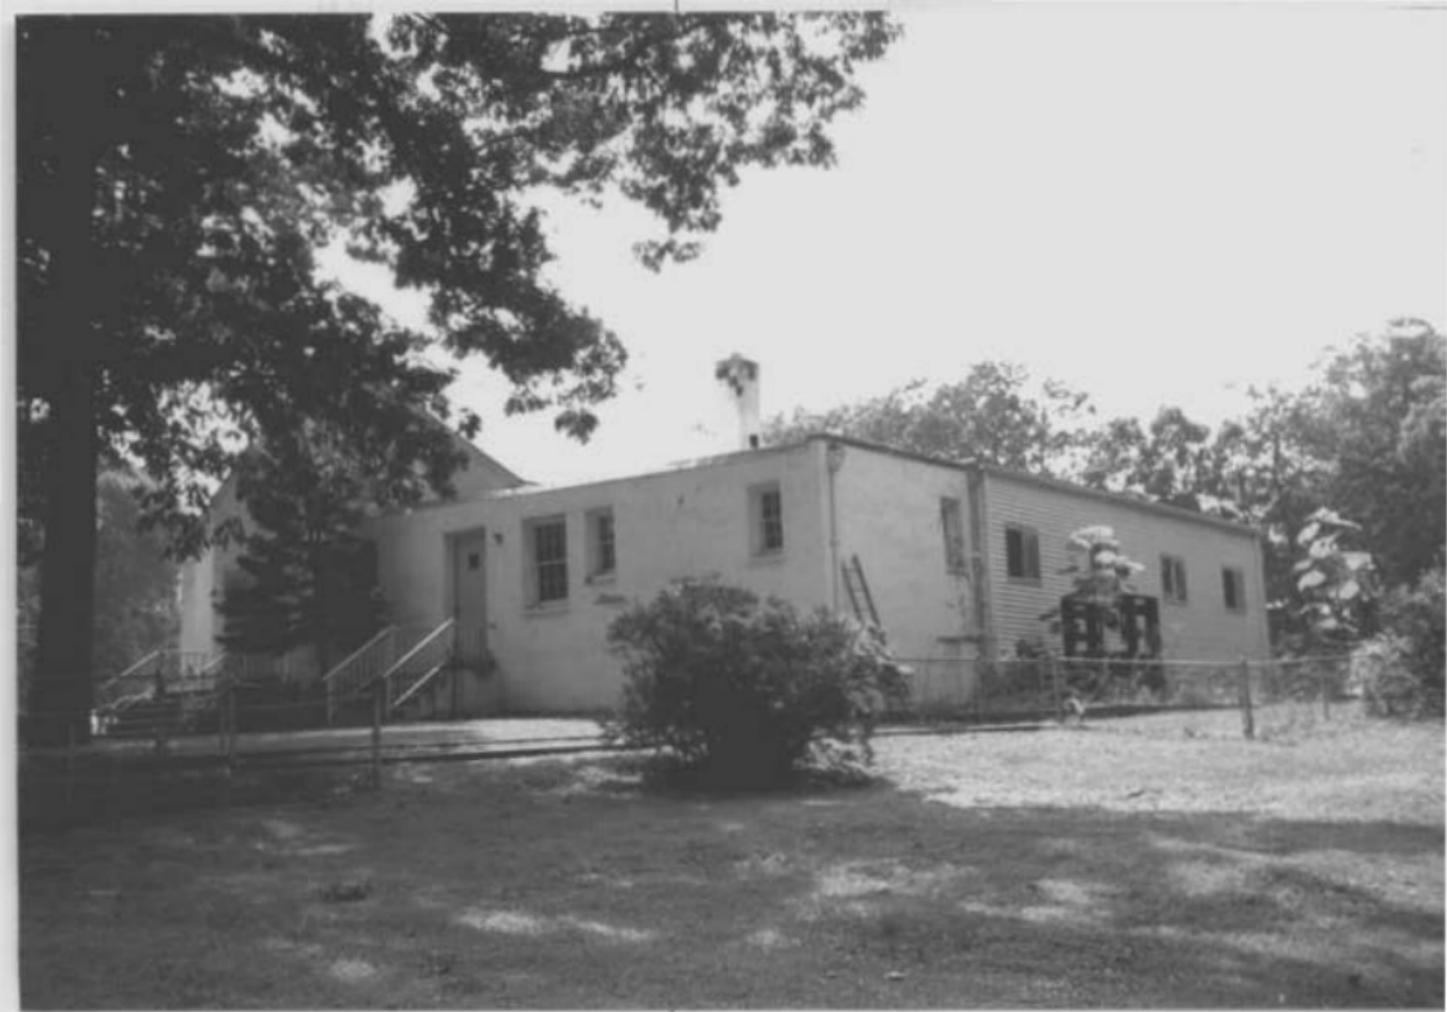
1. M: 28-51
2. Round Oak Missionary Baptist Church
3. Montgomery Co, MD
4. PAC Spero & Co.
5. 8/97
6. MD SHPO
7. Church, north & east elevations
8. 2 of 15

The north elevation is concealed by the 1-story, flat-roof addition. The addition was built in two sections. The east section, constructed in 1953, is a stucco covered concrete block entry hall with a wood door and five 4/4 double-hung wood windows. The west section, constructed in 1973 and enlarged in 1977, has vinyl siding, a wood door, and seven vinyl sliding windows.

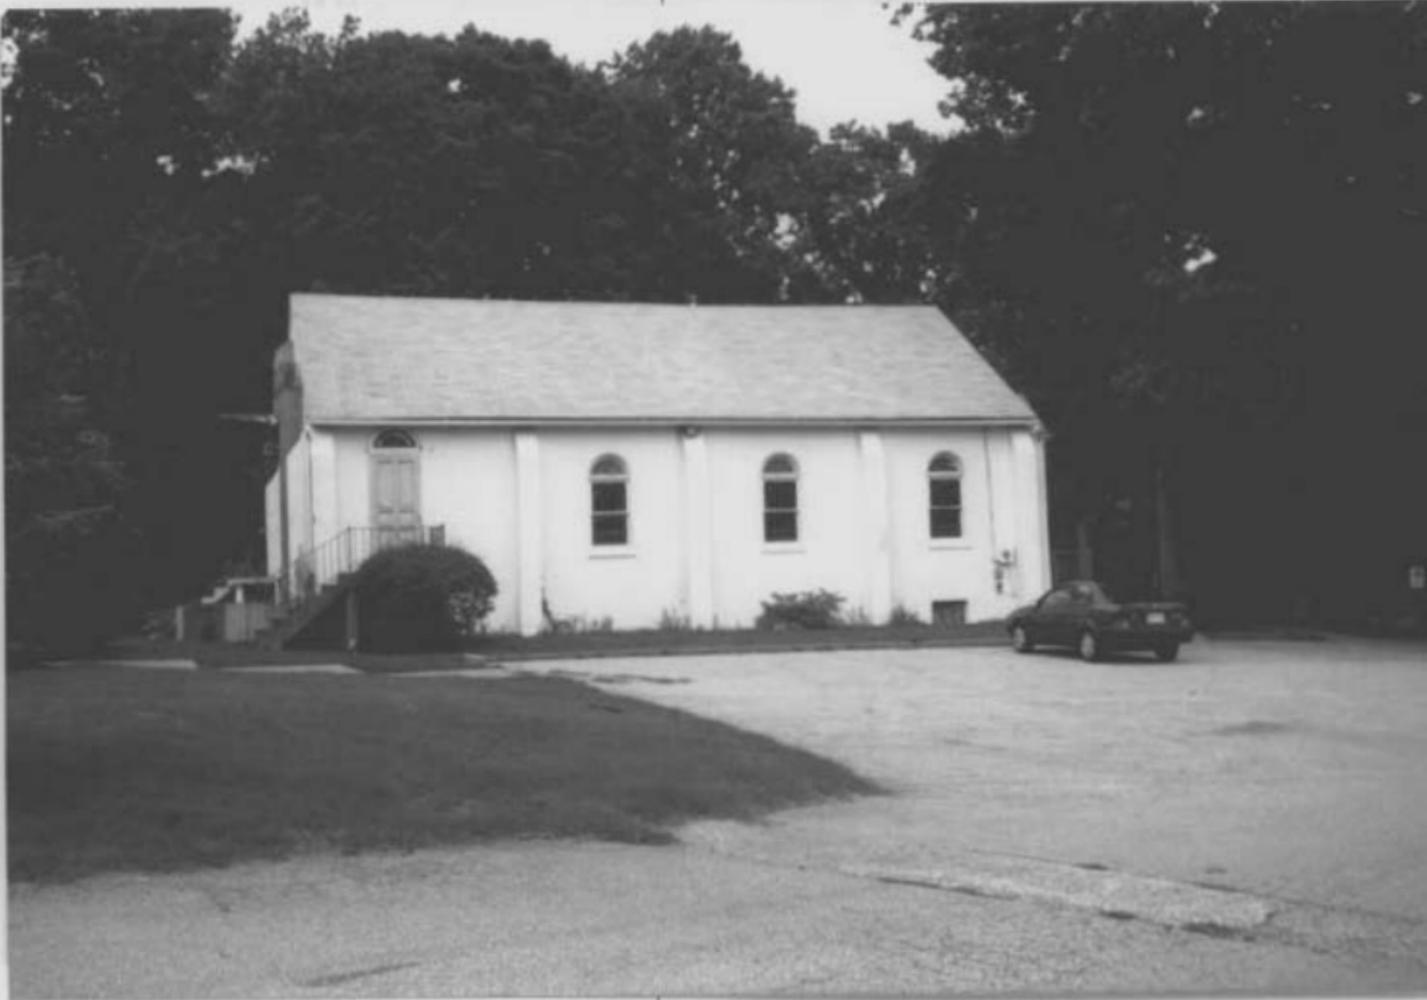
1. M: 28-51
2. Round Oak Missionary Baptist Church
3. Montgomery Co., MD
4. PAC Spaw & Co.
5. 8/97
6. MD SHPO
7. Church, south elevation
8. 3 of 15

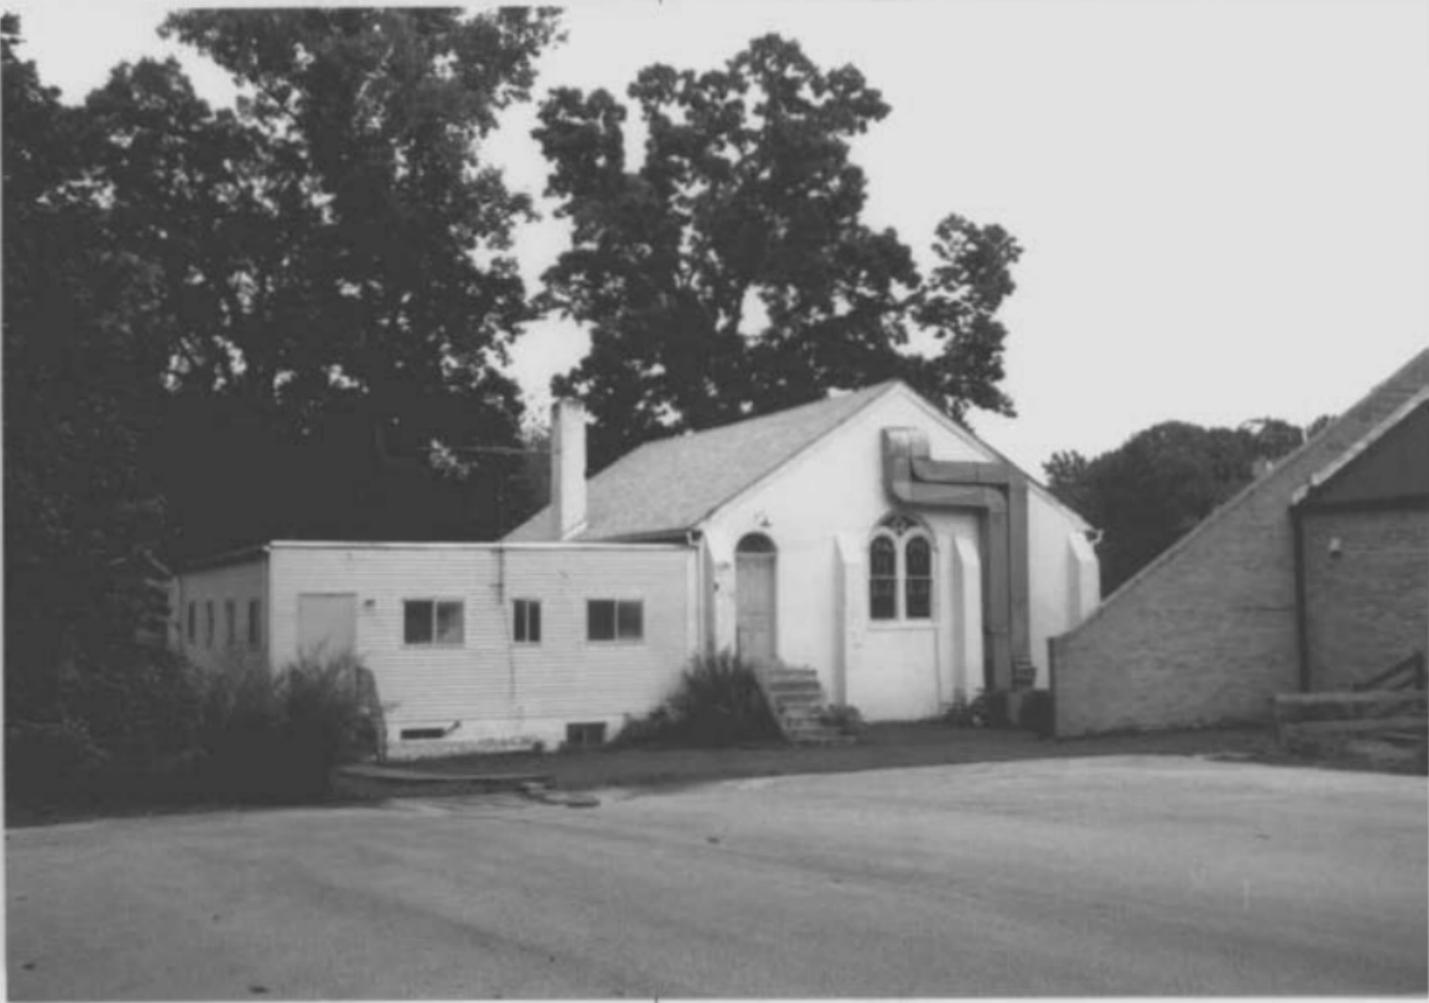
1. M: 28-51
2. Round Oak Missionary Baptist Church
3. Montgomery Co., MD
4. PAC Spaw & Co.
5. 8/97
6. MD SHPO
7. Church, west elevation
8. 4 of 15

The west, or rear elevation has four buttresses and a paired, round arch, leaded stained glass double-hung wood window. The window is located in the center of the elevation. The first bay has a wood door with a round arch leaded stained glass transom. The door is accessed by concrete steps. The third bay has air handling unit ductwork secured to the exterior wall.

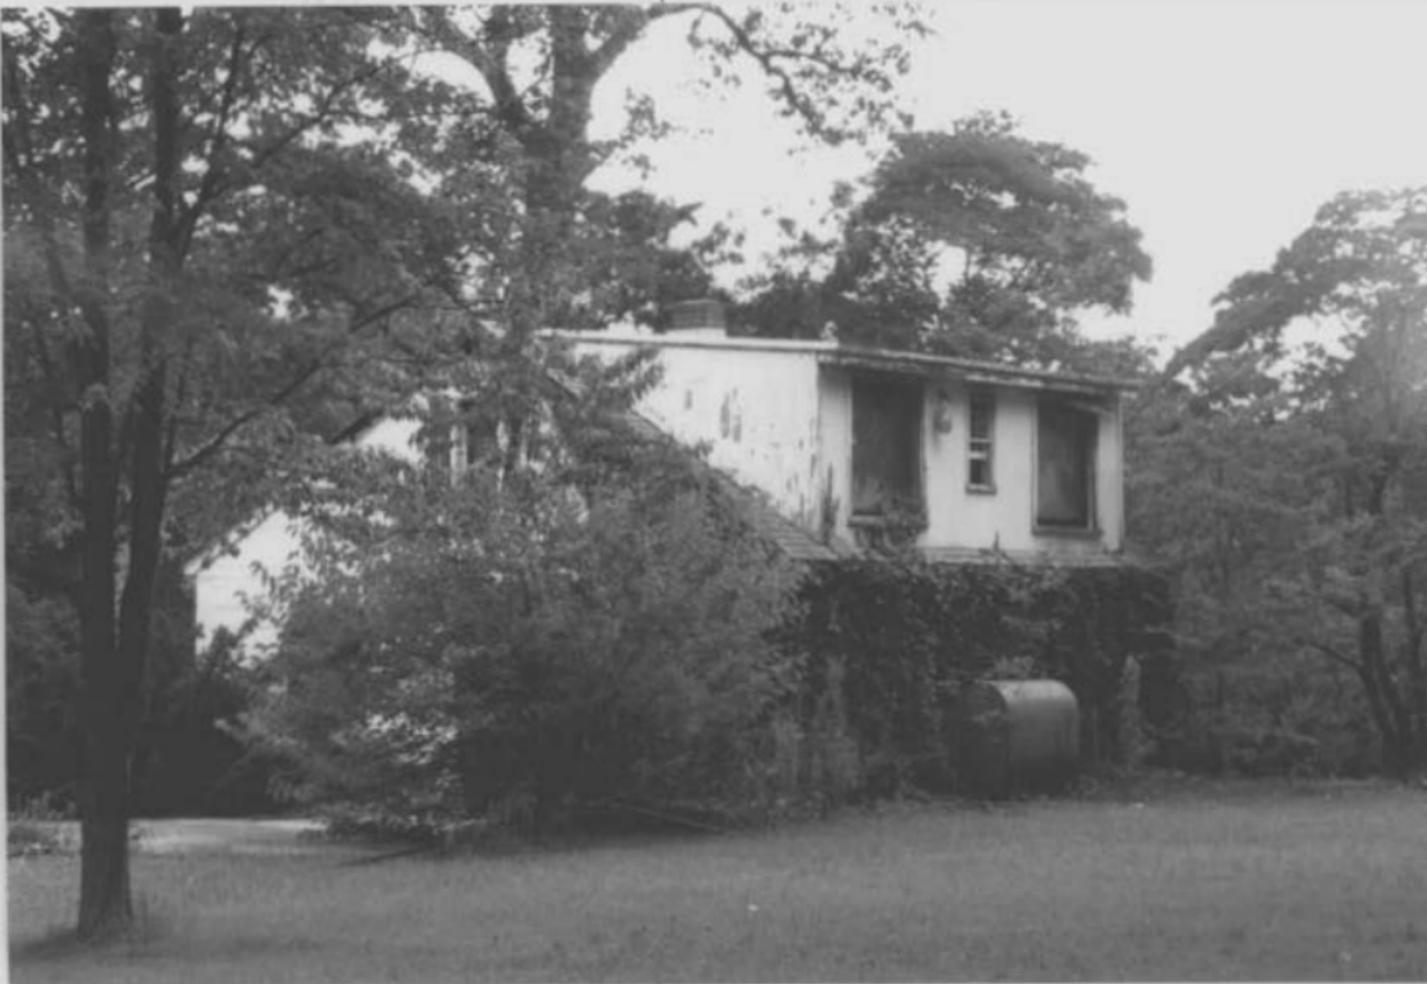
1. M: 28-51
2. Round Oak Missionary Baptist Church
3. Montgomery Co., MD
4. PAC Spero & Co.
5. 8/97
6. MD SHPO
7. residence, south & east elevations
8. 5 of 15

The first building associated with this property is a residence. Constructed circa 1945, the residence is a small, 1½-story, side-gable concrete block cottage. The structure is in deteriorated condition and many of the windows have been removed. It has an asphalt shingle roof with a large, plywood sheathed shed-roof dormer on the east side.

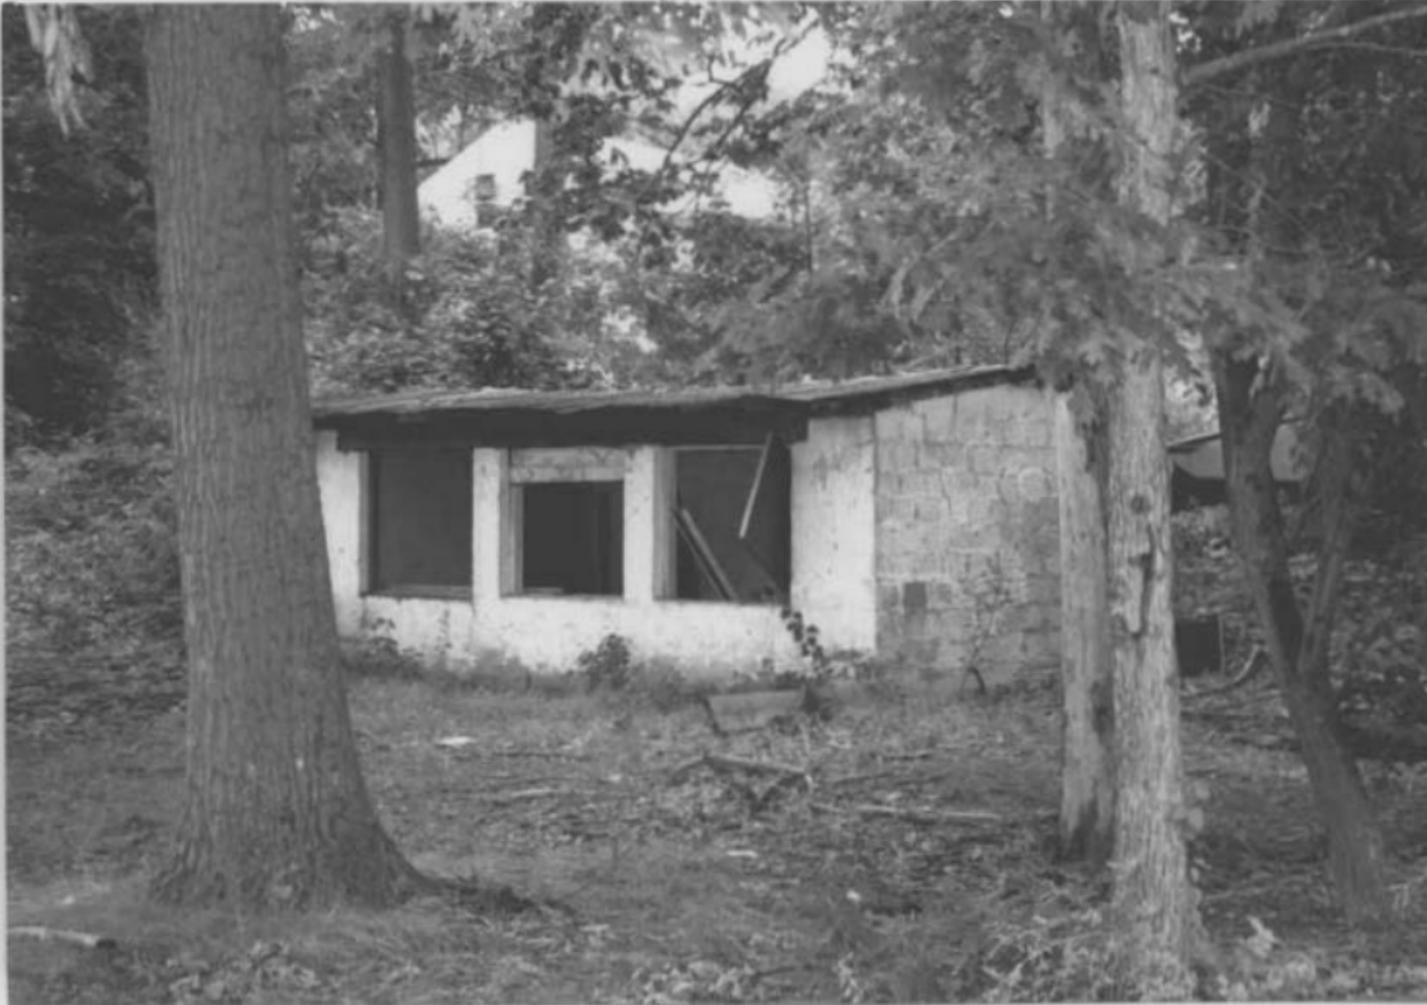
1. M: 28-51
2. Round Oak Missionary Baptist Church
3. Montgomery Co, MD
4. PAC Speer & Co.
5. 8/97
6. MD SHPO
7. shed, south + east elevations
8. 6 of 15

The second building is a small 1-story, concrete block shed with an standing seam metal, side-gable roof. The shed, constructed circa 1945, is in deteriorated condition; the door has been removed and there are three large openings on the west elevation. The shed is located west of the church and northeast of the residence. The first and second buildings were acquired by the church in 1987.

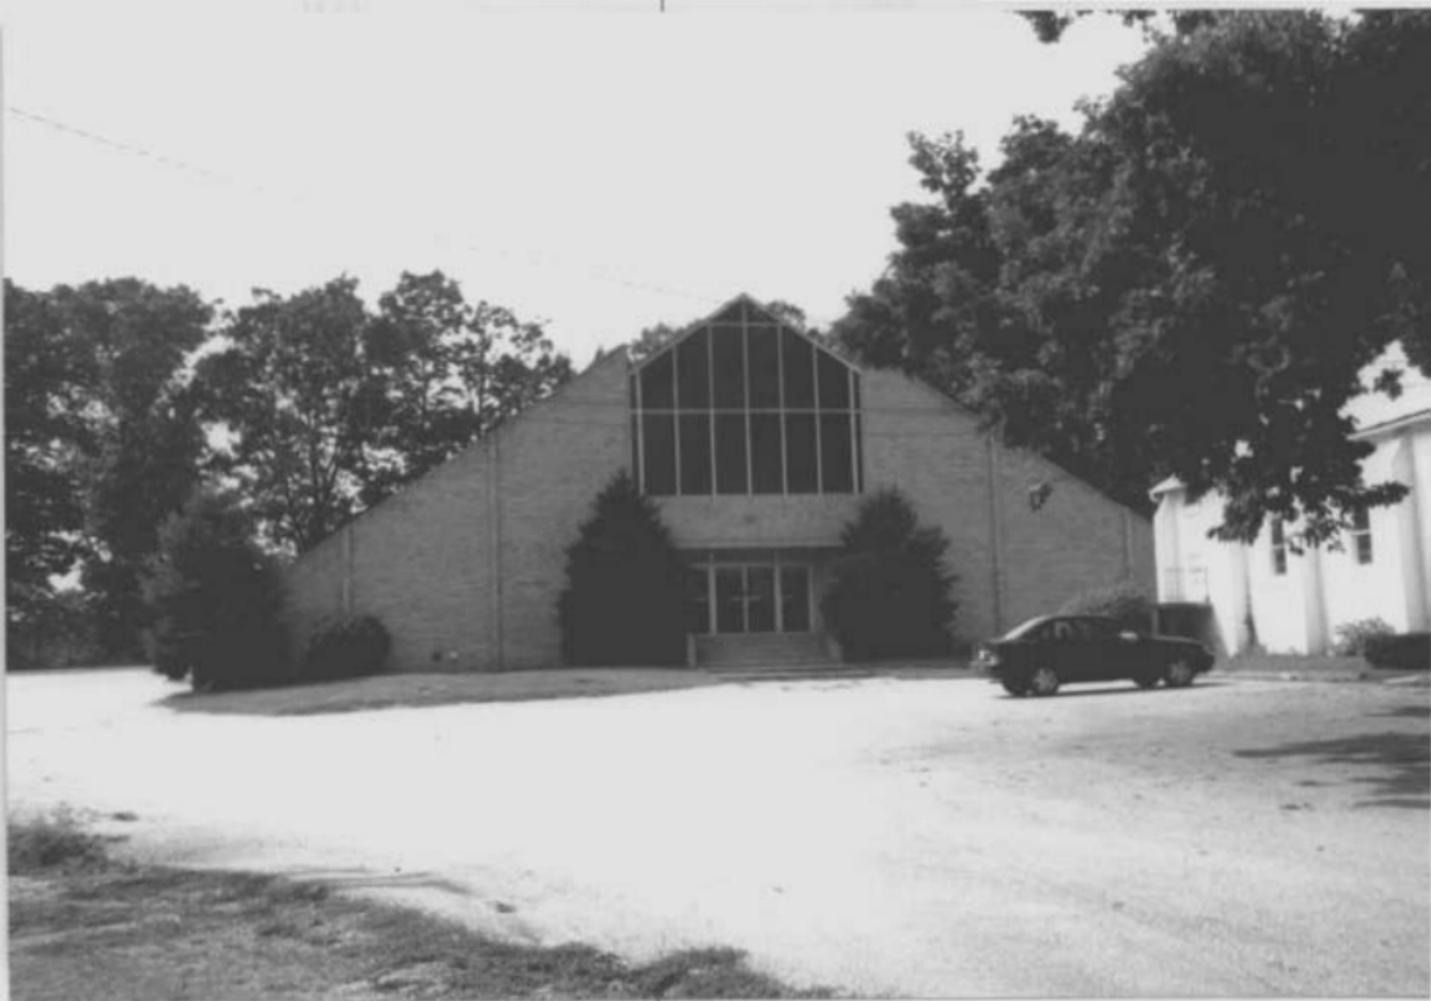
1. M: 28-51
2. Round Oak Missionary Baptist Church
3. Montgomery Co., MD
4. PAC Sperry & Co.
5. 8/97
6. MD SHPO
7. modern church, east elevation
8. 7 of 15

The third building is a large 1½-story church sanctuary and offices, constructed in 1982. The church is of concrete block construction with brick veneer. The east, or front elevation has a front-gable brick veneer facade with glass doors and a section of enamel panels in the gable end. The church is located a short distance west of the historic church.

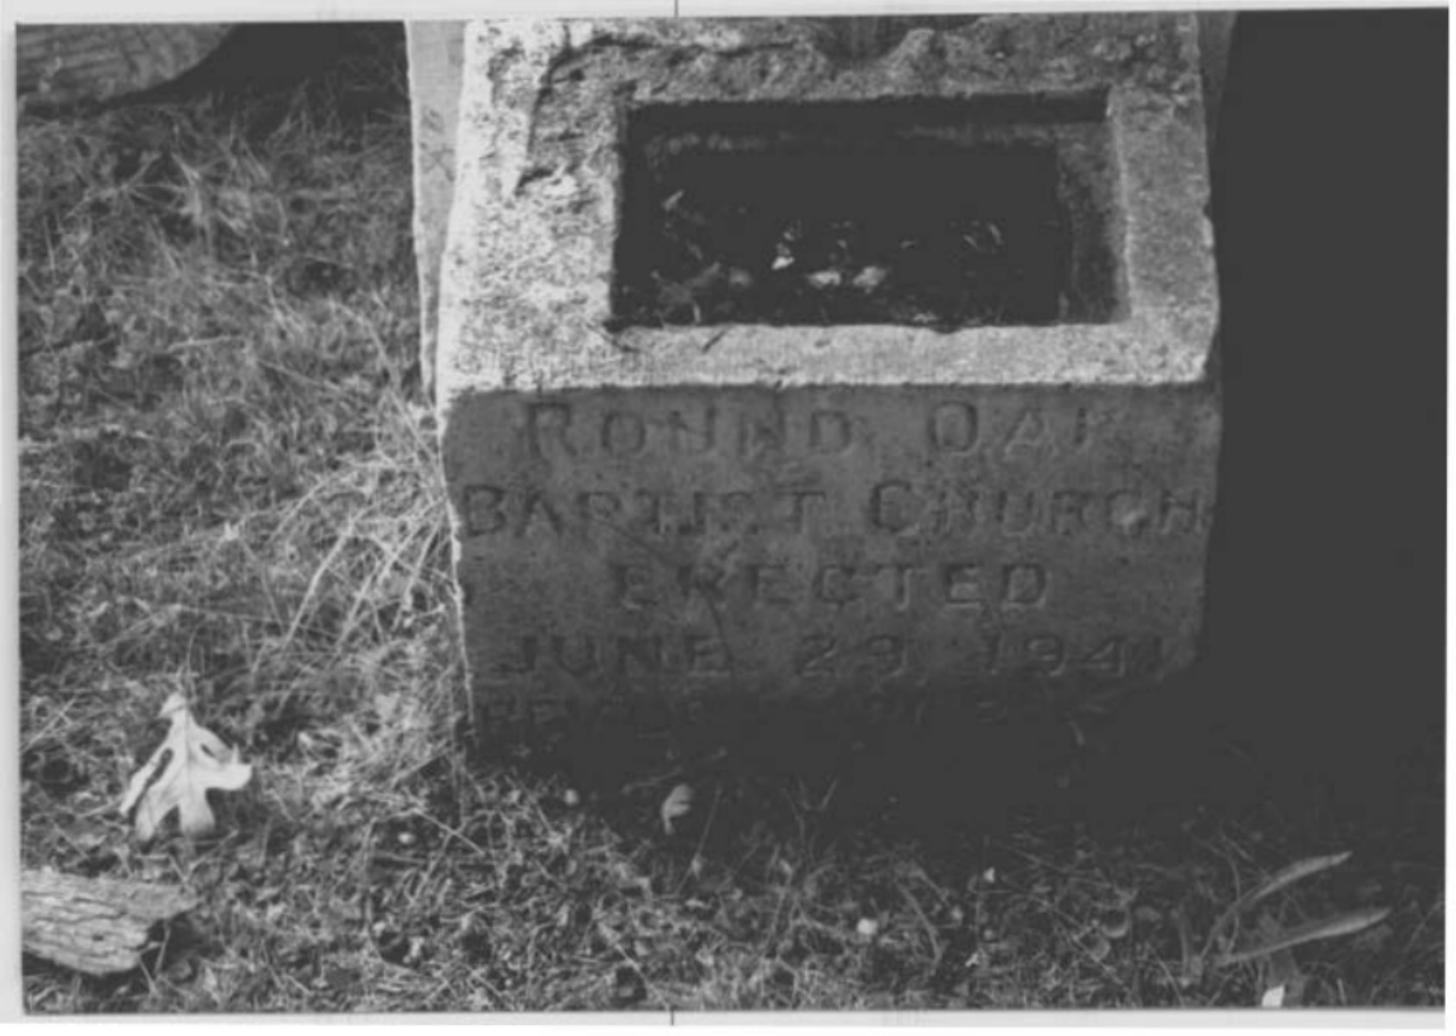
ROUND OAK
BAPTIST CHURCH
ERECTED
JUNE 29 1941

1. M: 28-51
2. Round Oak Missionary Baptist Church
3. Montgomery Co., MD
4. PAC Sperry & Co.
5. 8/97
6. MD SHPO
7. cornerstone, view north
8. 8 of 15

The Round Oak Missionary Baptist Church, constructed from 1941 to 1947 with a cemetery dating from circa 1885, is a 1-story, 3-bay vernacular front-gable church on the west side of Good Hope Road in the Cloverly area of Silver Spring, Montgomery County. The building has been altered by a 1-story addition to the north. The alteration concealed the location of the cornerstone, which was removed and placed on grade at the southeast corner of the building.

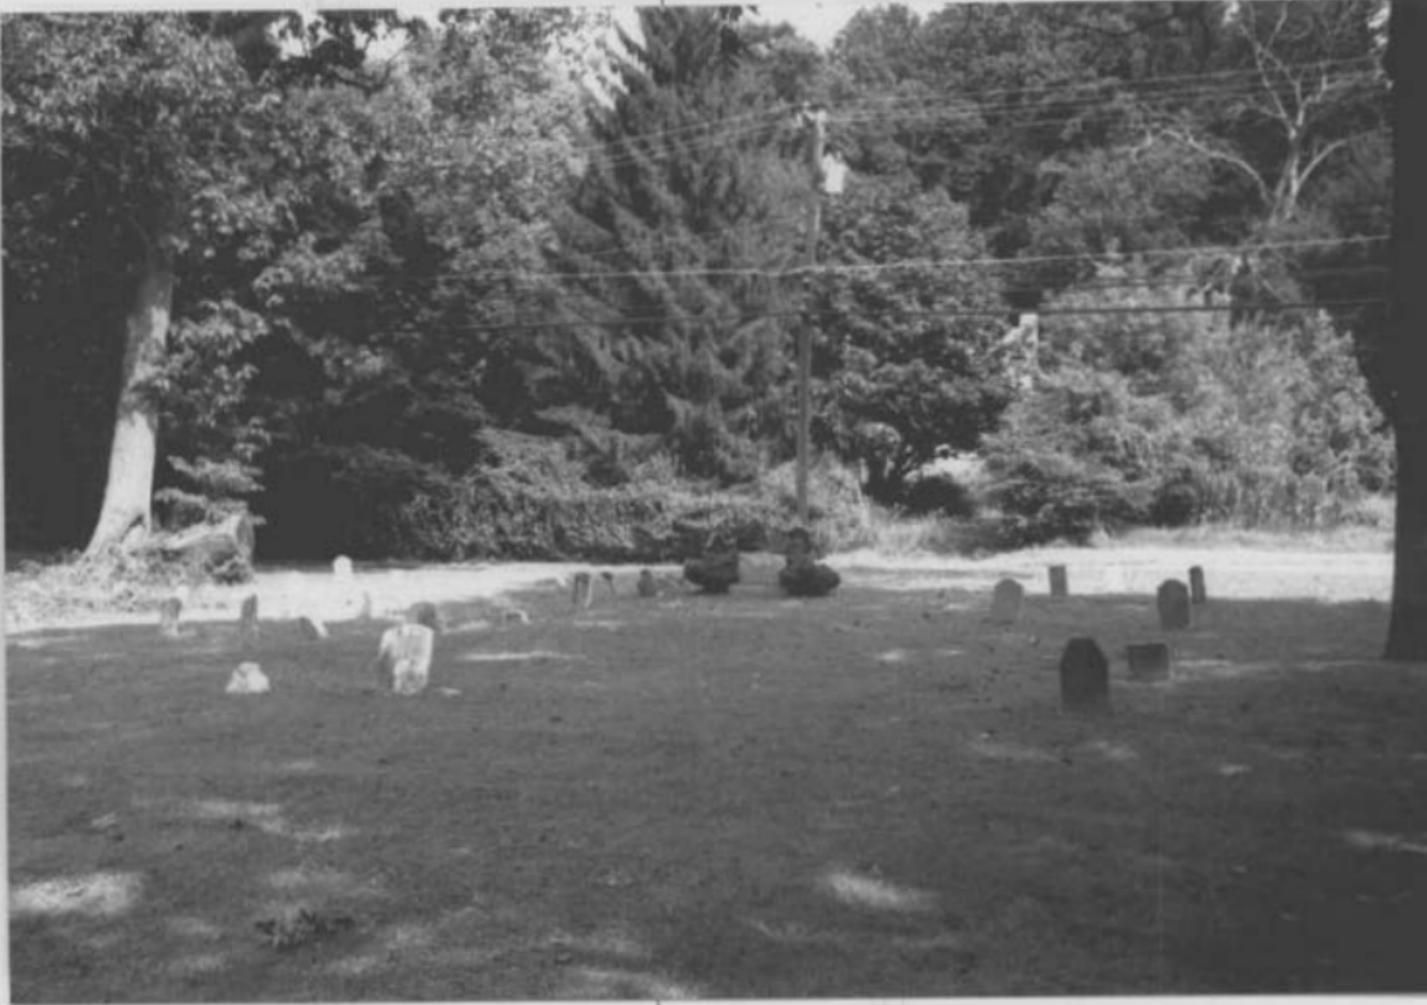
1. M: 28-51
2. Round Oak Missionary Baptist Church
3. Montgomery Co., MD
4. PAC Spaw & Co.
5. 8/97
6. MD SHPO
7. cemetery
8. 10 of 15

There are a cemetery and three buildings associated with this property. The cemetery, which is located northeast of the church, is laid out in a grid pattern with the stones facing east. The earliest stone located dates from 1888. Many of the stones, especially the stones from circa 1920 to circa 1945, have simple, hand carved inscriptions. The remaining stones are standard engraved types. Several of the stones have been broken and the inscriptions have been worn or damaged. Evidence indicates that the cemetery was still in use in the 1950s.

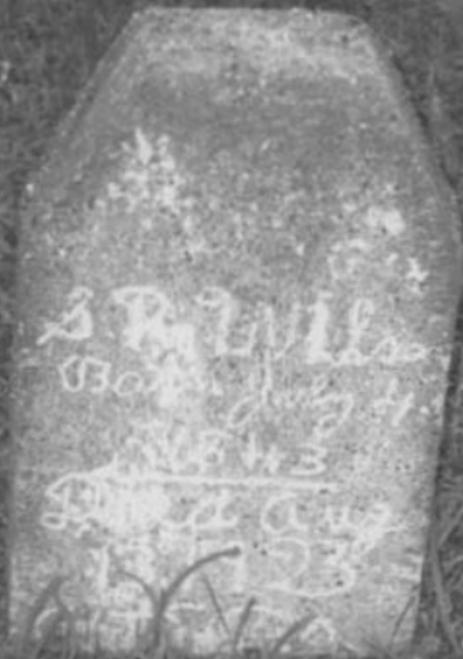
S. P. Miller
Born July 4
1843
Died Aug
1913

1. M: 28-51
2. Round Oak Missionary Baptist Church
3. Montgomery Co., MD
4. PAC Spero & Co.
5. 8/97
6. MD SHPO
7. 1923 headstone
8. 12 of 15

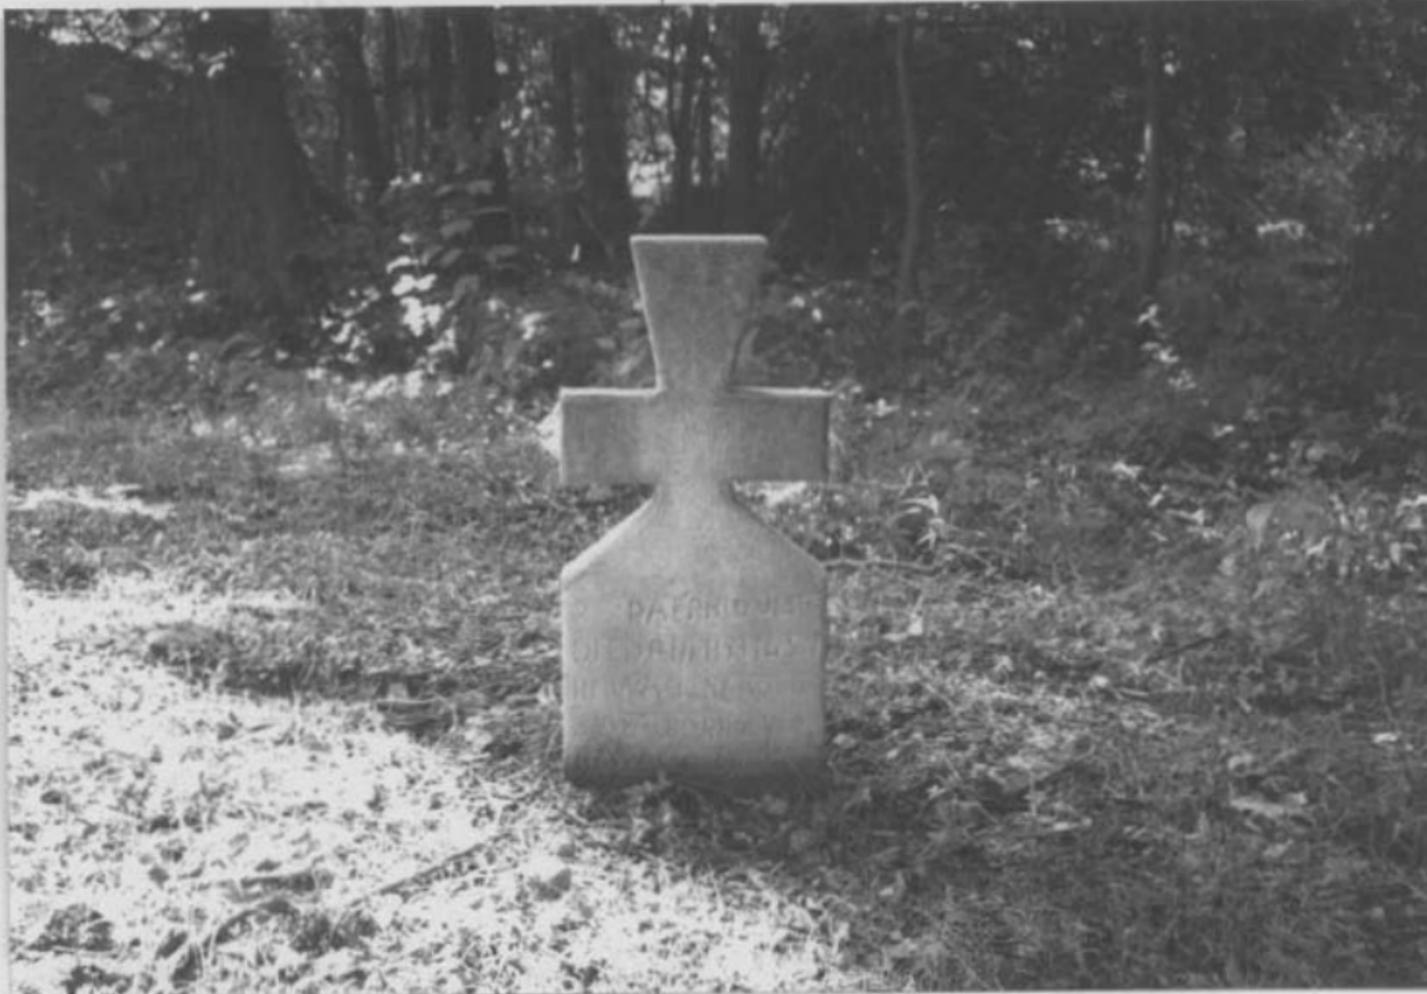
1. M: 28-51
2. Round Oak Missionary Baptist Church
3. Montgomery Co., MD
4. PAC Spero & Co.
5. 8/97
6. MD SHPO
7. 1945 headstone
8. 13 of 15

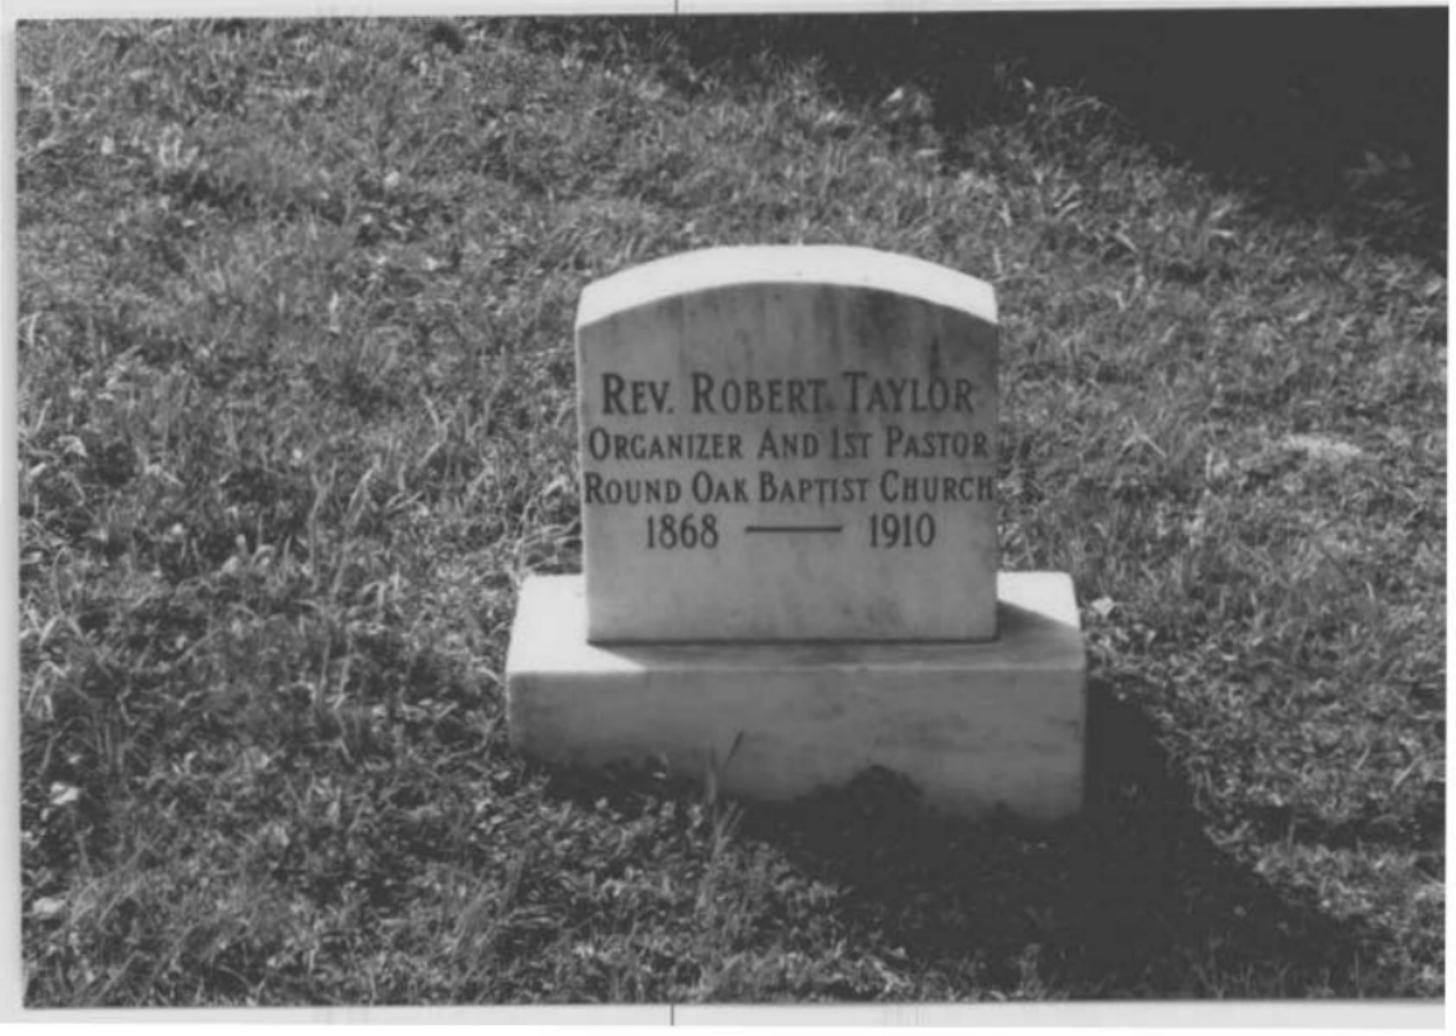
REV. ROBERT TAYLOR
ORGANIZER AND 1ST PASTOR
ROUND OAK BAPTIST CHURCH
1868 ——— 1910

1. M: 28-51
2. Round Oak Missionary Baptist Church
3. Montgomery Co., MD
4. PAC Spero & Co.
5. 8/97
6. MD SHPO
7. headstone of church organizer & 1st pastor
8. 14 of 15

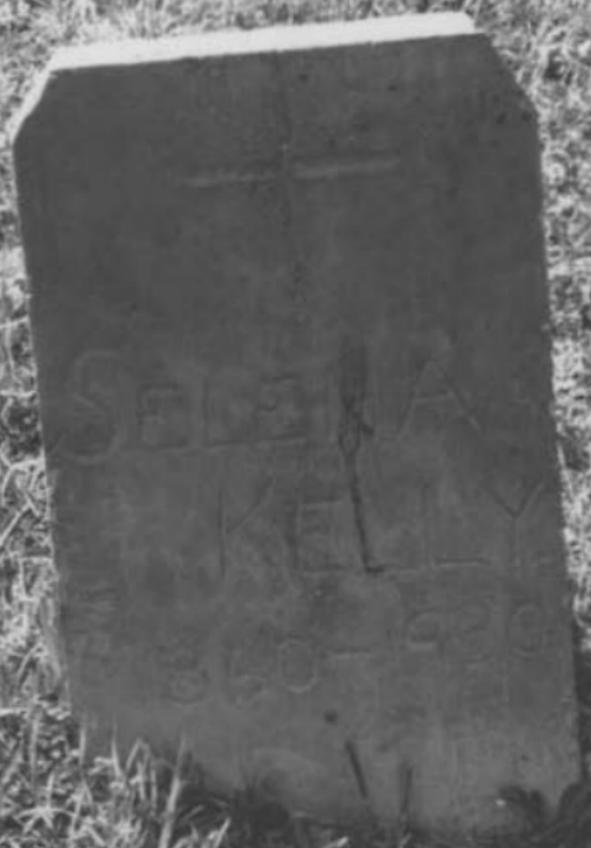
1. M: 28-51
2. Round Oak Missionary Baptist Church
3. Montgomery Co, MD
4. PAC Spero & Co.
5. 8/97
6. MD SHPO
7. 1930 headstone
8. 15 of 15
