MARYLAND INVENTORY OF HISTORIC BRIDGES
HISTORIC BRIDGE INVENTORY
MARYLAND STATE HIGHWAY ADMINISTRATION/
MARYLAND HISTORICAL TRUST

SHA Bridge No. M-85 Bridge name Talbot Avenue over CSXT Railroad

**Maryland Historical Trust
State Historic Sites Inventory Form**

and/or common Talbot Avenue Bridge

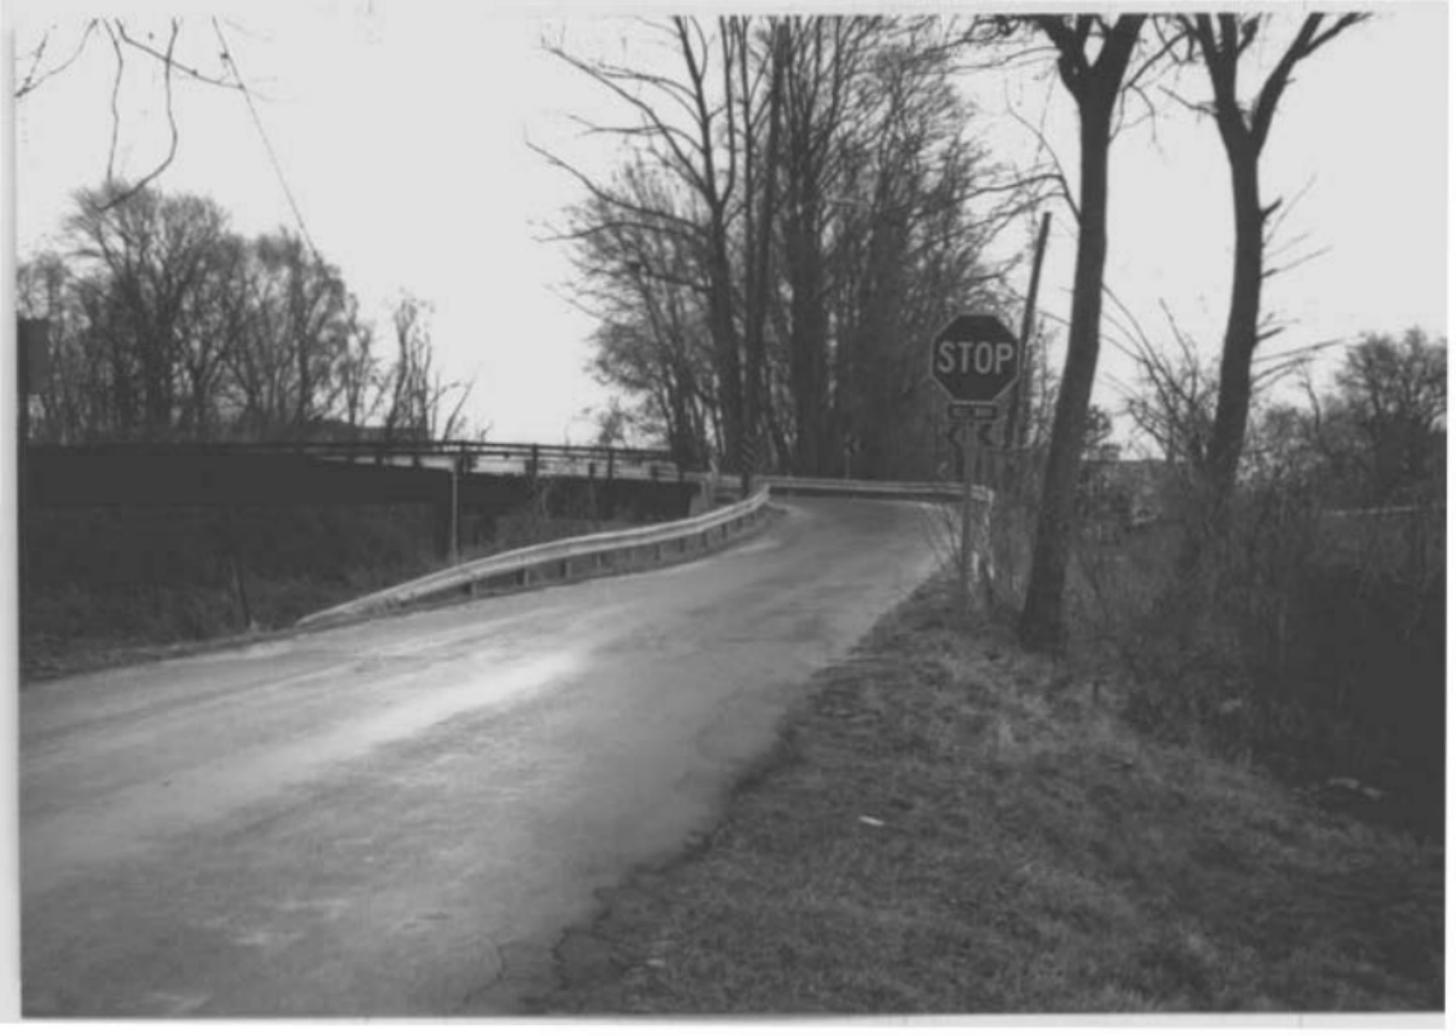
1. m: 36-30
2. Talbot Avenue over CSXT Railroad
3. Montgomery Co.
4. Tim Tamburino
5. 3-97
6. MD SHPO
7. West approach
8. 1 of 5

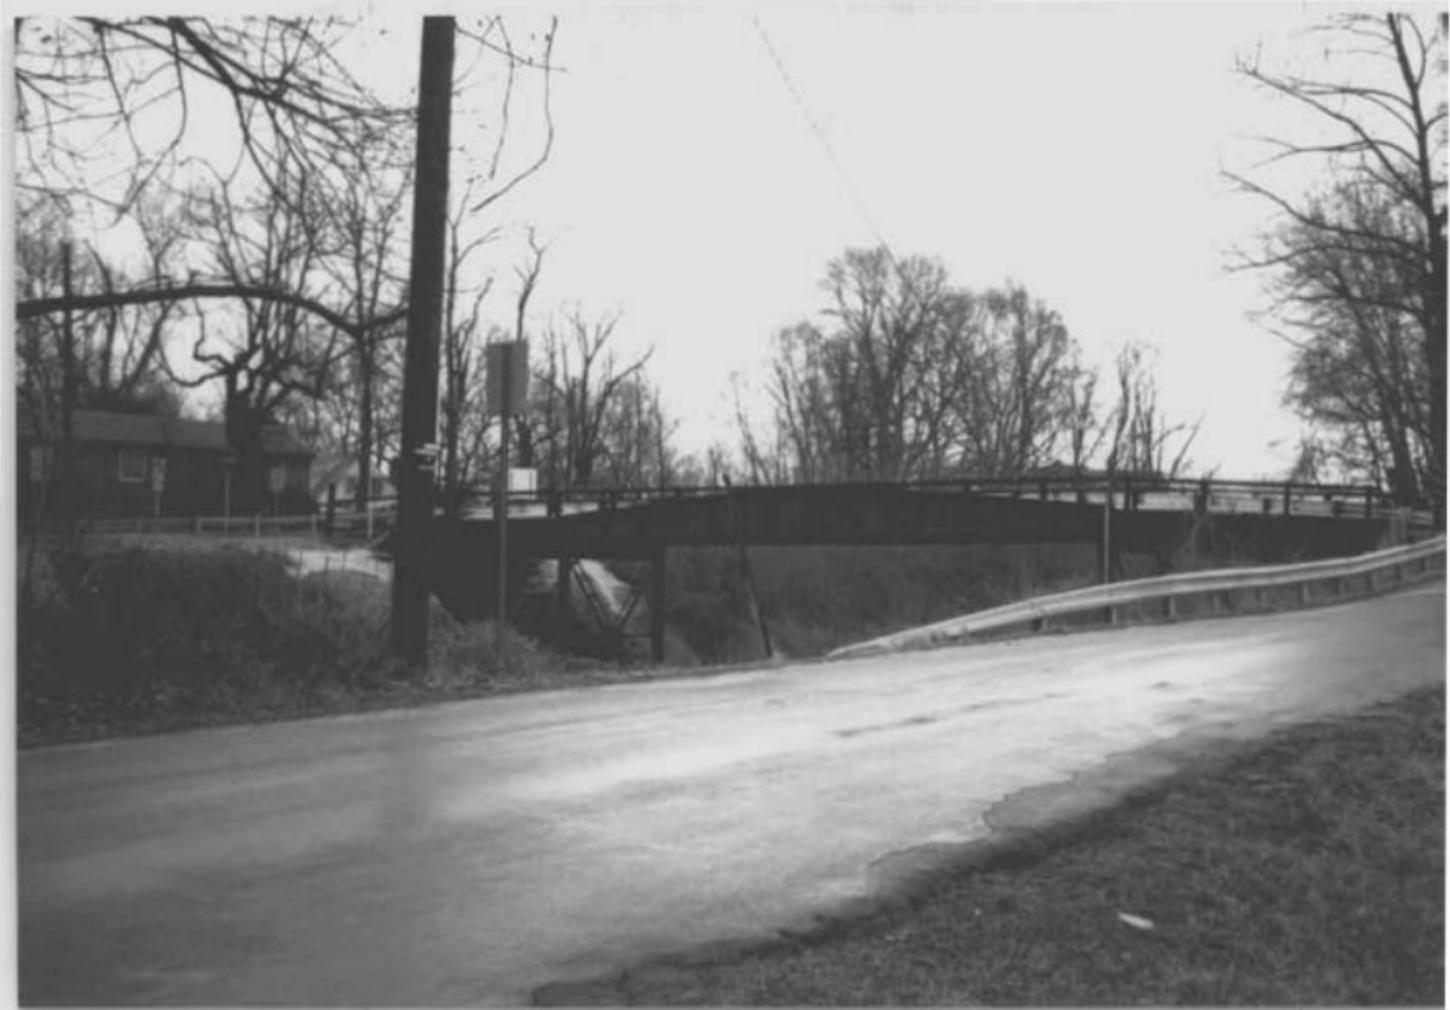
8. 2 of 5

7. West elevation

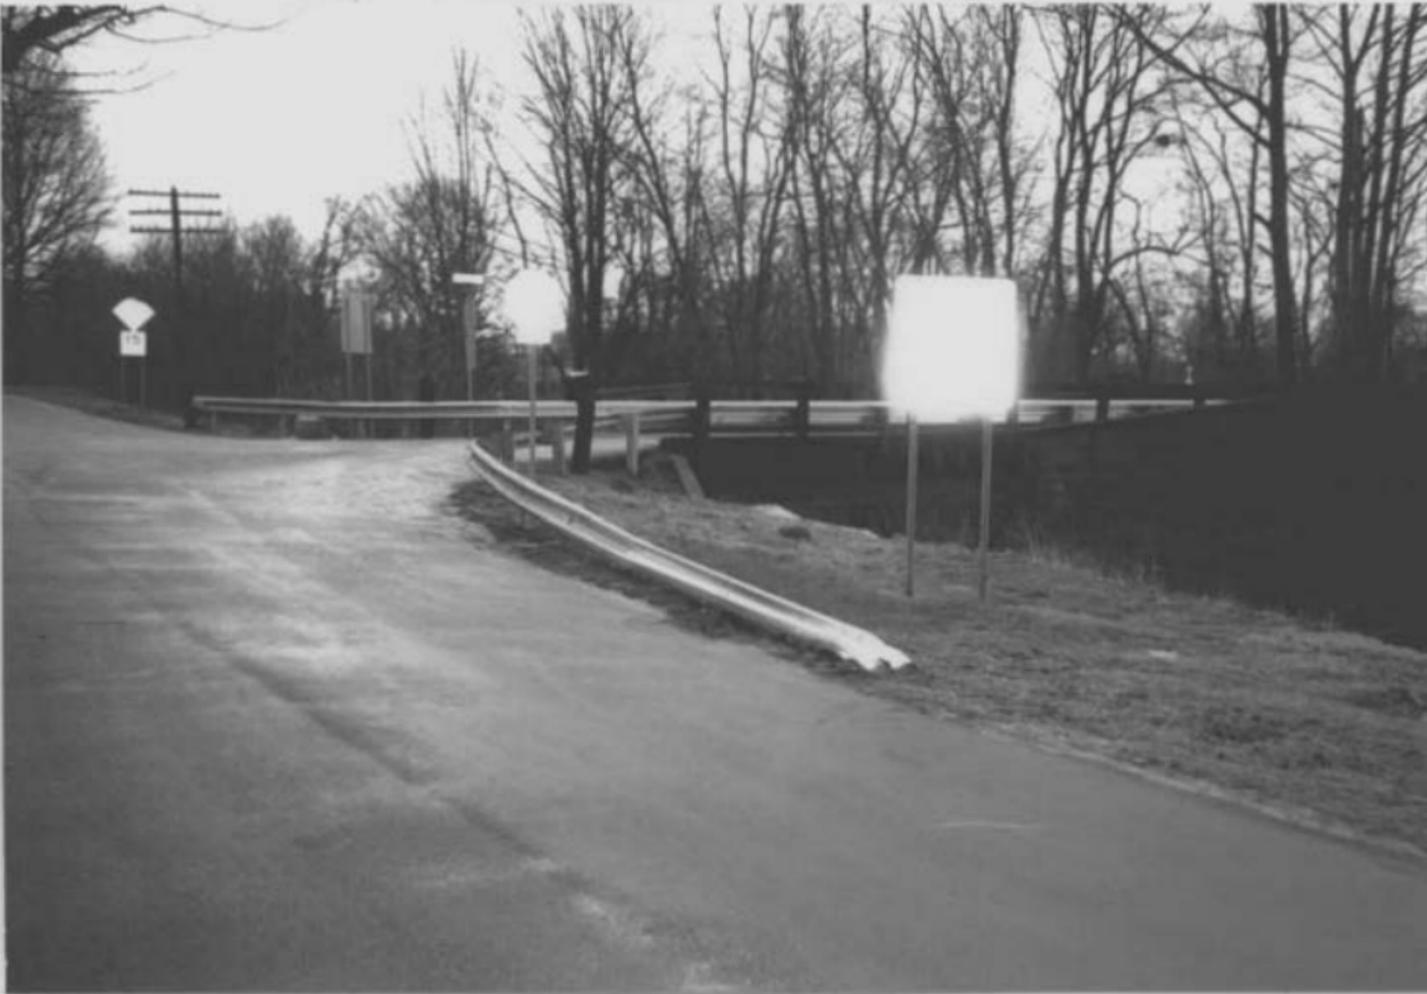
8. 3 of 5

7. West approach

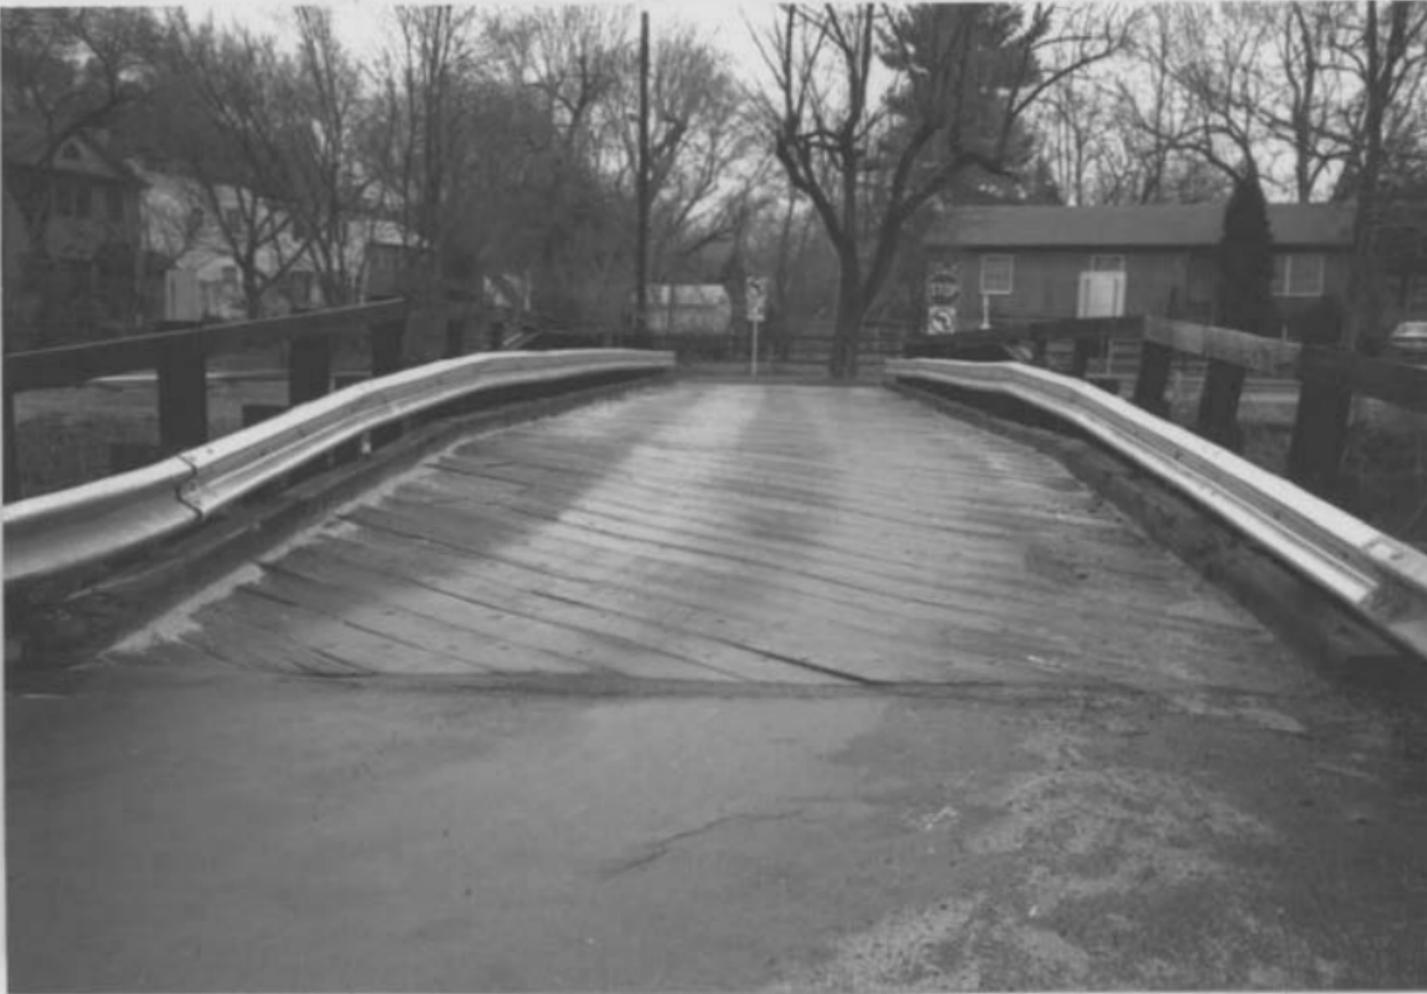
1. M: 36-30
2. Talbot Avenue over CS&T Railroad
3. Montgomery Co. MD
4. Tim Tamburino
5. 3-97
6. MD SHPO
7. Decks
8. 4 of 5

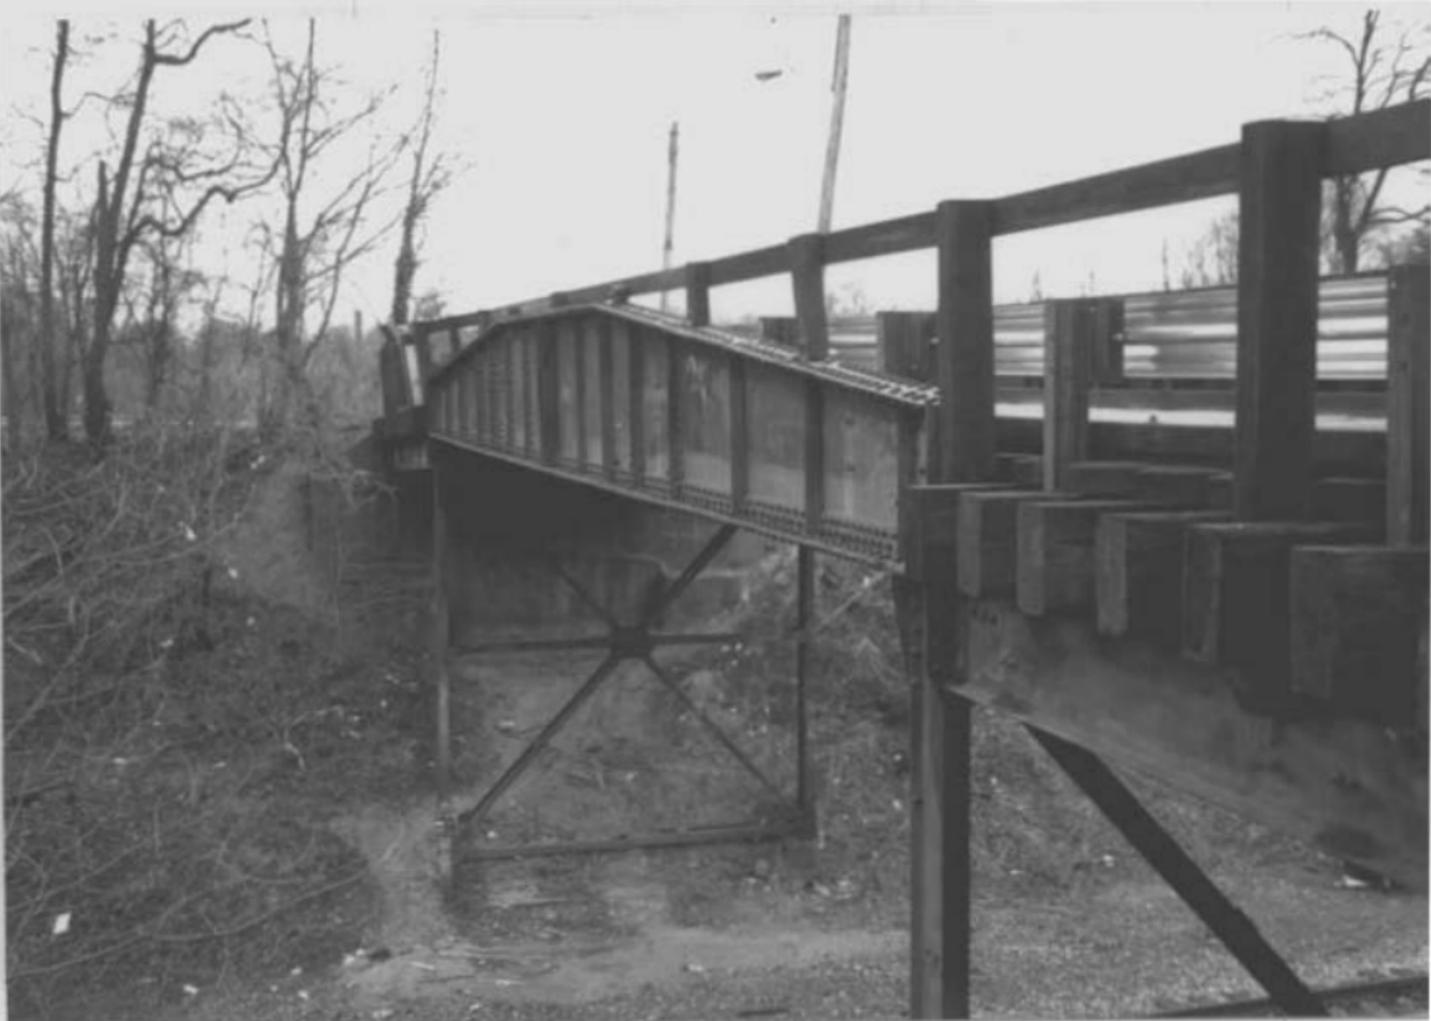
1. M: 36-30
2. Talbot Avenue over CSAT Railroad
3. Montgomery Co, MD
4. Tim Tam Serrino
5. 3-97
6. MD SHPO
7. East elevation, detail of
8. 5 of 5

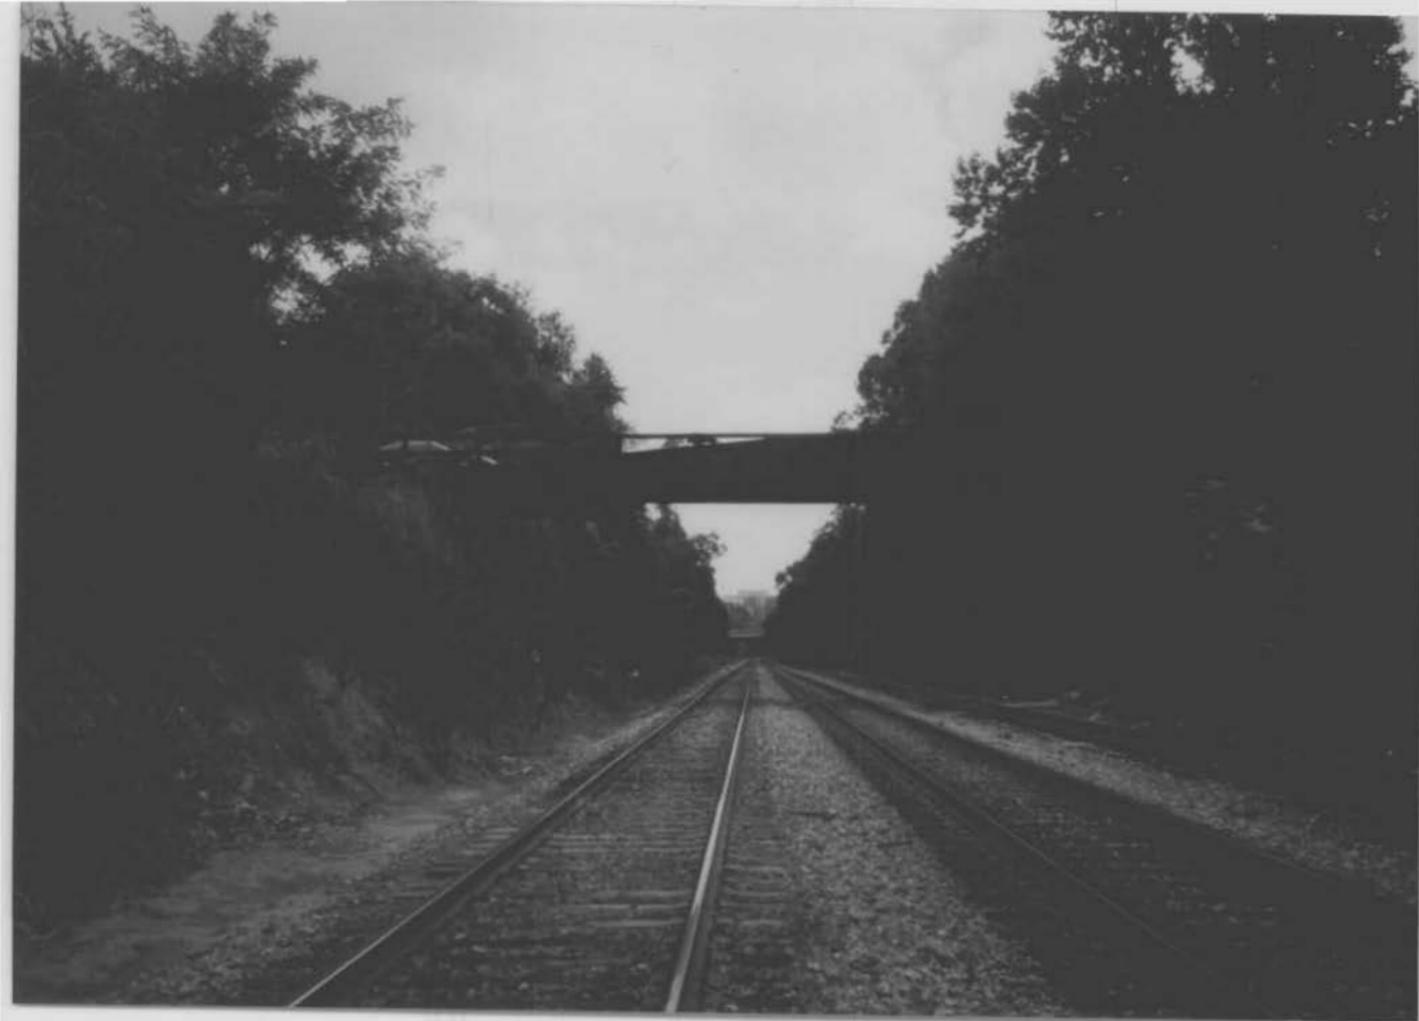
1 OF 1

VIEW LOOKING SOUTHEAST, NORTH WEST

ELEVATION OF BRIDGE.
